MONITORING YEAR 1 ANNUAL REPORT

BIG HARRIS CREEK MITIGATION SITE

Cleveland County, NC
DMS Project No. 739
DEQ Contract 006256
DWR 401 Project No. 10-0811
USACE Action ID No. SAW-2009-0475
Broad River Basin
HUC 03050105

Submission Date: February 6, 2019

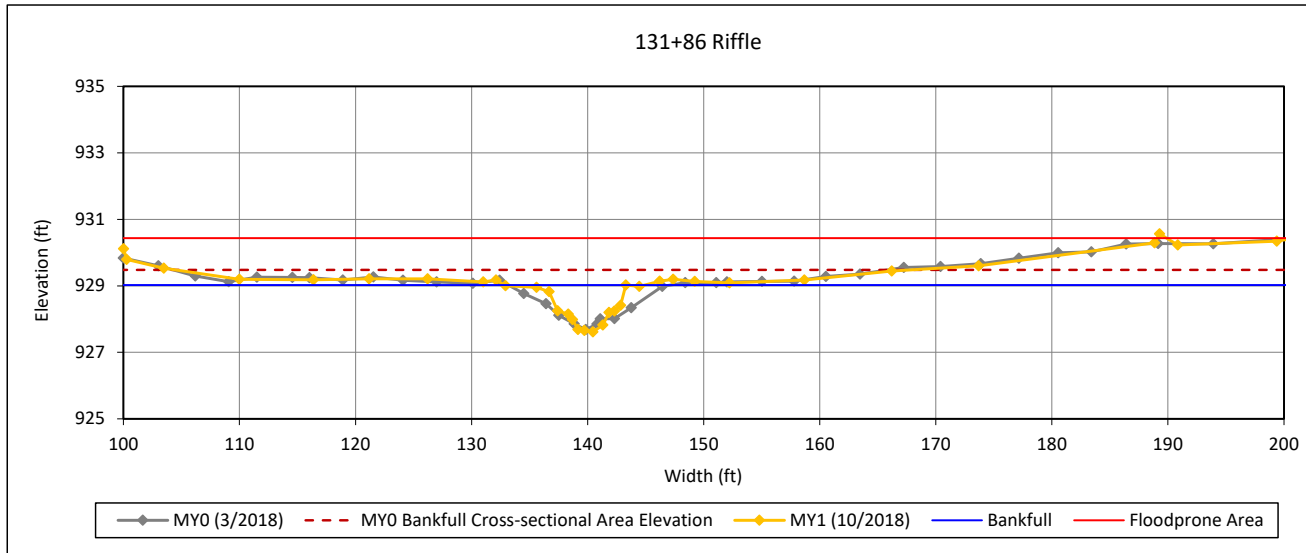
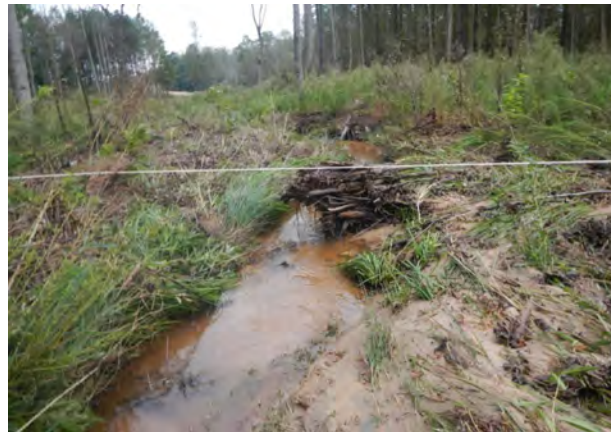
UBHC Reach 2A: Cross-Section 1

6.6	x-section area (ft.sq.)
10.4	width (ft)
0.6	mean depth (ft)
1.4	max depth (ft)
11.3	wetted perimeter (ft)
0.6	hydraulic radius (ft)
16.5	width-depth ratio
104.1	W flood prone area (ft)
10.0	entrenchment ratio
0.8	low bank height ratio

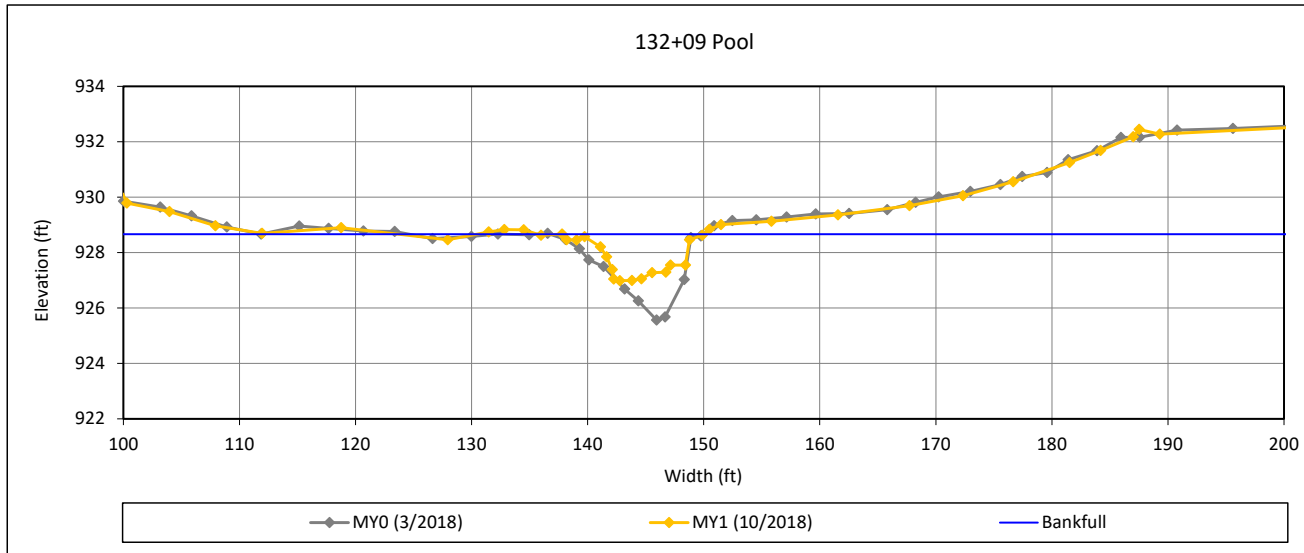
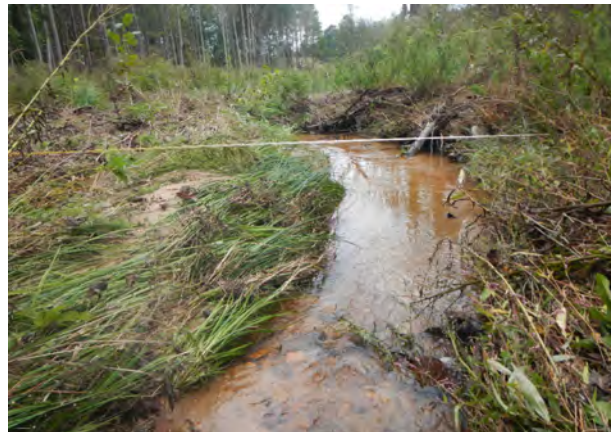
UBHC Reach 2A: Cross-Section 2

11.0	x-section area (ft.sq.)
12.2	width (ft)
0.9	mean depth (ft)
1.7	max depth (ft)
13.6	wetted perimeter (ft)
0.8	hydraulic radius (ft)
13.5	width-depth ratio

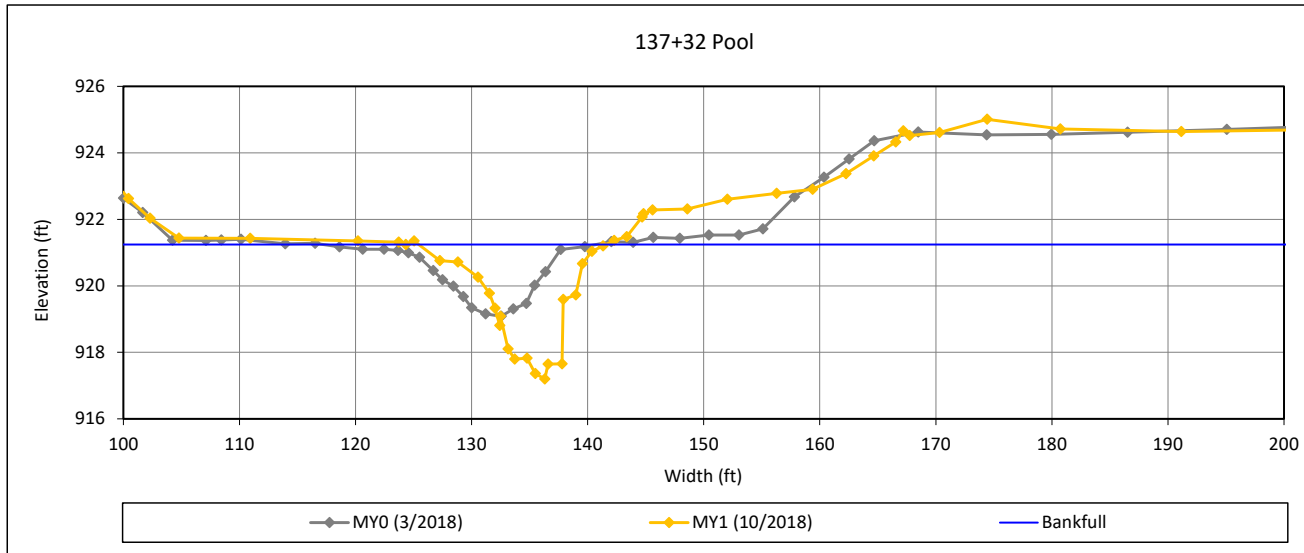
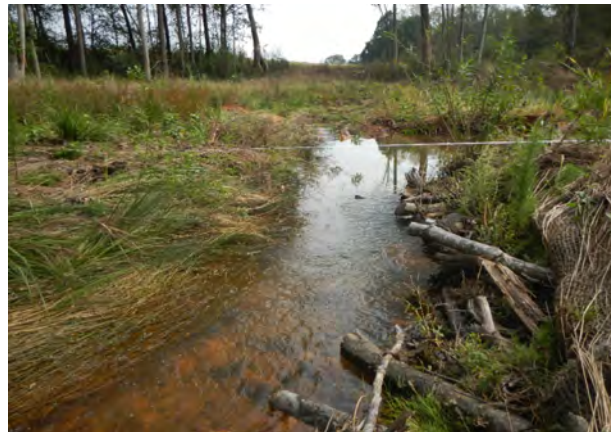
UBHC Reach 2B: Cross-Section 3

27.0	x-section area (ft.sq.)
16.1	width (ft)
1.7	mean depth (ft)
4.0	max depth (ft)
22.9	wetted perimeter (ft)
1.2	hydraulic radius (ft)
9.6	width-depth ratio

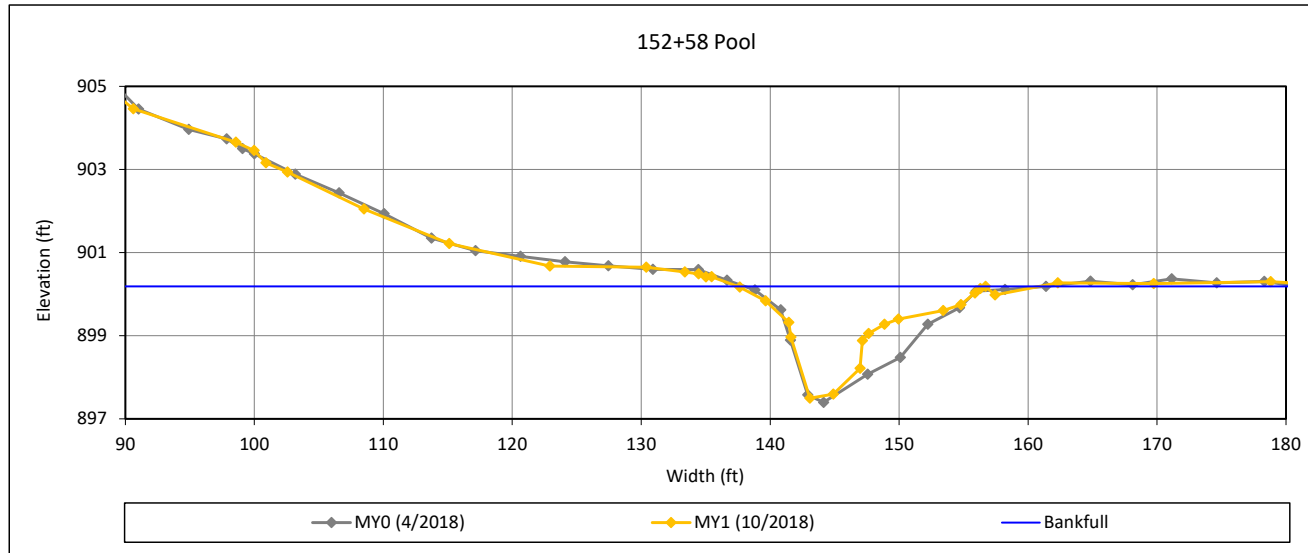
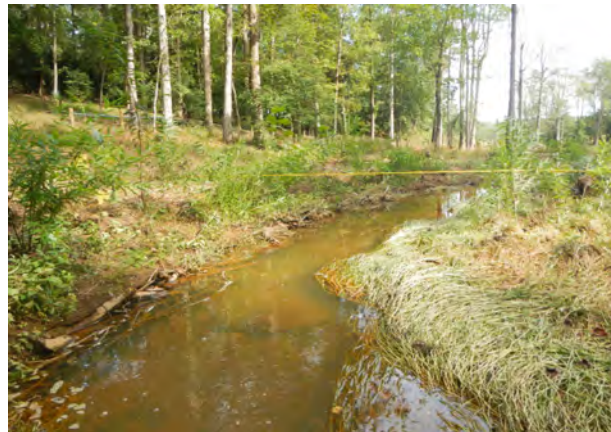
UBHC Reach 4: Cross-Section 5

20.6	x-section area (ft.sq.)
19.2	width (ft)
1.1	mean depth (ft)
2.7	max depth (ft)
20.9	wetted perimeter (ft)
1.0	hydraulic radius (ft)
17.9	width-depth ratio

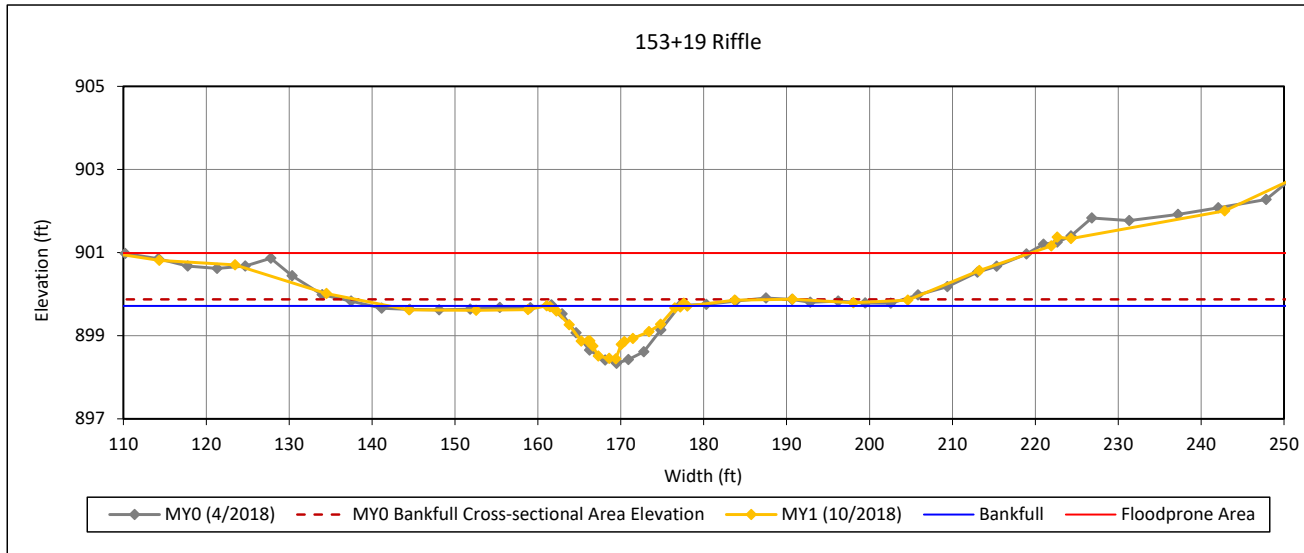
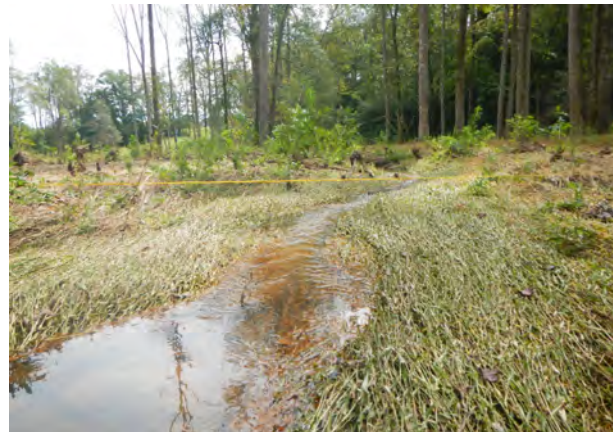
UBHC Reach 4: Cross-Section 6

10.5	x-section area (ft.sq.)
16.2	width (ft)
0.6	mean depth (ft)
1.3	max depth (ft)
16.5	wetted perimeter (ft)
0.6	hydraulic radius (ft)
25.1	width-depth ratio
110.8	W flood prone area (ft)
6.8	entrenchment ratio
0.9	low bank height ratio

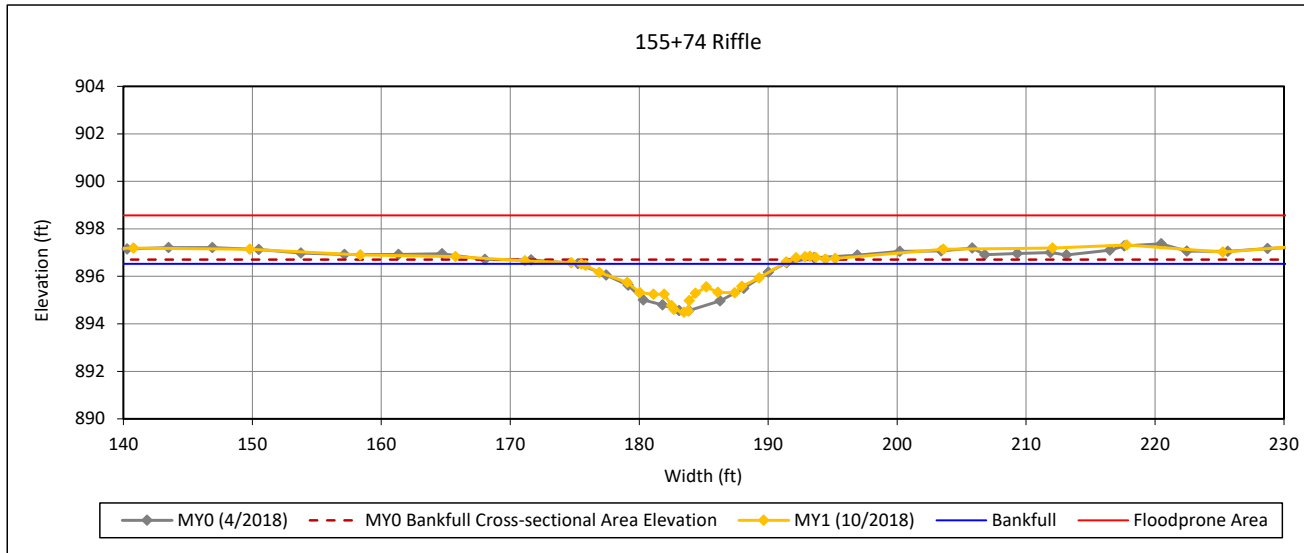
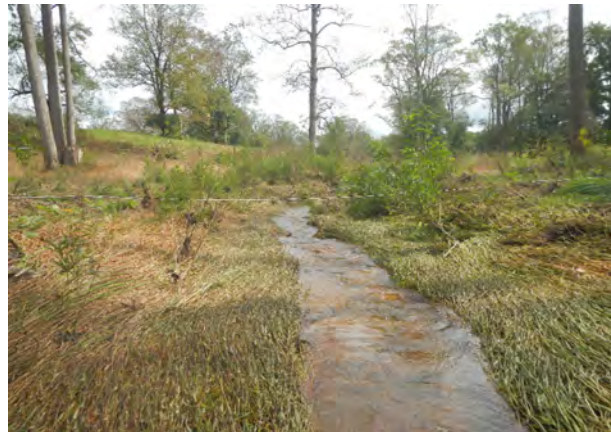
UBHC Reach 4: Cross-Section 7

14.7	x-section area (ft.sq.)
15.7	width (ft)
0.9	mean depth (ft)
2.0	max depth (ft)
16.8	wetted perimeter (ft)
0.9	hydraulic radius (ft)
16.6	width-depth ratio
167.4	W flood prone area (ft)
10.7	entrenchment ratio
0.9	low bank height ratio

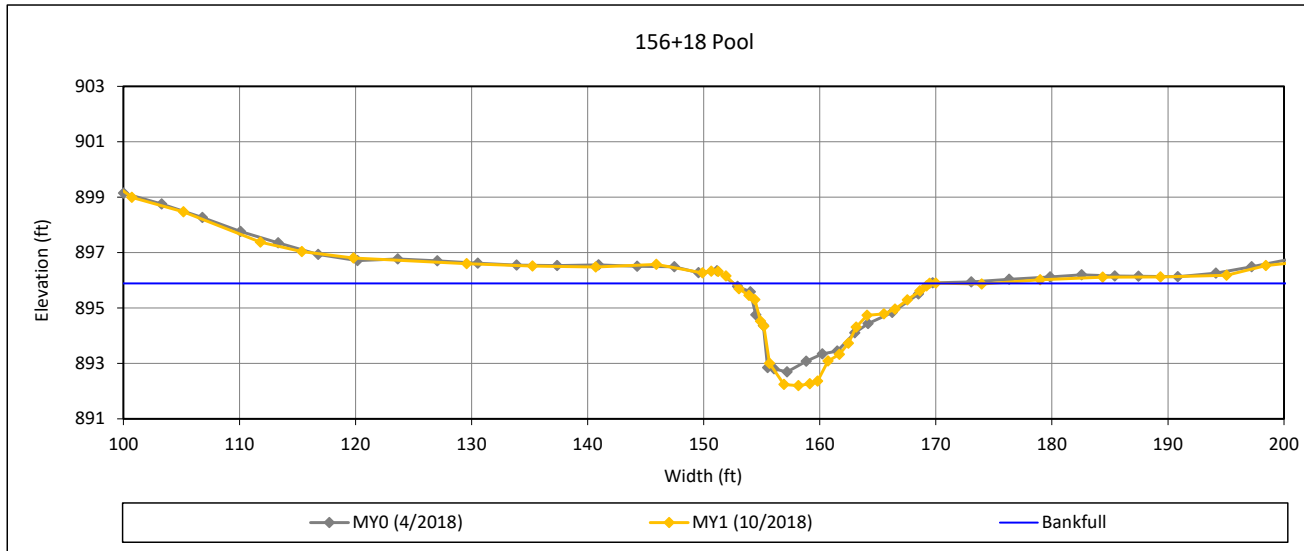
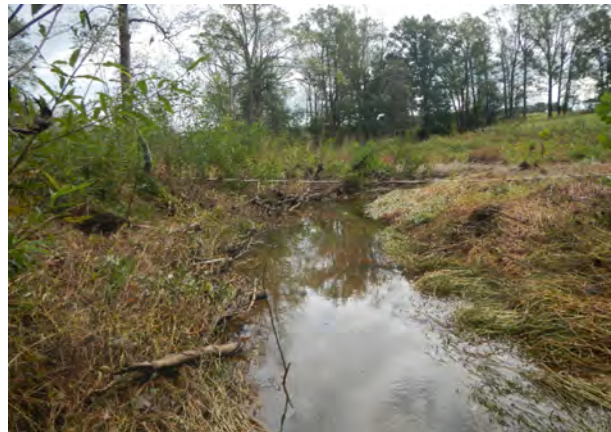
UBHC Reach 4: Cross-Section 8

31.0	x-section area (ft.sq.)
16.9	width (ft)
1.8	mean depth (ft)
3.7	max depth (ft)
19.5	wetted perimeter (ft)
1.6	hydraulic radius (ft)
9.2	width-depth ratio

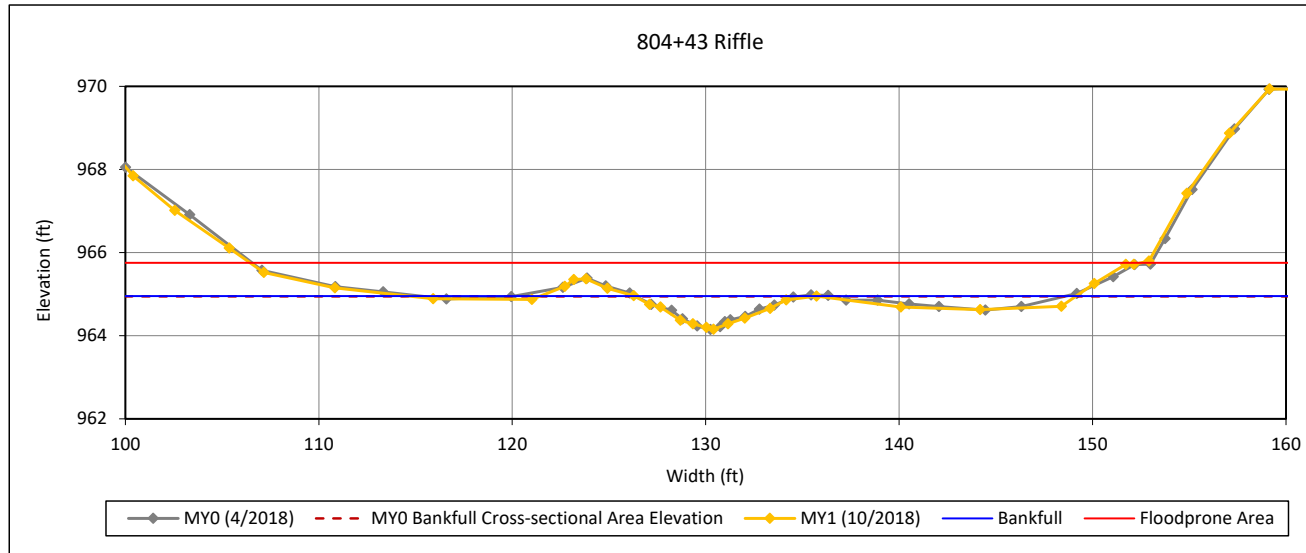
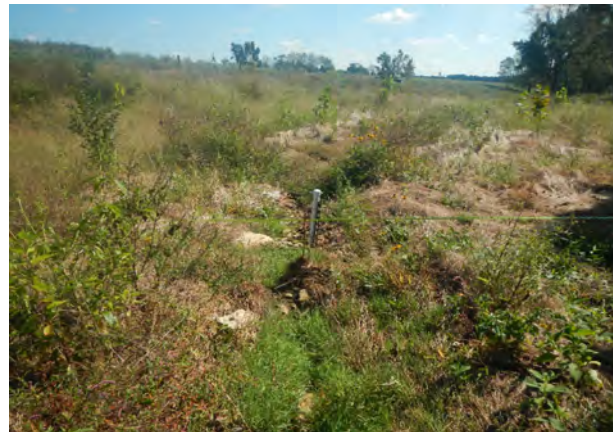
Royster Creek Reach 1: Cross-Section 9

3.7	x-section area (ft.sq.)
9.4	width (ft)
0.4	mean depth (ft)
0.8	max depth (ft)
9.6	wetted perimeter (ft)
0.4	hydraulic radius (ft)
24.1	width-depth ratio
46.1	W flood prone area (ft)
4.9	entrenchment ratio
1.0	low bank height ratio

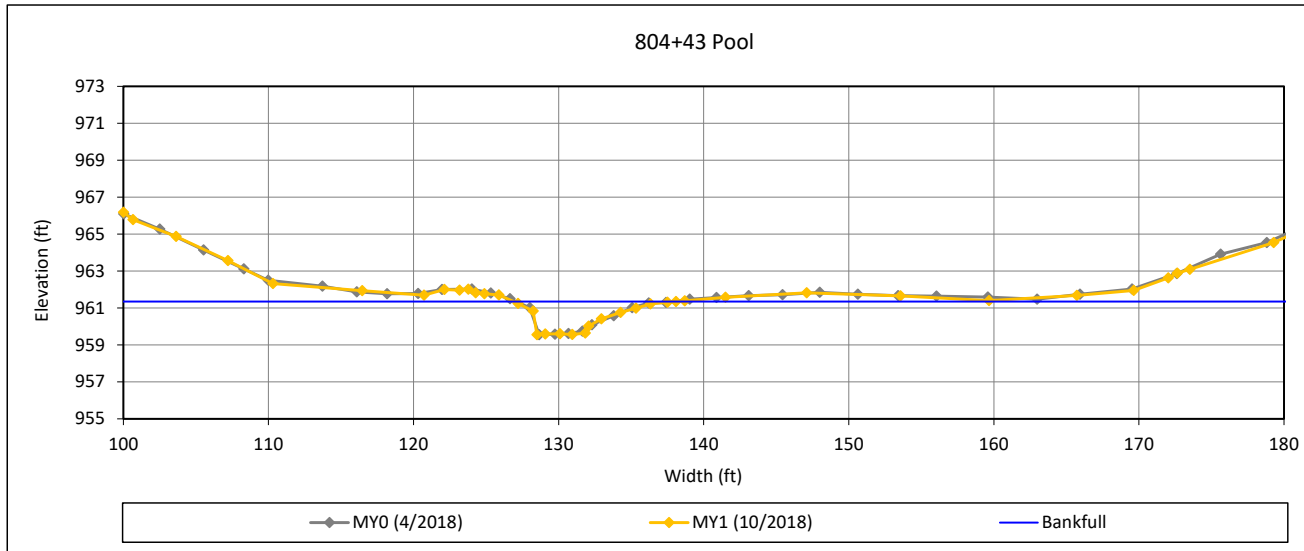
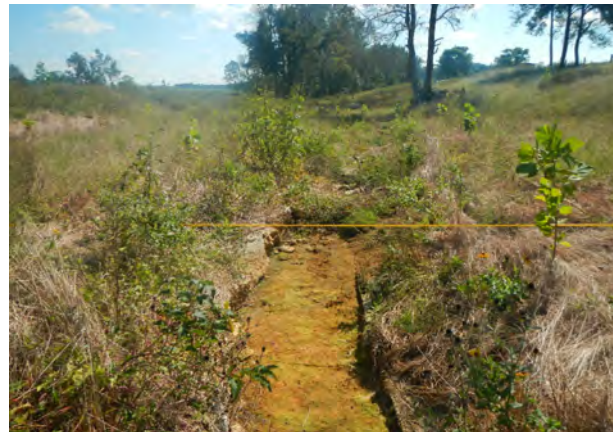
Royster Creek Reach 1: Cross-Section 10

9.7	x-section area (ft.sq.)
11.2	width (ft)
0.9	mean depth (ft)
1.8	max depth (ft)
12.7	wetted perimeter (ft)
0.8	hydraulic radius (ft)
12.9	width-depth ratio

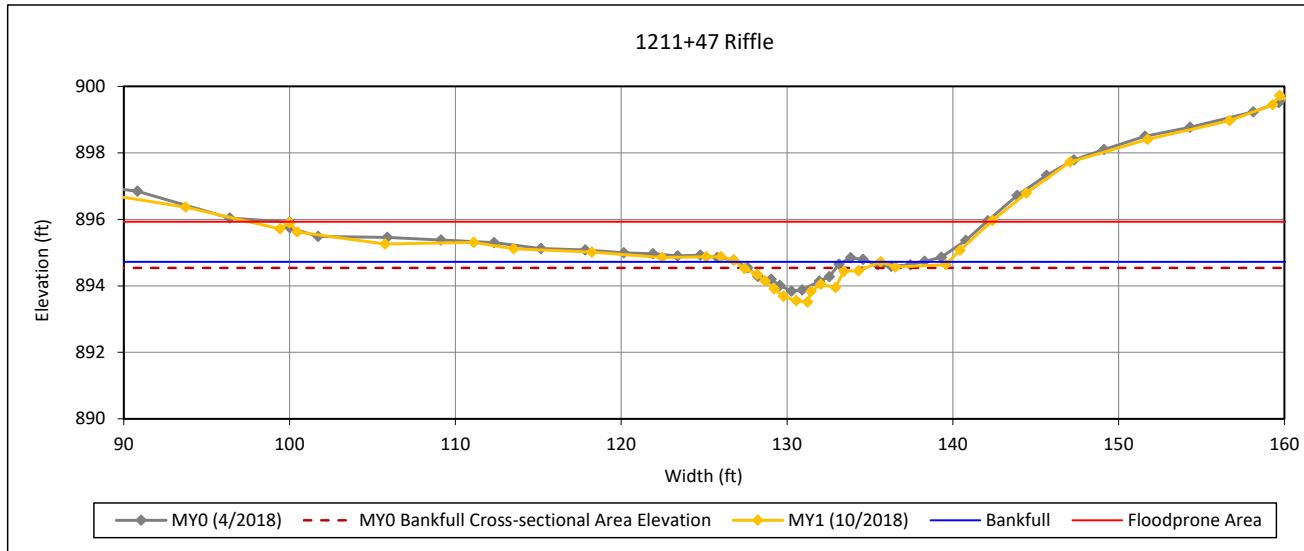
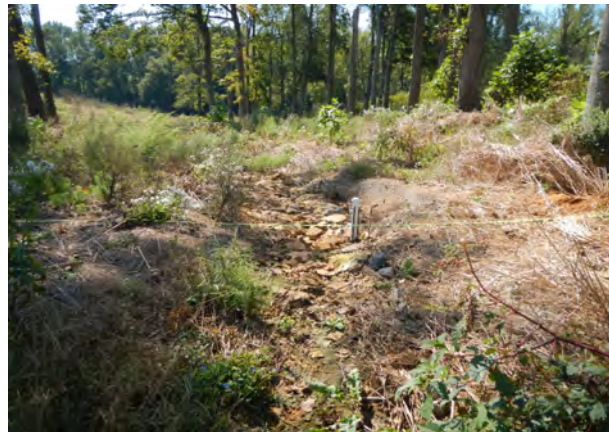
Scott Creek: Cross-Section 11

5.1	x-section area (ft.sq.)
8.7	width (ft)
0.6	mean depth (ft)
1.2	max depth (ft)
9.4	wetted perimeter (ft)
0.5	hydraulic radius (ft)
15.0	width-depth ratio
44.8	W flood prone area (ft)
5.1	entrenchment ratio
1.2	low bank height ratio

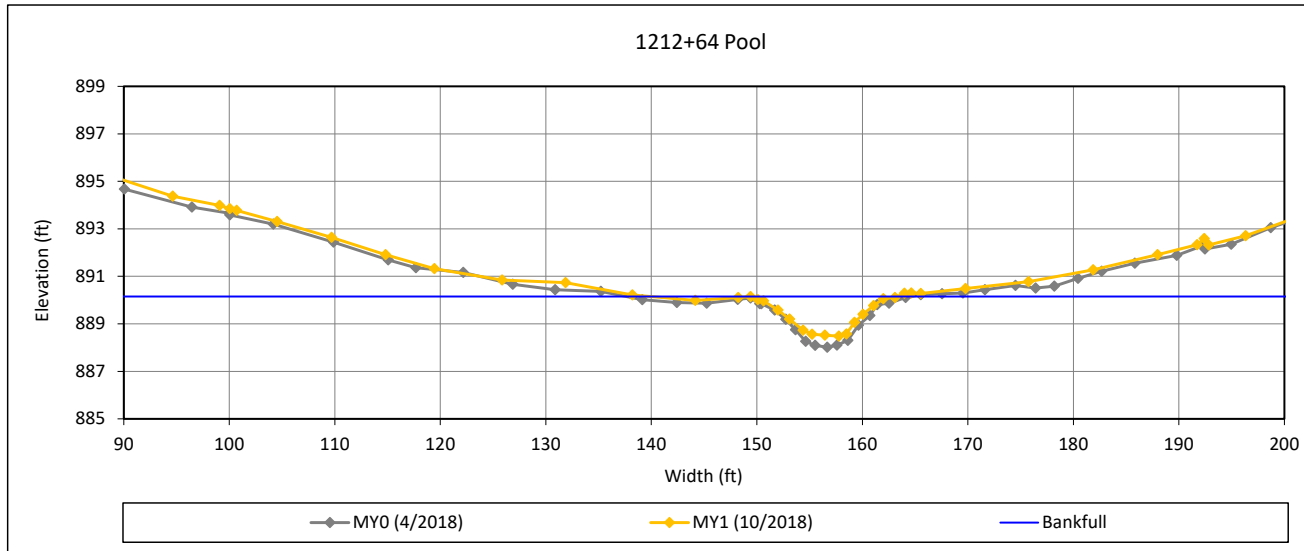
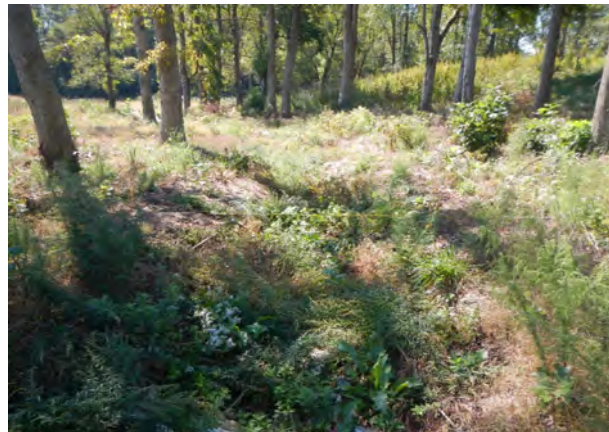
Scott Creek: Cross-Section 12

12.2	x-section area (ft.sq.)
13.9	width (ft)
0.9	mean depth (ft)
1.7	max depth (ft)
14.5	wetted perimeter (ft)
0.8	hydraulic radius (ft)
15.8	width-depth ratio

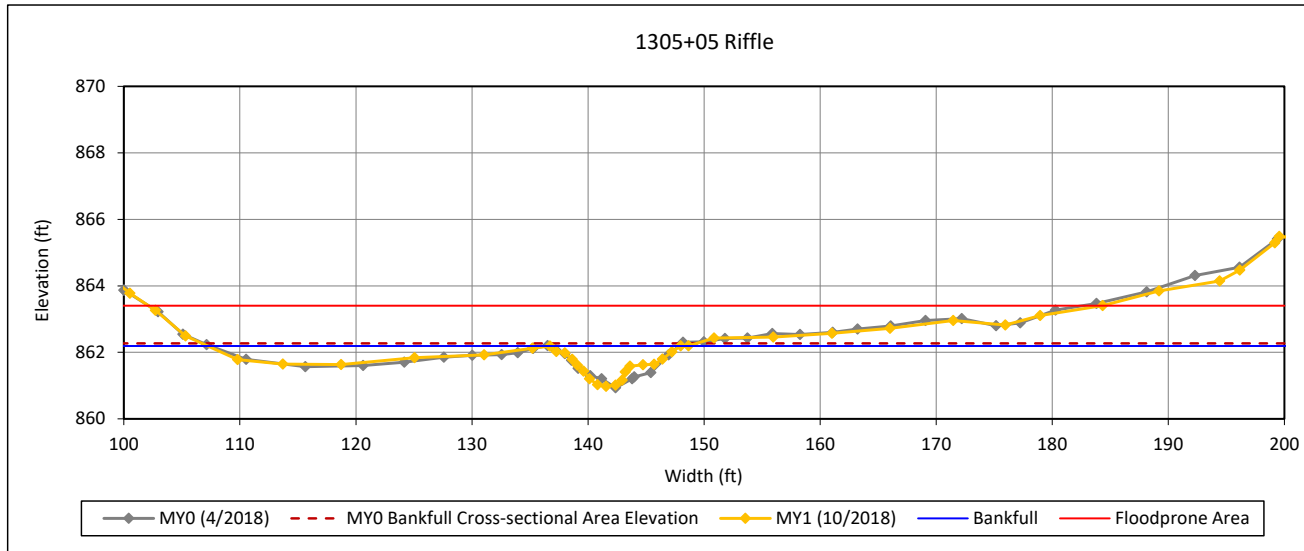
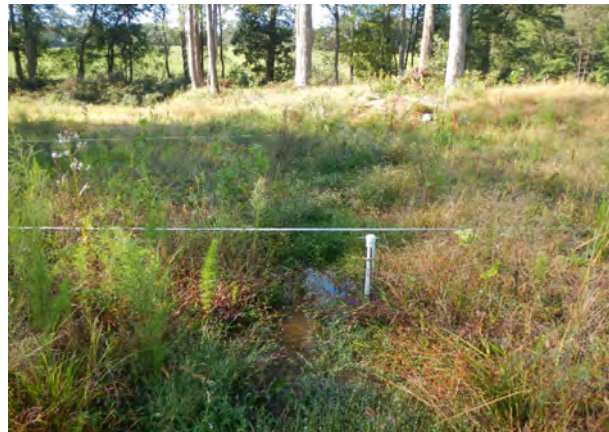
Carroll Creek Reach 1: Cross-Section 13

7.0	x-section area (ft.sq.)
11.3	width (ft)
0.6	mean depth (ft)
1.2	max depth (ft)
11.7	wetted perimeter (ft)
0.6	hydraulic radius (ft)
18.2	width-depth ratio
82.1	W flood prone area (ft)
7.3	entrenchment ratio
0.9	low bank height ratio
