MONITORING YEAR 2 ANNUAL REPORT

BIG HARRIS CREEK MITIGATION SITE

Cleveland County, NC
DMS Project No. 739
DEQ Contract 006256
DWR 401 Project No. 10-0811
USACE Action ID No. SAW-2009-0475
Broad River Basin
HUC 03050105

Data Collection Period: March – October 2019

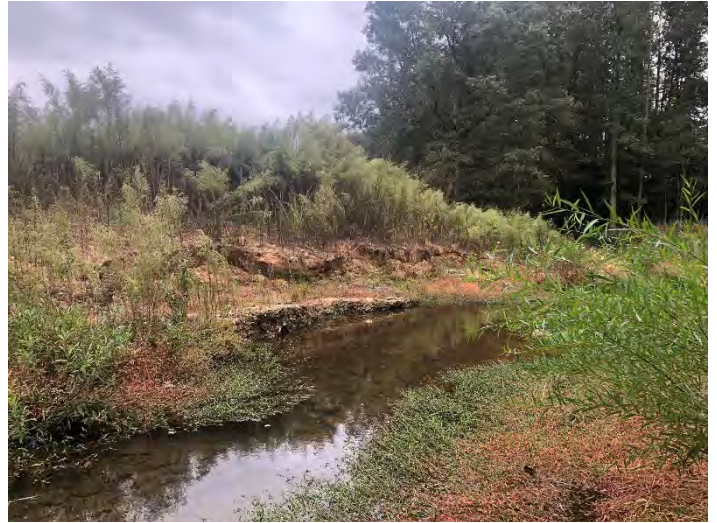
UBHC R6 Bank Scour (Station 176+00) – view downstream (10/8/2019)

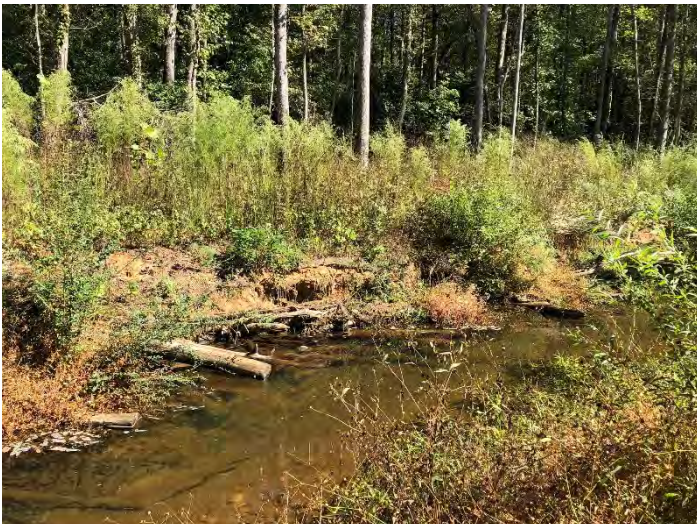
LBHC R2 Bank Scour (Station 316+00) – view downstream (10/8/2019)
