MONITORING YEAR 3 ANNUAL REPORT

BIG HARRIS CREEK MITIGATION SITE

Cleveland County, NC
DMS Project No. 739
DEQ Contract 006256
DWR 401 Project No. 10-0811
USACE Action ID No. SAW-2009-0475
Broad River Basin
HUC 03050105

Data Collection Period: February – November 2020
Final Submission Date: February 15, 2021

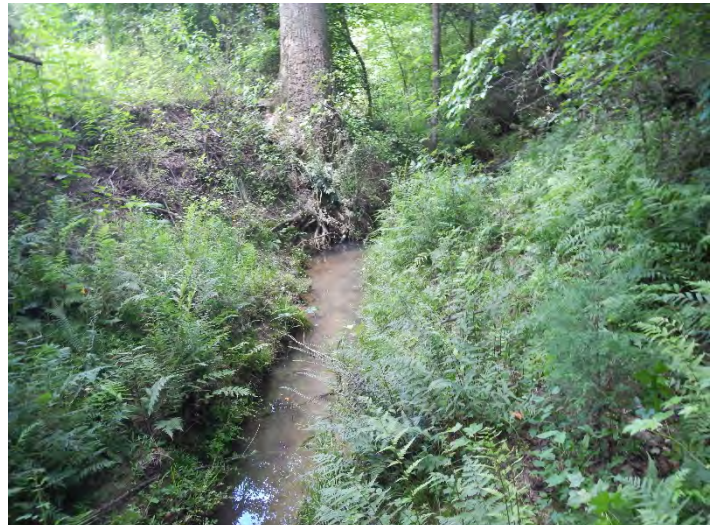
USEC R2 Photo Point 58 – view downstream (6/13/2020)

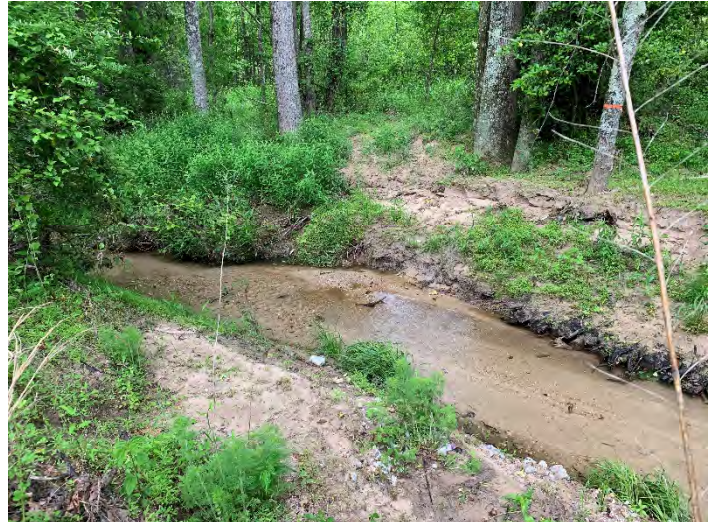
USEC R4A Photo Point 63 – view downstream (5/6/2020)

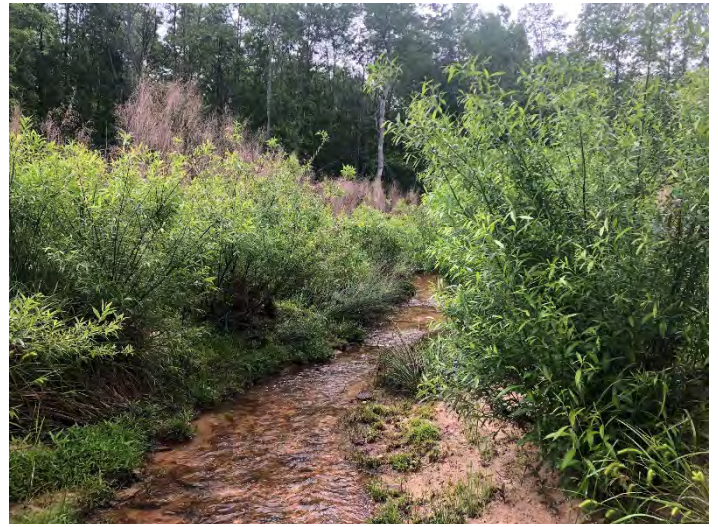
USEC R5 Photo Point 66 – view downstream (5/6/2020)

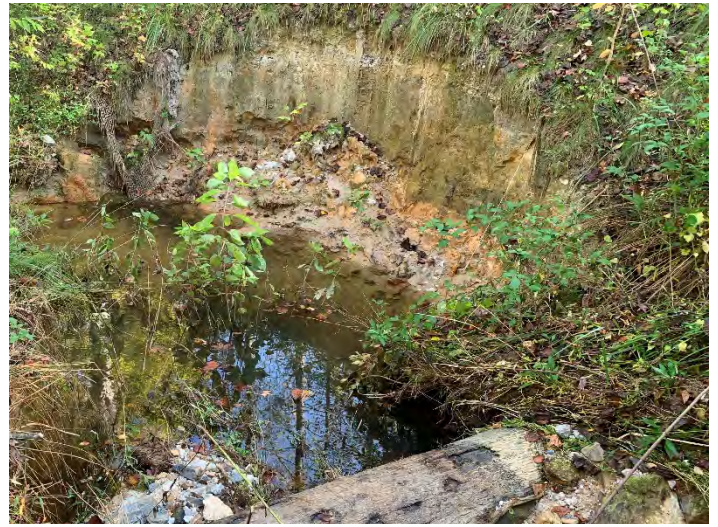
USEC R1 Bank Scour (STA 1005+57 – 1005+75) – view downstream
(10/20/2020)

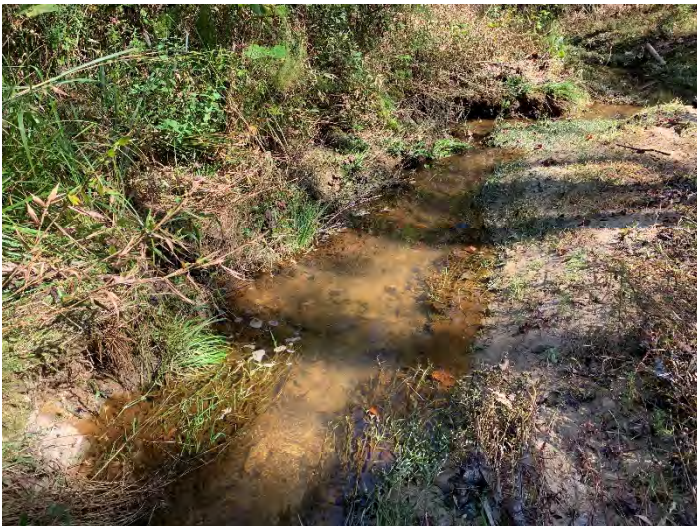
USEC R3 Aggradation (STA 1026+74 – 1026+89) – view downstream
(10/20/2020)

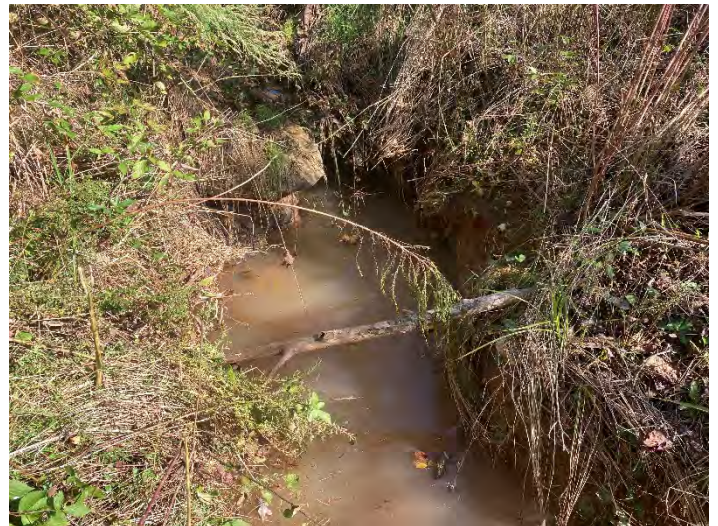
Scott Creek Incision (STA 1211+25 – 1211+36) – view upstream
(11/2/2020)

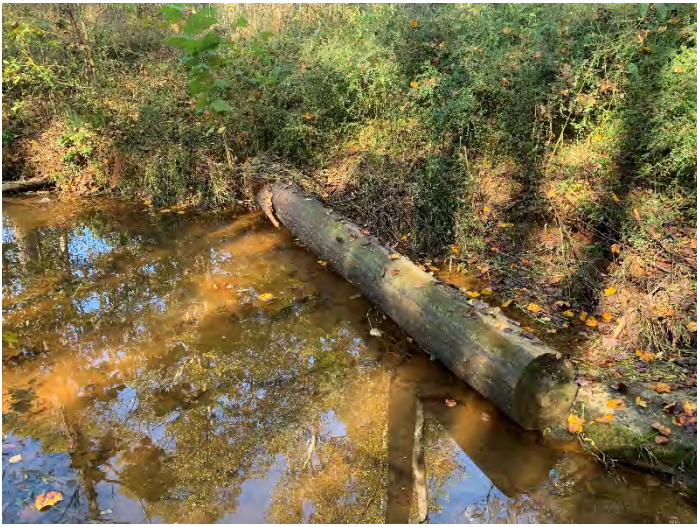
UBHC R3 Log Dislodged (STA 145+48) – view upstream
(10/27/2020)

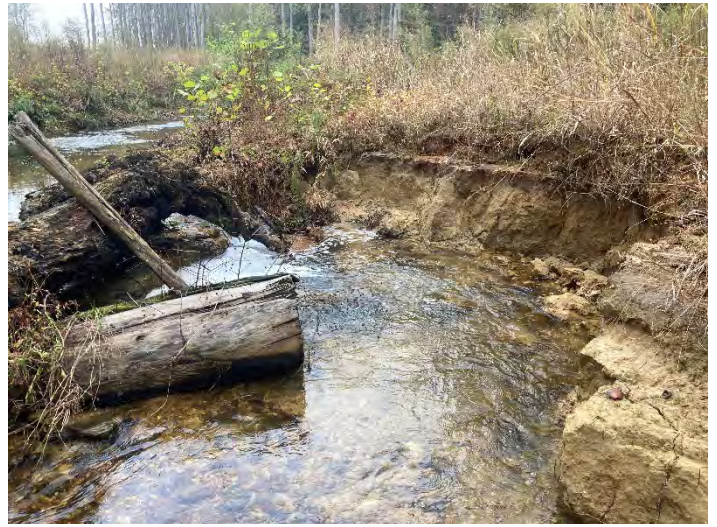
LBHC R2 Log Sill Bypassed (STA 317+45) – view upstream
(10/27/2020)
