As-built report for the AH&W Mitigation Site Big and Little Warrior Creeks Wilkes County

As-built report for the AH&W
Mitigation Site, Big and Little Warrior
Creeks, Wilkes County

North Carolina Wildlife Resources Commission

February 24, 2003

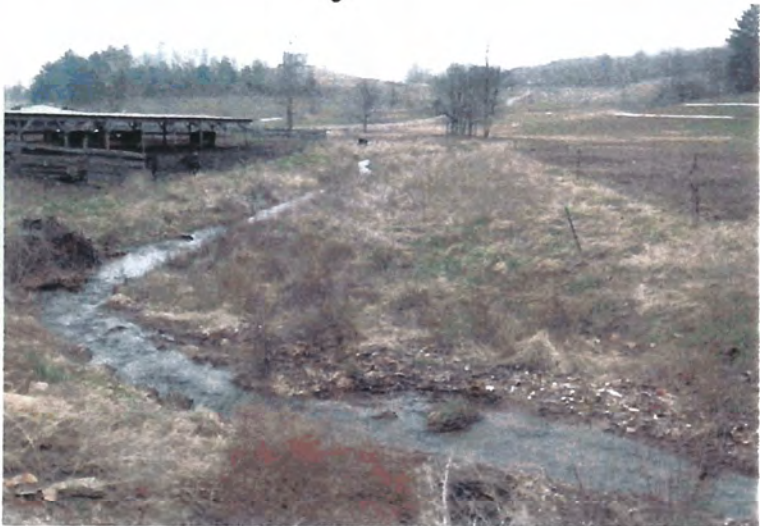
Big Warrior Creek after construction, 1/30/03

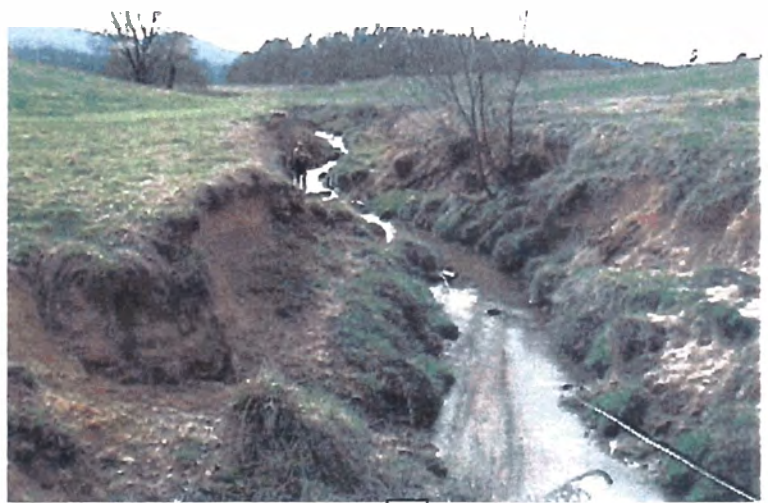
Little Warrior Creek before construction, 12/11/98

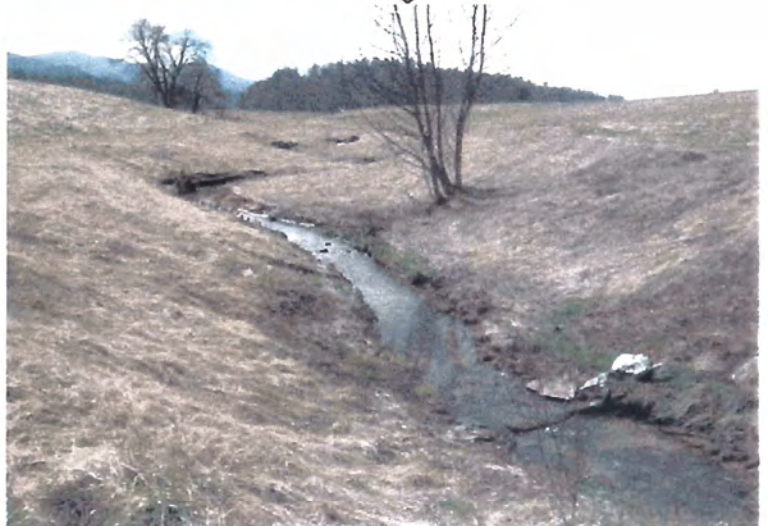
Little Warrior Creek after construction, 1/30/03
