# ANNUAL REPORT FOR 2004

**Big Warrior and Little Warrior Creek Mitigation Site**  
**Wilkes County**  
**WBS Element 34404.4.1**  
**TIP No. R-2239 B**

Prepared By:  
Office of Natural Environment & Roadside Environmental Unit  
North Carolina Department of Transportation  
January 2005

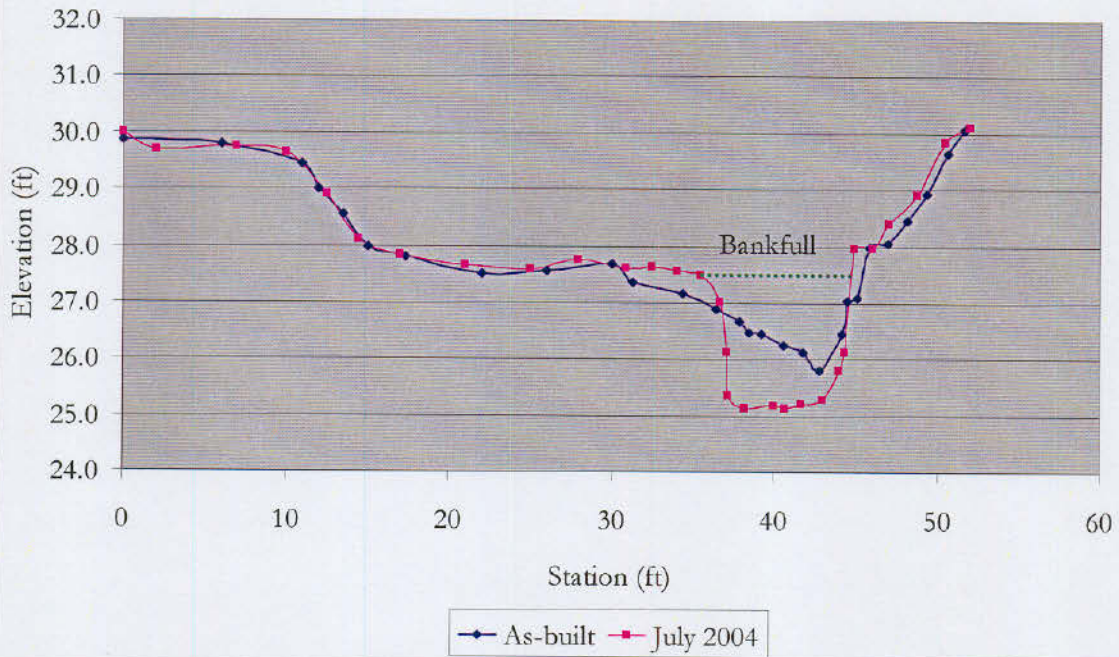
### Cross Section #1 Big Warrior Creek

As-built	2004
Bankfull Cross Sectional Area (ft <sup>2</sup> )	15.3	16.7
Maximum Bankfull Depth (ft)	1.9	2.3
Bankfull Mean Depth (ft)	1	1.8
Bankfull Width (ft)	15.5	9.2

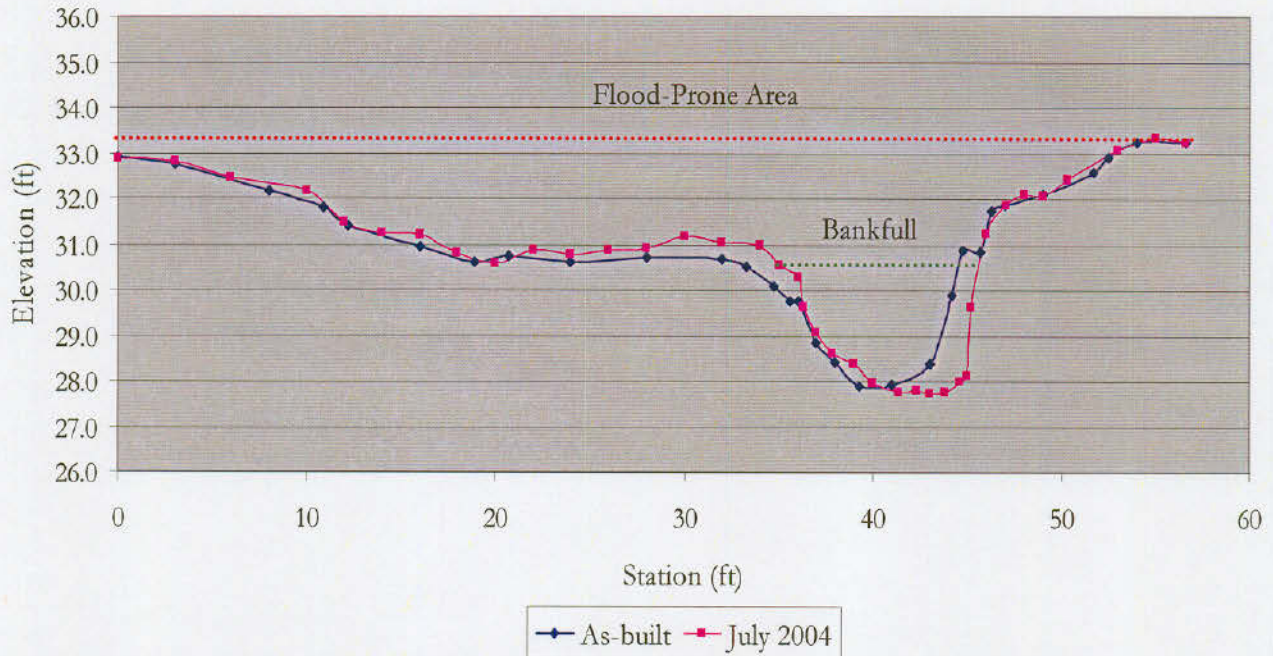
### Cross Section #2 Big Warrior Creek

As-built	2004
Bankfull Cross Sectional Area (ft <sup>2</sup> )	20.3	21.5
Maximum Bankfull Depth (ft)	2.8	2.8
Bankfull Mean Depth (ft)	1.6	2
Width/Depth Ratio	7.9	5.3
Entrenchment Ratio	5.3	6.6
Bankfull Width (ft)	12.7	10.7
Width of Flood Prone Area	67	70

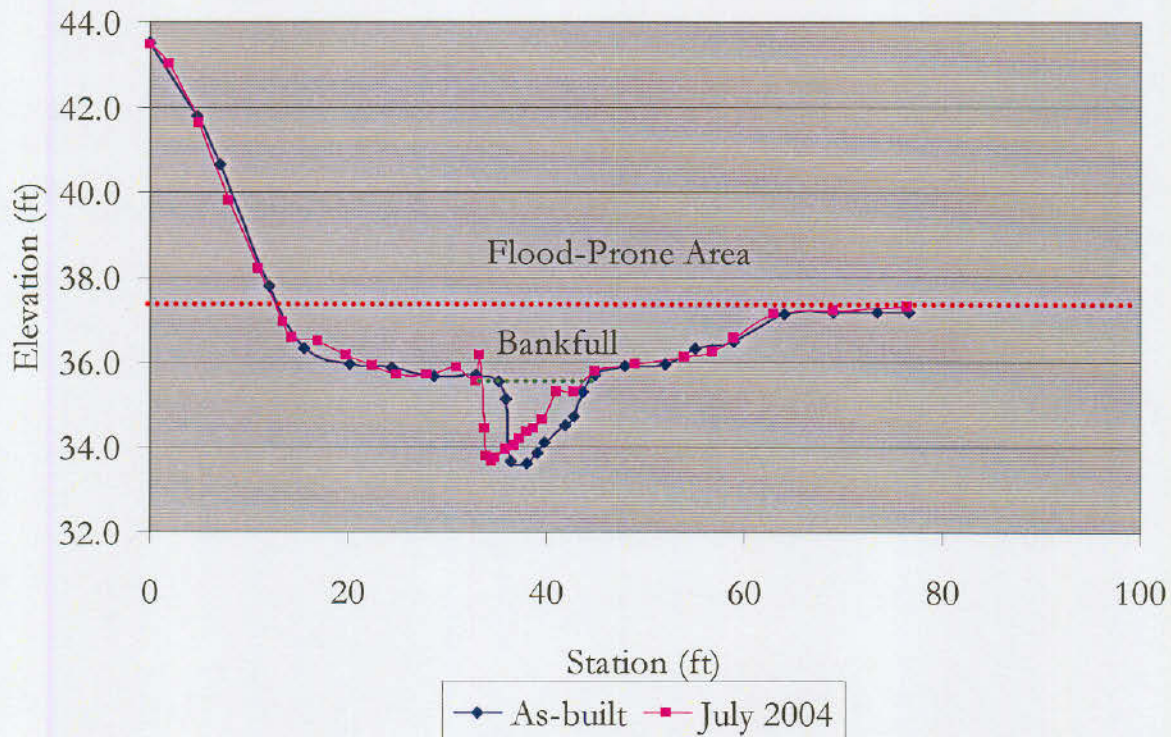
### Cross Section #3 Big Warrior Creek

As-built	2004
Bankfull Cross Sectional Area (ft <sup>2</sup> )	12.8	10.1
Maximum Bankfull Depth (ft)	2.1	1.9
Bankfull Mean Depth (ft)	1	1
Width/Depth Ratio	11.6	10.9
Entrenchment Ratio	6.9	6.5
Bankfull Width (ft)	12.2	10.5
Width of Flood Prone Area	84	68

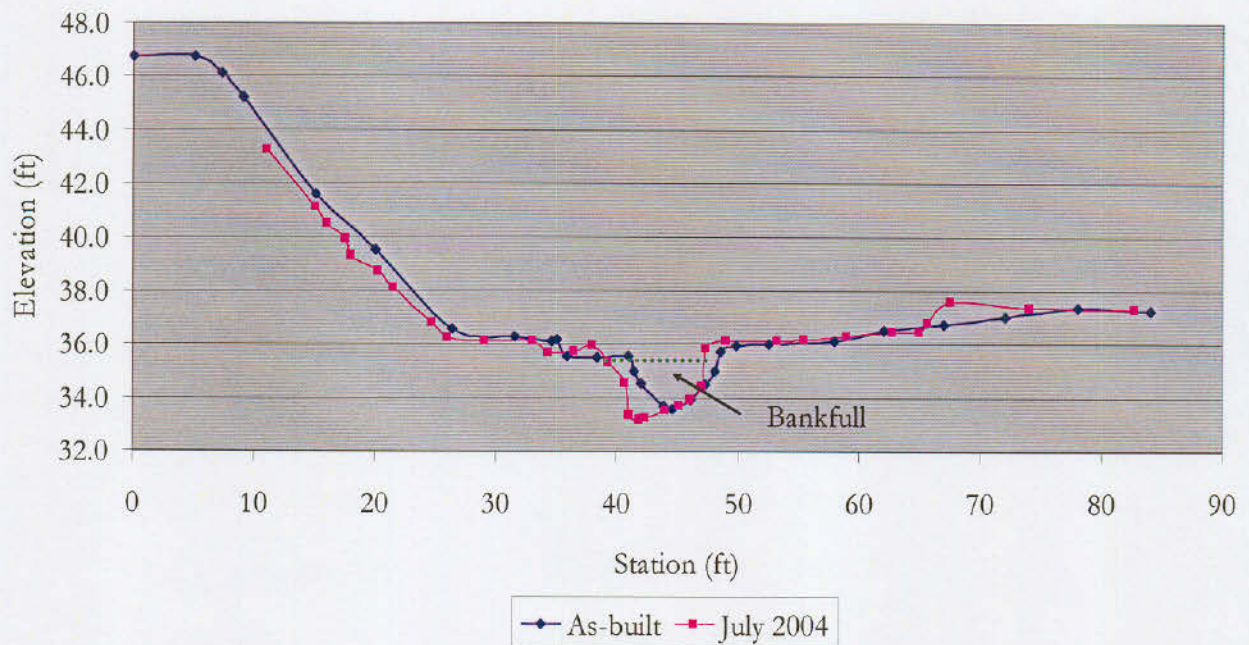
### Cross Section #4 Big Warrior Creek

As-built	2004
Bankfull Cross Sectional Area (ft <sup>2</sup> )	19.5	11.8
Maximum Bankfull Depth (ft)	2.6	2.2
Bankfull Mean Depth (ft)	1.1	1.5
Bankfull Width (ft)	17.5	8

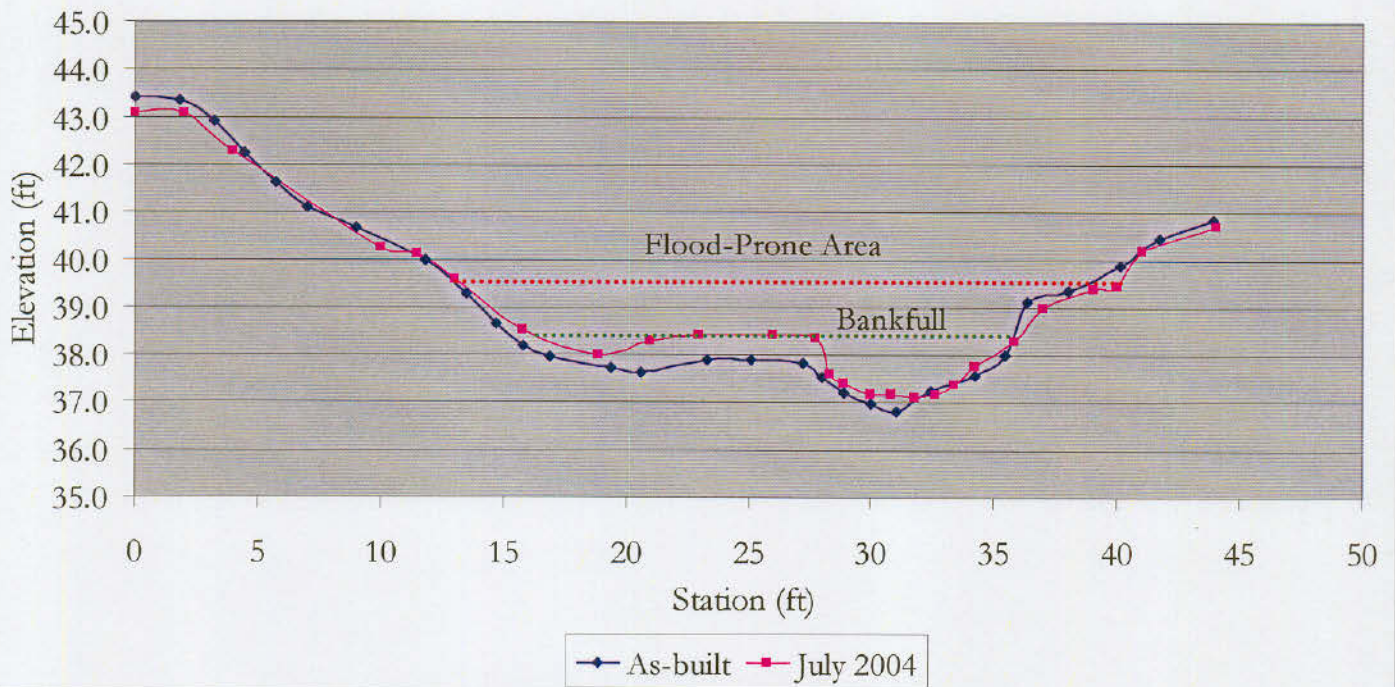
### Cross Section #5 Big Warrior Creek

As-built	2004
Bankfull Cross Sectional Area (ft <sup>2</sup> )	20.3	7.8
Maximum Bankfull Depth (ft)	1.9	1.2
Bankfull Mean Depth (ft)	1	0.6
Width/Depth Ratio	22.3	22.3
Entrenchment Ratio	1.5	2.1
Bankfull Width (ft)	21.3	13.2
Width of Flood Prone Area	32	28

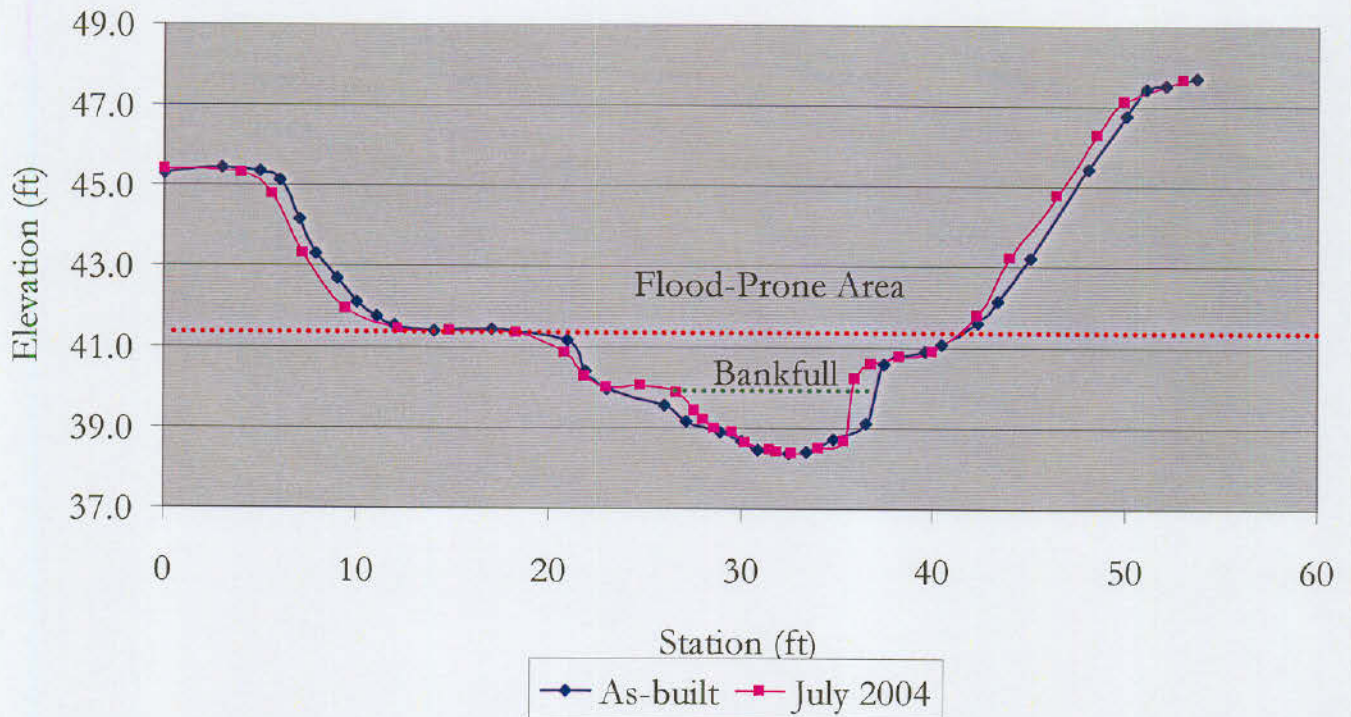
### Cross Section #6 Big Warrior Creek

As-built	2004
Bankfull Cross Sectional Area (ft <sup>2</sup> )	22.3	10
Maximum Bankfull Depth (ft)	2.2	1.5
Bankfull Mean Depth (ft)	1.4	1.1
Width/Depth Ratio	10.9	8.3
Entrenchment Ratio	2.3	3.9
Bankfull Width (ft)	15.6	9.1
Width of Flood Prone Area	35	35

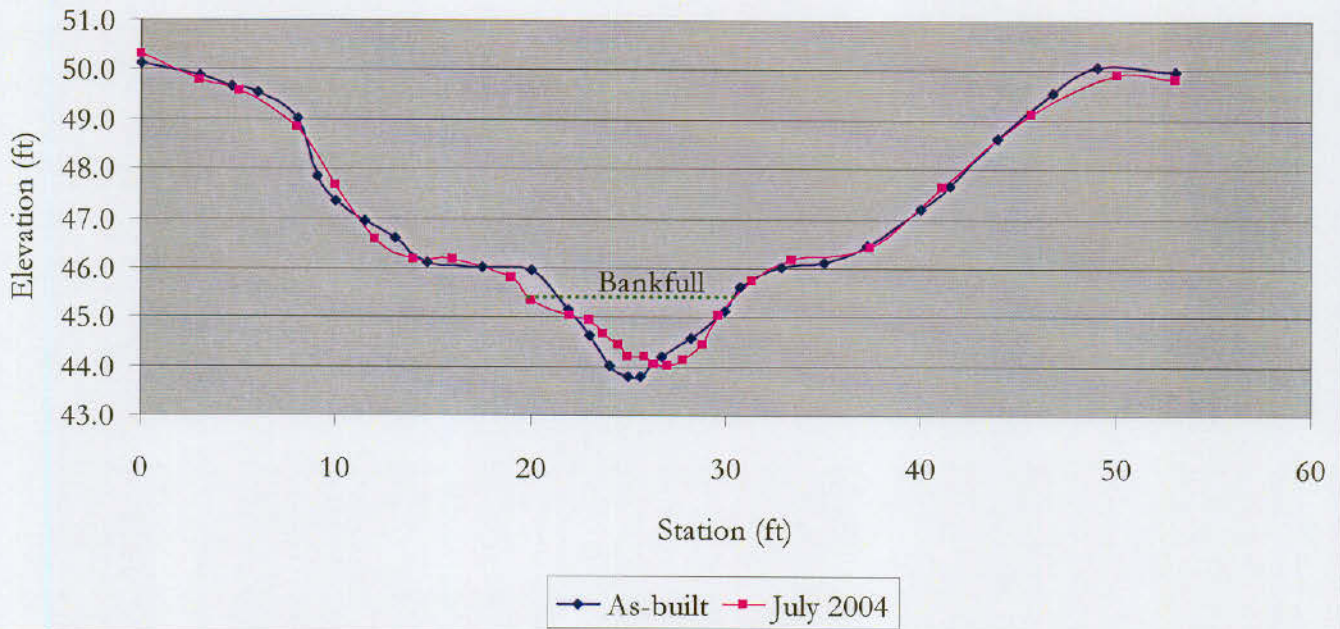
### Cross Section #7 Big Warrior Creek

As-built	2004
Bankfull Cross Sectional Area (ft <sup>2</sup> )	16.4	7.3
Maximum Bankfull Depth (ft)	2.3	1.3
Bankfull Mean Depth (ft)	1.1	0.7
Bankfull Width (ft)	15.2	10.4

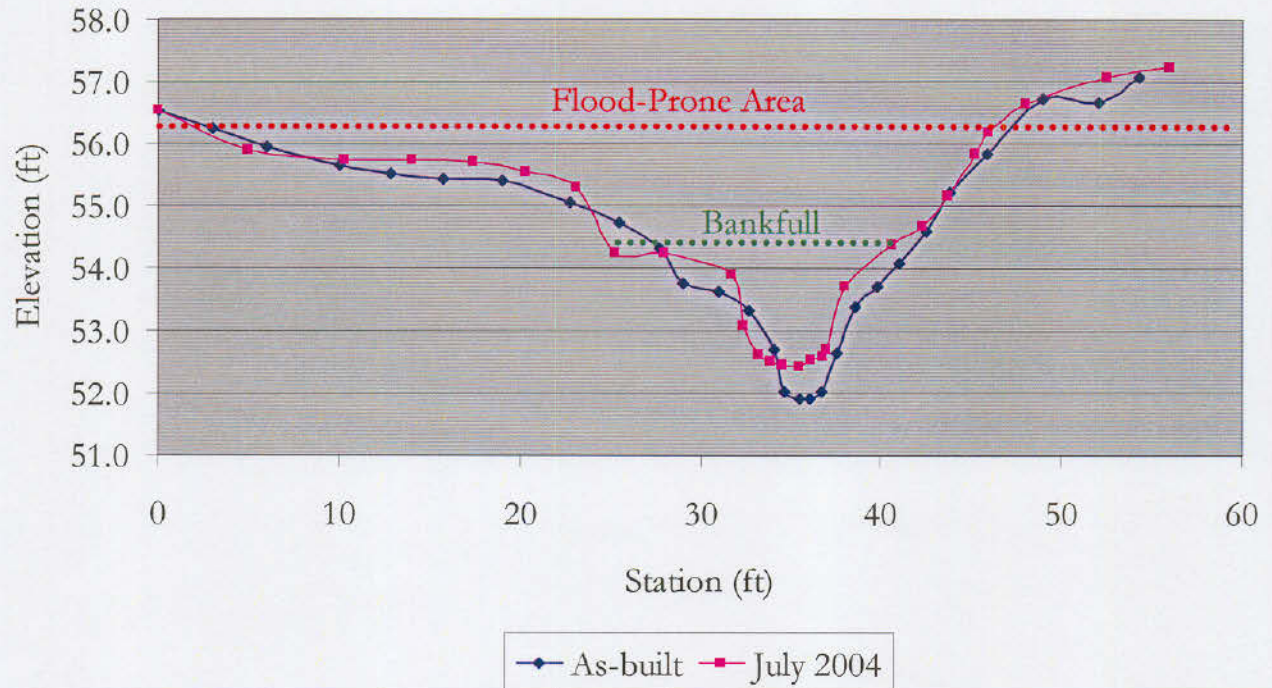
### Cross Section #8 Big Warrior Creek

As-built	2004
Bankfull Cross Sectional Area (ft <sup>2</sup> )	15.32	5.8
Maximum Bankfull Depth (ft)	2.39	1.3
Bankfull Mean Depth (ft)	1.1	0.9
Width/Depth Ratio	12.8	6.5
Entrenchment Ratio	3.5	3.3
Bankfull Width (ft)	14	6.1
Width of Flood Prone Area	49	20

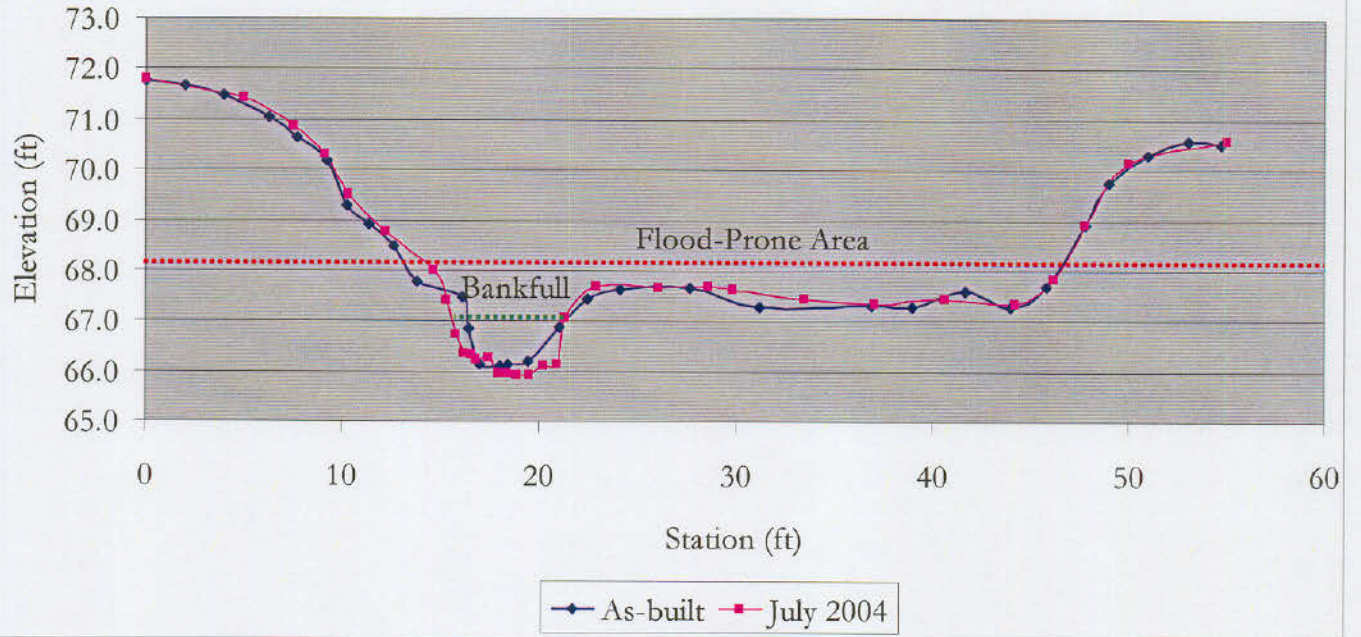
### Cross Section #9 Big Warrior Creek

As-built	2004
Bankfull Cross Sectional Area (ft <sup>2</sup> )	16	13.2
Maximum Bankfull Depth (ft)	1.7	1.8
Bankfull Mean Depth (ft)	0.5	0.4
Width/Depth Ratio	64.1	70.7
Entrenchment Ratio	1.2	1.3
Bankfull Width (ft)	32	30.6
Width of Flood Prone Area	38	39

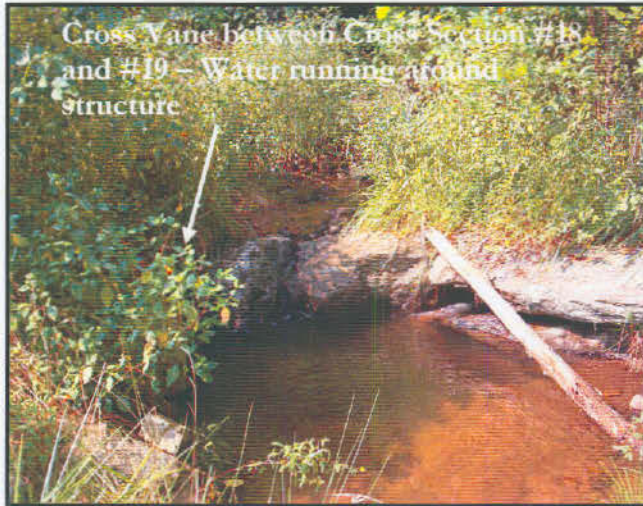
Cross Vane between Cross Section #18 and #19 - Water running around structure

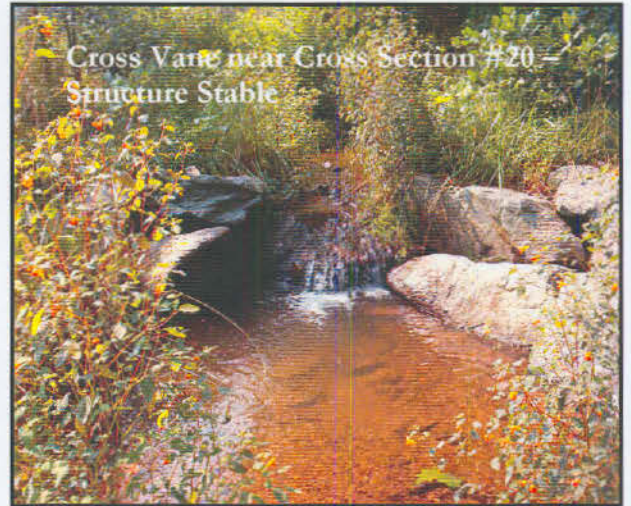
Cross Vane near Cross Section #20 - Structure Stable

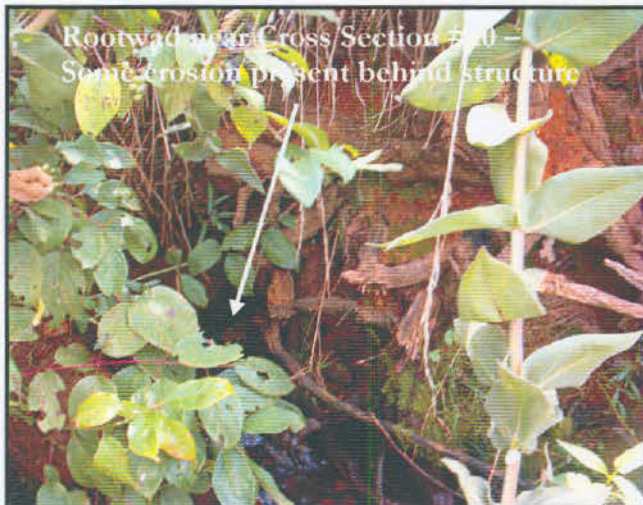
Rootwad near Cross Section #10 - Some erosion present behind structure

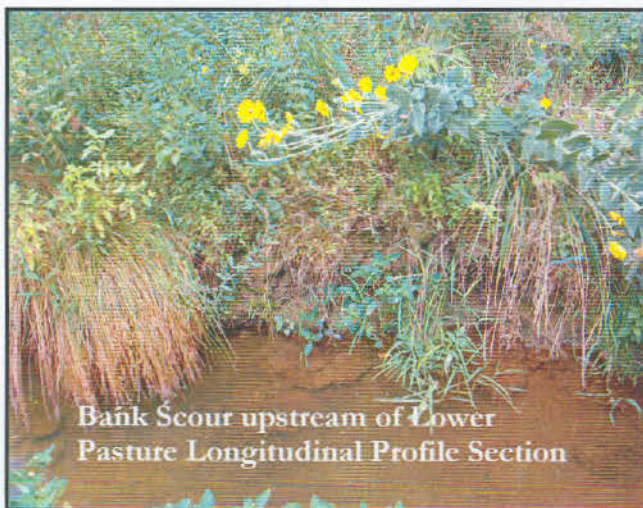
Bank Scour upstream of Lower Pasture Longitudinal Profile Section

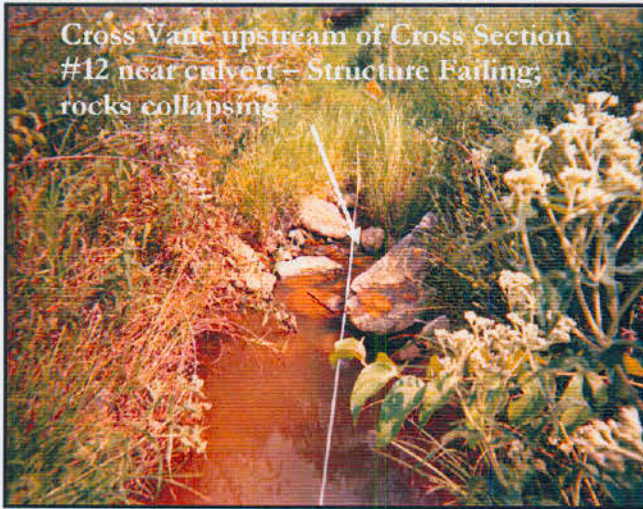
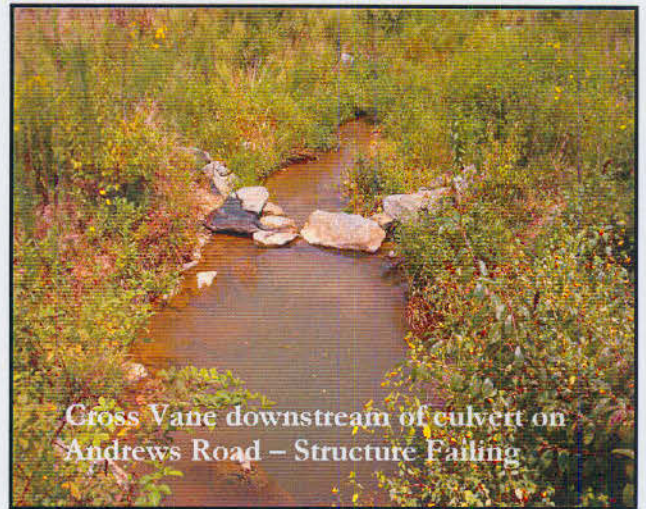
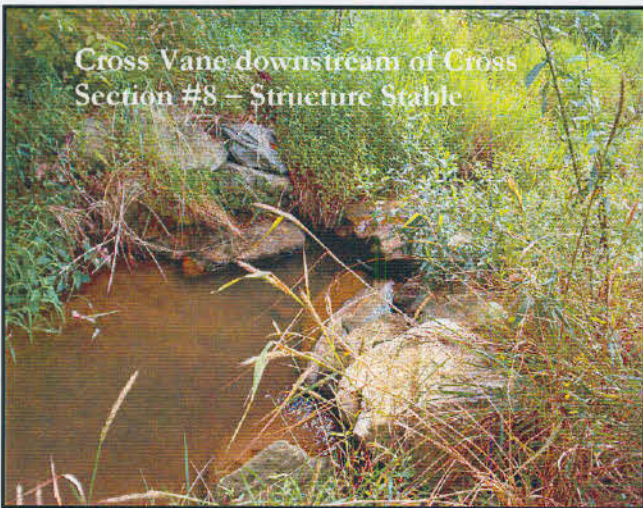
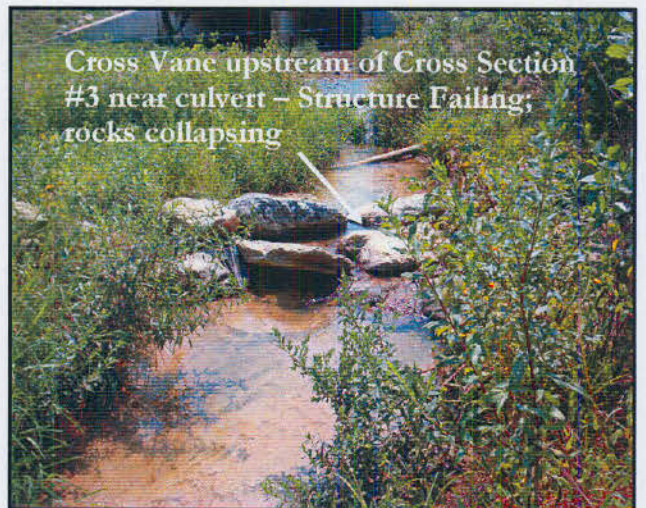
**Little Warrior Creek Structures**

Big Warrior Creek remains stable; however, there are isolated areas of degradation and instability. A number of the structures are not functioning properly throughout the Upper Pasture and Feed Lot Sections. These areas should be assessed during the next monitoring period to determine if remedial actions are necessary.
