**UT to Billy's Creek Stream Restoration  
Final 2006 Monitoring Report  
Monitoring Year One**

**Ecosystem Enhancement Program Project Number 36**

Submitted: January 19, 2007

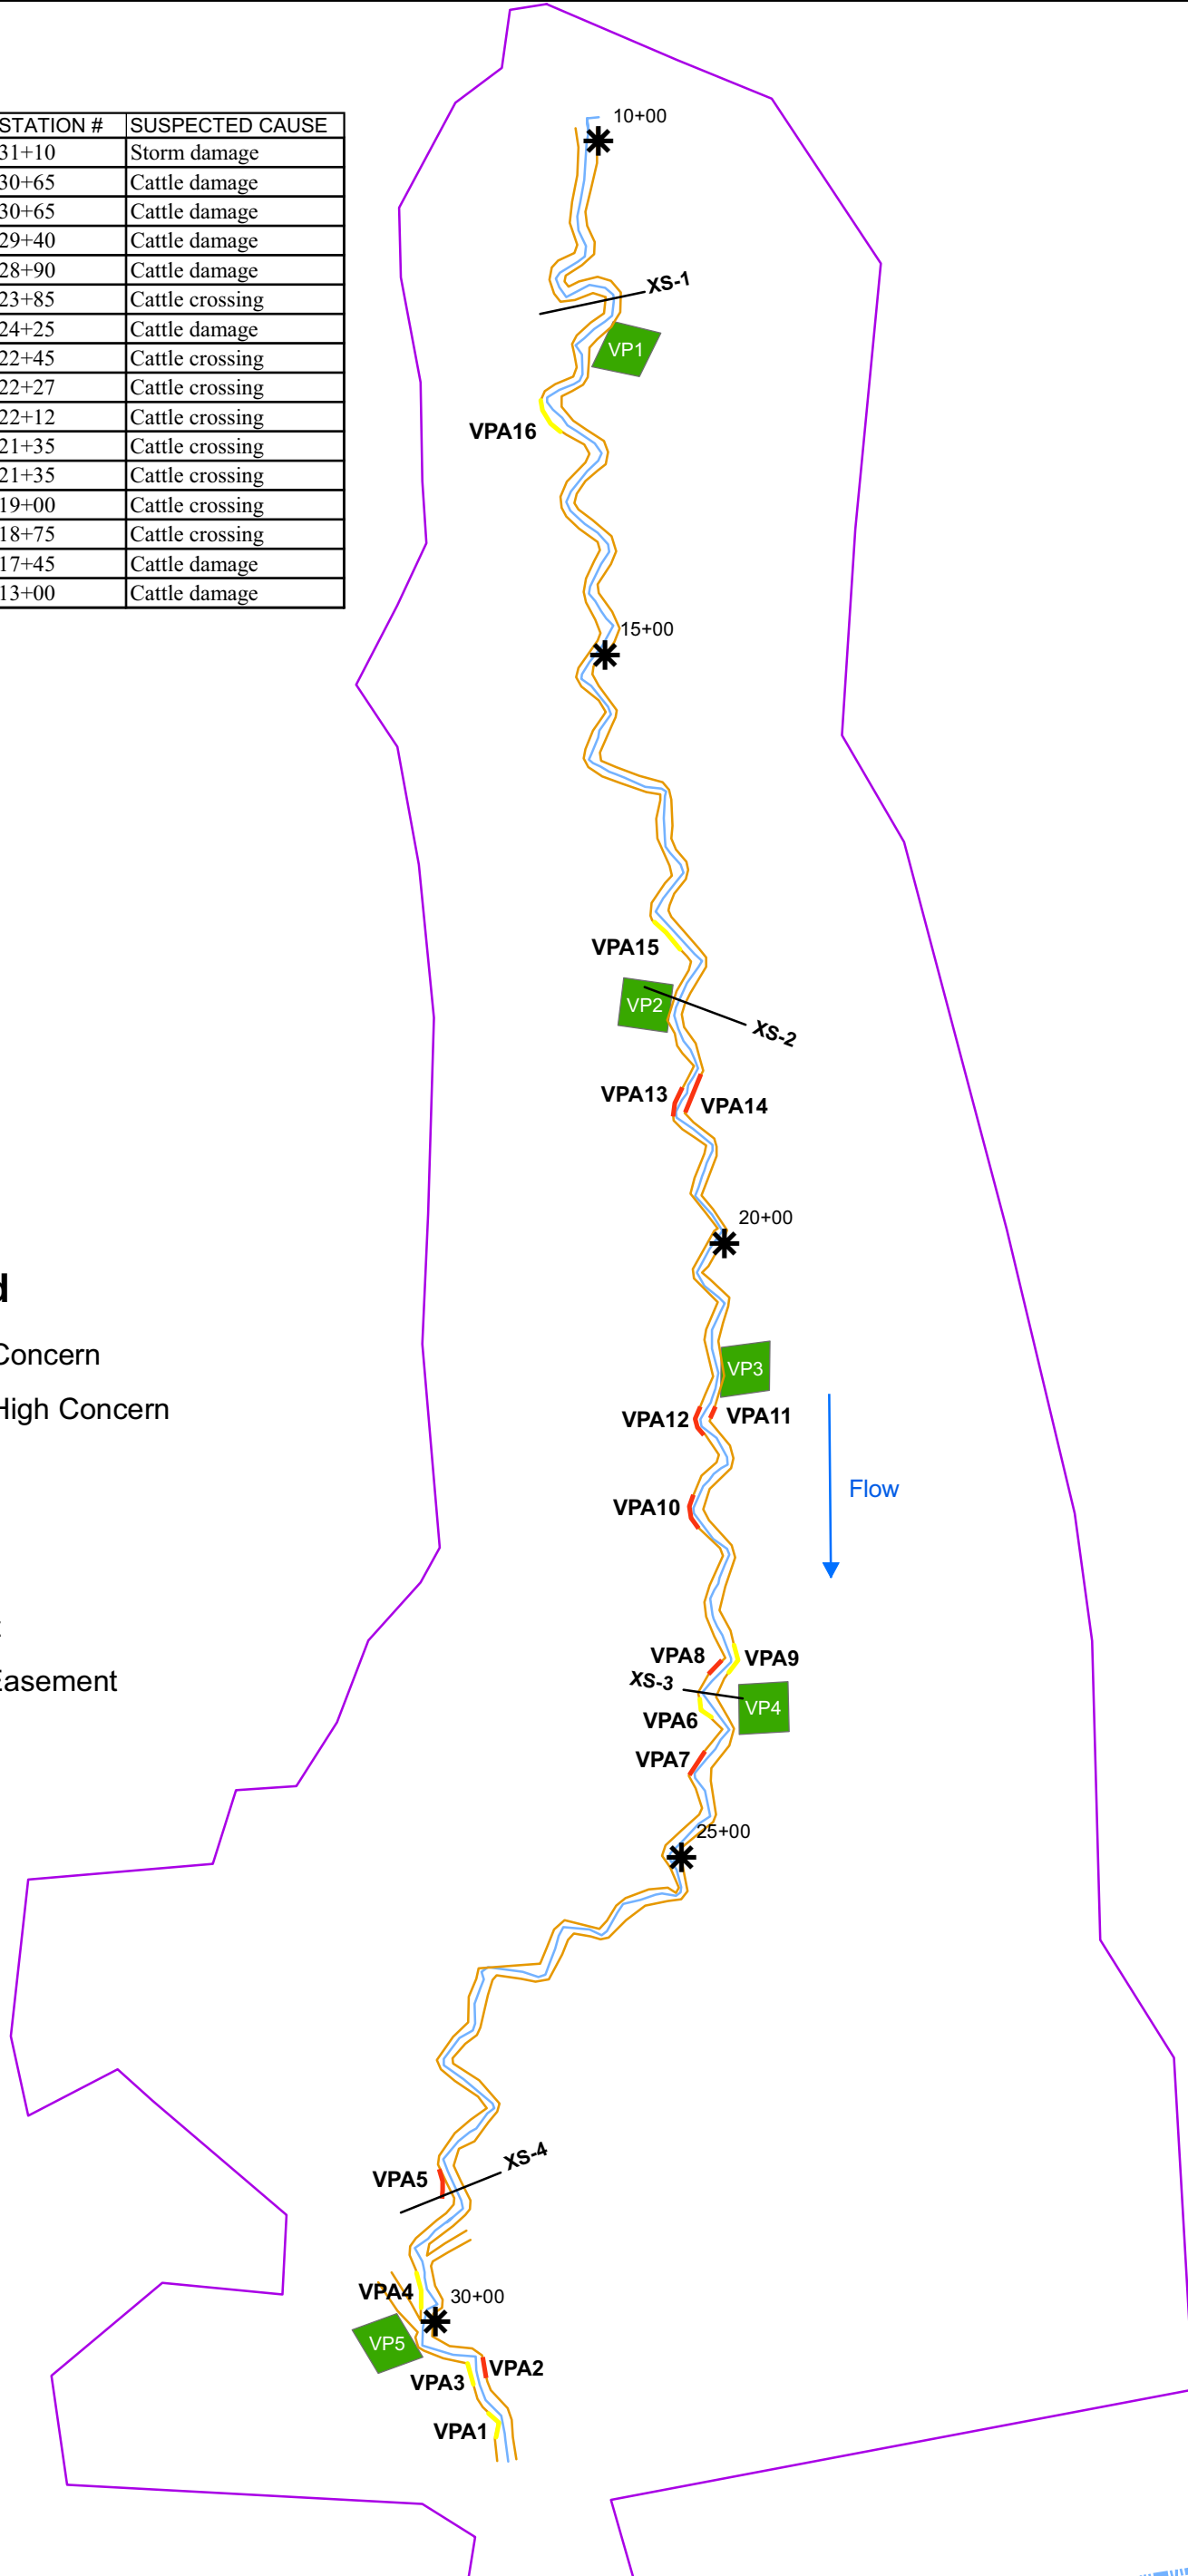
Sixteen vegetative problem areas were identified (Table AI). These vegetative problem areas were present throughout the site, but were primarily concentrated in the downstream portion of the project reach. The majority of the vegetative problem areas along UT to Billy's Creek appear to be the result of cattle grazing and trampling. Although the site is fenced in its entirety, a portion of the lower wire along one of the unnamed tributaries was loose in the spring of 2006. The electricity to the fence was not active at this time, allowing cattle to enter the restored channel and trample and/or eat the newly planted vegetation.

Despite fencing, cattle paths were present along both sides of the banks throughout the project reach, and these paths no longer support vegetation. Planted vegetation was sparse along the project reach, especially on the banks. However, the site appeared to be stabilizing. Since the June storm event and the exclusion of cattle, site conditions have improved. The site was observed on July 21, 2006, August 18, 2006, and again during the monitoring effort on September 6, 2006. Site conditions appeared to improve with each subsequent visit. Grazed seedlings are re-leafing and rushes (*Juncus* spp.) are populating the streambanks.

FEATURE #	FEATURE ISSUE	STATION #	SUSPECTED CAUSE
VPA1	Bare Bank	31+10	Storm damage
VPA2	Bare Bank	30+65	Cattle damage
VPA3	Bare Floodplain	30+65	Cattle damage
VPA4	Bare Floodplain	29+40	Cattle damage
VPA5	Bare Floodplain	28+90	Cattle damage
VPA6	Bare Bank	23+85	Cattle crossing
VPA7	Bare Bank	24+25	Cattle damage
VPA8	Bare Bank	22+45	Cattle crossing
VPA9	Bare Bank	22+27	Cattle crossing
VPA10	Bare Bank	22+12	Cattle crossing
VPA11	Bare Bank	21+35	Cattle crossing
VPA12	Bare Bank	21+35	Cattle crossing
VPA13	Bare Bank	19+00	Cattle crossing
VPA14	Bare Bank	18+75	Cattle crossing
VPA15	Bare Bank	17+45	Cattle damage
VPA16	Bare Floodplain	13+00	Cattle damage

Recommendations for UT to Billy's Creek include the following: 1) work with land owner and NRCS to ensure cattle exclusion (e.g. existing wires tightened, additional strands added, bring fence on-line or "live"), 2) treat exotic stems (e.g. privet), and 3) allow time for vegetation to mature and bankfull events to work sediment through system. Overall, the site is functioning well as above bankfull events are accessing the floodplain, pools are maintaining, and the pattern is maintaining. Vegetation has been stressed; however, planted species are present and should continue to mature.
