**UT to BILLY'S CREEK
FINAL MONITORING REPORT
YEAR 2 OF 5
2007**

**EEP Project # 36
Franklin County, North Carolina**

**UNNAMED TRIBUTARY TO BILLY’S CREEK STREAM RESTORATION
YEAR 2 MONITORING REPORT**

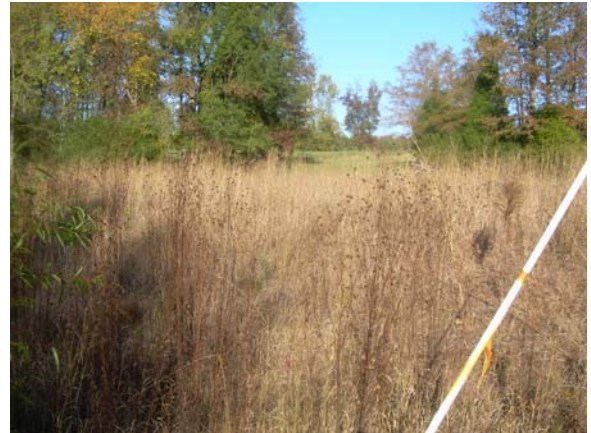
Photo 4: Vegetation Plot 4.

It should be noted that the Monitoring Year 1 performers had apparently mis-identified two *Viburnum dentatum* individuals as *Viburnum nudum* as well as an individual *Alnus serrulata* as *Betula nigra* in VP #4; and an individual *Quercus phellos* as *Quercus falcata* in VP #5. This mistake has been corrected in all stem count documentation.

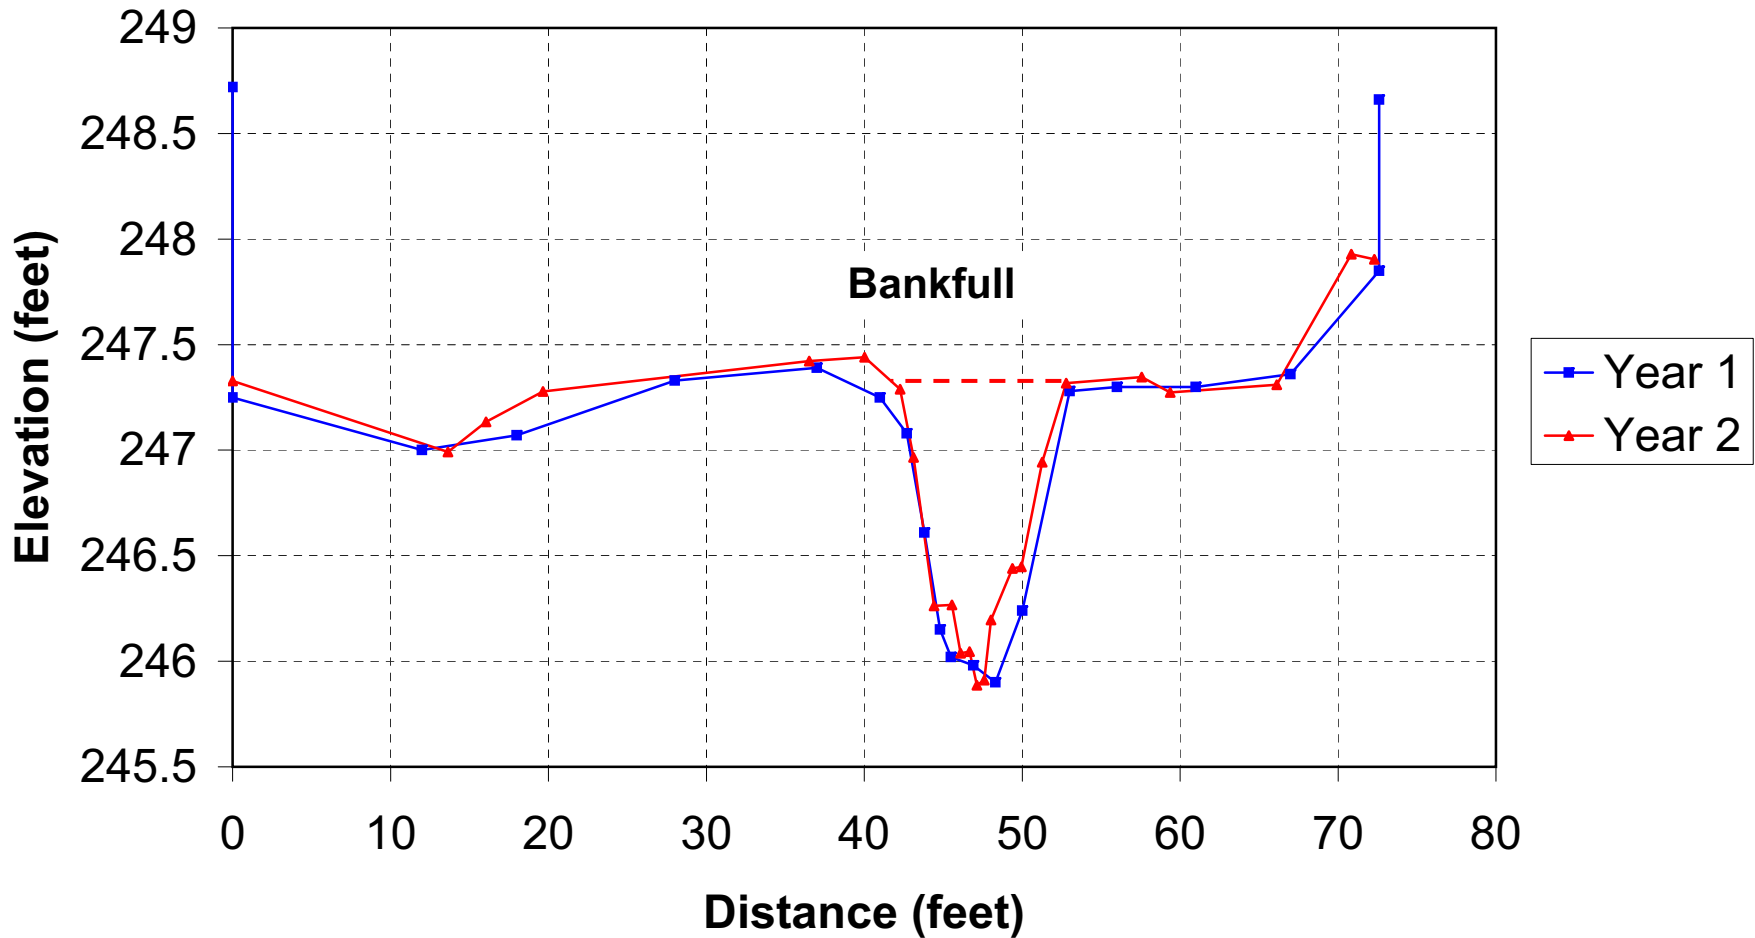
Cross Section Overlay (Years 1 & 2)
UT to Billy's Creek
Cross Section #2 - Riffle

by a notable decrease in cross sectional area and wetted perimeter. Cross section #2 lies downstream of the above-mentioned deposition. Accordingly, very little change in dimension was observed between monitoring years, with the exception of a slight amount of deposition at the bank toe on either side of the channel. However, the small amount of change observed was probably just normal year-to-year channel adjustment. Cross section #3 is associated with an area of fine sediment deposition (see stream problem area plan view, Appendix C), and as a result, the channel dimension has changed notably since Monitoring Year 1. It is apparent through the annual cross section overlay that the channel bed rose a significant amount across the entire channel between monitoring years. This observation is evident in large decreases since Monitoring Year 1 in cross sectional area, bankfull width, mean depth, wetted perimeter, and hydraulic radius at this cross section. The stream bed at cross section #4 has experienced approximately five inches of downcutting since Monitoring Year 1 as observed in the annual overlay. This may be a section of stream to observe closely during future monitoring. However, it is apparent upon observation of the longitudinal profile annual overlay, that the downcutting is limited to just this riffle (station 28+60 to approximately station 28+75 along the thalweg). In addition, it is apparent that downcutting in riffles is not a trend observed throughout the project and, in fact, is isolated to just the small section of stream crossed by cross section #4.
