**UT to BILLY'S CREEK  
FINAL MONITORING REPORT  
YEAR 3  
2008**

EEP Project # 36  
Franklin County, North Carolina

## **Executive Summary**

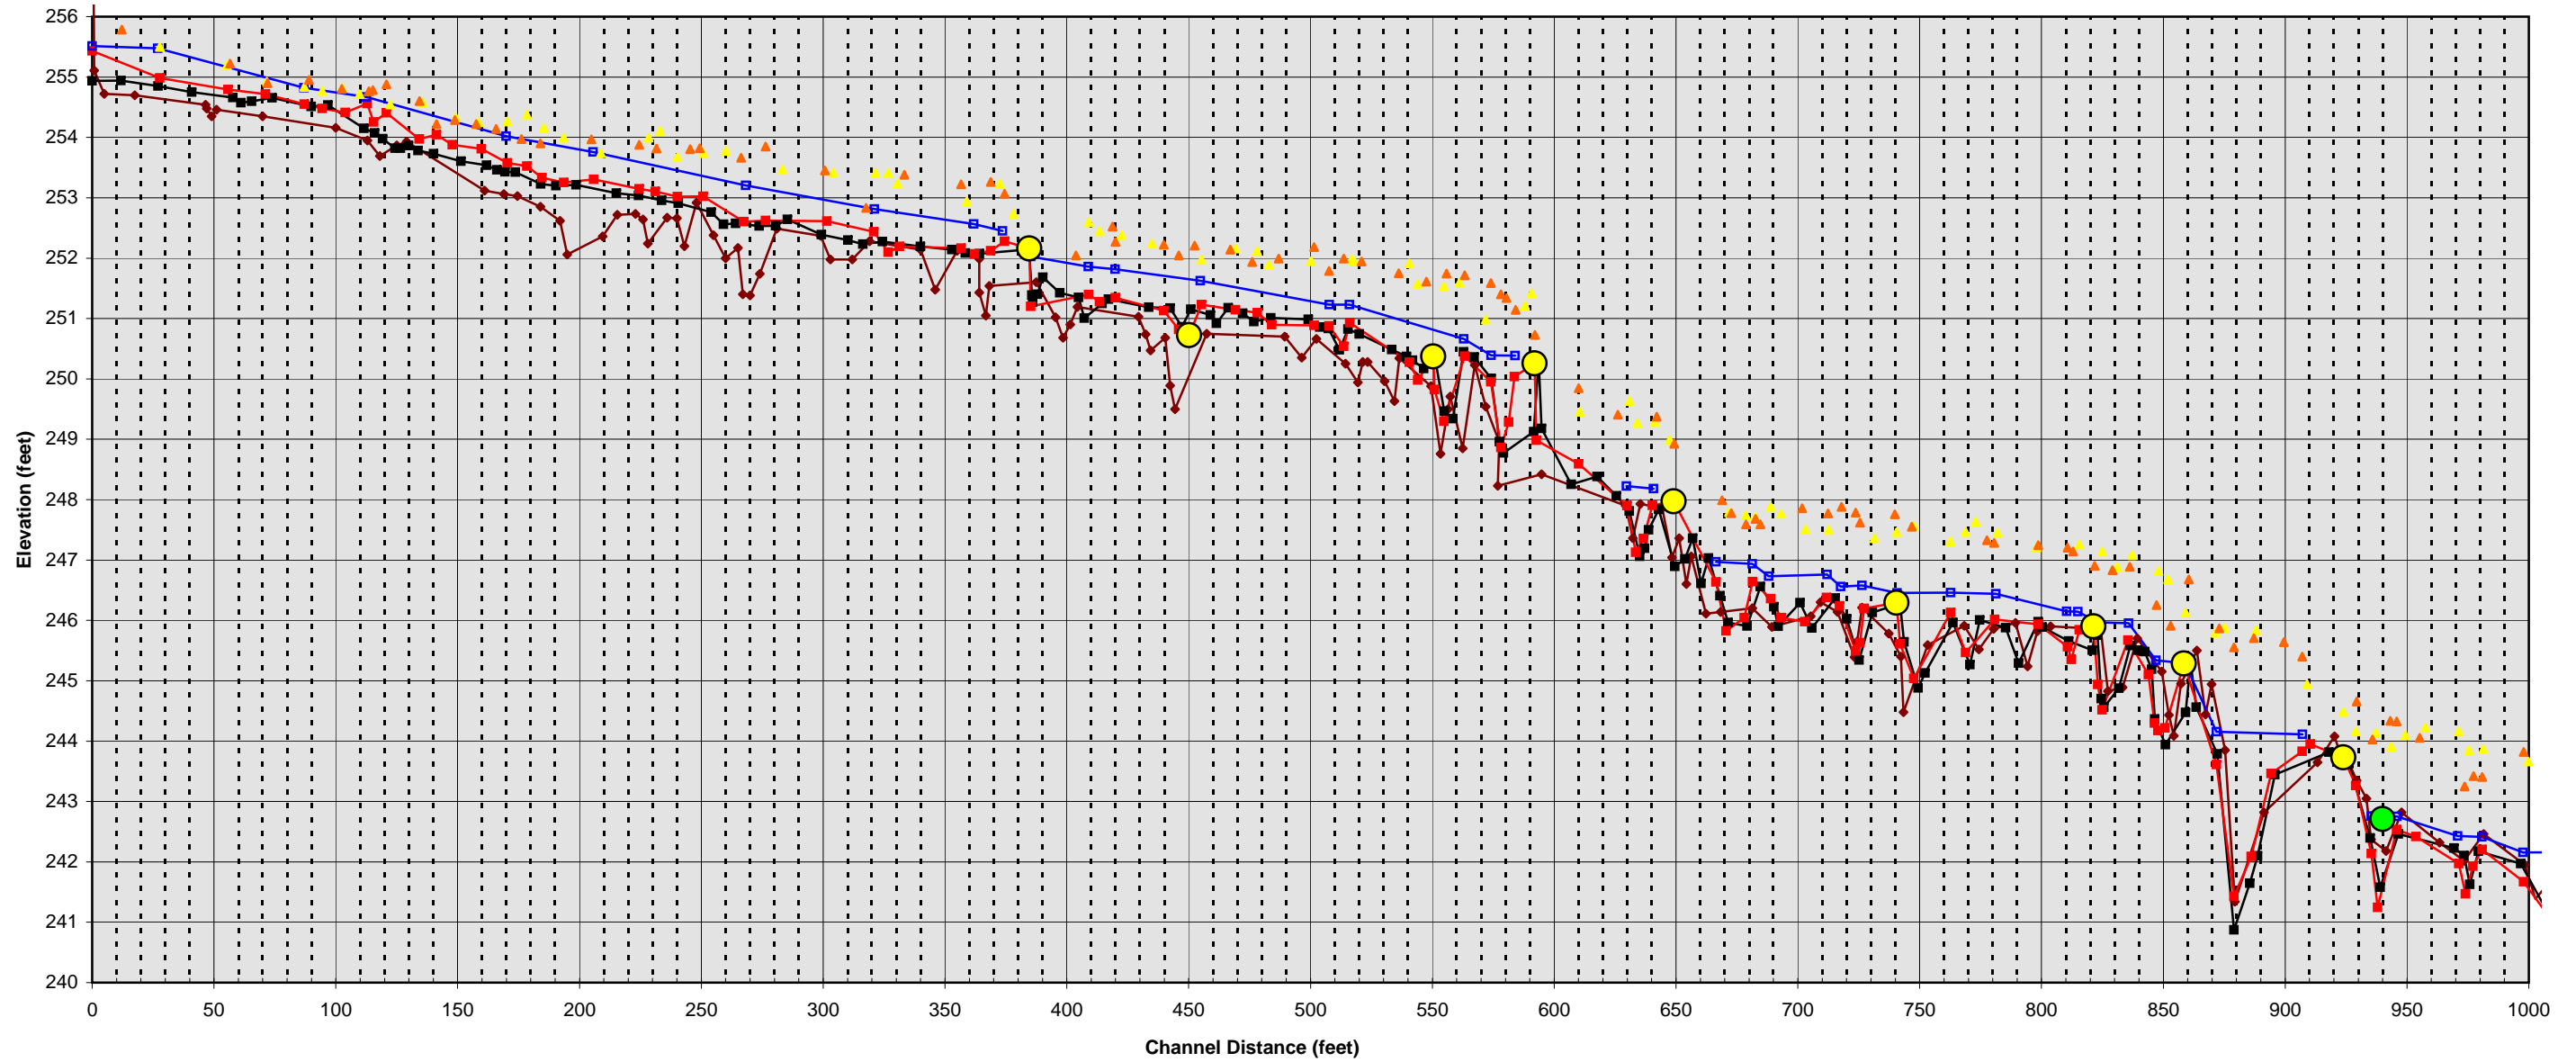
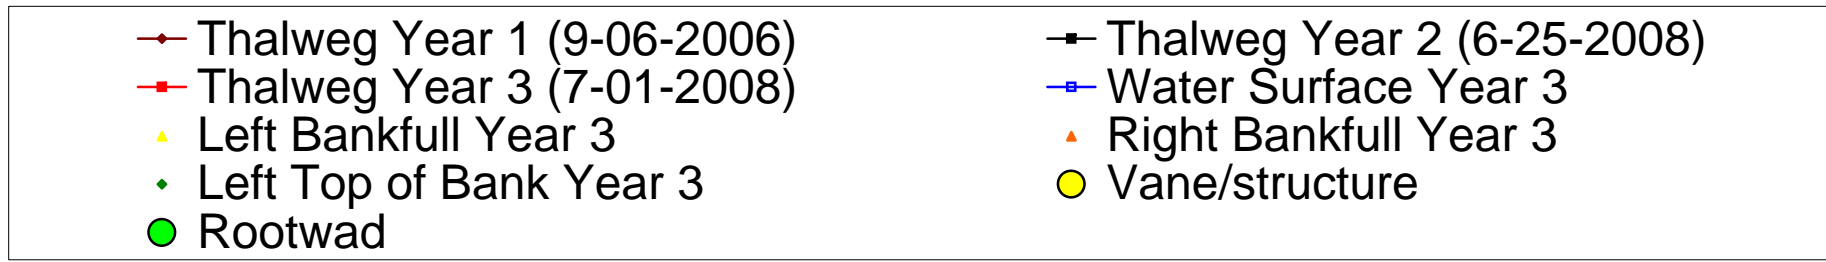
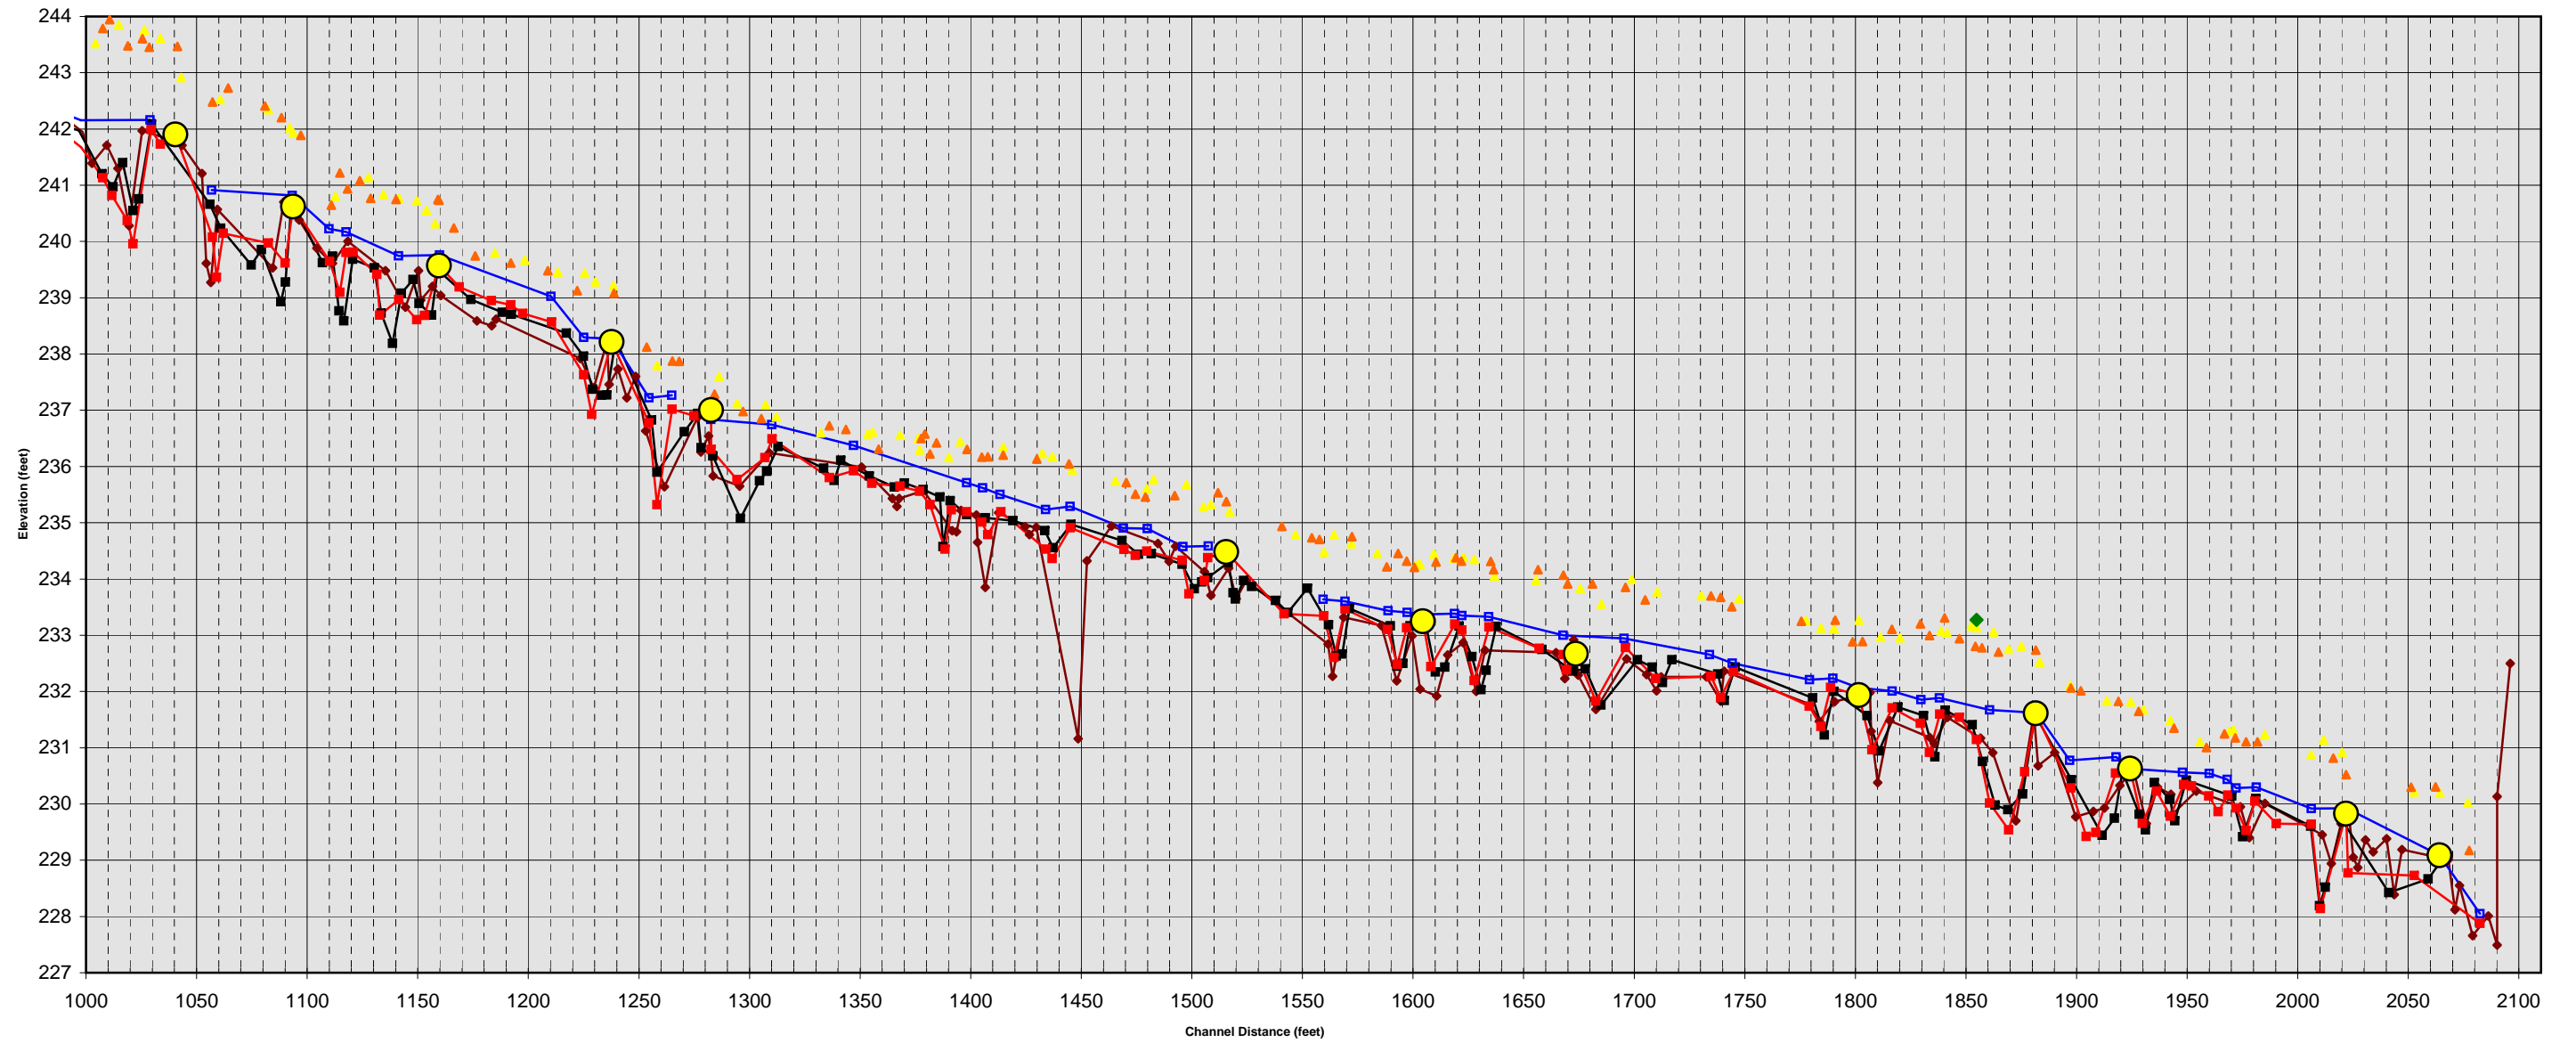
Longitudinal Profile Overlay (Years 1-3) Page 1 of 2  
 UT to Billy's Creek

Sand deposition (noted as aggradation on the problem area plan view) has “blanketed” the entire upper quarter of the project reach effect of homogenizing channel units into long run sections. Soft rush has “choked” the entire channel in this area, making it very difficult to locate channel features. These areas now look much more like linear wetland than stream channel. The sediment source is presumably upstream of the project. There are three bank erosion areas to keep an eye on, as noted on the problem area plan views (Appendix C). Although bank erosion does not appear to be a major problem of concern (bank condition of 98% in the Visual Morphological Stability Estimate), there are two specific erosion areas rated severe that should be watched closely in the future. These two areas, located at Station 18+72 and at Station 20+19 along the thalweg, have major slumping of both banks. Repair assessment may be warranted at these locations. All structures appeared to be in good physical condition, except for one stone grade control structure, located at Station 15+90 along the thalweg, that had water piping around the right side that caused some bank scour.

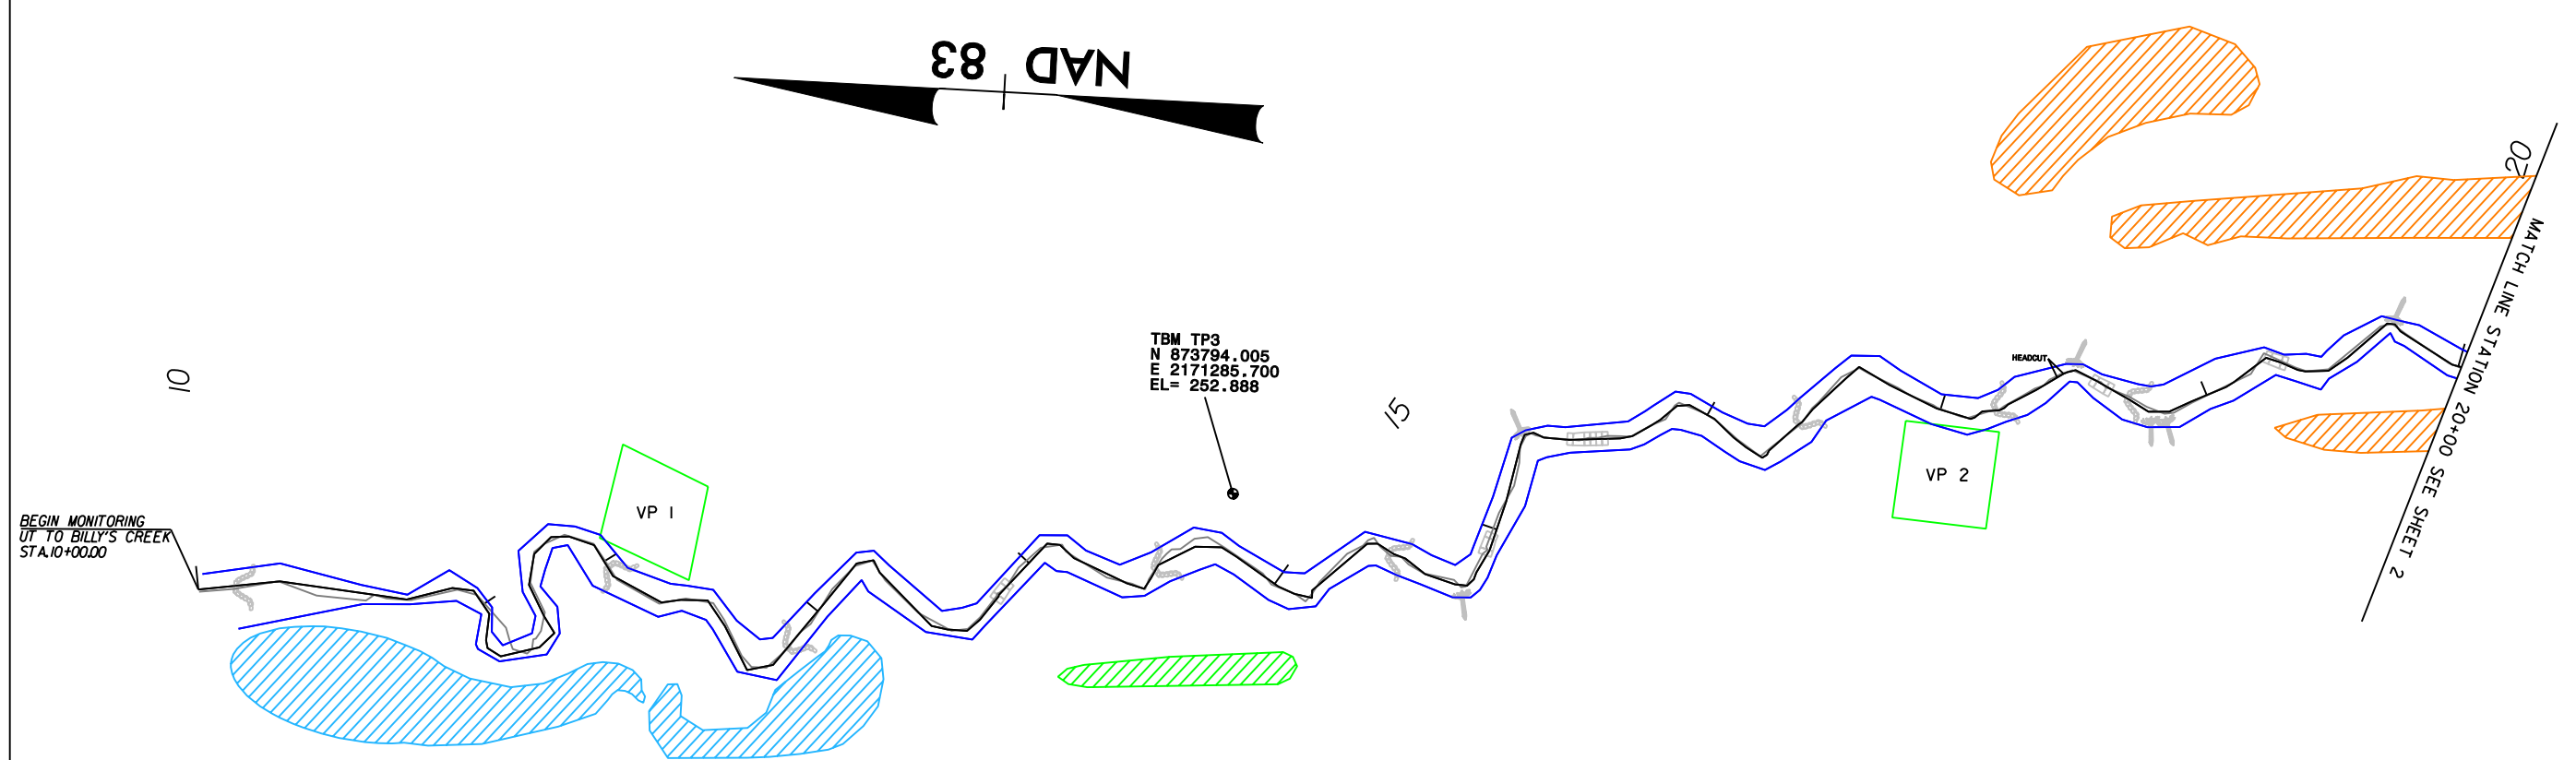
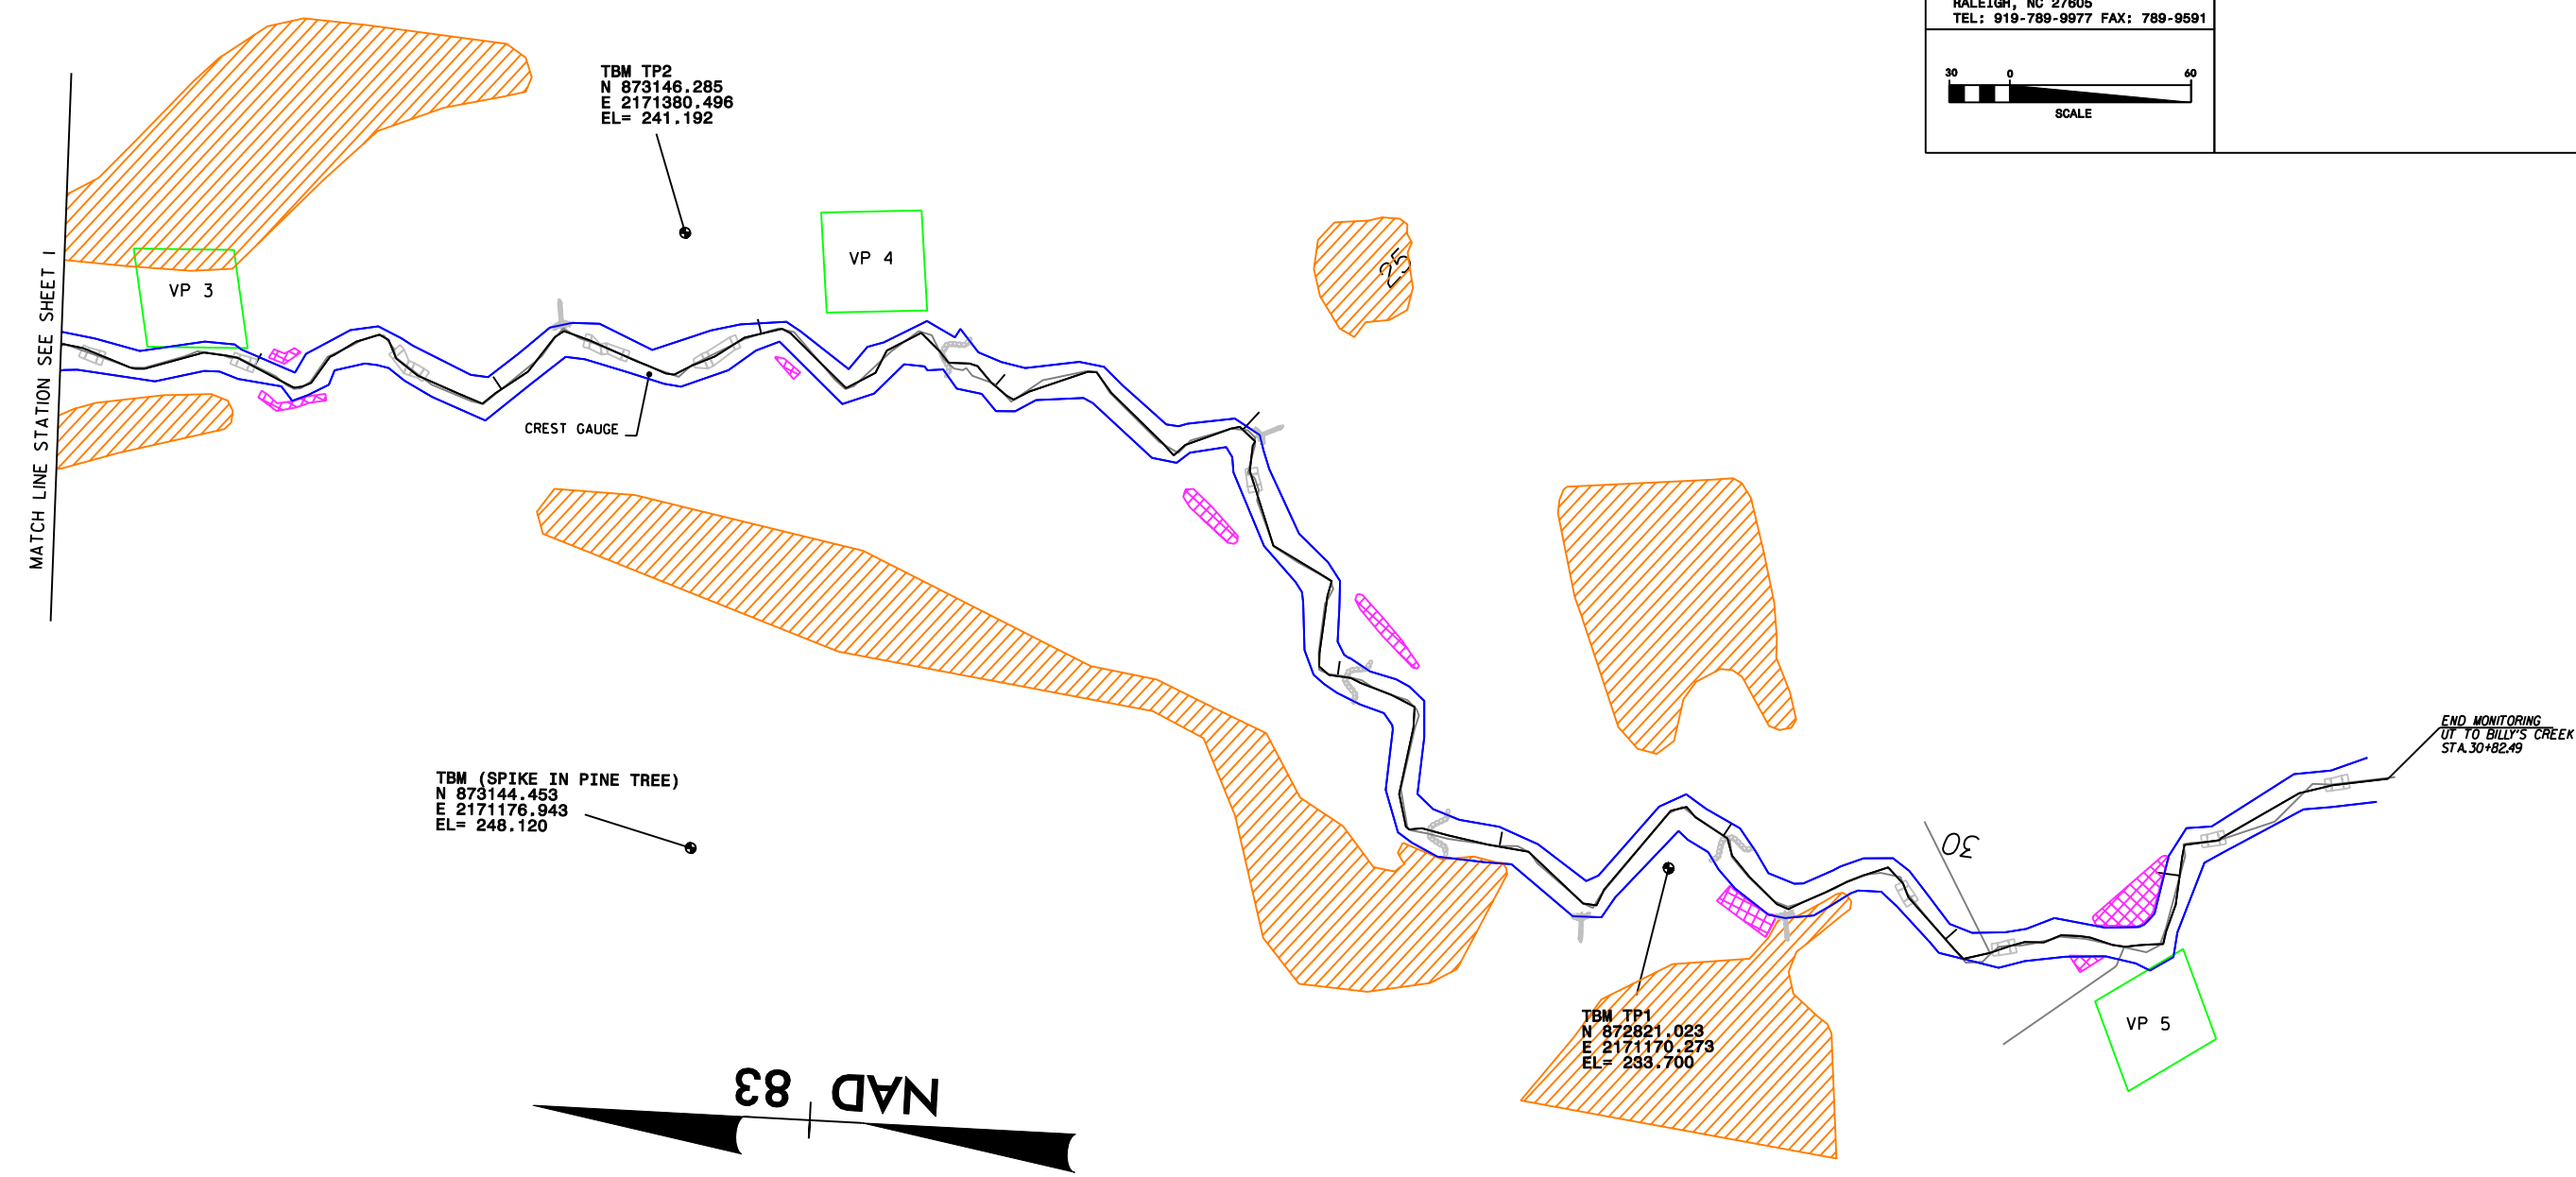
LOCATION: <b>UT TO BILLY'S CREEK VEGETATION MONITORING - YEAR 3</b>	
PROJ #: <b>36</b>	COUNTY: <b>FRANKLIN</b>
PREPARED BY: <b>IPJ</b>	
CHECKED BY: <b>PDB</b>	DATE: <b>2/10/09</b>

Several populations of invasive *Ligustrum sinense* (Chinese privet) were noted along the project corridor during Monitoring Year 3. These areas occur along the length of the project and are noted on the problem area plan view as well as the vegetative problem area list. There is a small population of *Microstegium virmineum* that was discovered during Monitoring Year 3 (Station 13+75 to 15+13). Although not considered a ‘problem,’ it should be noted that cattails, which are sometimes considered to be invasive, were noted near the upper end of the reach.

\*POPULATIONS OF *LIGUSTRUM SINENSE* ARE SCATTERED ALONG THE PROJECT FROM APPROXIMATELY STATION 18+00.00 TO THE END. ONLY THE MOST SUBSTANTIAL OF THESE AREAS ARE NOTED AS POLYGONS ON THIS PLAN VIEW.
