**UT to BILLY'S CREEK
FINAL MONITORING REPORT
YEAR 4 OF 5
2009**

EEP Project # 36
Franklin County, North Carolina

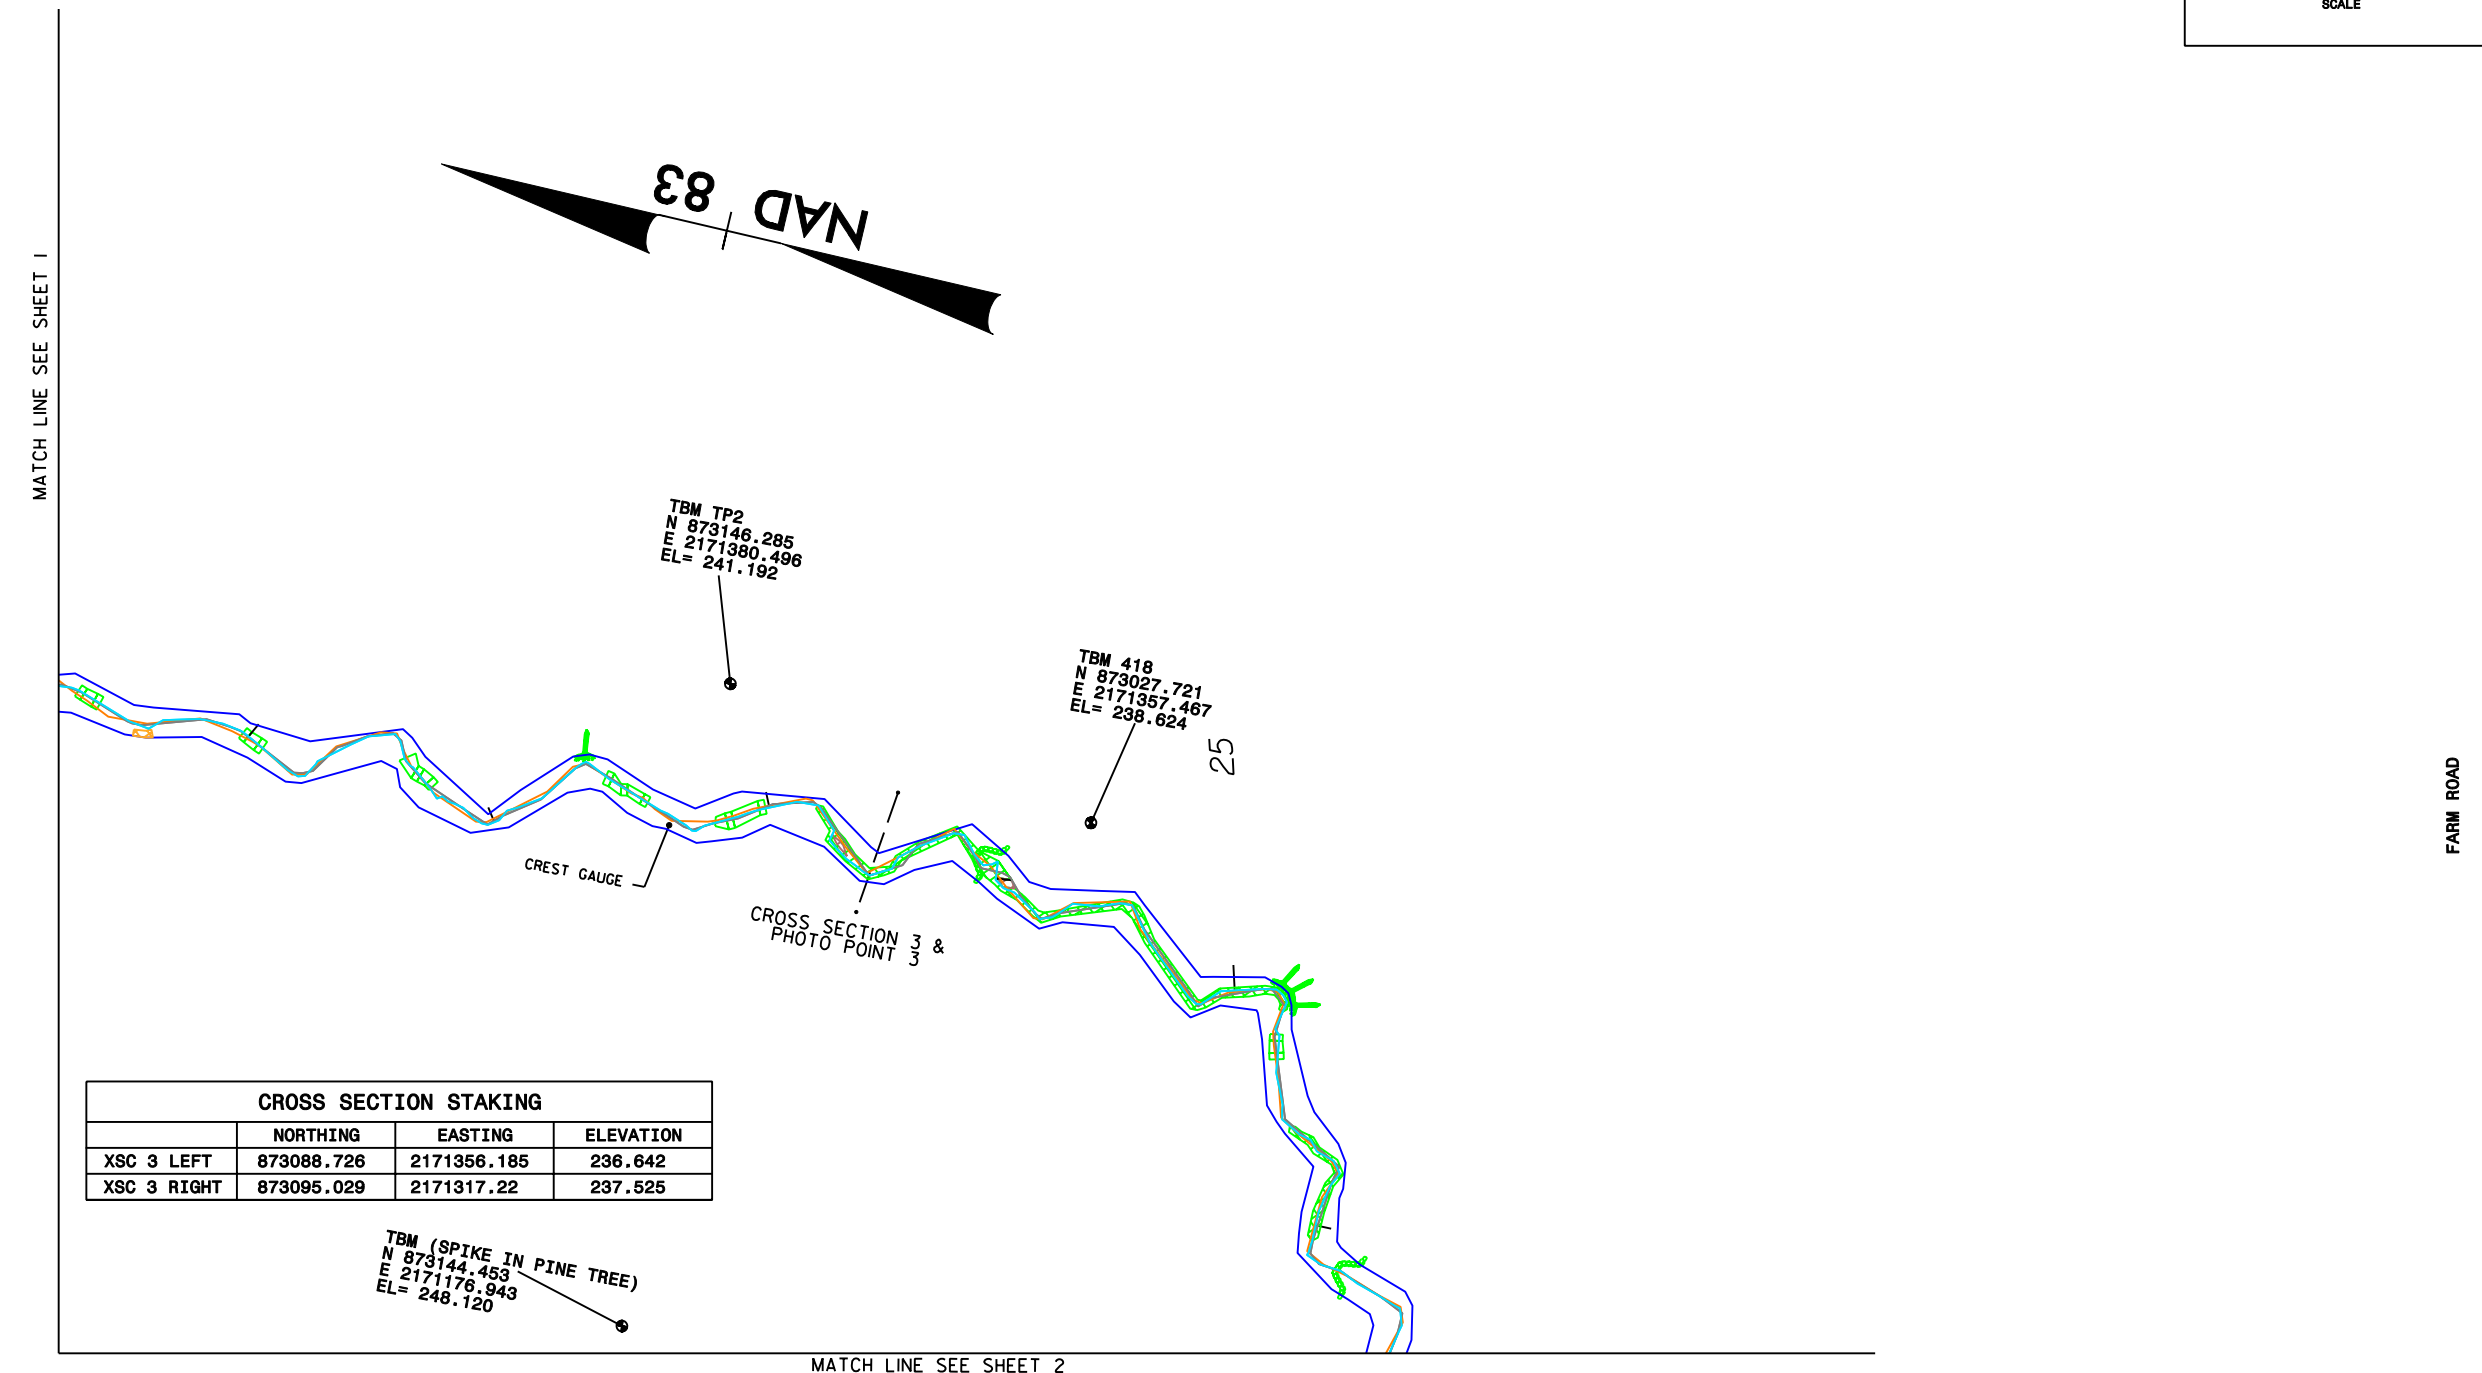
LOCATION: UT TO BILLY'S CREEK	
CURRENT CONDITIONS PLAN VIEW	
FINAL STREAM - YEAR 4	
PROJ #: 36	COUNTY: FRANKLIN
PREPARED BY: IPJ	
CHECKED BY: PDB	DATE: 3/01/2010

The majority of the UT Billys restoration reach remained stable through Monitoring Year 4, with the exception of a 378 foot section of sand deposition at the upstream end of the reach (Station 10+00 to 13+78). Excess sand deposition has completely filled the channel and blanketed out over the floodplain making it very difficult to locate the main channel in the upstream-most 150 feet due to braiding. This deposition has changed the channel dimension and profile significantly over the monitoring period. Cross Section 1 (Station 11+73) clearly shows a steady stream-bed elevation rise through Monitoring Year 4 that is likely correlated with this deposition. Furthermore, the Monitoring Year 4 bankfull cross sectional area of Cross Section 1 was the lowest documented compared to the three previous monitoring years. There were a few additional aggradation areas found further downstream that appear to have excess sediment deposits for long sections (See 'Stream Problem Area Plan View' Appendix A). Other problem areas were associated with bank erosion. Bank erosion is not a major problem in the reach because it has impacted a low percentage of the total banks. The two areas of past severe concern (Station 18+73 and 20+63) have apparently stabilized. No further signs of active erosion were observed at these locations in 2010. All structures appeared to be in good physical condition. The only structure-associated problems noted for Monitoring Year 4 are several structures and their associated pools that have been buried under excess sand deposition.
