Blair Creek Stream Mitigation Project

Year 1 (2022) Monitoring Report FINAL

Clay County, North Carolina

DMS Project ID No. 100047

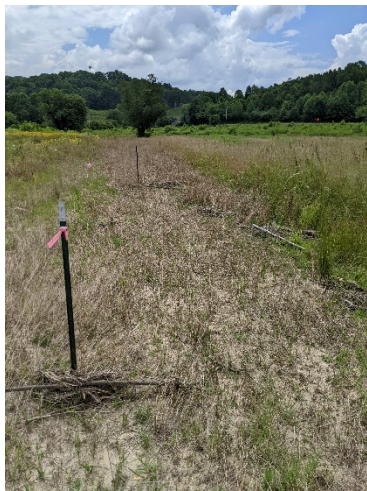
Overbank evidence. Debris in lower Reach 1 floodplain. (Photo taken July 1, 2022)

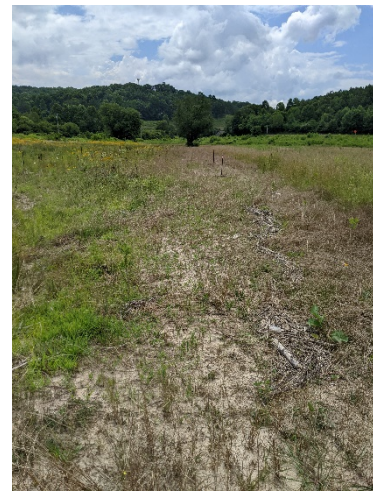
Overbank evidence. Debris in lower Reach 1 floodplain (Photo taken July 1, 2022)

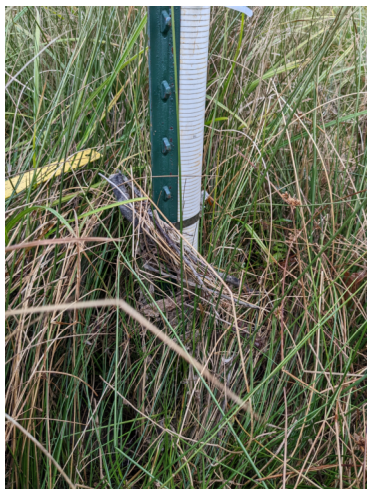
Overbank evidence. Debris jam on Crest Gauge 3 Reach 2 Left floodplain. (Photo taken November 22, 2022)

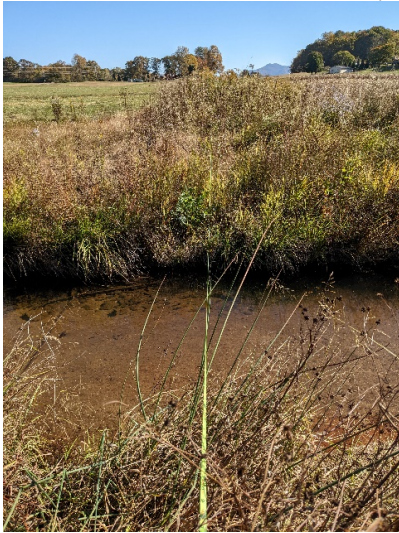
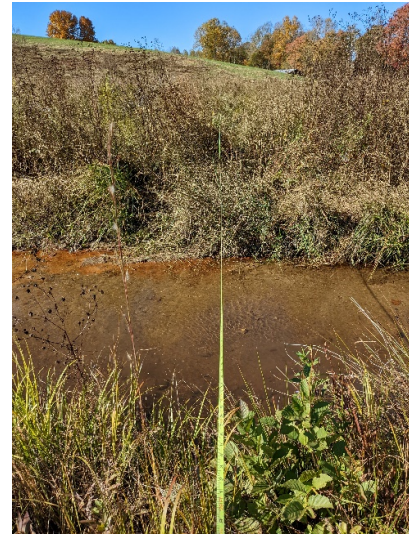
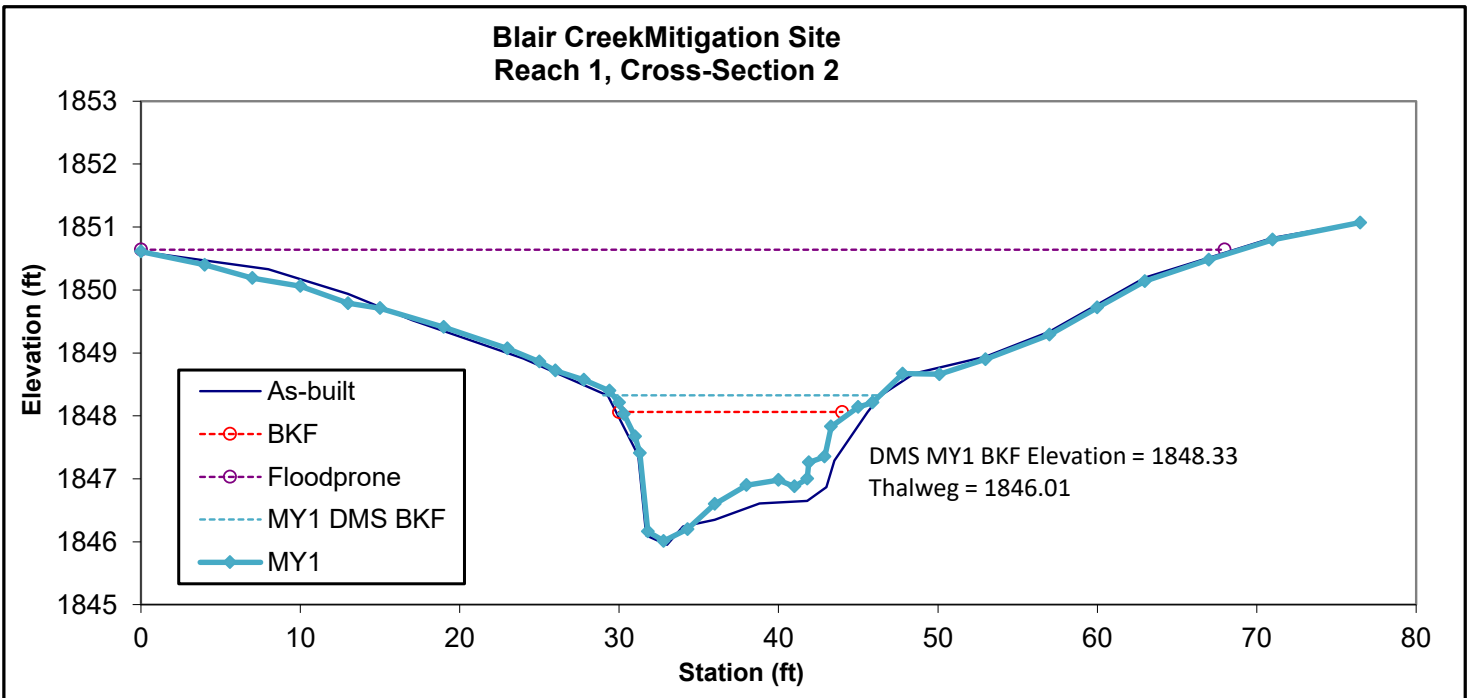
Permanent Cross-Section 2

Feature	Stream Type	BKF Area	BKF Width	BKF Depth	Max BKF Depth	W/D	BH Ratio	ER	BKF Elev	TOB Elev
Riffle	E	16.70	14.30	1.20	2.00	12.20	1.0	4.5	1848.06	1848.14

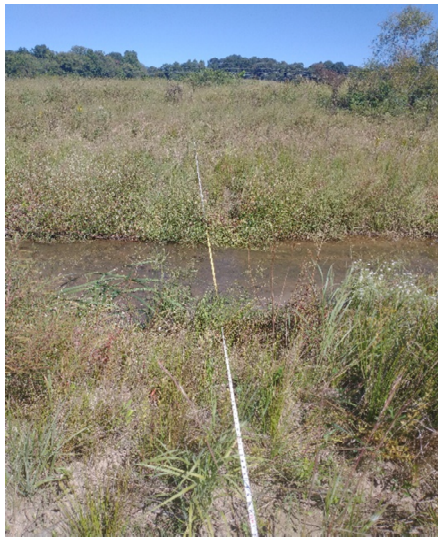
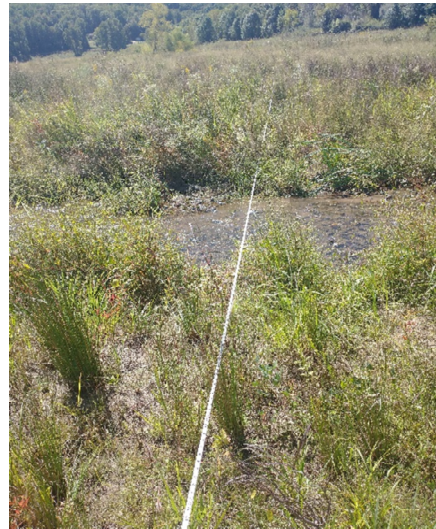
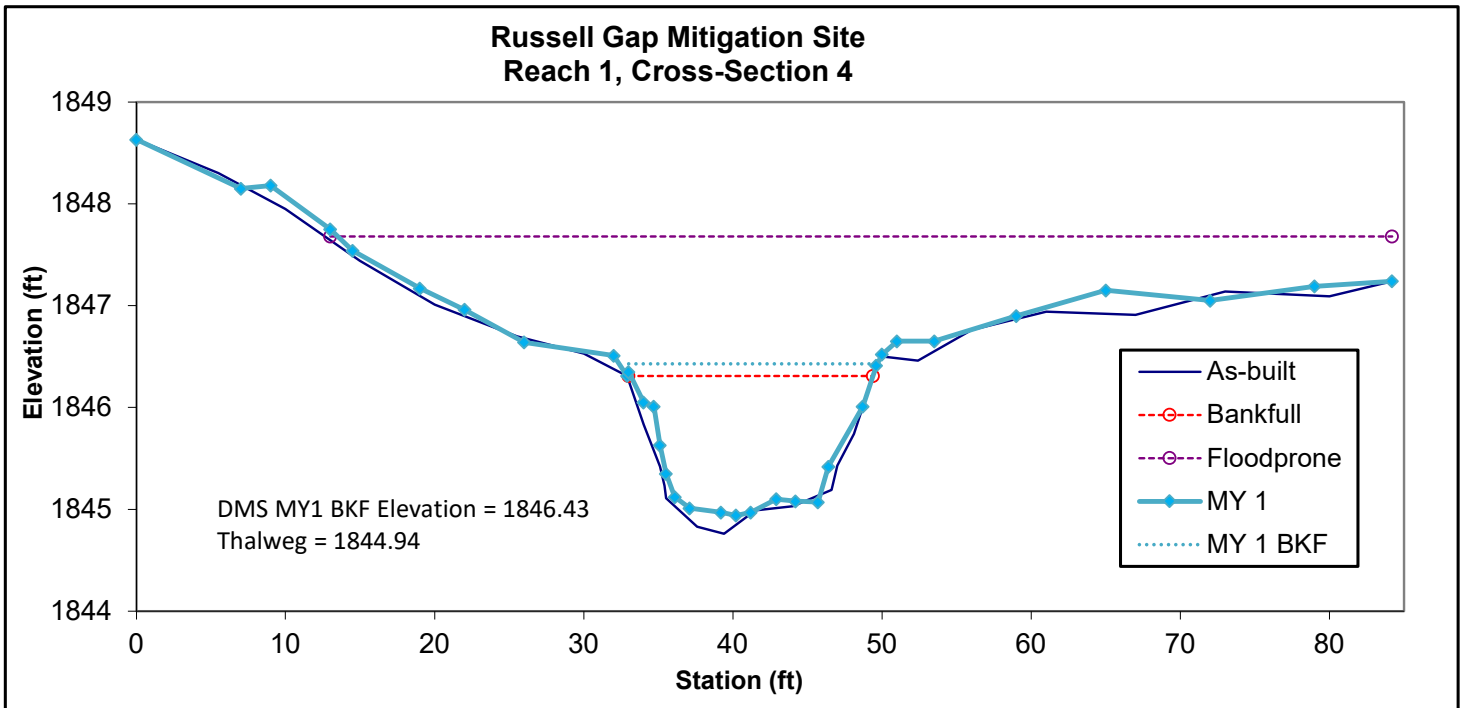
Permanent Cross-Section 4

Feature	Stream Type	BKF Area	BKF Width	BKF Depth	Max BKF Depth	W/D	BH Ratio	ER	BKF Elev	LTOB Elev
Riffle	C	16	16.2	1	1.4	16.5	1.10	1.1	1846.31	1846.51

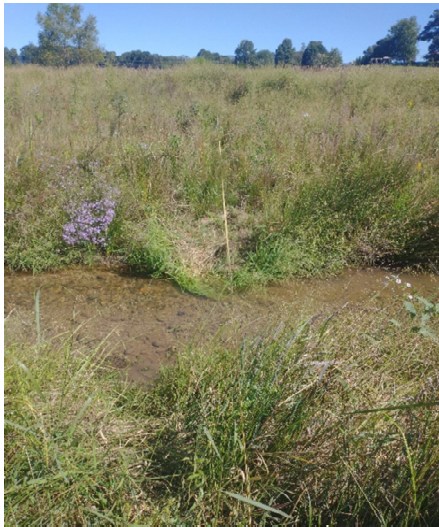
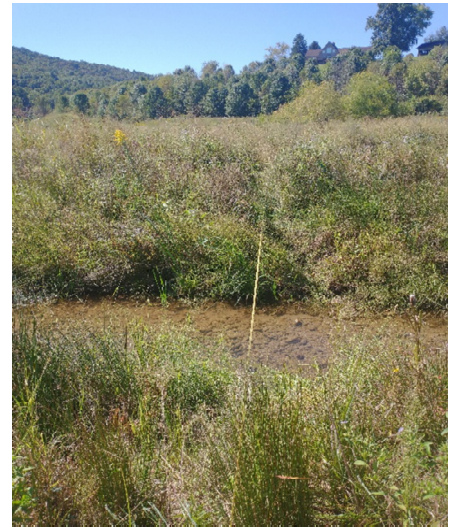
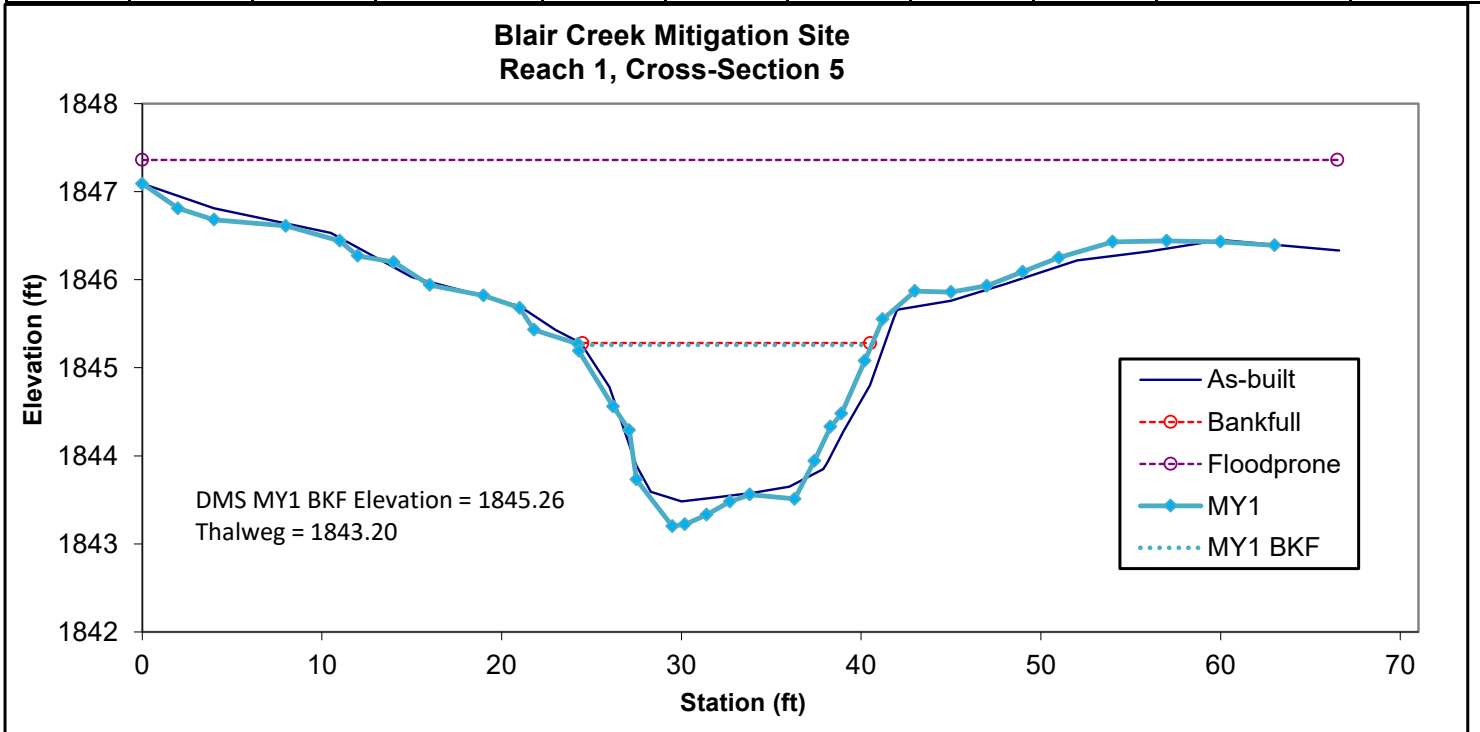
Permanent Cross-Section 5

Feature	Stream Type	BKF Area	BKF Width	BKF Depth	Max BKF Depth	W/D	BH Ratio	ER	BKF Elev	LTOB Elev
Riffle	C	22.2	16.50	1.30	2.1	12.3	1.0	4.1	1845.28	1845.25

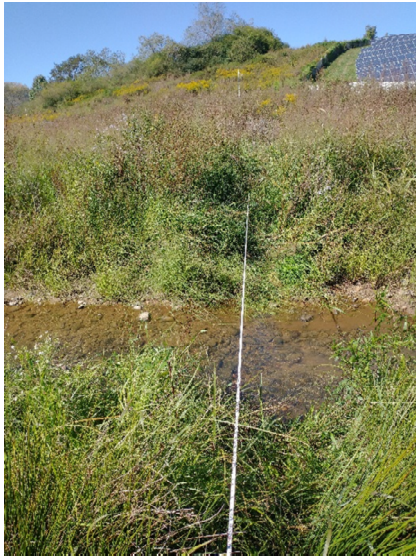
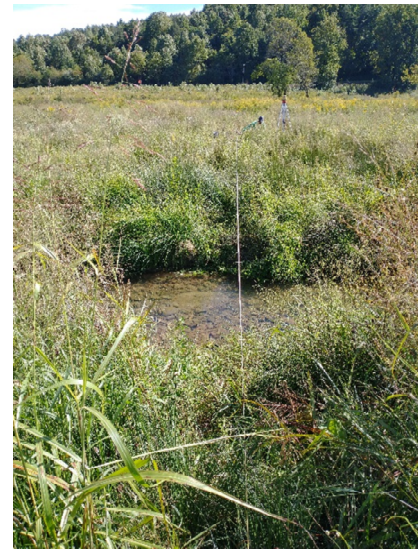
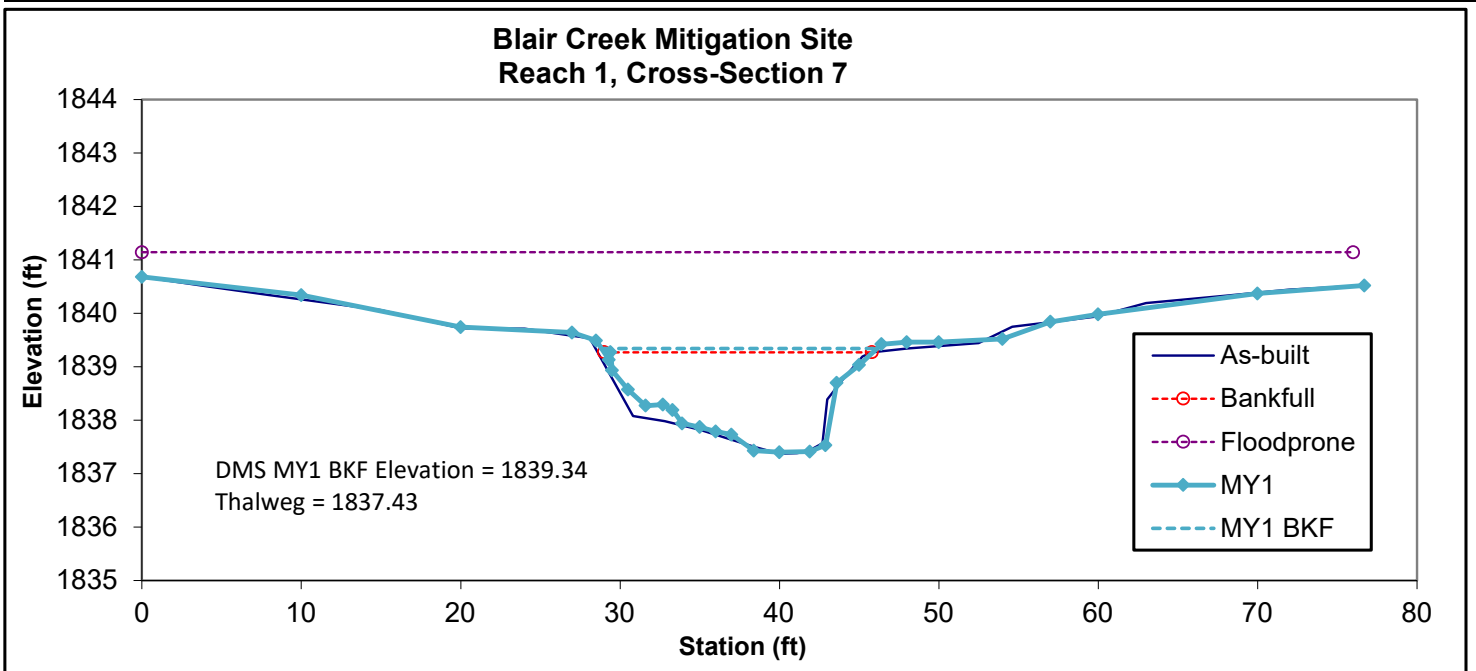
Permanent Cross-Section 7

Feature	Stream Type	BKF Area	BKF Width	BKF Depth	Max BKF Depth	W/D	BH Ratio	ER	BKF Elev	TOB Elev
Riffle	C	20.6	16.9	1.2	1.9	13.8	1.00	4.40	1839.27	1839.42

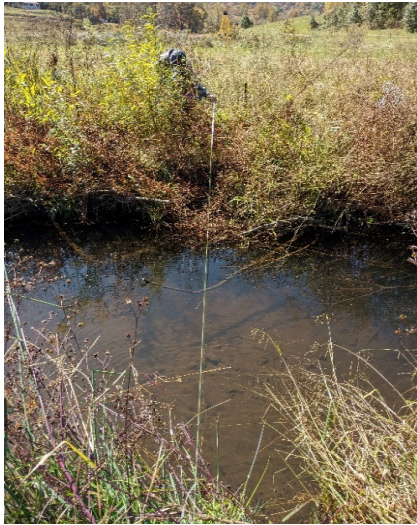
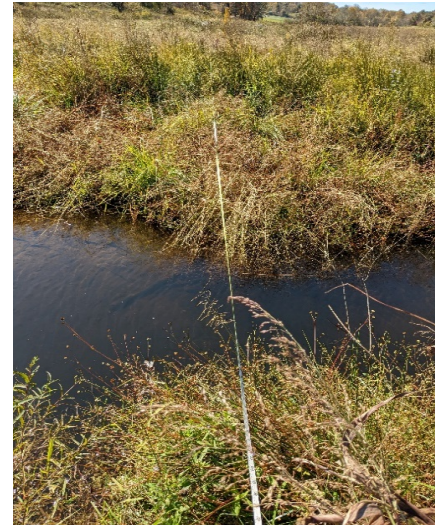
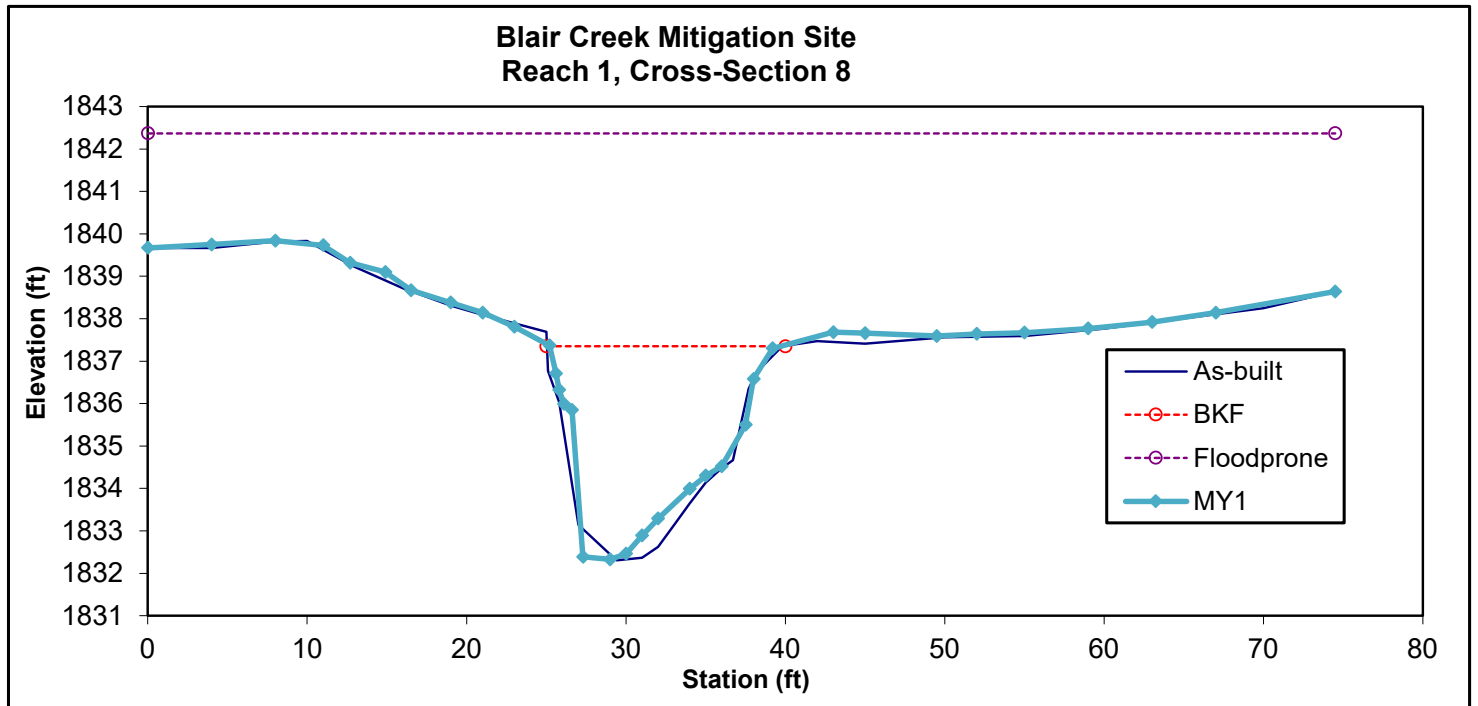
Permanent Cross-Section 8

Feature	Stream Type	BKF Area	BKF Width	BKF Depth	Max BKF Depth	W/D	BH Ratio	ER	BKF Elev	LTOB Elev
Pool	--	44.2	13.99	3.16	5.02	4.43	--	--	1837.35	1837.35

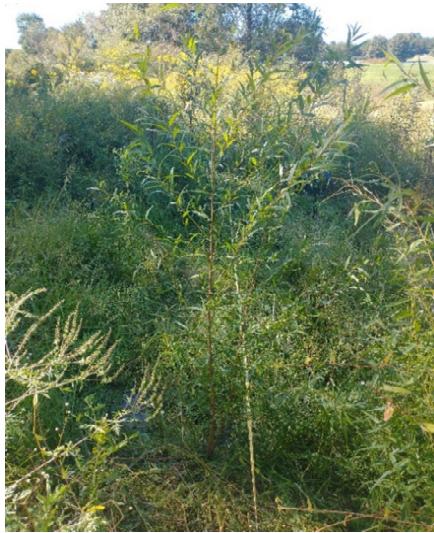
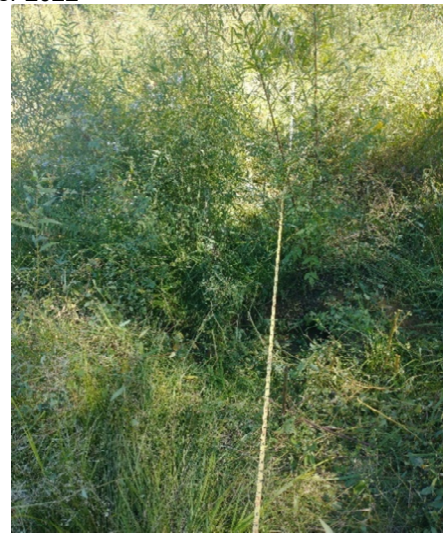
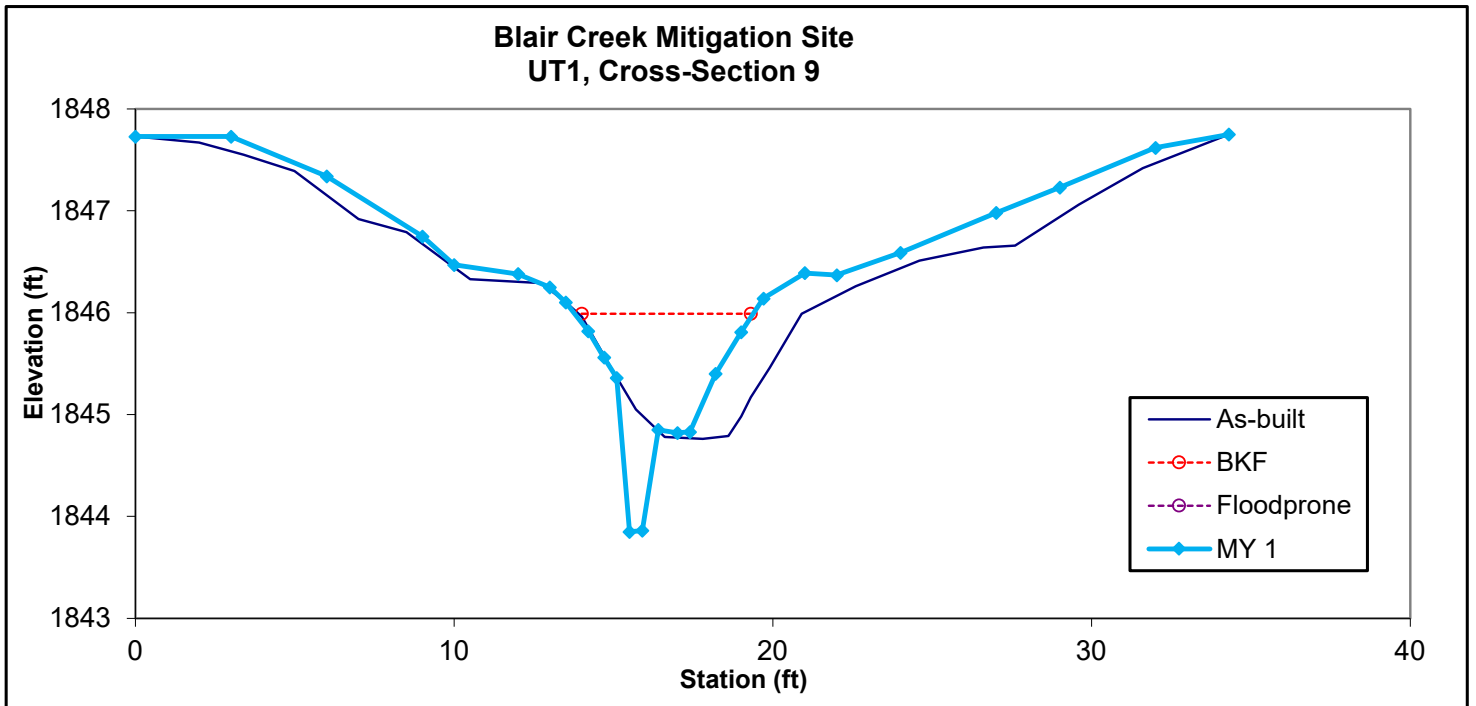
Permanent Cross-Section 9

Feature	Stream Type	BKF Area	BKF Width	BKF Depth	Max BKF Depth	W/D	BH Ratio	ER	BKF Elev	LTOB Elev
Pool	--	4.8	5.56	0.9	2.1	6.39	--	--	1845.99	1846.25

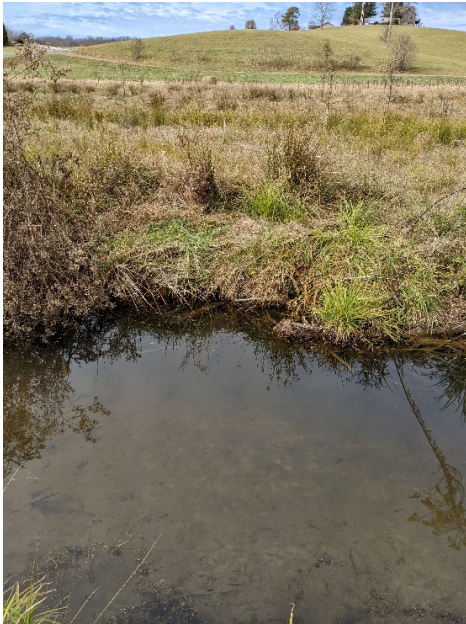
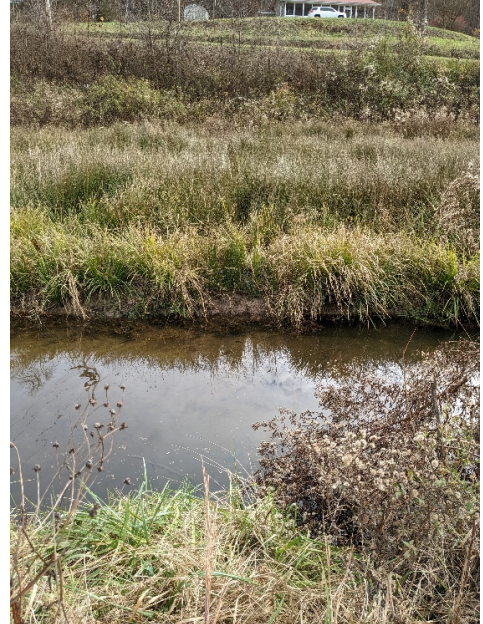
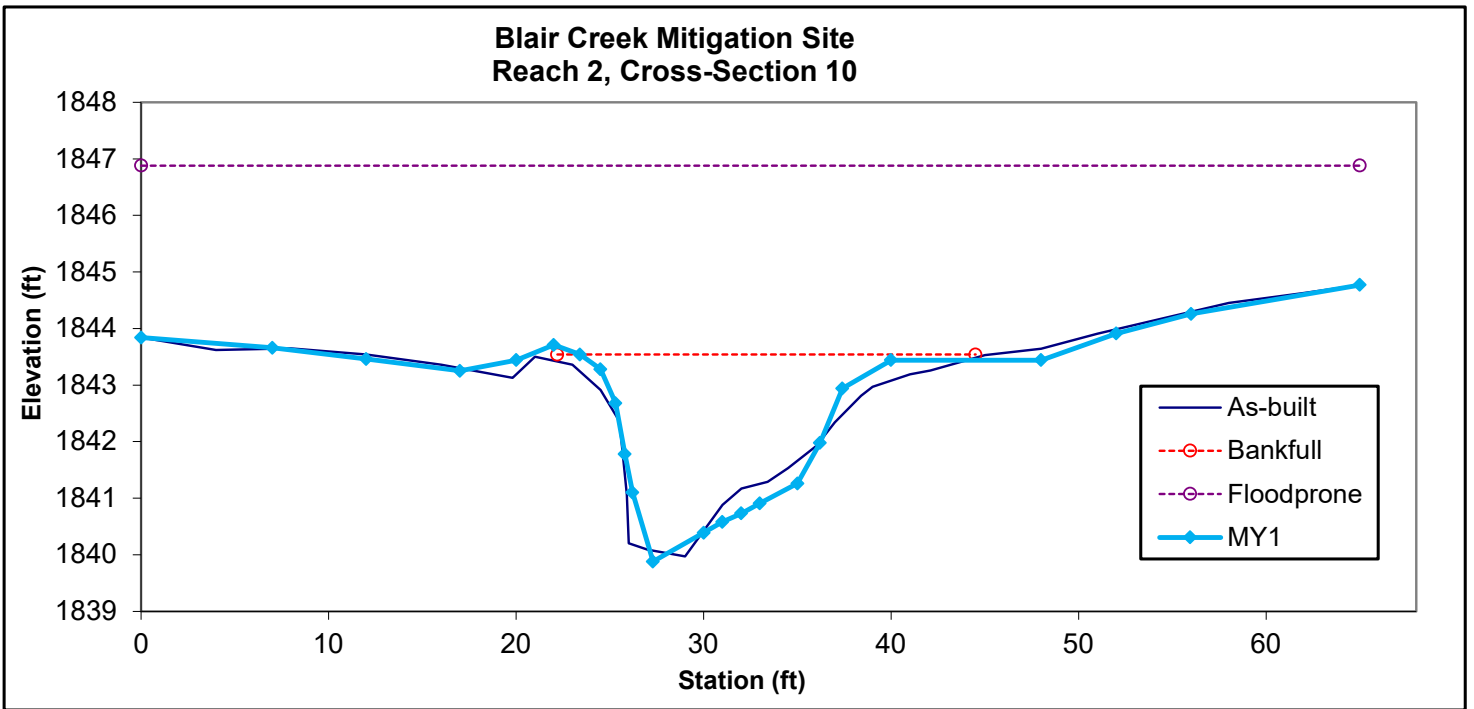
Permanent Cross-Section 10

Feature	Stream Type	BKF Area	BKF Width	BKF Depth	Max BKF Depth	W/D	BH Ratio	ER	BKF Elev	TOB Elev
Pool	--	33.46	24.10	1.39	3.66	17.34	--	--	1843.54	1843.54

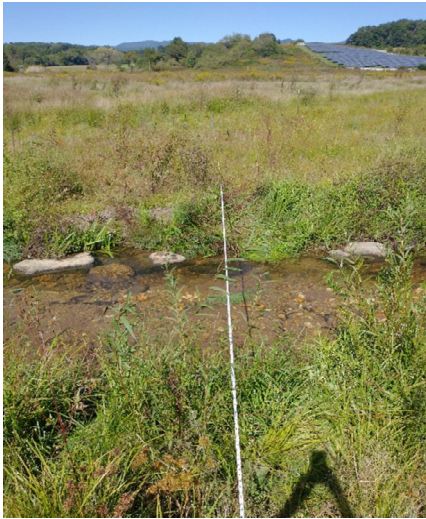
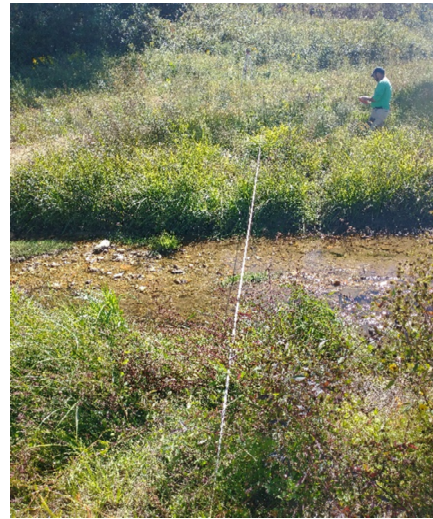
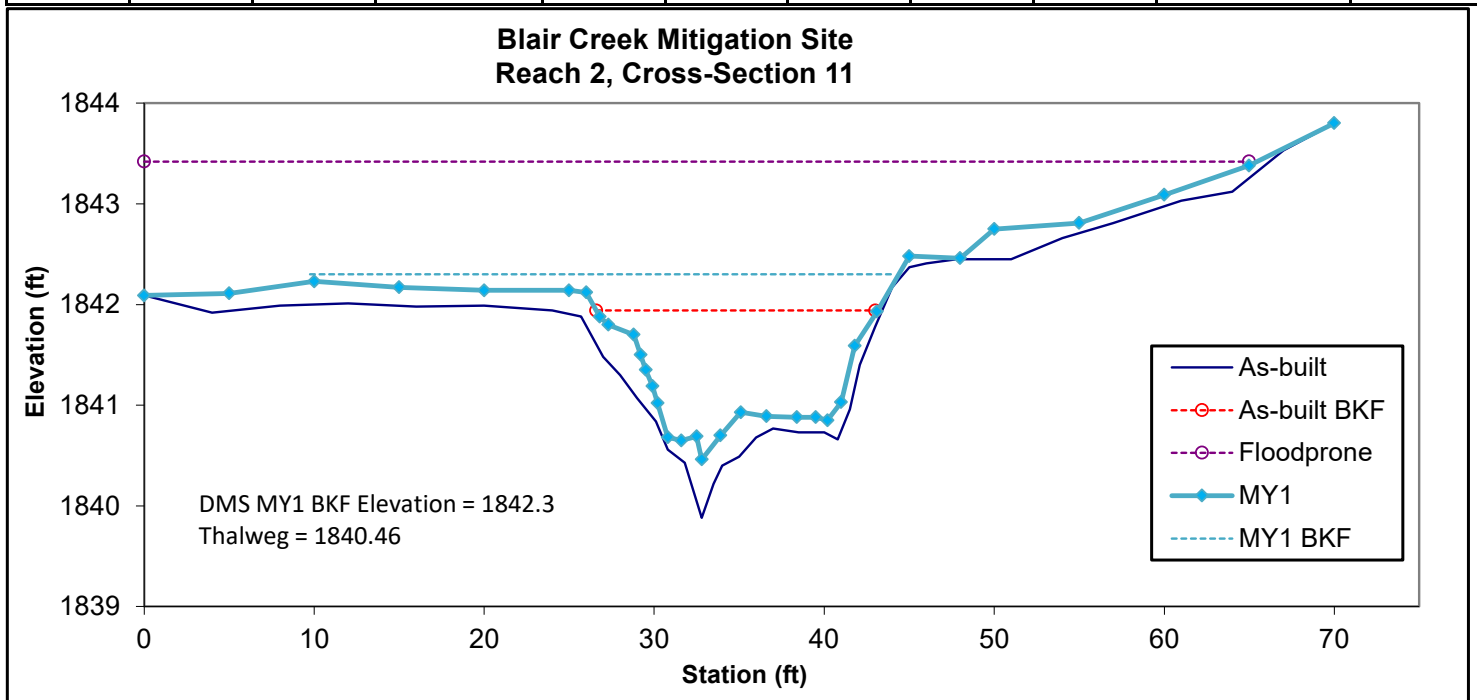
Permanent Cross-Section 11

Feature	Stream Type	BKF Area	BKF Width	BKF Depth	Max BKF Depth	W/D	BH Ratio	ER	BKF Elev	LTOB Elev
Riffle	C	14.1	16.7	0.8	1.5	19.7	1.00	4.4	1841.94	1842.23

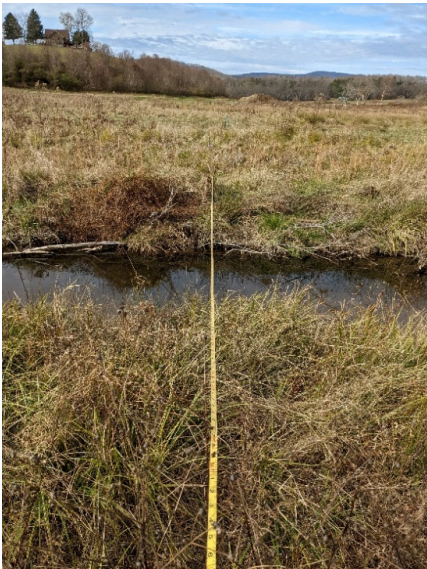
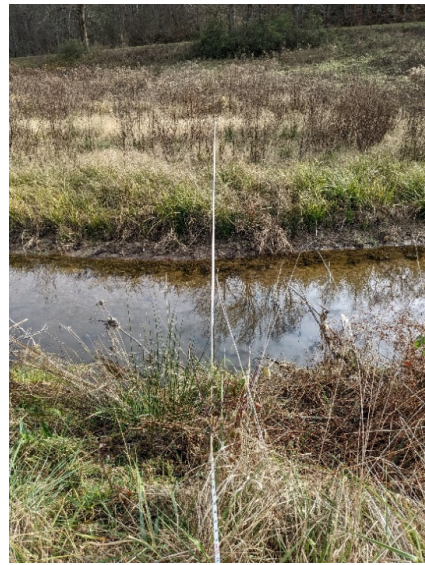
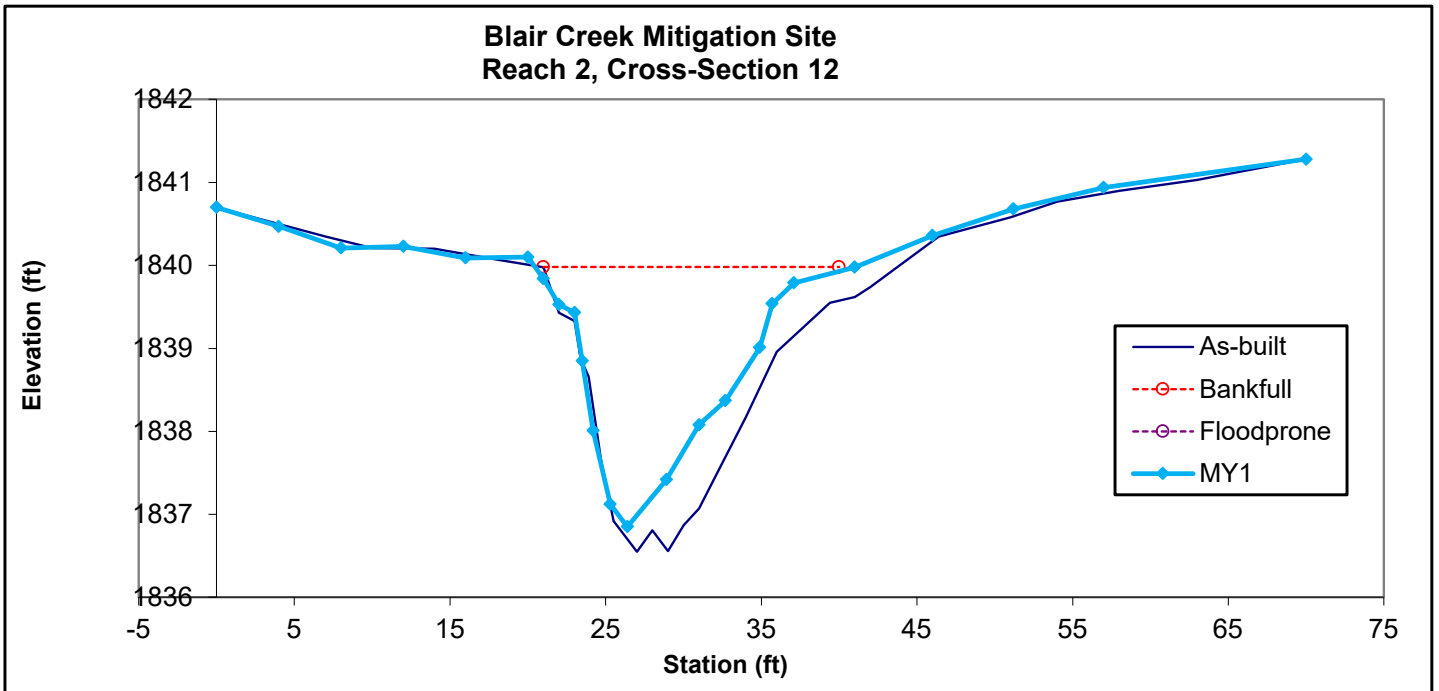
Permanent Cross-Section 12
 Year 1 Survey Collected: November 2022
 Restoration

Feature	Stream Type	BKF Area	BKF Width	BKF Depth	Max BKF Depth	W/D	BH Ratio	ER	BKF Elev	TOB Elev
Pool	--	27.28	20.54	1.33	3.13	15.44	--	--	1839.98	1839.98

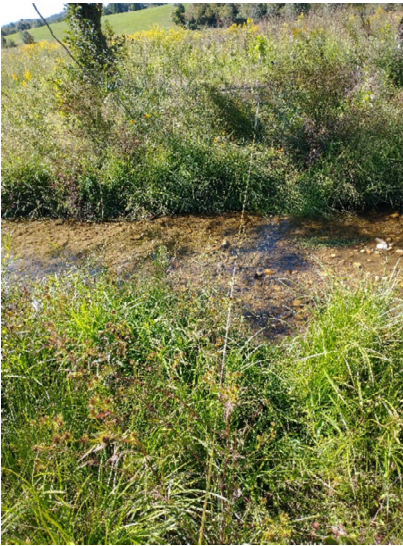
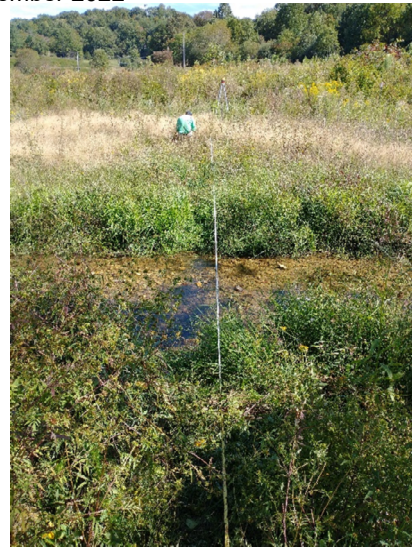
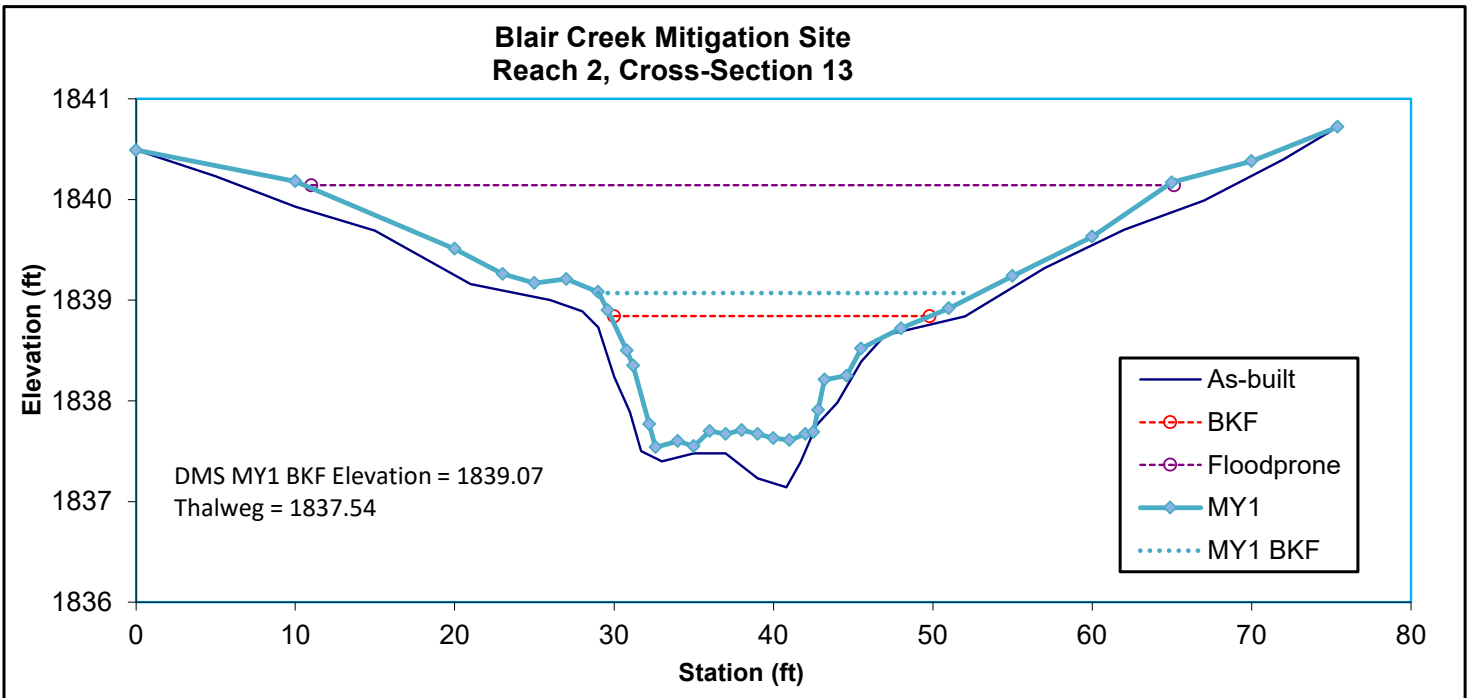
Permanent Cross-Section 13

Feature	Stream Type	BKF Area	BKF Width	BKF Depth	Max BKF Depth	W/D	BH Ratio	ER	BKF Elev	TOB Elev
Riffle	C	16.00	20.00	0.80	1.3	25.00	0.9	3.1	1838.84	1838.92

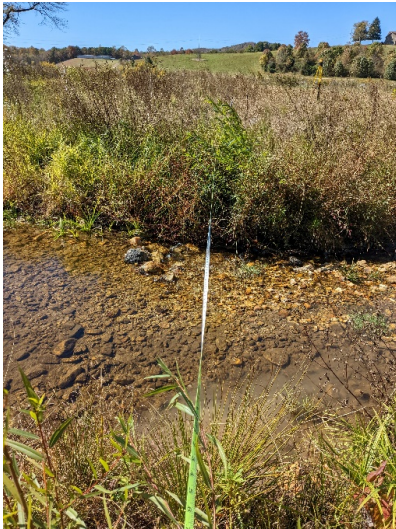
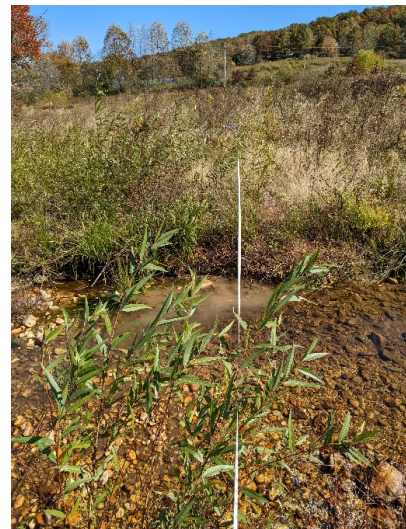
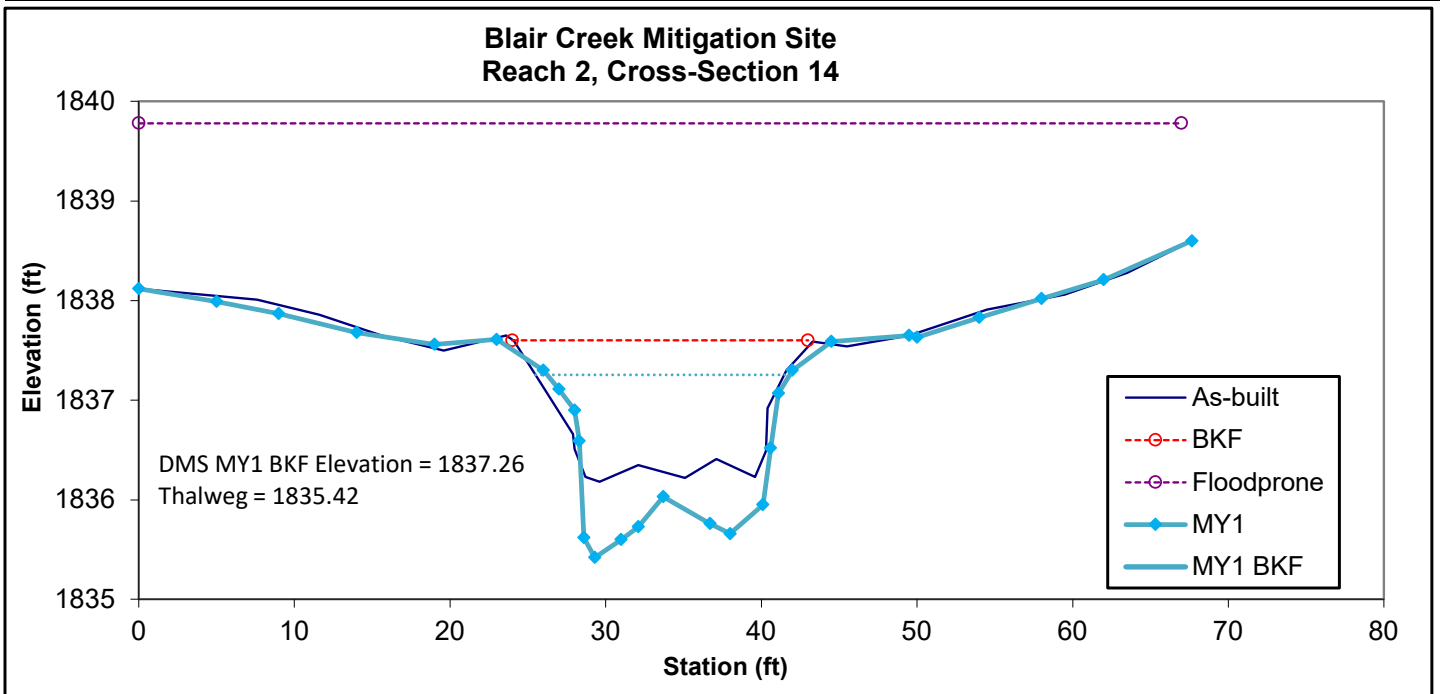
Permanent Cross-Section 14
 Year 1 Survey Collected: October 2022
 Restoration

Feature	Stream Type	BKF Area	BKF Width	BKF Depth	Max BKF Depth	W/D	BH Ratio	ER	BKF Elev	TOB Elev
Riffle	C	25.2	22.2	1.1	2.2	19.6	1.0	4.3	1837.60	1837.25

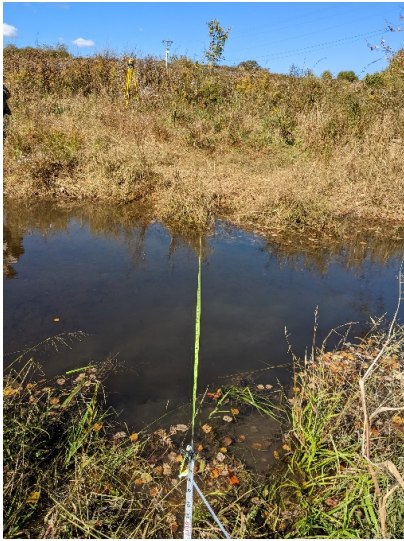
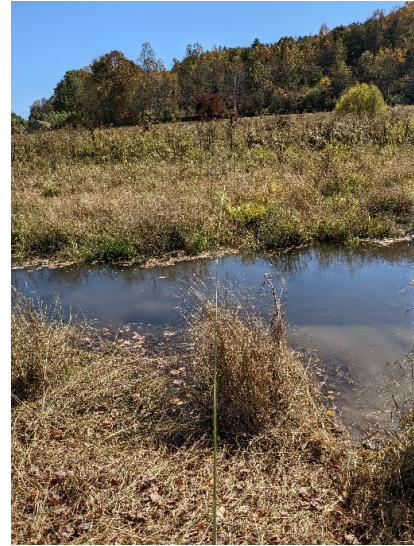
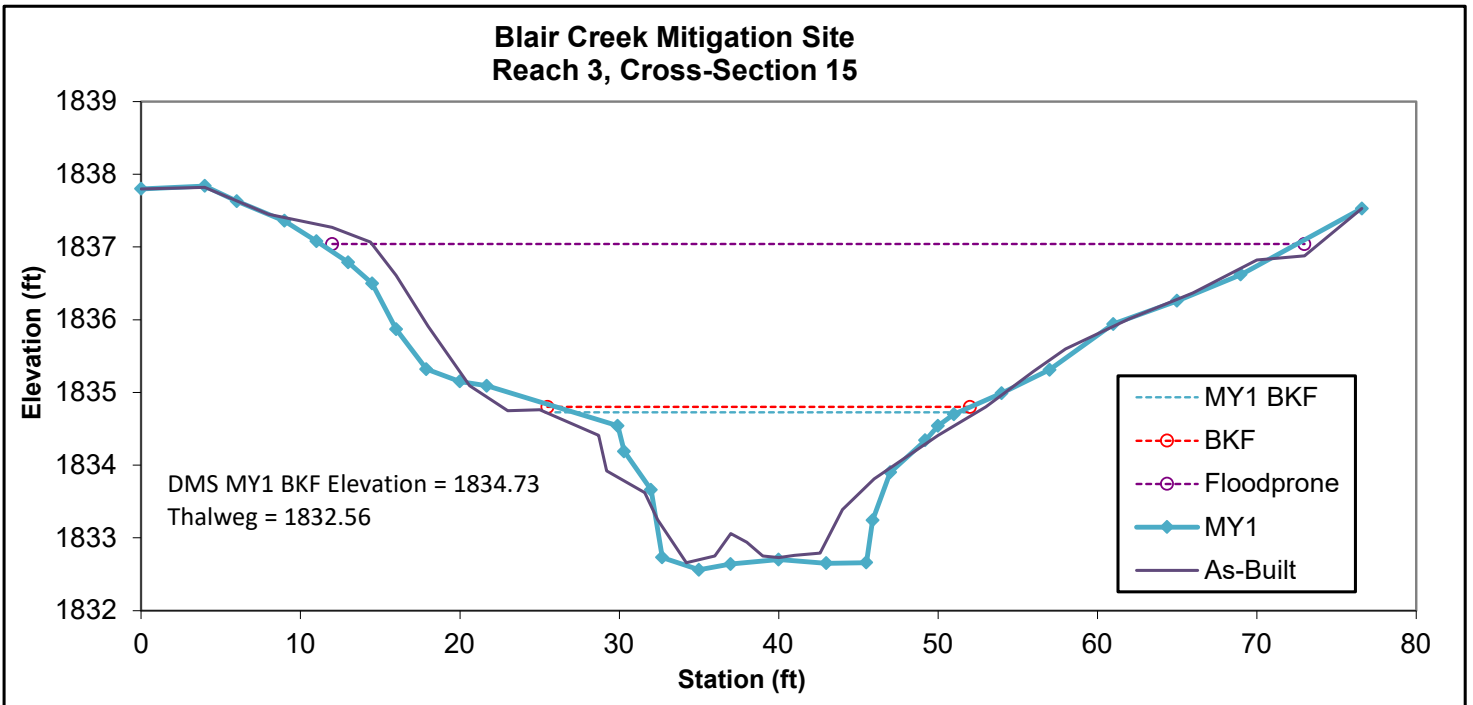
Permanent Cross-Section 15

Feature	Stream Type	BKF Area	BKF Width	BKF Depth	Max BKF Depth	W/D	BH Ratio	ER	BKF Elev	TOB Elev
Riffle	B	34.9	26.0	1.3	2.2	19.40	1	2.5	1834.8	1834.8

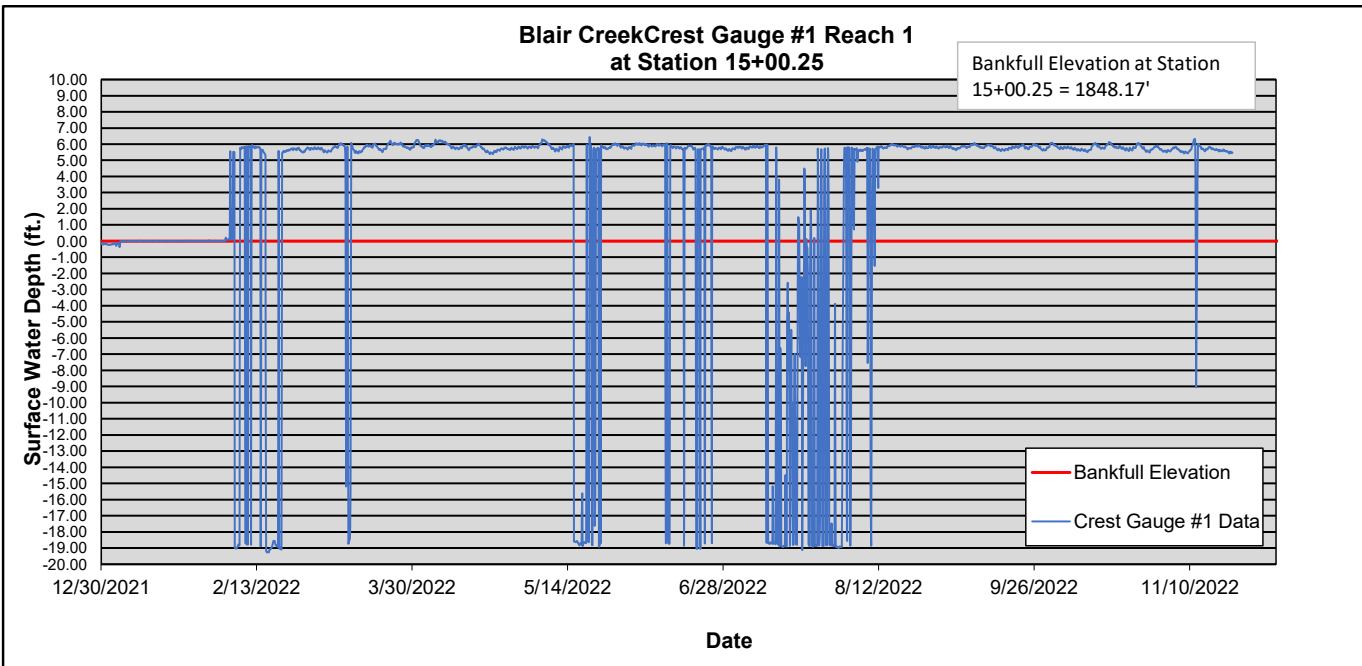
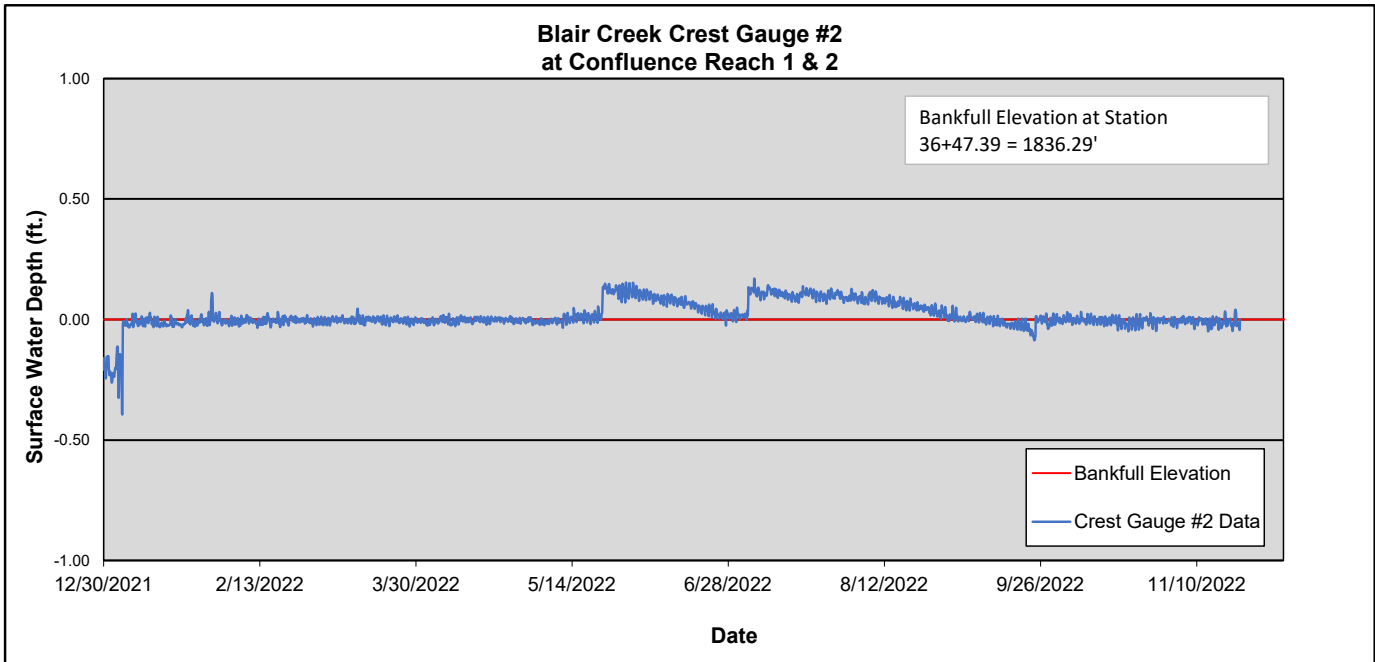
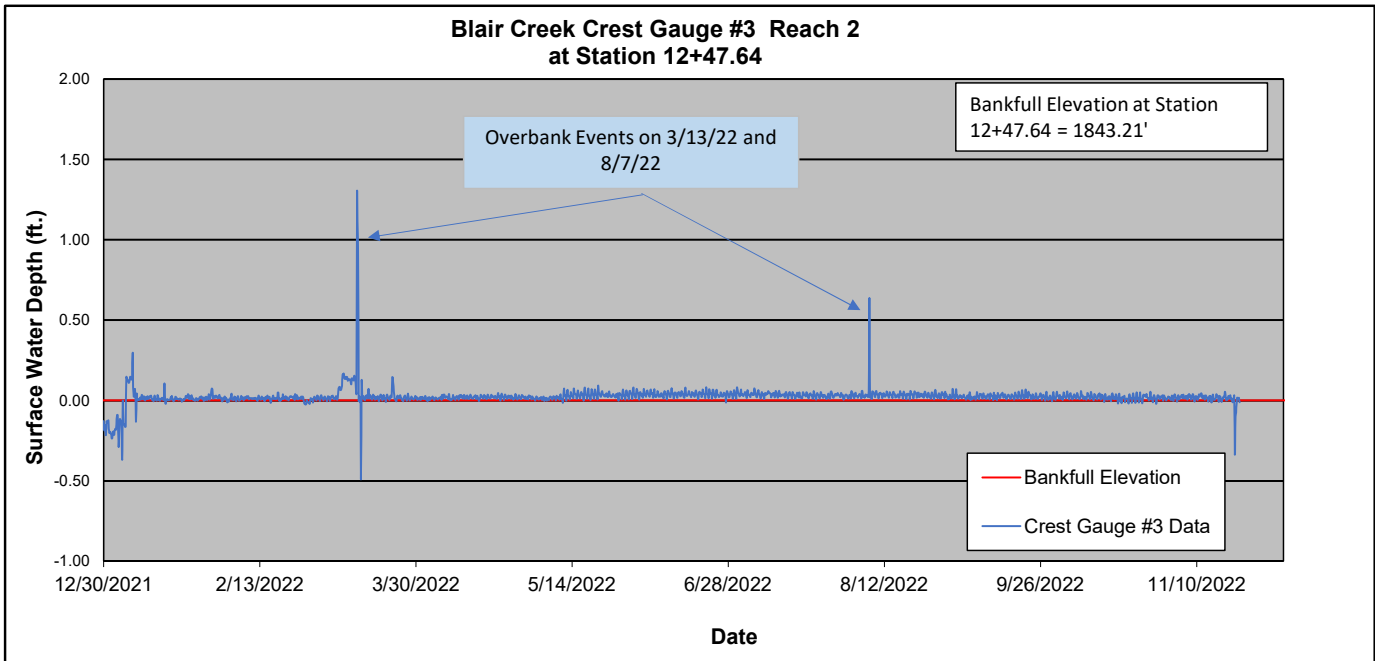
Date of Data Collection	Reach 1 Lower Right Floodplain	Crest Gauge 3. Reach 2, Left Floodplain	Estimated Date of Bankfull Event Occurrence	Method of Data Collection
Year 1 Monitoring (2022)				
7/1/2022	Photographic Evidence on right floodplain of Lower R1 and Left floodplain of R2 at Crest Gauge 3.		3/13/2022	Photographic Evidence
11/22/2022		Photographic Evidence on floodplain and Continuous Logger Data	3/13/2022 & 8/7/2022	Photographic Evidence & Continuous Logger

Note: Crest gauge readings were corroborated with associated spikes in the automated Continuous Stage Recorder (see graph in Below) and/or with photographs (Appendix B).
