Blair Creek Stream Mitigation Project

Year 1 (2022) Monitoring Report FINAL

Clay County, North Carolina

DMS Project ID No. 100047

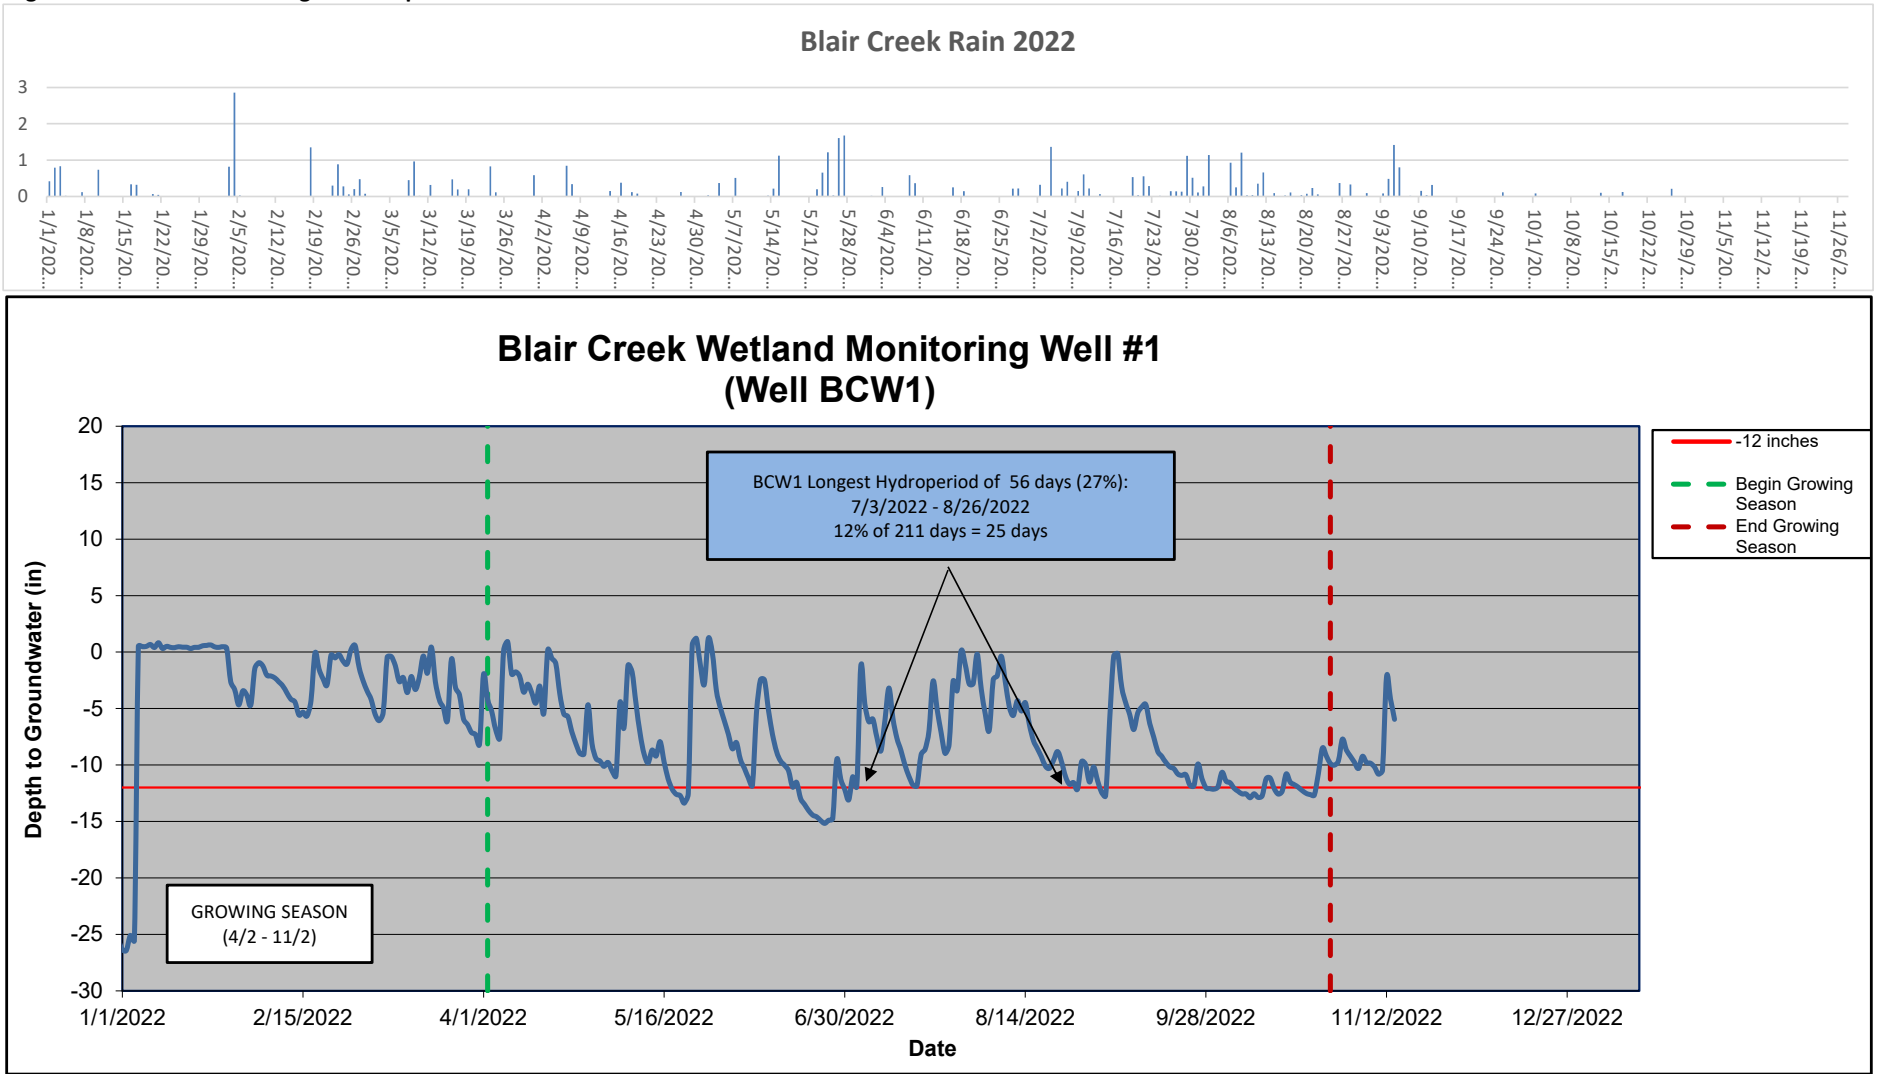
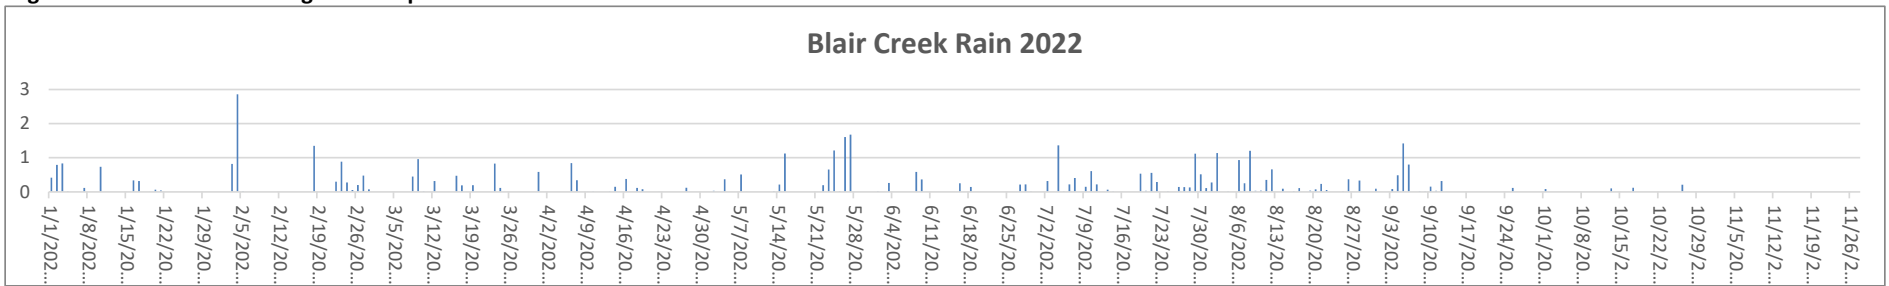
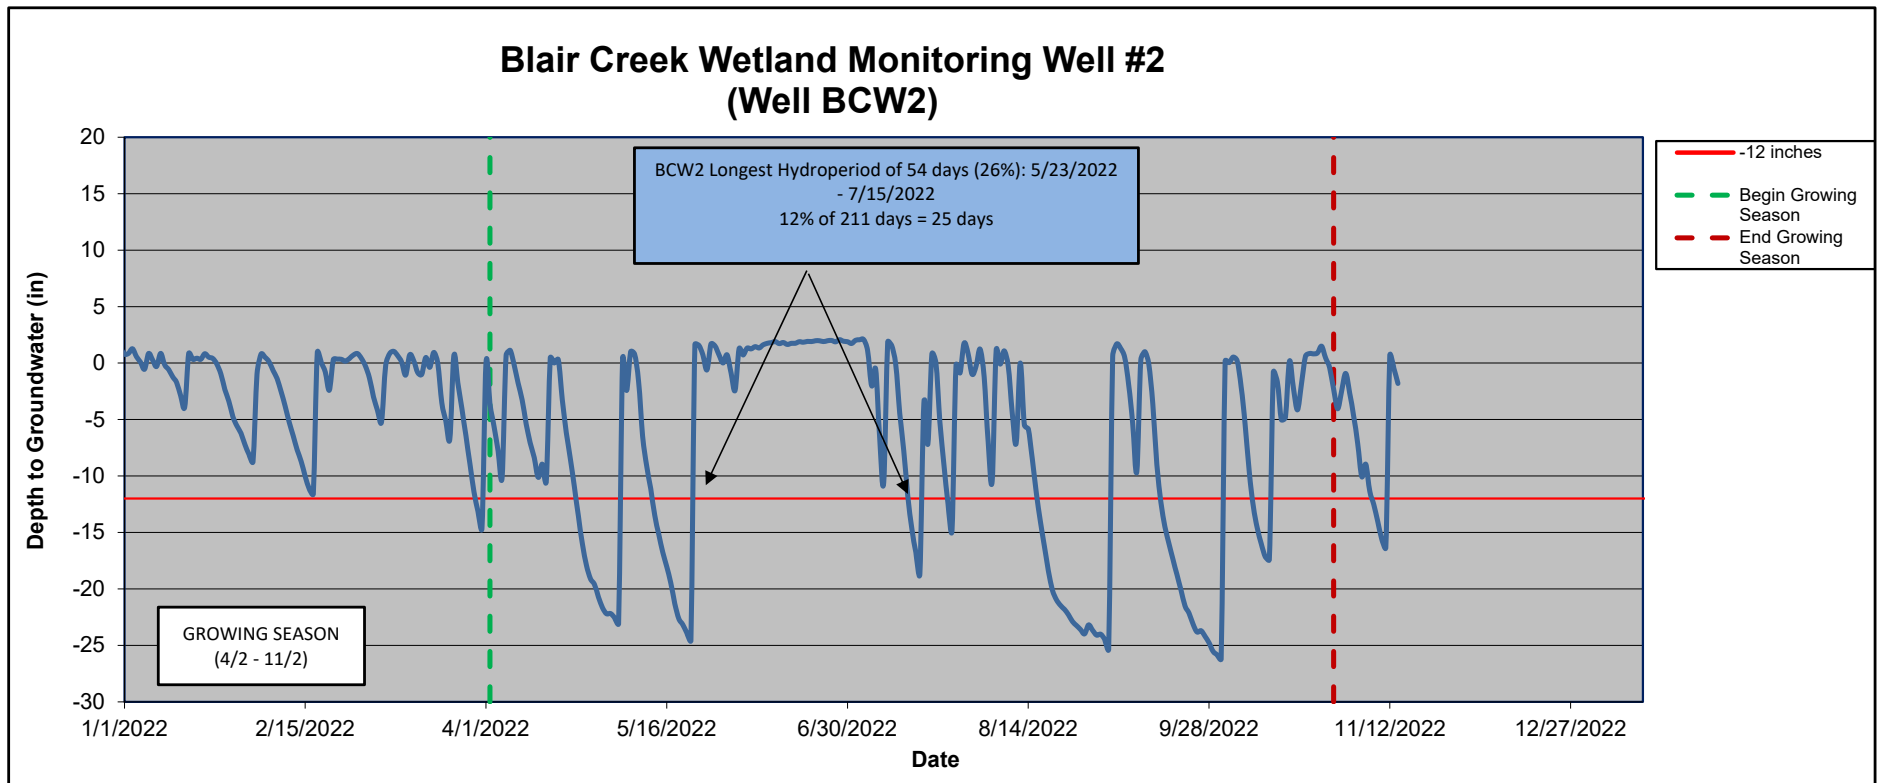
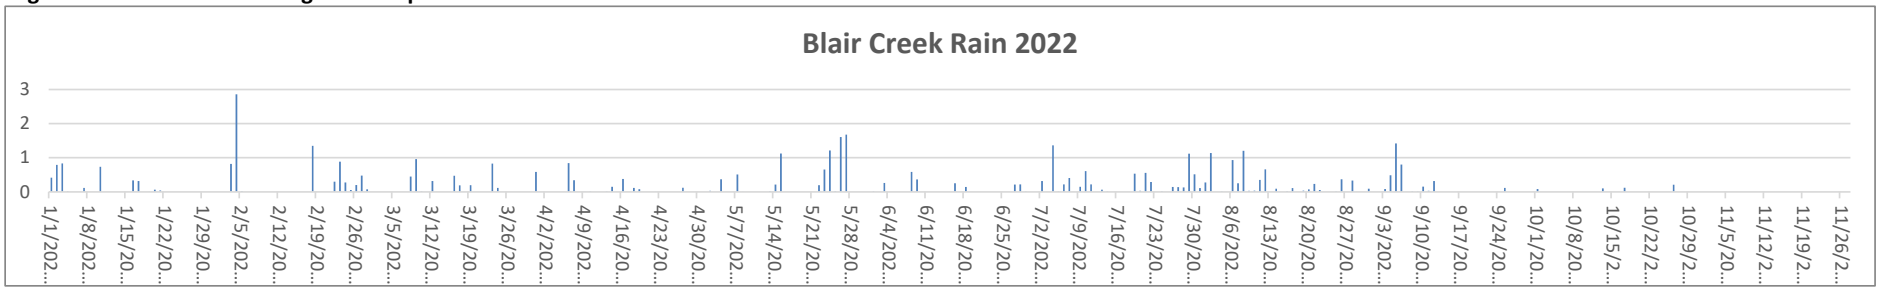
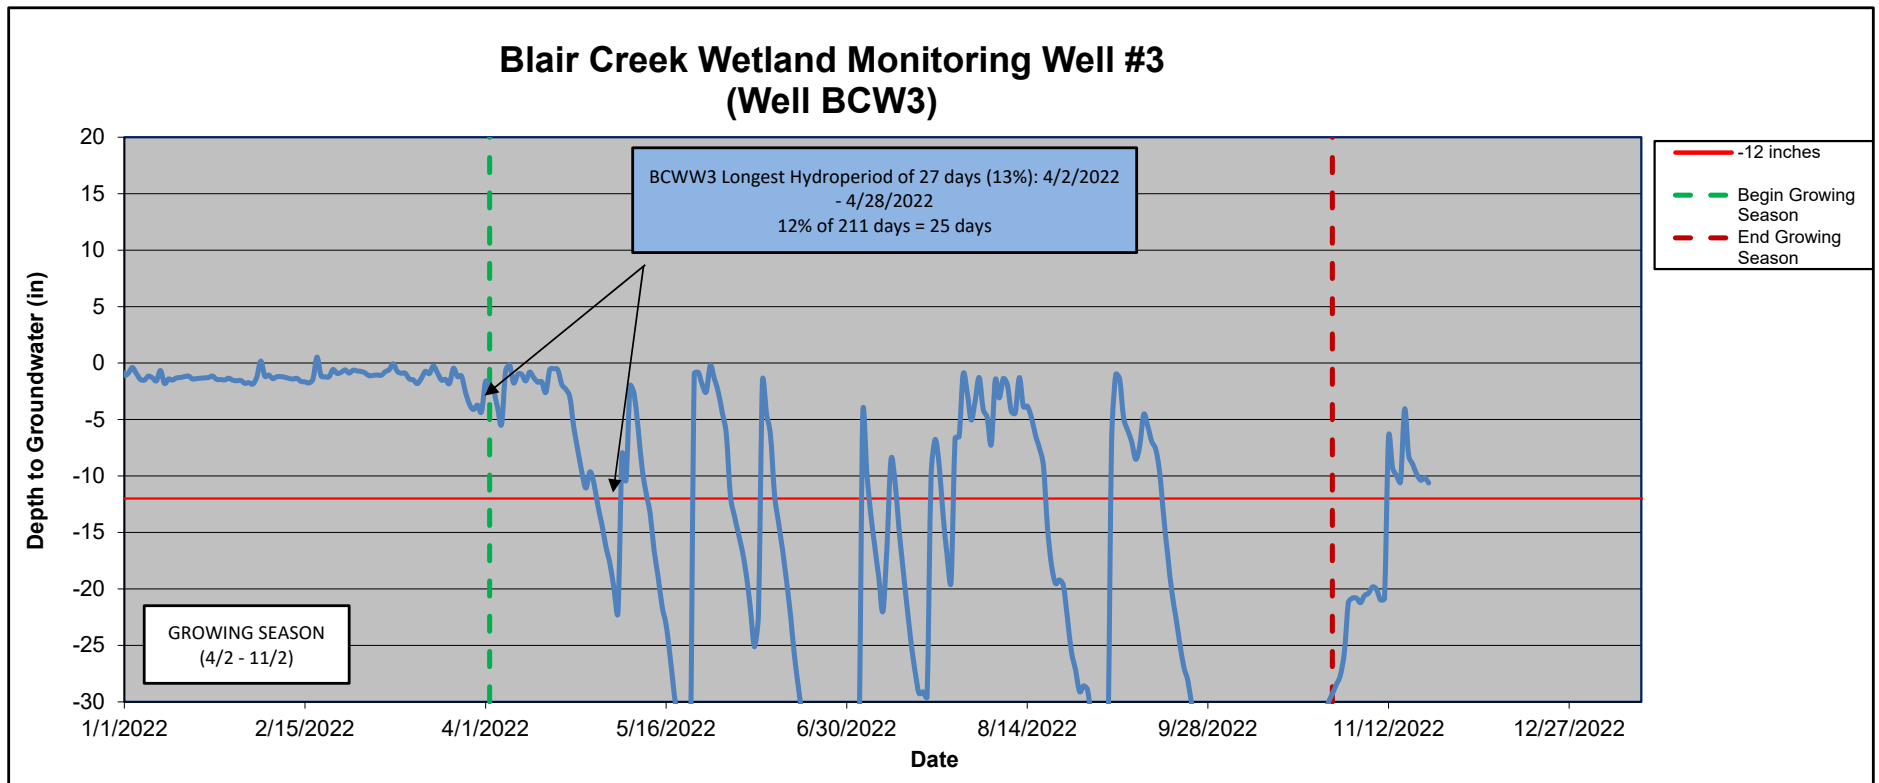
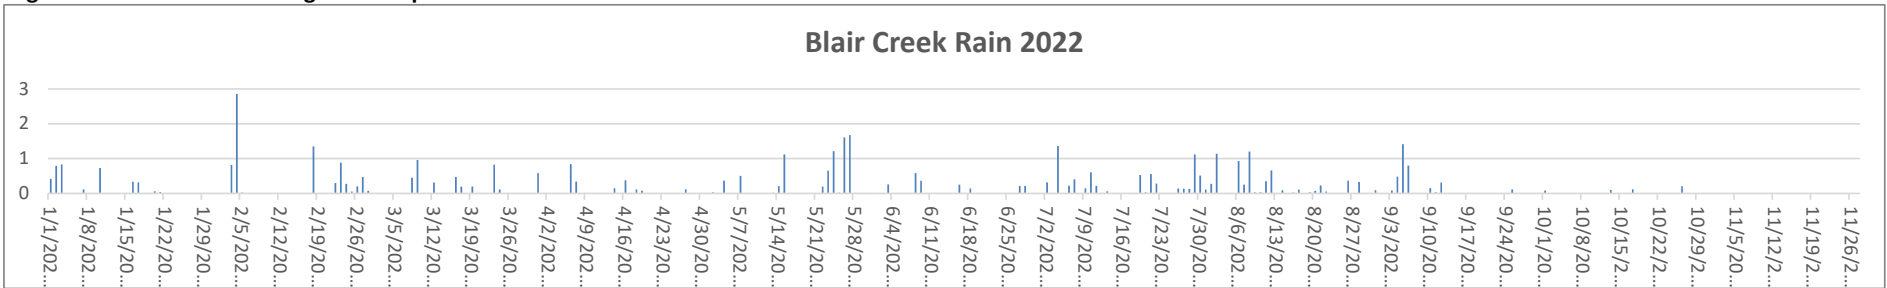
Figure 5. Wetland Monitoring Well Graphs

Table 11. Wetland Hydrology Summary Data																																	
Blair Creek Stream Mitigation Project - NCDMS Project No. 100047																																	
Well ID	Percentage of Consecutive Days <12 inches from Ground Surface ¹							Most Consecutive Days Meeting Criteria ²							Percentage of Cumulative Days <12 inches from Ground Surface							Cumulative Days Meeting Criteria ³											
	Year 1 (2022)	Year 2 (2023)	Year 3 (2024)	Year 4 (2025)	Year 5 (2026)	Year 6 (2027)	Year 8 (2028)	Year 1 (2022)	Year 2 (2023)	Year 3 (2024)	Year 4 (2025)	Year 5 (2026)	Year 6 (2027)	Year 8 (2028)	Year 1 (2022)	Year 2 (2023)	Year 3 (2024)	Year 4 (2025)	Year 5 (2026)	Year 6 (2027)	Year 8 (2028)	Year 1 (2022)	Year 2 (2023)	Year 3 (2024)	Year 4 (2025)	Year 5 (2026)	Year 6 (2027)	Year 8 (2028)					
Wetland Monitoring Wells (Installed December 2021)																																	
BCW1	27.0							56							82.0													172

BCW2	26.0							54							68.0														144				
BCW3	13.0							27							43.0														90				
BCW4	10.0							22							38.0														80				
BCW5	10.0							22							30.0														63				
BCW6	44.0							92							47.0														199				
BCW7	11.0							24							30.0														63				
BCW8	4.0							9							17.0														35				
BCW9	11.0							23							41.0														87				
BCW10	11.0							24							38.0														81

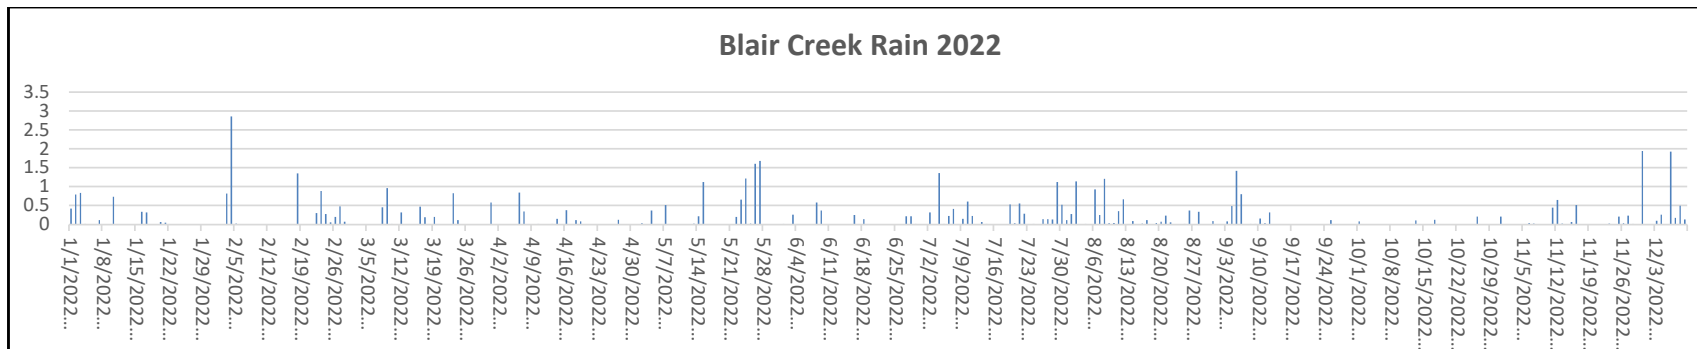
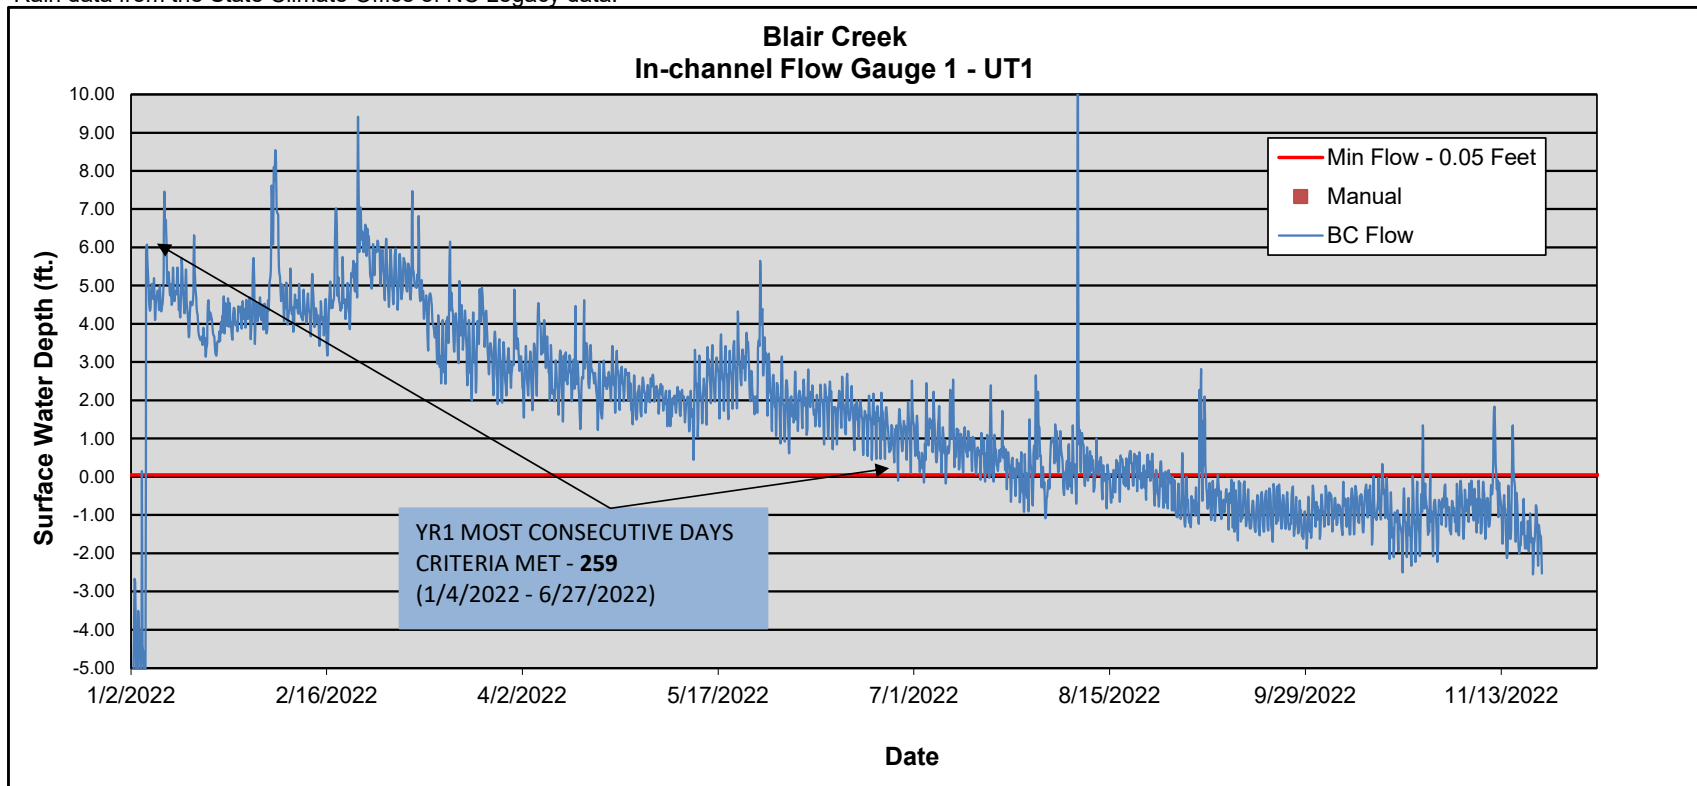
Figure 6: Flow Gauge Graphs

*Surface water flow is estimated to have occurred when the pressure transducer reading is equal to or above 0.05 feet in depth.

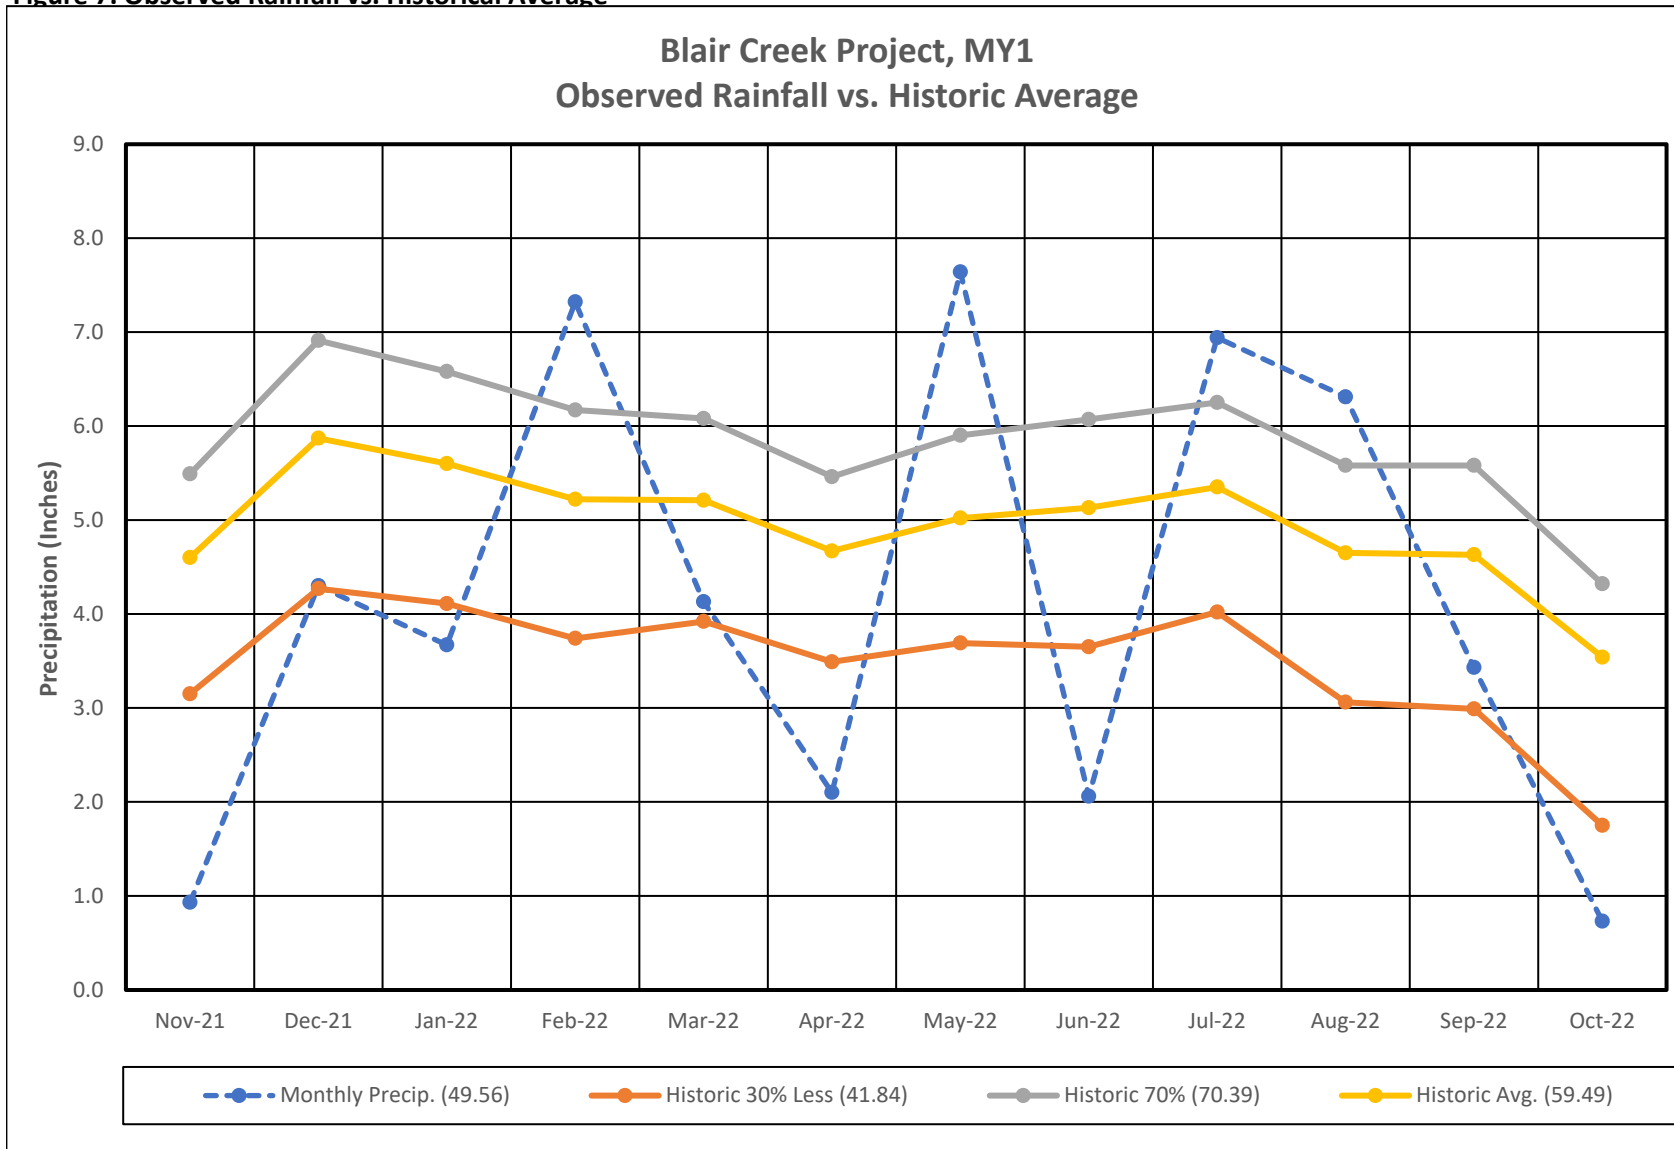
Figure 7. Observed Rainfall vs. Historical Average

As the observed monthly rainfall data for the project presented in Figure 6 in Appendix E demonstrates, the past 12 months have varied dramatically from month to month as compared to historic average precipitation. A total of 49.56 inches of rainfall was observed for the project, while the region averages 59.49 inches of annual rainfall, a deficit of 9.93 inches. All observed project rainfall was collected from the North Carolina Climate Office Weather Climate Database Legacy System. The rain gauge deployed on site suffered repeated malfunctions during MY1 therefore the data was not reliable. The rain gauge will be repaired and re-deployed during MY2.
