Blair Creek Stream Mitigation Project

Year 2 (2023) Monitoring Report FINAL

Clay County, North Carolina

DMS Project ID No. 100047

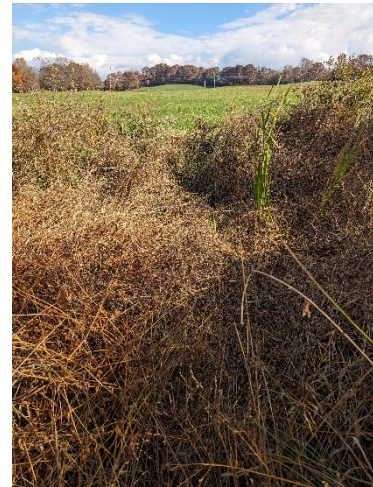
Flow Gauge 1. UT1

Encroachment Area into existing drain swale. R1 Left floodplain.

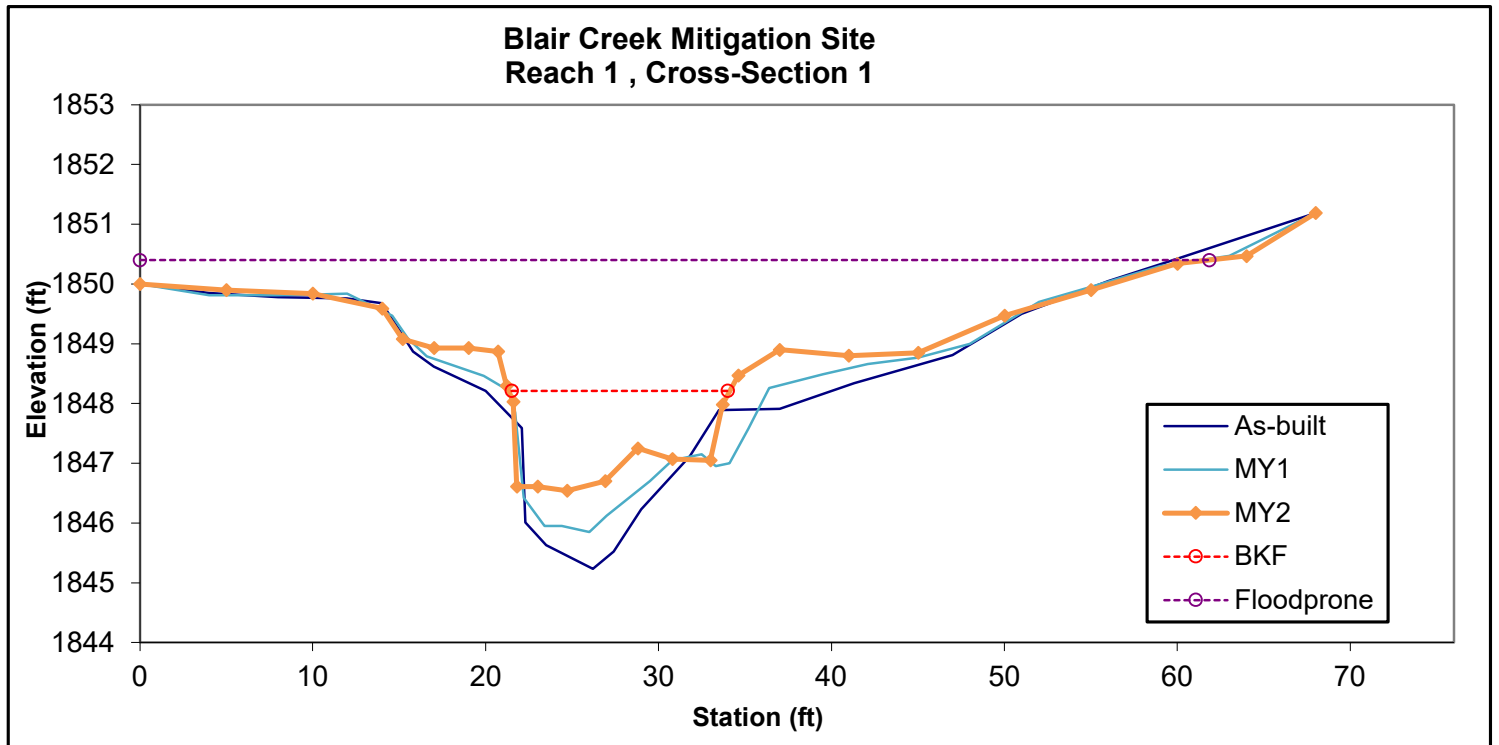
Permanent Cross-section 1

Feature	Stream Type	BKF Area	BKF Width	BKF Depth	Max BKF Depth	W/D	BH Ratio	ER	BKF Elev	TOB Elev
Pool	--	15.9	12.8	1.2	1.7	10.3	--	--	1848.21	1848.2

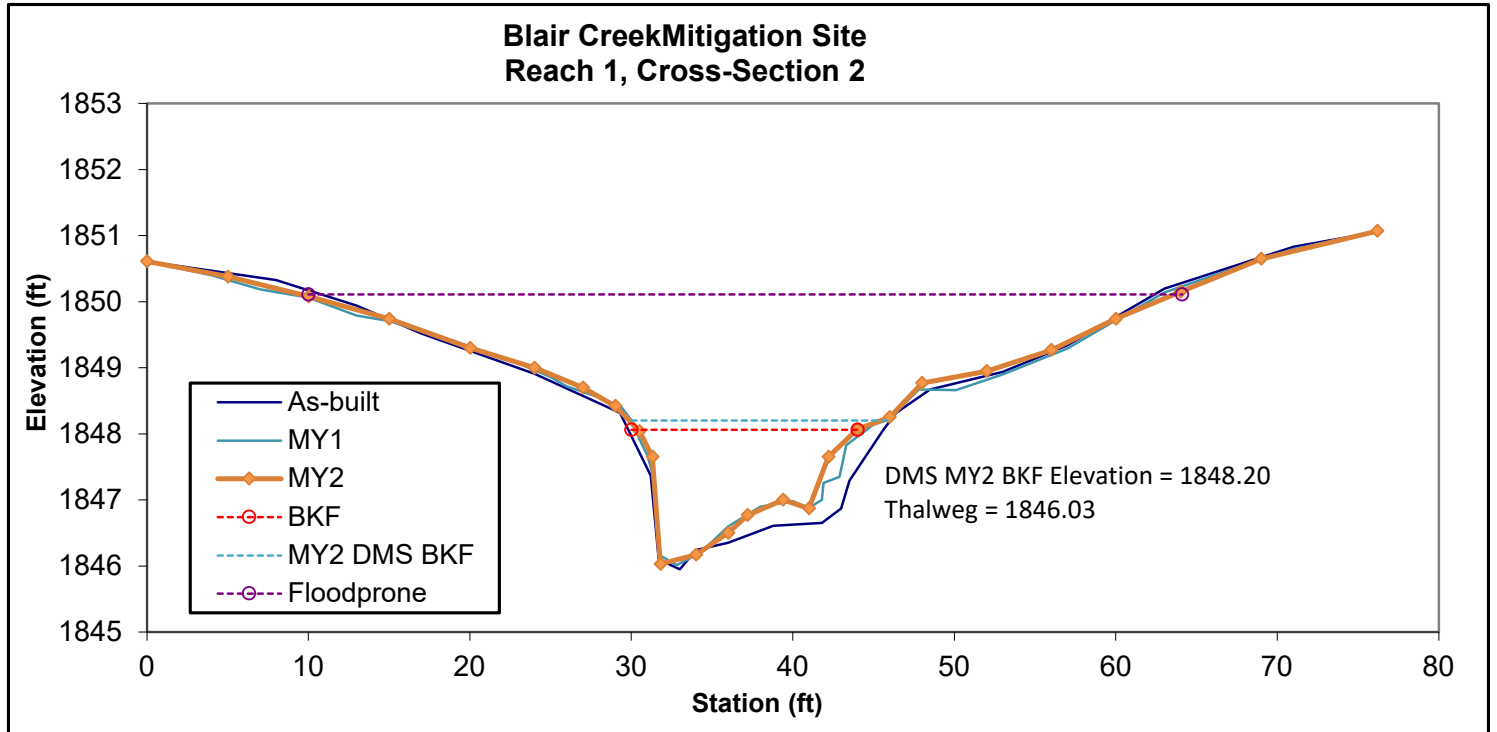
Permanent Cross-section 2
(Year 2 Data - Collected September 2023)

Feature	Stream Type	BKF Area	BKF Width	BKF Depth	Max BKF Depth	W/D	BH Ratio	ER	BKF Elev	TOB Elev
Riffle	E	18.5	16	1.2	2.2	13.9	1.0	3.7	1848.06	1848.2

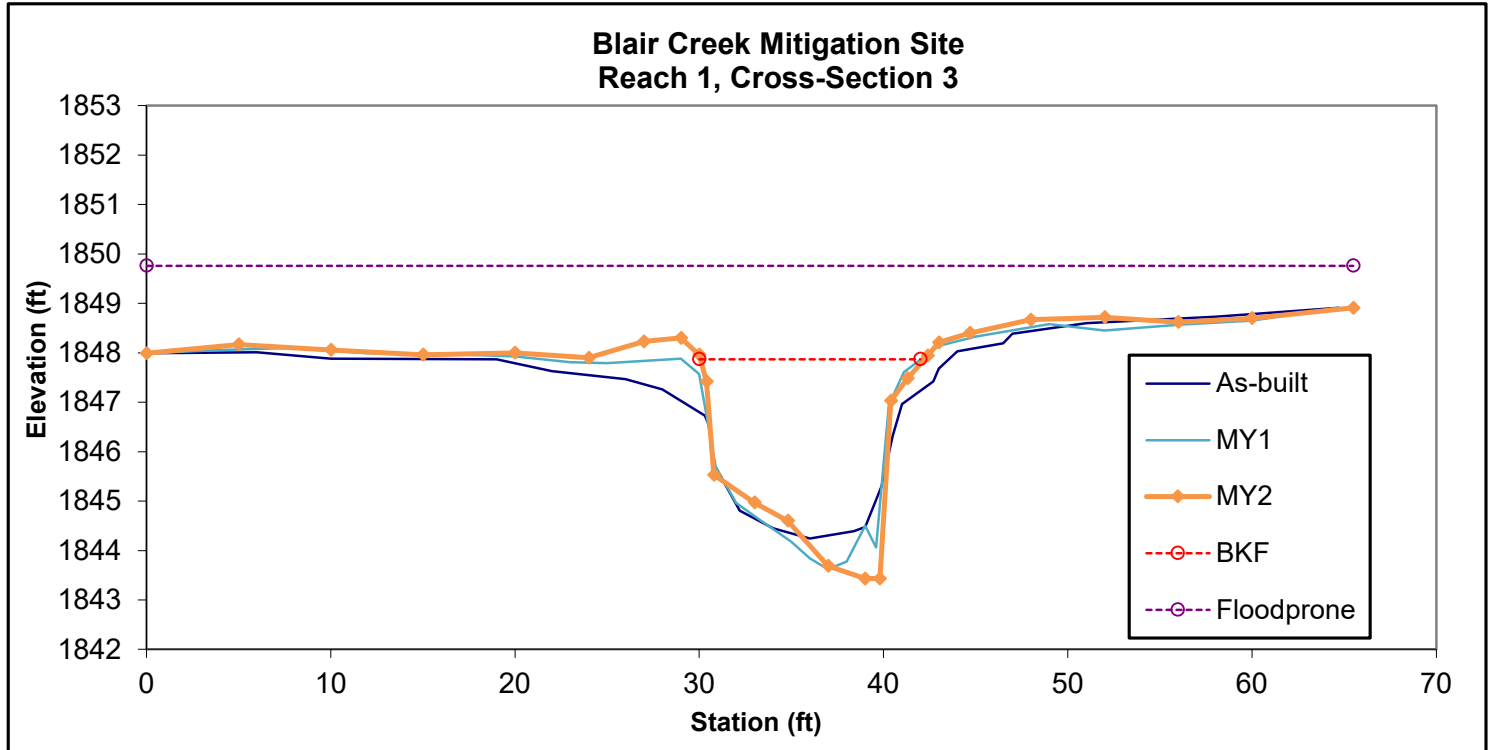
Permanent Cross-section 3

Feature	Stream Type	BKF Area	BKF Width	BKF Depth	Max BKF Depth	W/D	BH Ratio	ER	BKF Elev	TOB Elev
Pool	--	34.6	12.2	2.8	4.4	4.3	--	--	1847.87	1847.9

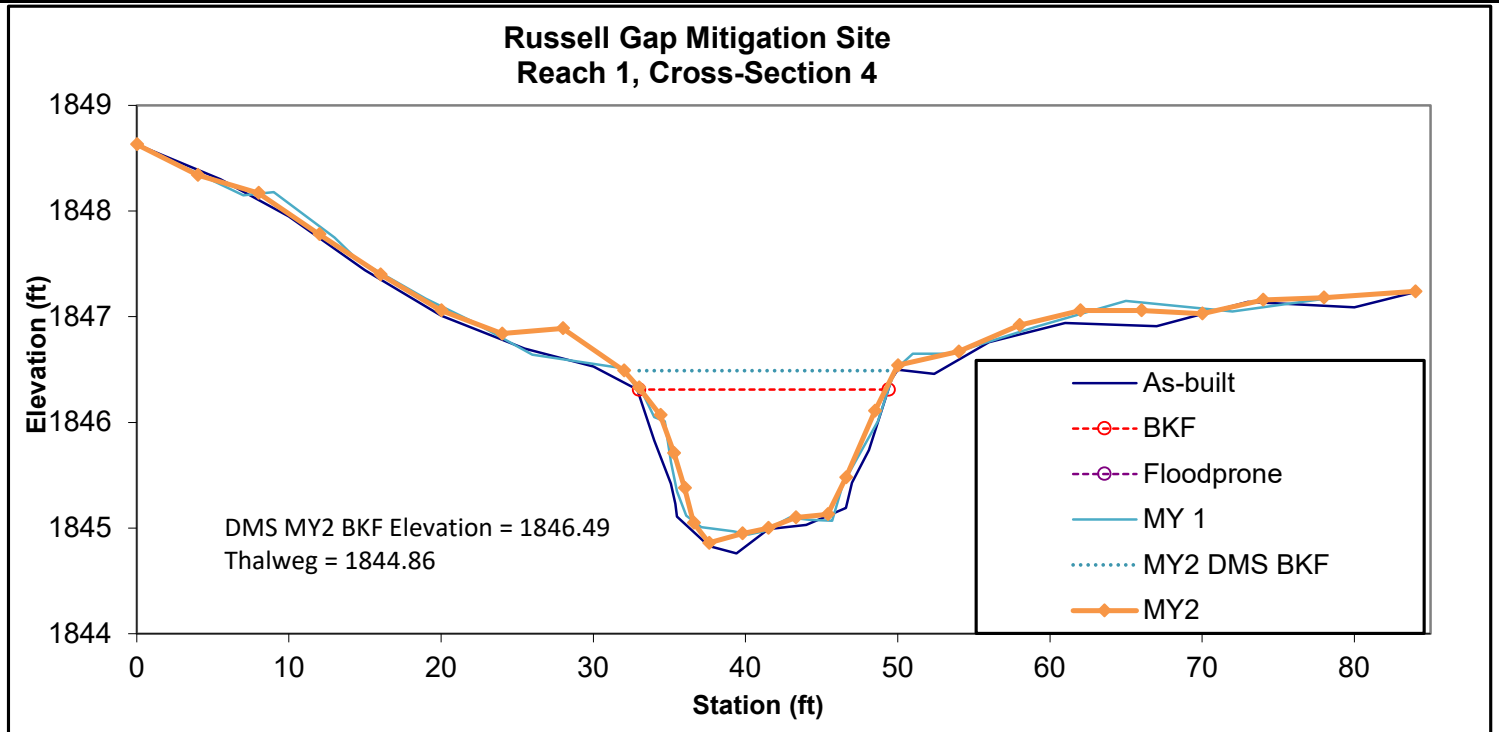
Permanent Cross-section 4

Feature	Stream Type	BKF Area	BKF Width	BKF Depth	Max BKF Depth	W/D	BH Ratio	ER	BKF Elev	TOB Elev
Riffle	C	15	15.8	0.9	1.4	16.7	1.0	4.3	1846.31	1846.5

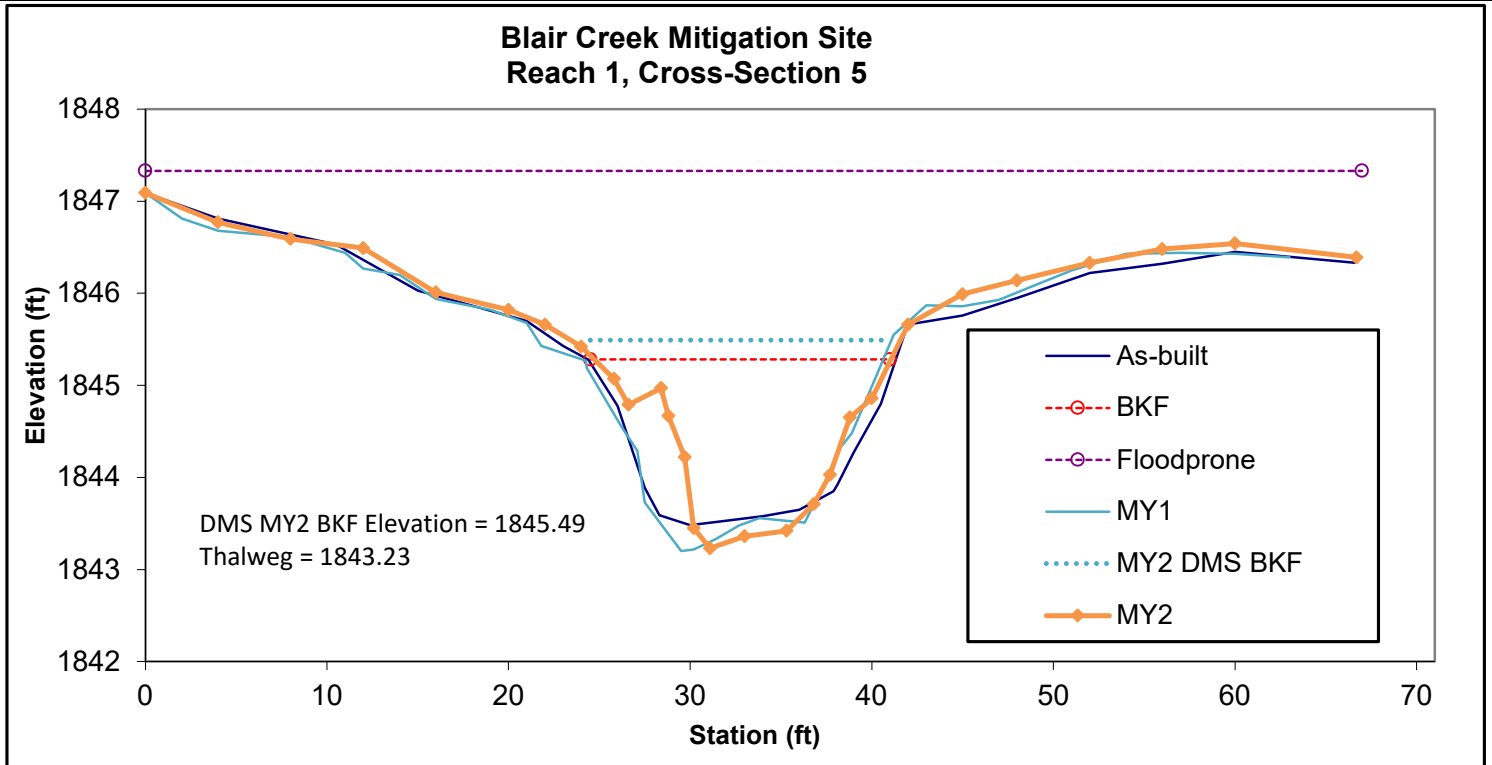
Permanent Cross-section 5

Feature	Stream Type	BKF Area	BKF Width	BKF Depth	Max BKF Depth	W/D	BH Ratio	ER	BKF Elev	TOB Elev
Riffle	C	18.4	16.3	1.1	2	14.5	1.0	3.7	1845.28	1845.5

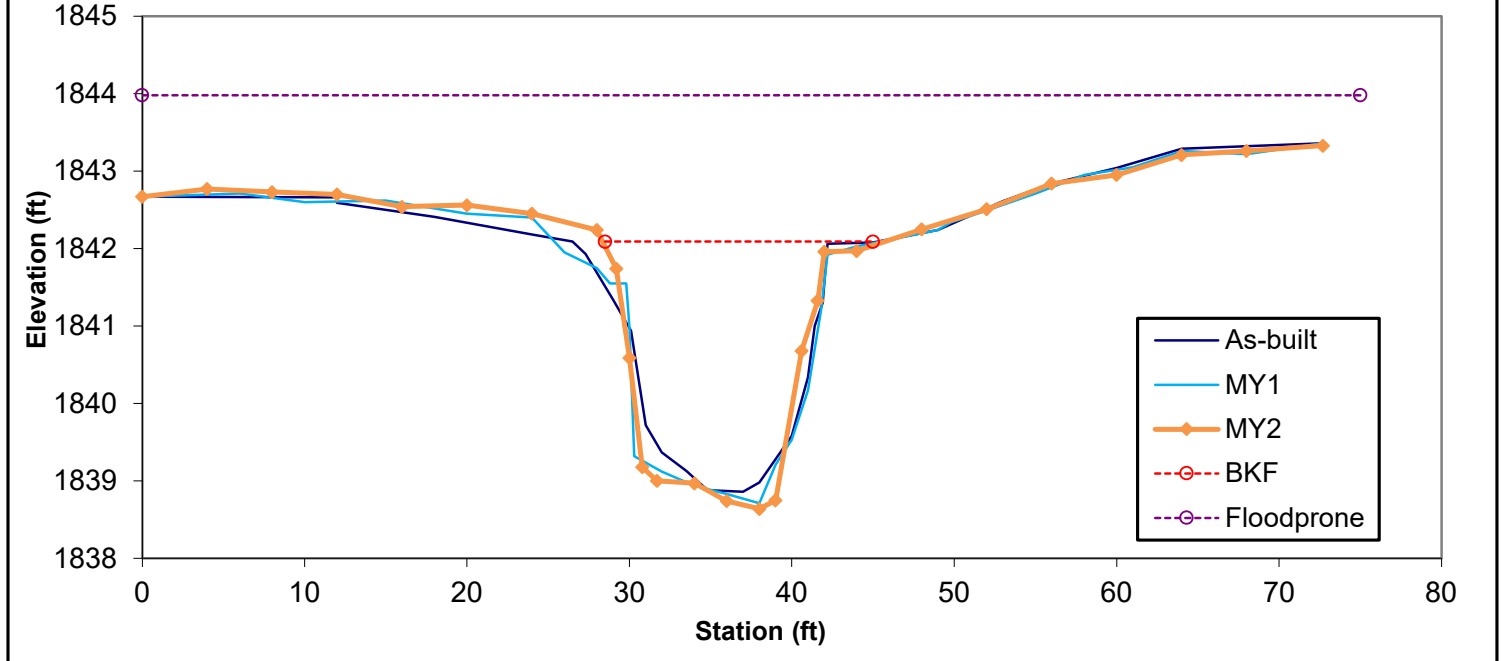
Permanent Cross-section 6

Feature	Stream Type	BKF Area	BKF Width	BKF Depth	Max BKF Depth	W/D	BH Ratio	ER	BKF Elev	TOB Elev
Pool	--	34.6	17.4	2	3.4	8.7	--	--	1842.09	1842.1

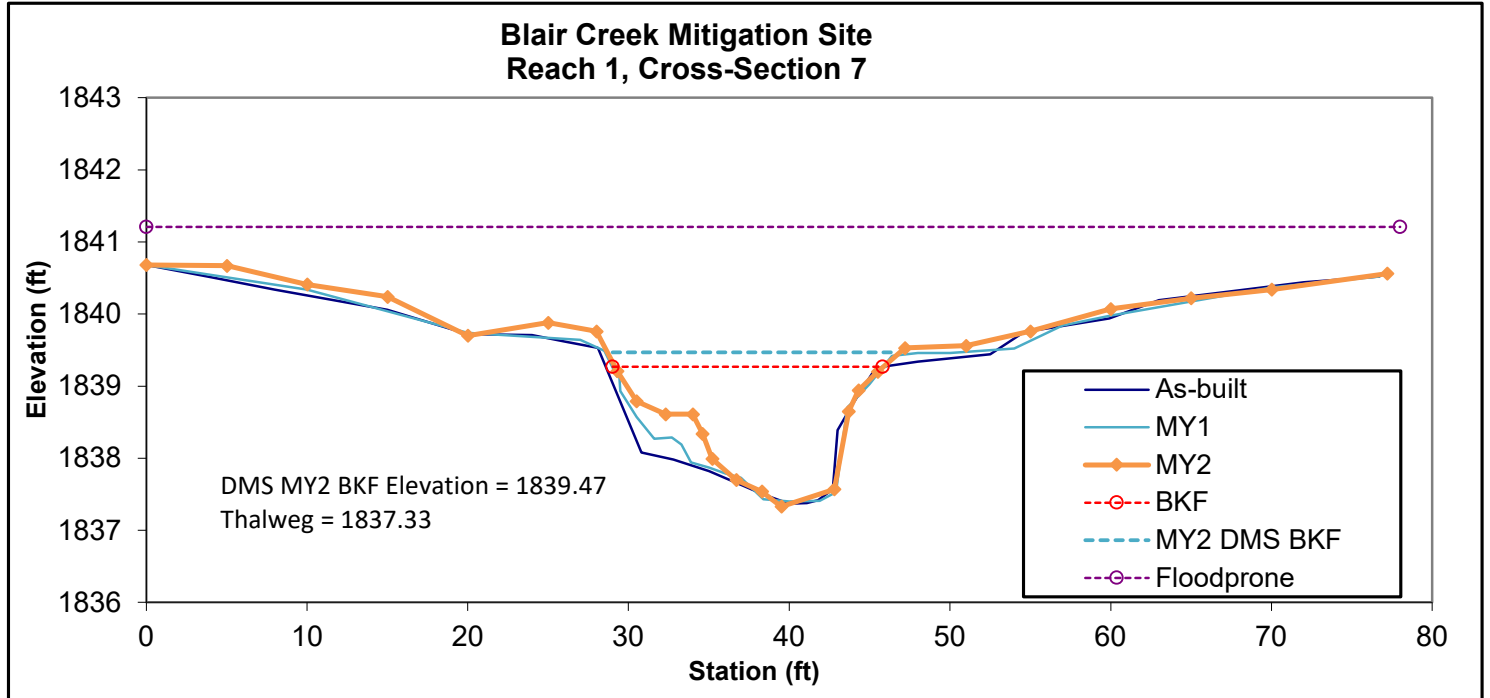
Permanent Cross-section 7

Feature	Stream Type	BKF Area	BKF Width	BKF Depth	Max BKF Depth	W/D	BH Ratio	ER	BKF Elev	TOB Elev
Riffle	C	18.2	16.7	1.1	1.9	15.3	1.0	4.2	1839.27	1839.4

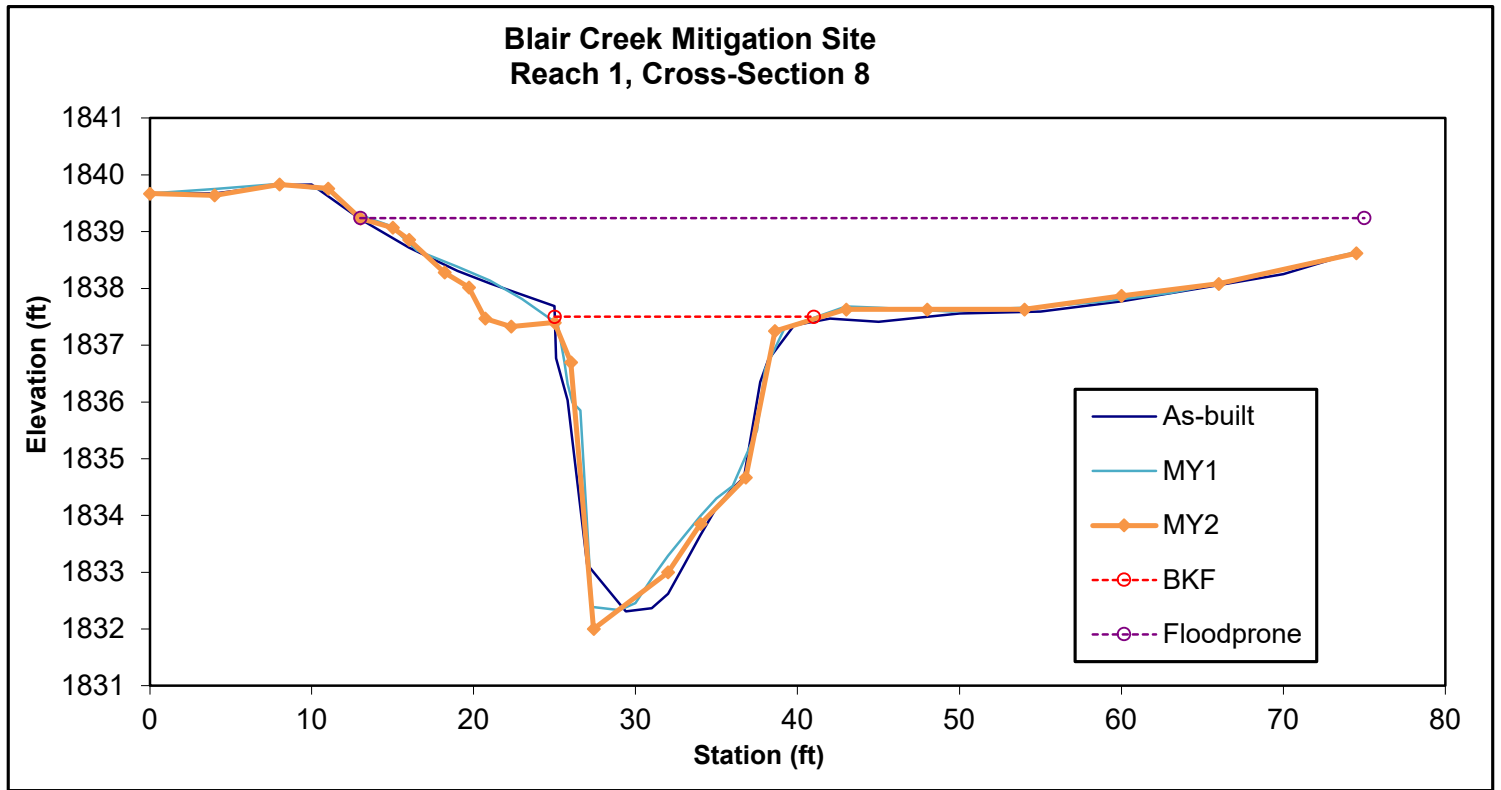
Permanent Cross-section 8

Feature	Stream Type	BKF Area	BKF Width	BKF Depth	Max BKF Depth	W/D	BH Ratio	ER	BKF Elev	TOB Elev
Pool	--	45.9	15.7	2.9	5.3	5.4	--	--	1837.5	1837.5

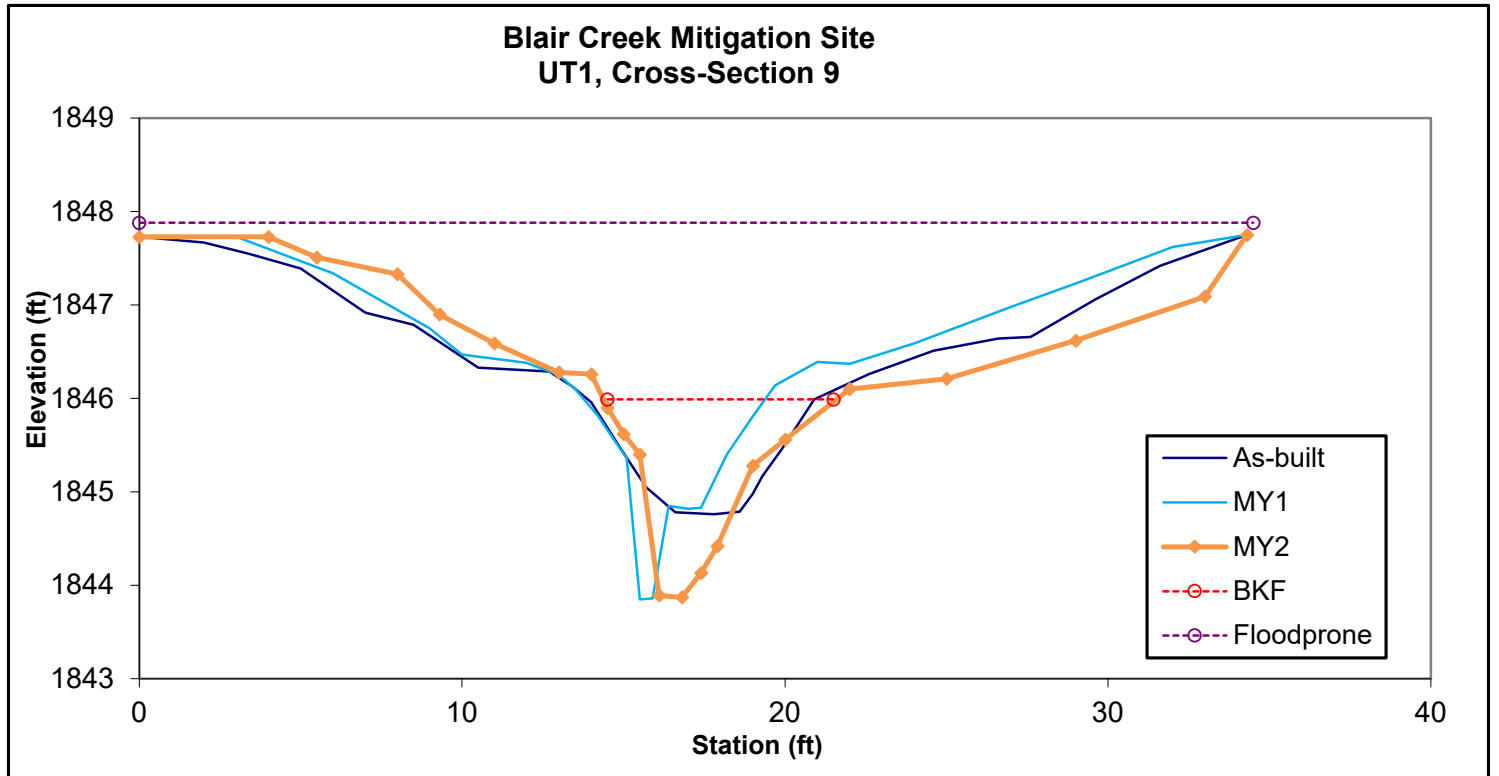
Permanent Cross-section 9

Feature	Stream Type	BKF Area	BKF Width	BKF Depth	Max BKF Depth	W/D	BH Ratio	ER	BKF Elev	TOB Elev
Pool	--	6.1	6		2.12	6	--	--	1845.99	1846.0

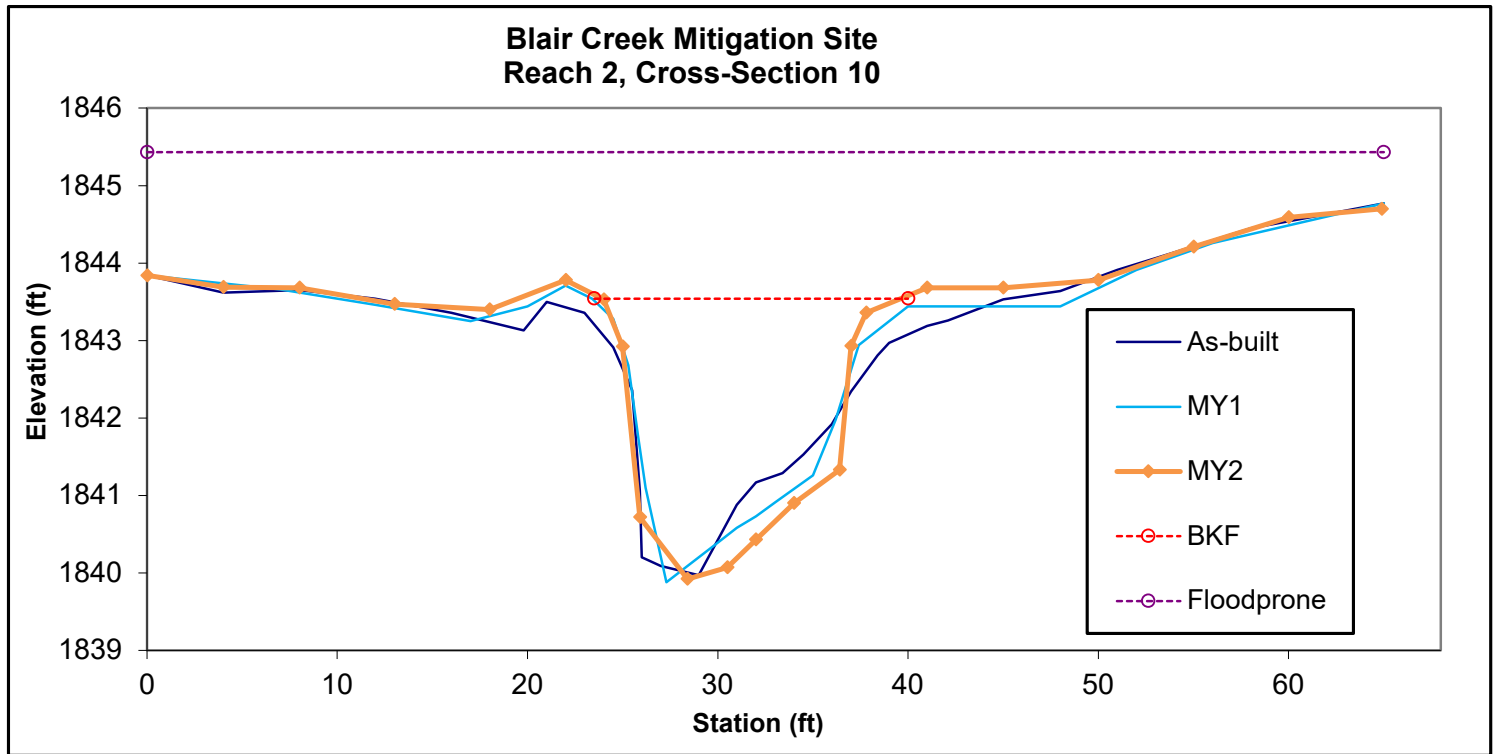
Permanent Cross-section 10
(Year 2 Data - September 2023)

Feature	Stream Type	BKF Area	BKF Width	BKF Depth	Max BKF Depth	W/D	BH Ratio	ER	BKF Elev	TOB Elev
Pool	--	35.2	15.7	2.2	3.6	7	--	--	1843.54	1843.5

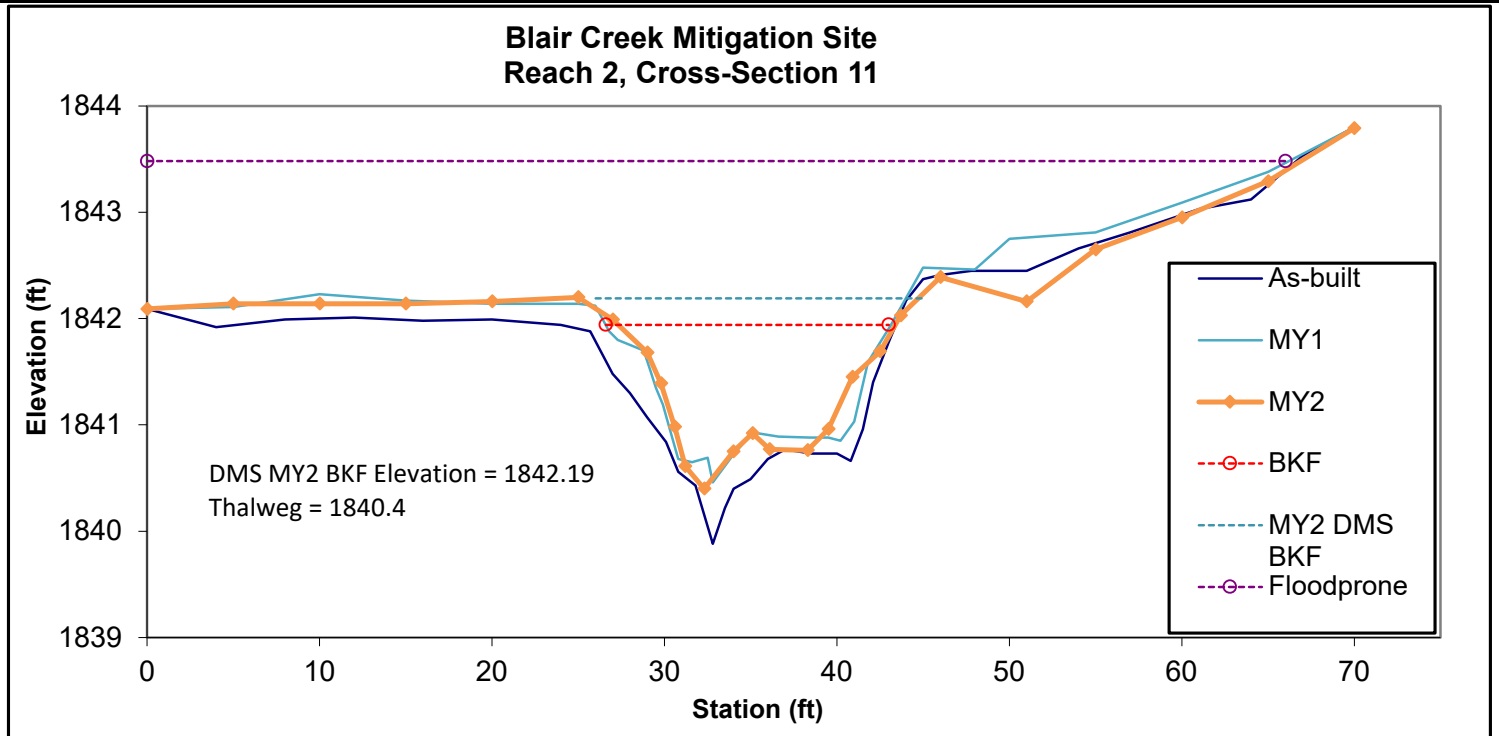
Permanent Cross-section 11

Feature	Stream Type	BKF Area	BKF Width	BKF Depth	Max BKF Depth	W/D	BH Ratio	ER	BKF Elev	TOB Elev
Riffle	C	13.7	16.1	0.9	1.5	18.9	1.0	1.5	1841.94	1842.2

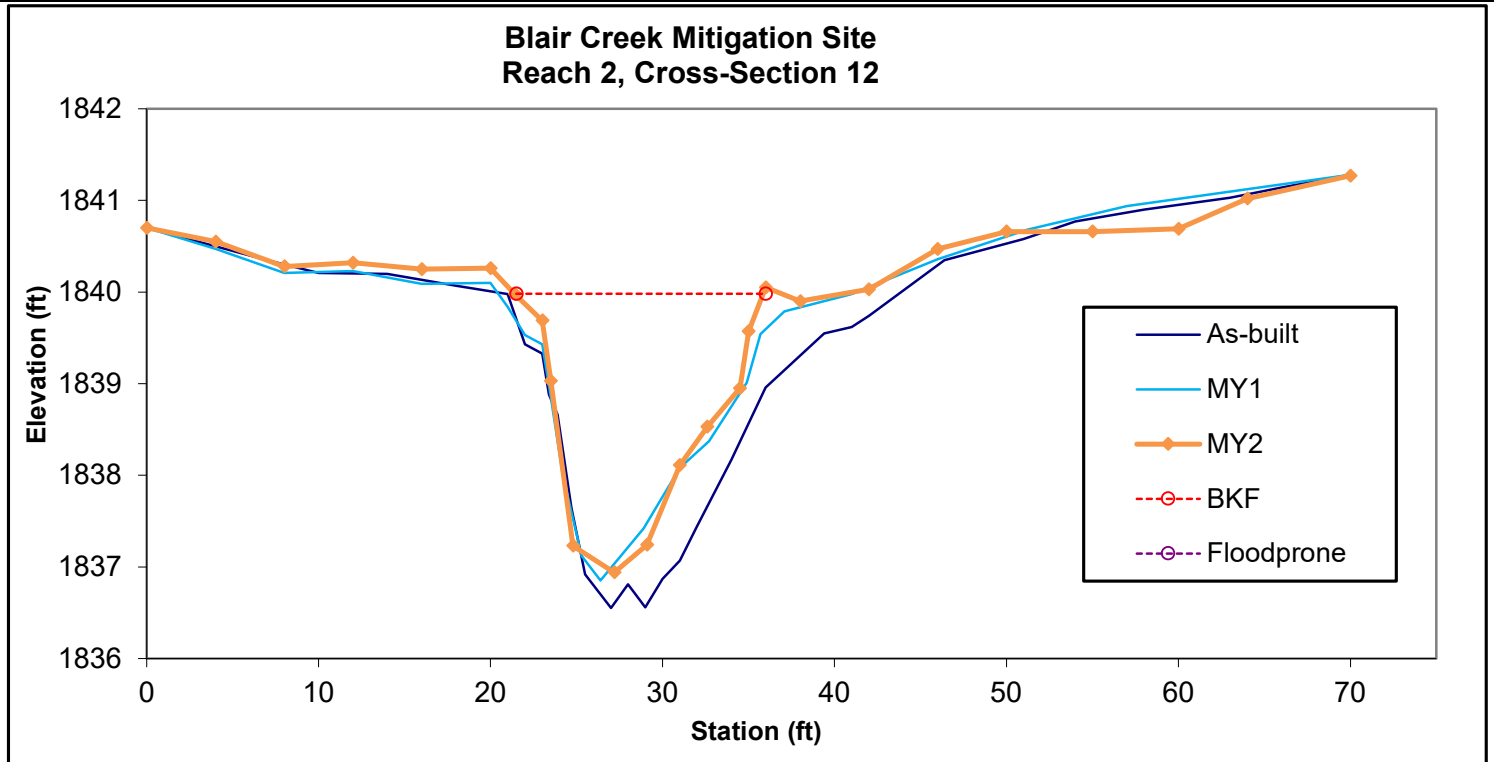
Permanent Cross-section 12

Feature	Stream Type	BKF Area	BKF Width	BKF Depth	Max BKF Depth	W/D	BH Ratio	ER	BKF Elev	TOB Elev
Pool	--	25.5	18	1.4	3.04	12.7	--	--	1839.98	1840.0

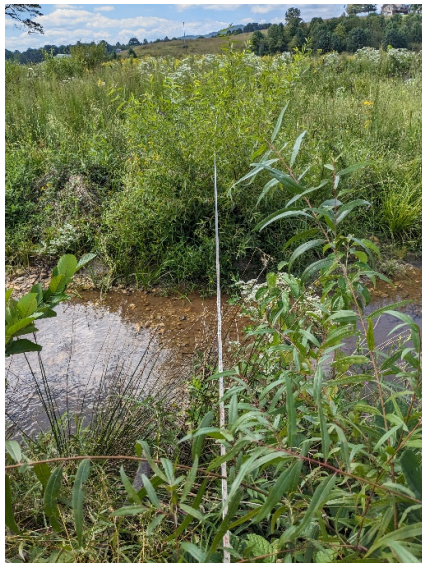
Looking at the Left Bank

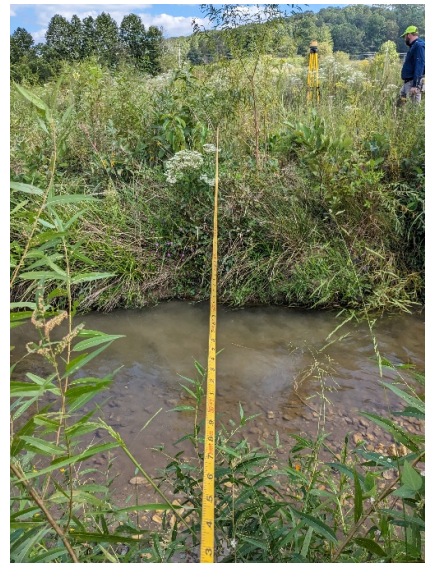
Looking at the Right Bank

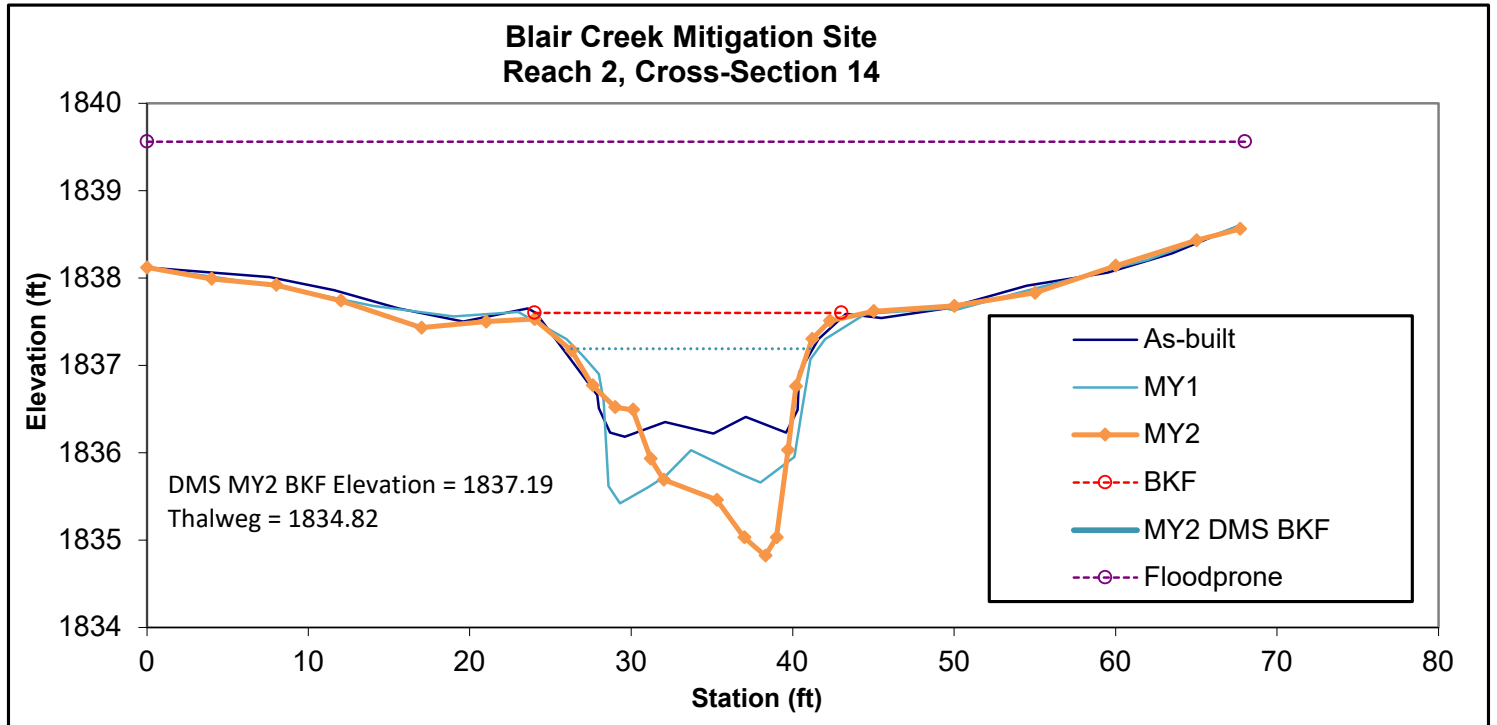
Permanent Cross-section 14

Feature	Stream Type	BKF Area	BKF Width	BKF Depth	Max BKF Depth	W/D	BH Ratio	ER	BKF Elev	TOB Elev
Riffle	C	25.9	20.5	1.3	2.8	16.3	1.10	4.6	1837.6	1837.5

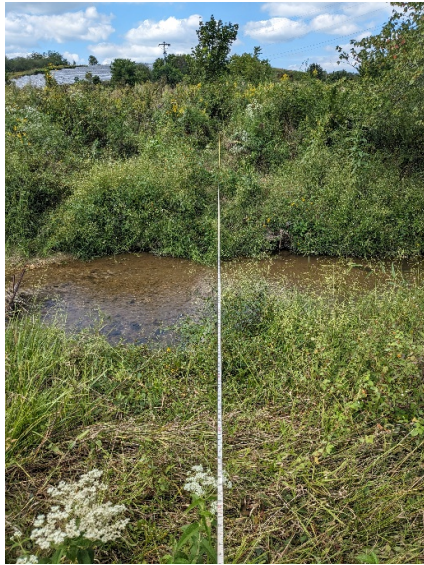
Looking at the Left Bank

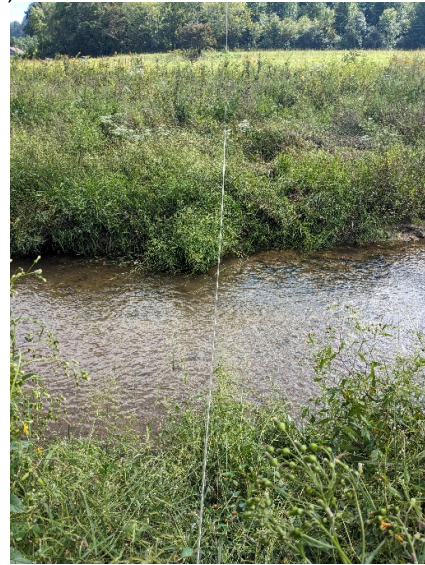
Looking at the Right Bank

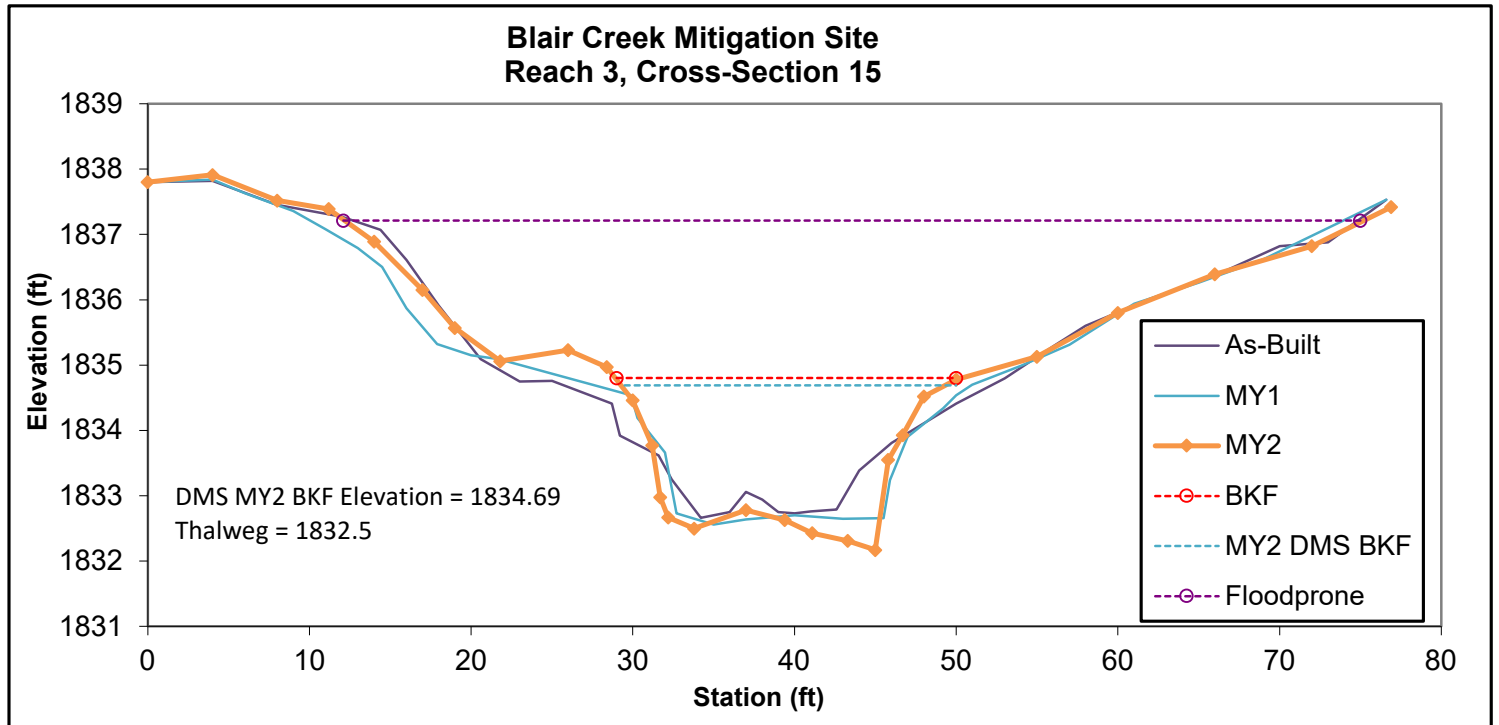
Permanent Cross-section 15
(Year 2 Data - September 2023)

Feature	Stream Type	BKF Area	BKF Width	BKF Depth	Max BKF Depth	W/D	BH Ratio	ER	BKF Elev	TOB Elev
Riffle	B	35.3	21.4	1.7	2.6	12.9	1	3.1	1834.8	1834.8

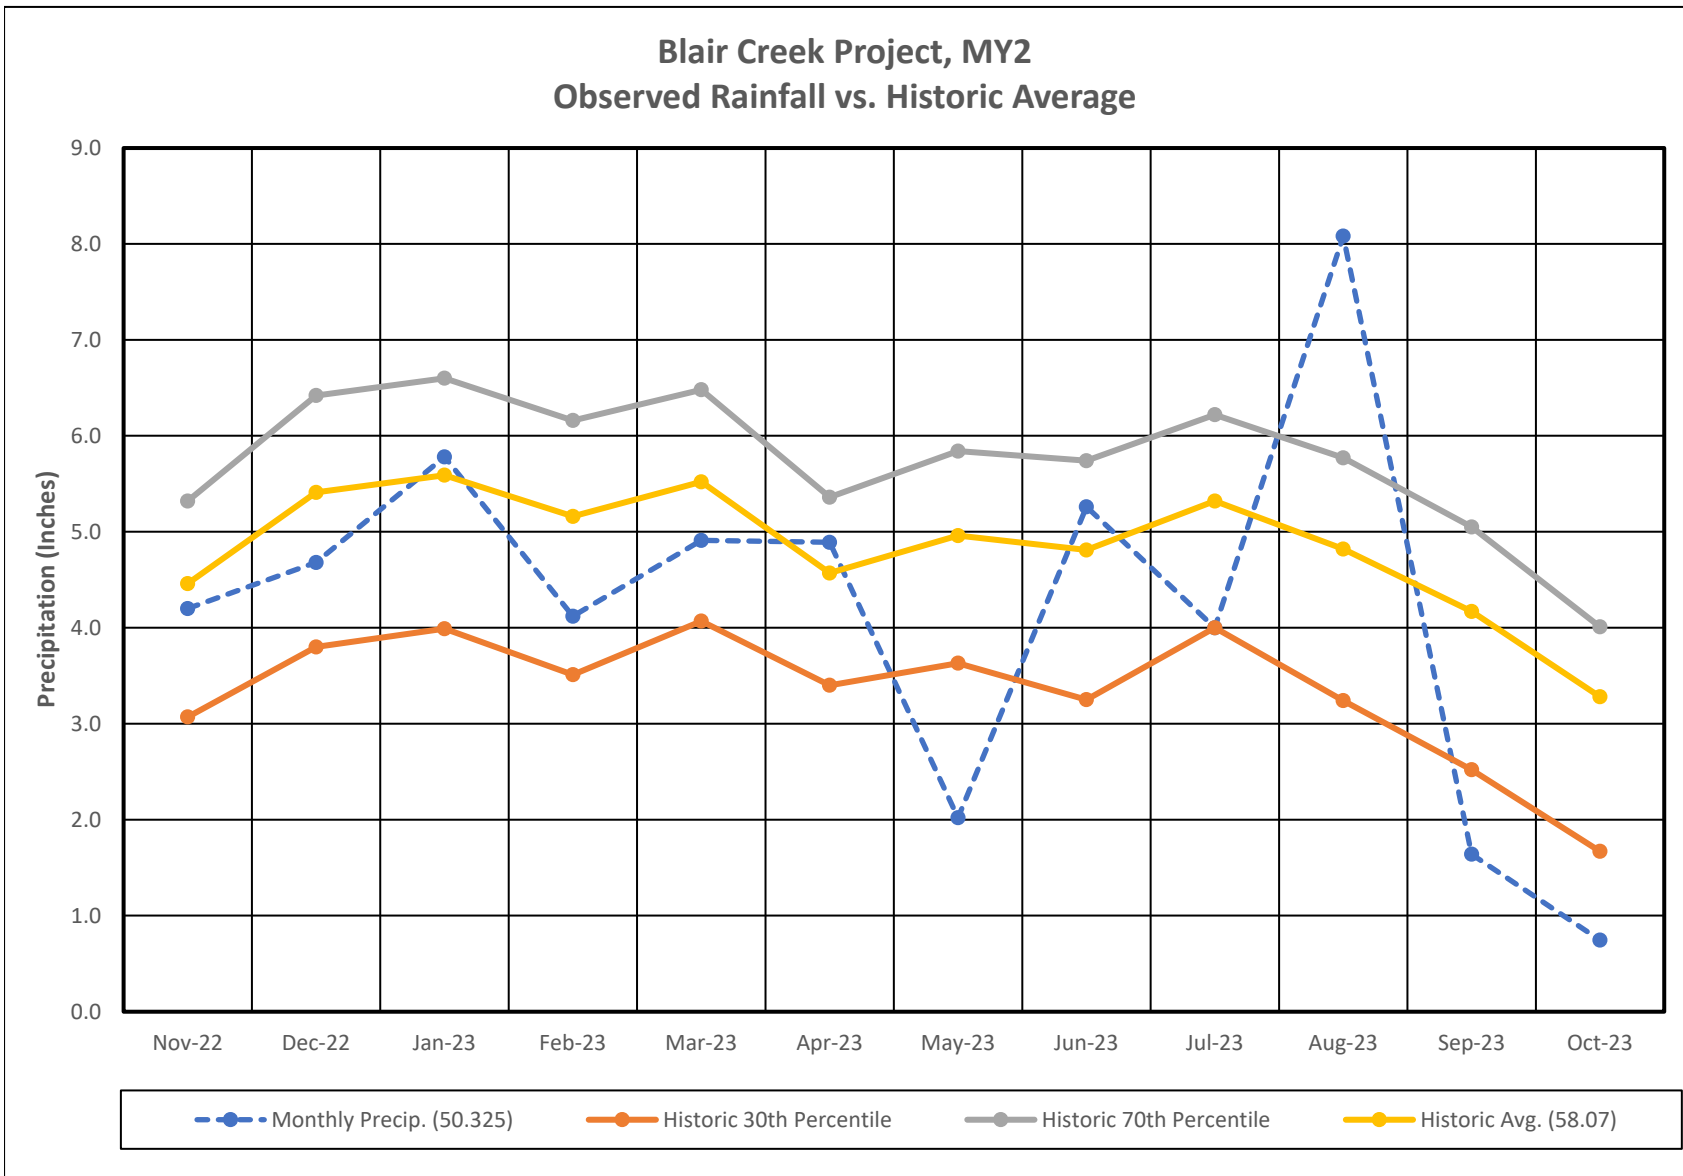
Figure 7. Observed Rainfall vs. Historical Average

As the observed monthly rainfall data for the project (Figure 7) demonstrates, the past 12 months have varied dramatically from month to month as compared to historic average precipitation. A total of 50.33 inches of rainfall was observed in the project area, while the region averages 58.07 inches of annual rainfall,
