Blockhouse Creek Mitigation Project

Year 2 Monitoring Report-Final

Polk County, North Carolina

Date Submitted: October 2010

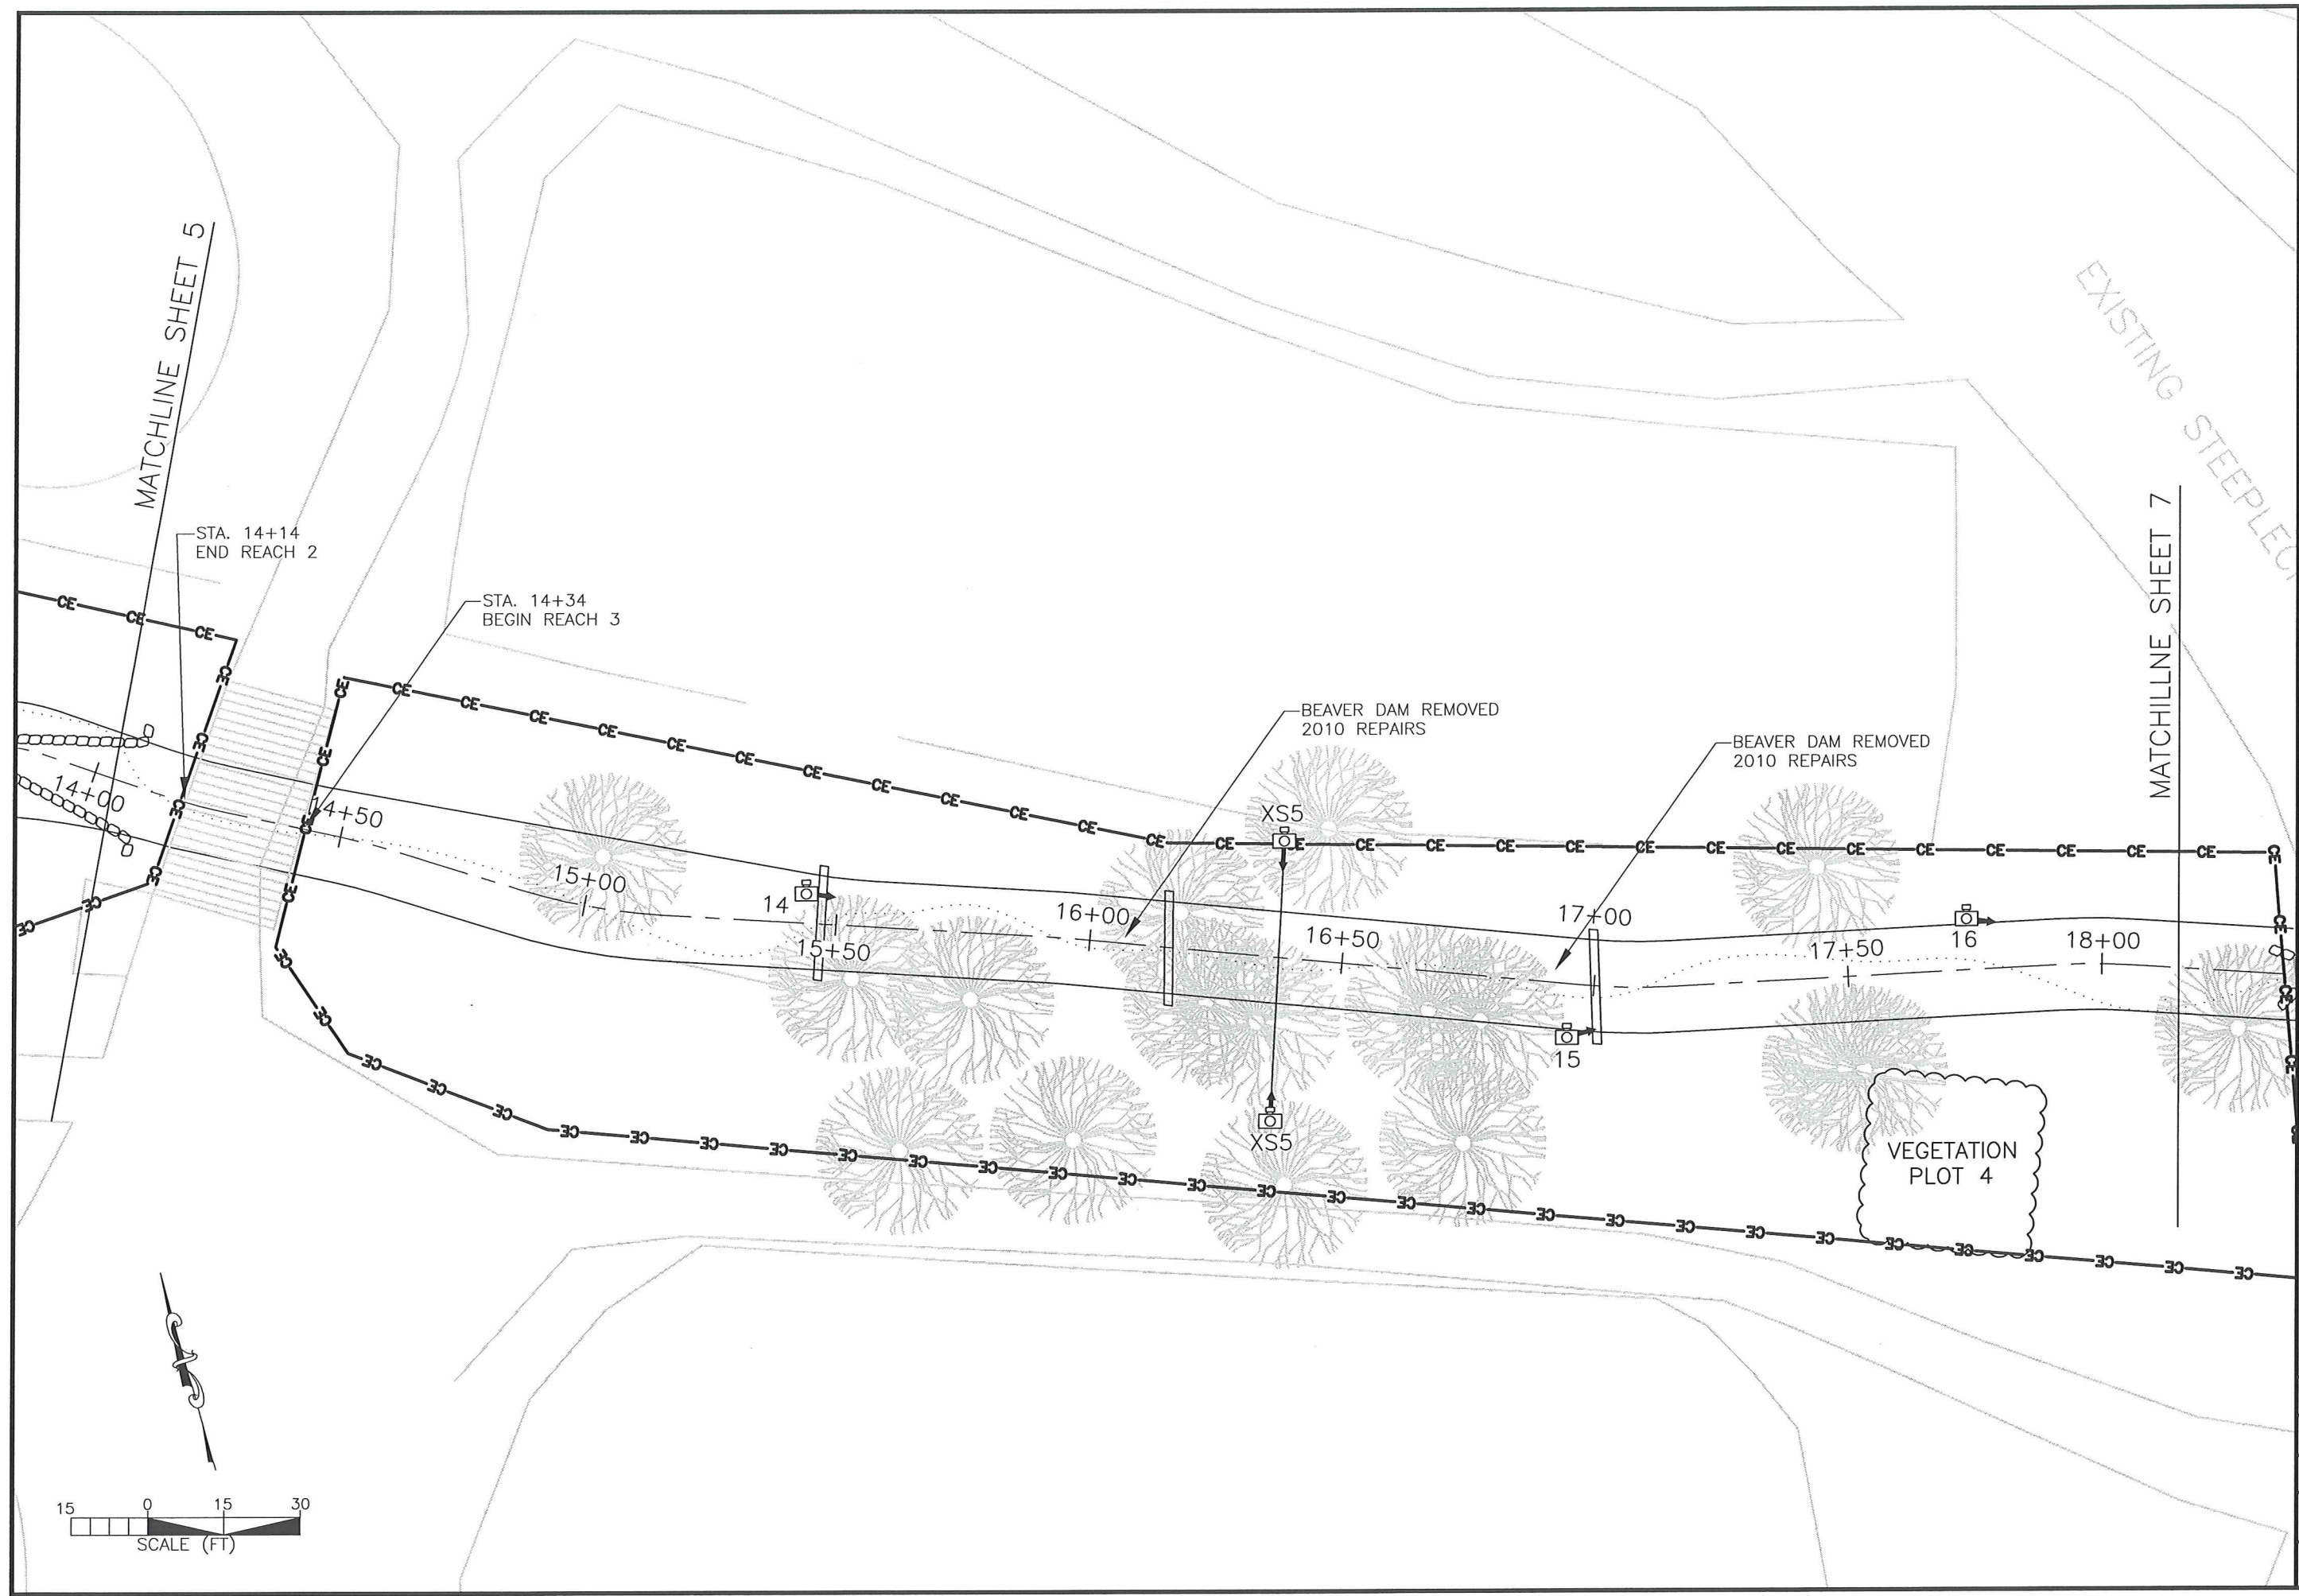
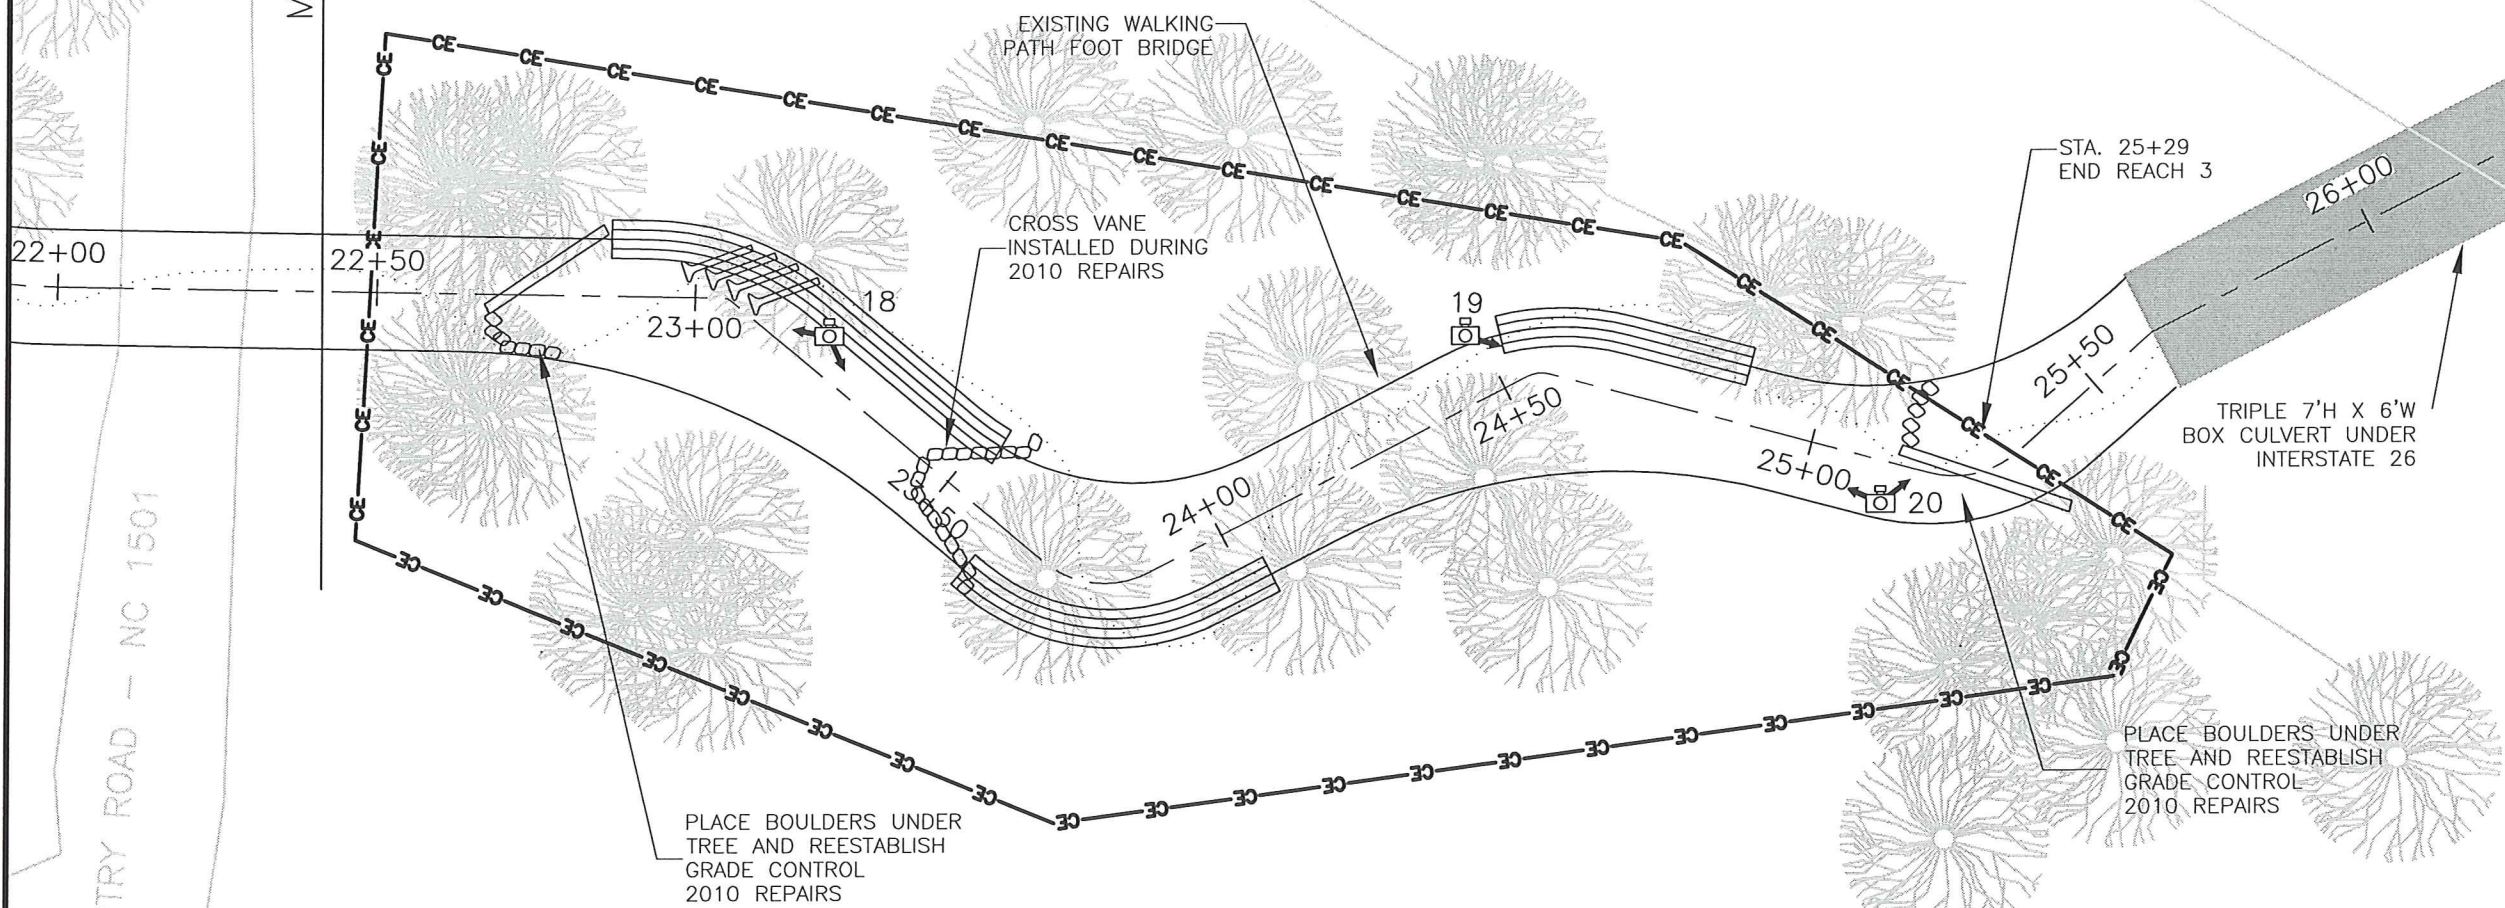
RIGHT BANK FROM 23+00-25+25 WAS LOWERED TO ADJUST BANKFULL AFTER SAND WASHED FROM THE CULVERTS AND LOWERED FLOW ELEVATIONS
