# Blockhouse Creek Mitigation Project

## Year 4 Monitoring Report

### Polk County, North Carolina

Contract Number: D06027-A, NCEEP Project #92516

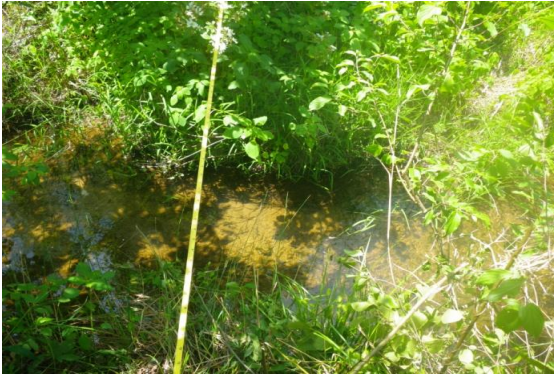
Photo 1: XS-1 facing right bank

Cross-section 1 is located in a riffle in Blockhouse Reach 1 that has consistently narrowed over time due to bank deposition and the establishment of herbaceous vegetation and live stakes. Many of the riffle cross sections across the project area exhibit this trend. Although not all riffles have narrowed, and some have in fact widened, all riffles surveyed appear to be stable. Cross-sections 3 and 8 were surveyed at pools that were filled in as a result of bank failure (the right bank at Cross-section 3 appears largely stable). Both pools should continue to improve; Cross-section 8 already appears to be trending toward as-built dimensions with differences primarily due to deposition on the point bar. Besides the widening of the pool at Cross-section 8, no major cross-sectional changes were observed on the mainstem between Monitoring Years 3 and 4.
