FINAL
YEAR 1 (2016) ANNUAL
MONITORING REPORT

BOBS CREEK
STREAM MITIGATION SITE

NCDMS Project No. 92879
Contract No. D09023S
USACE Action ID No. SAW-2009-917 & NCDWR Project No. 10-0122
SCO No. 08-07308-01
McDowell County, North Carolina

Data Collection: May-November 2016
Submission: January 2017

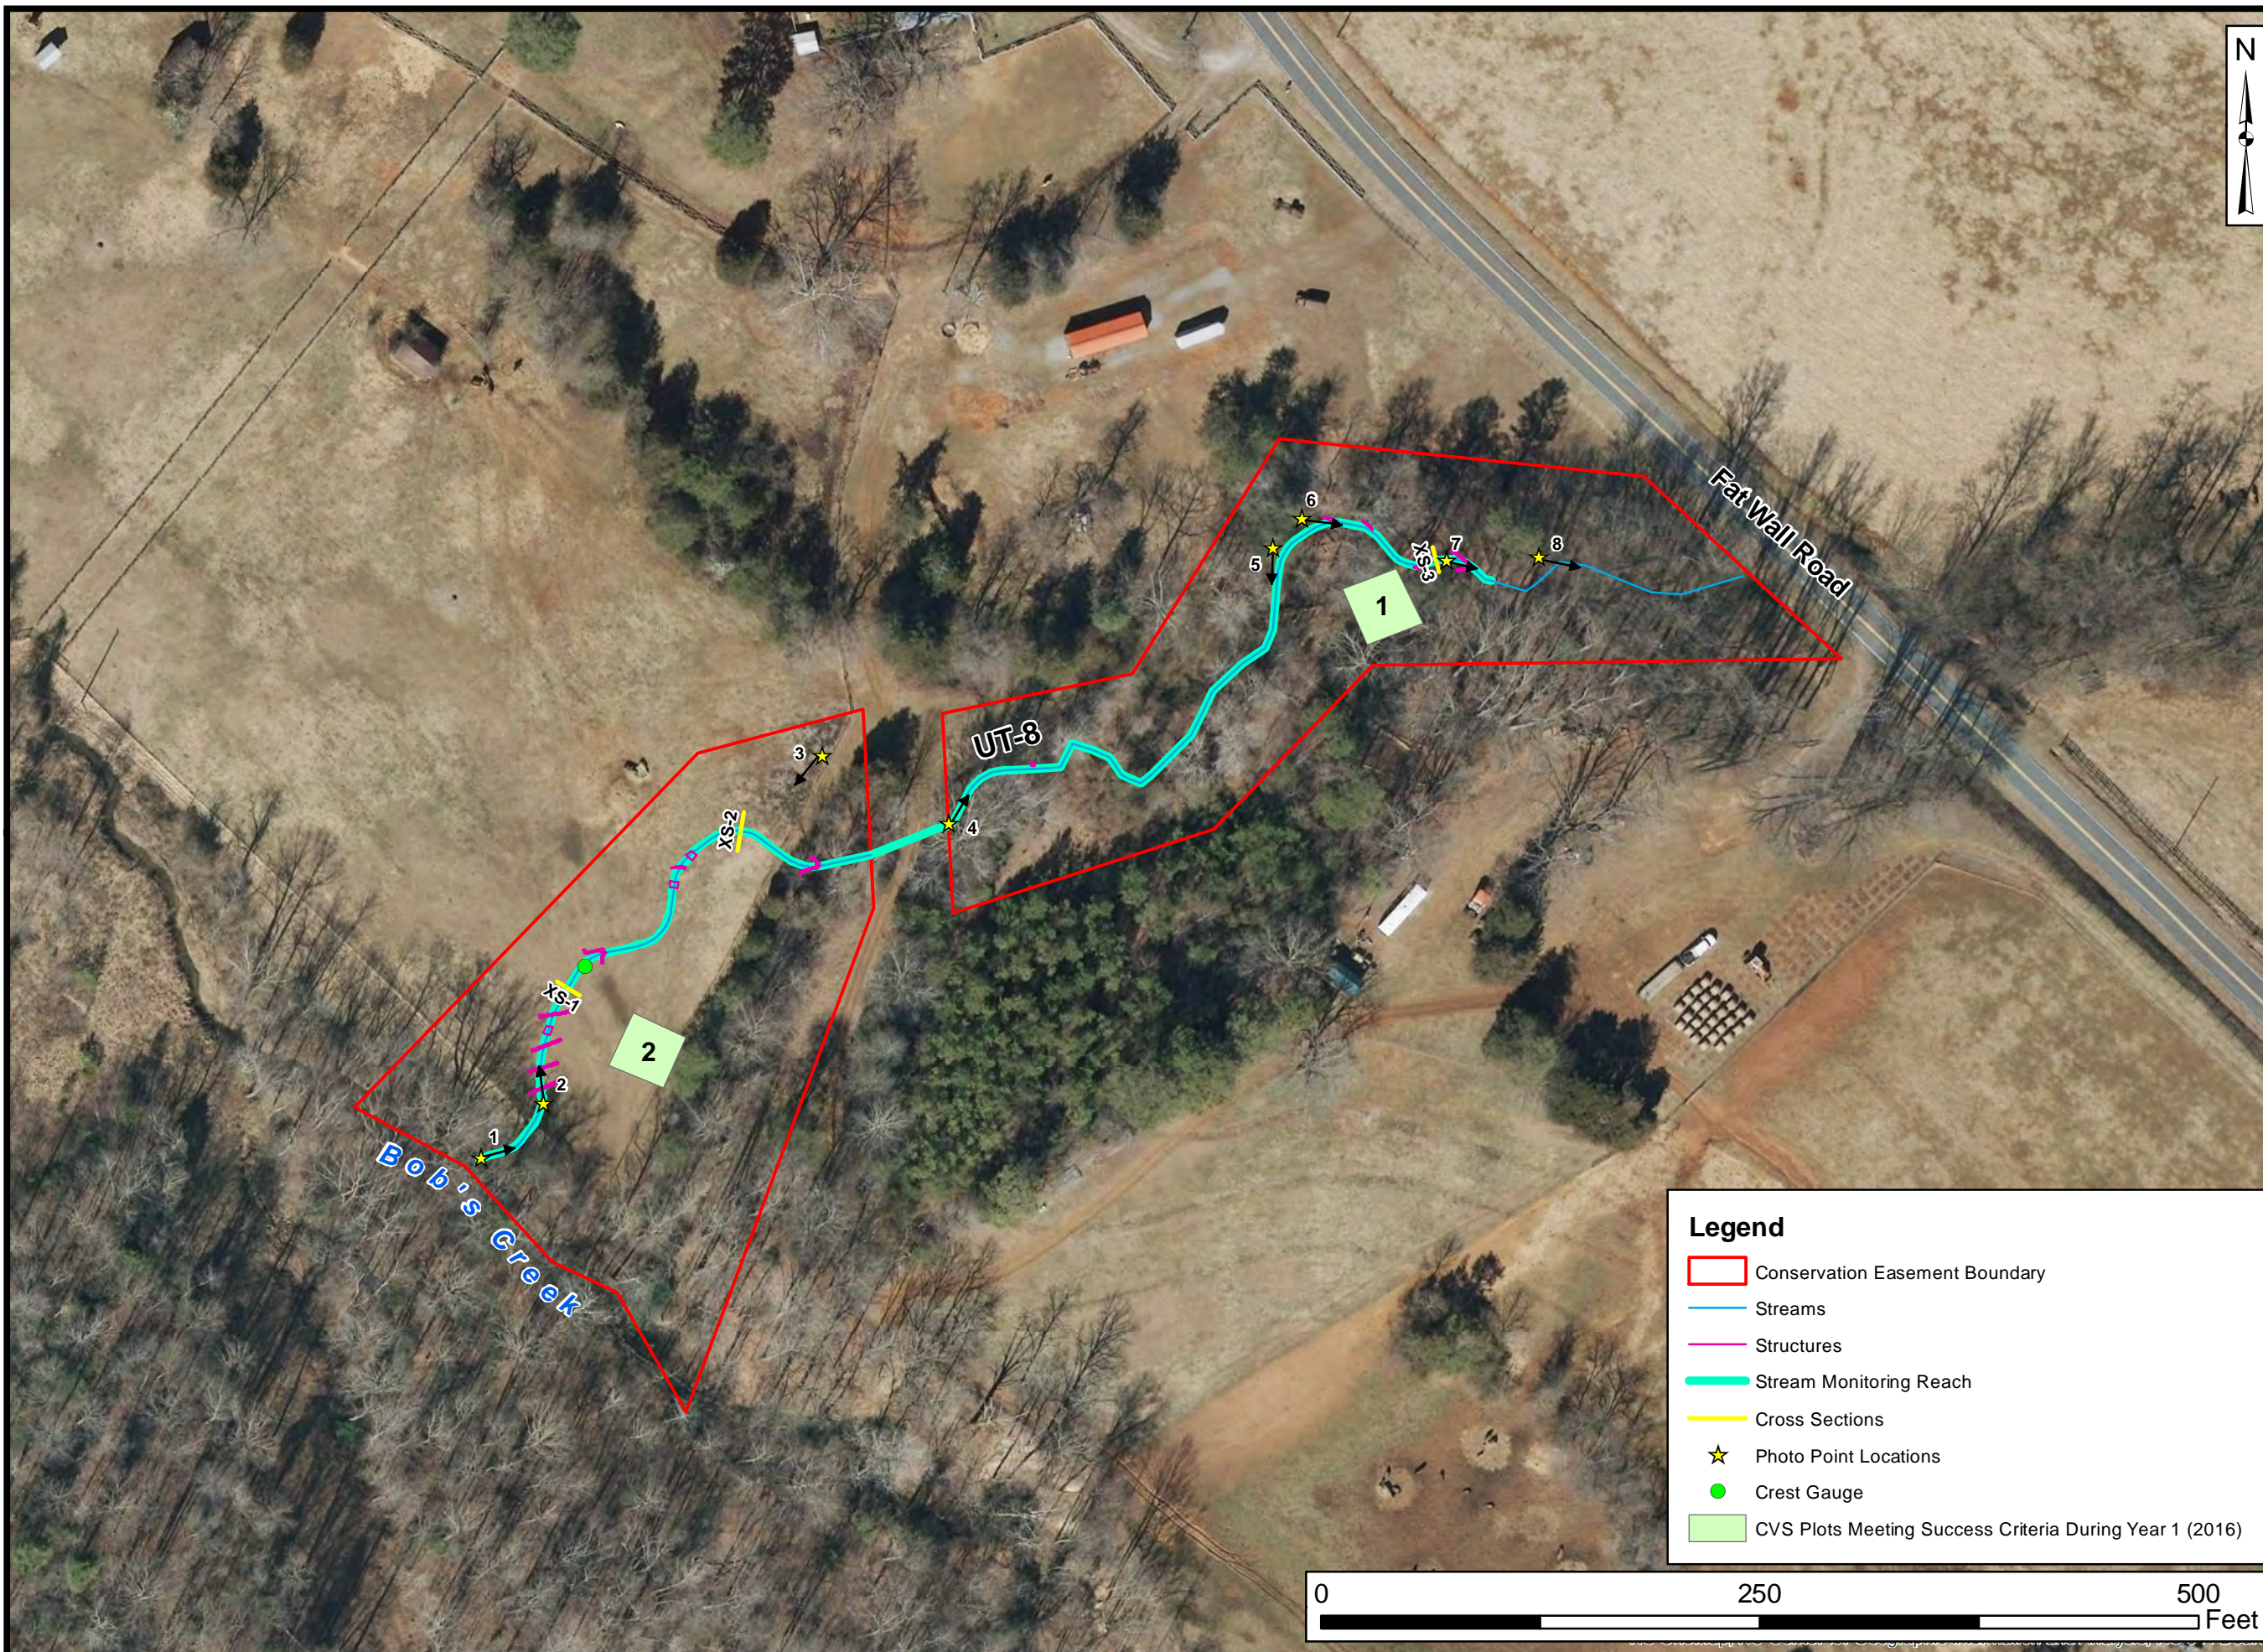
FIGURE
2A

Title:
Current Conditions Plan View

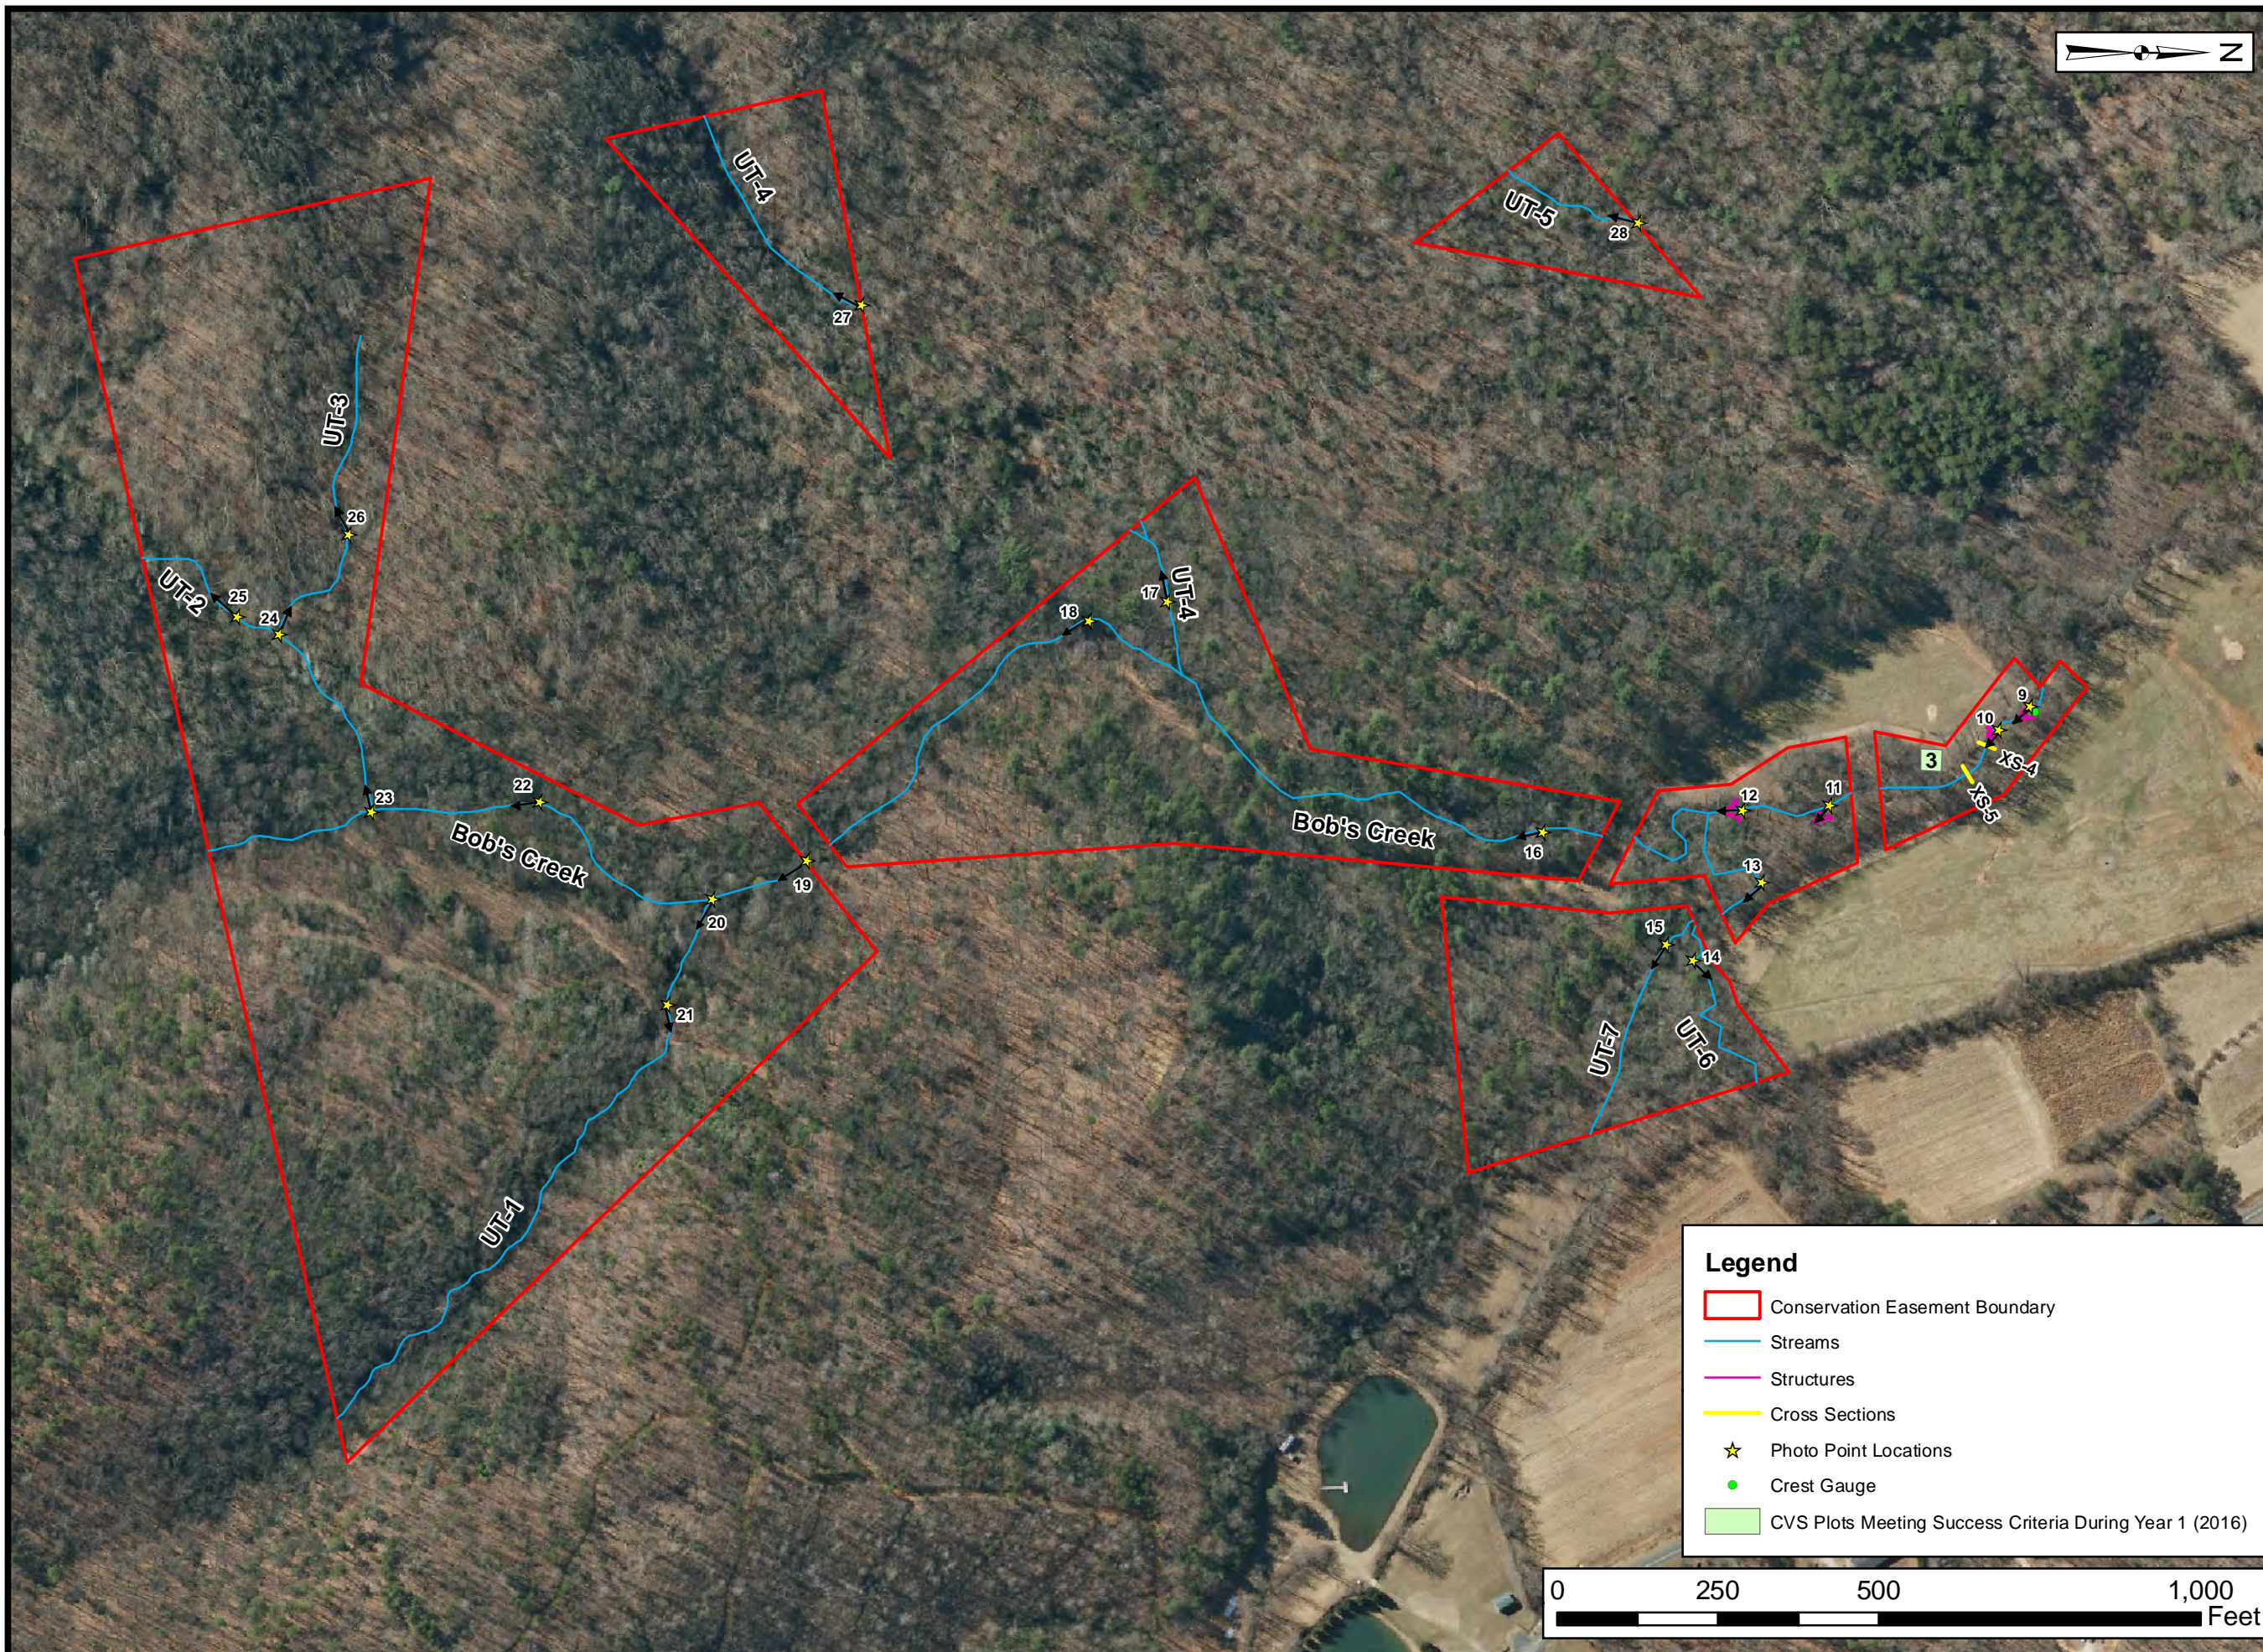
FIGURE
2B

Title:
Current Conditions Plan View

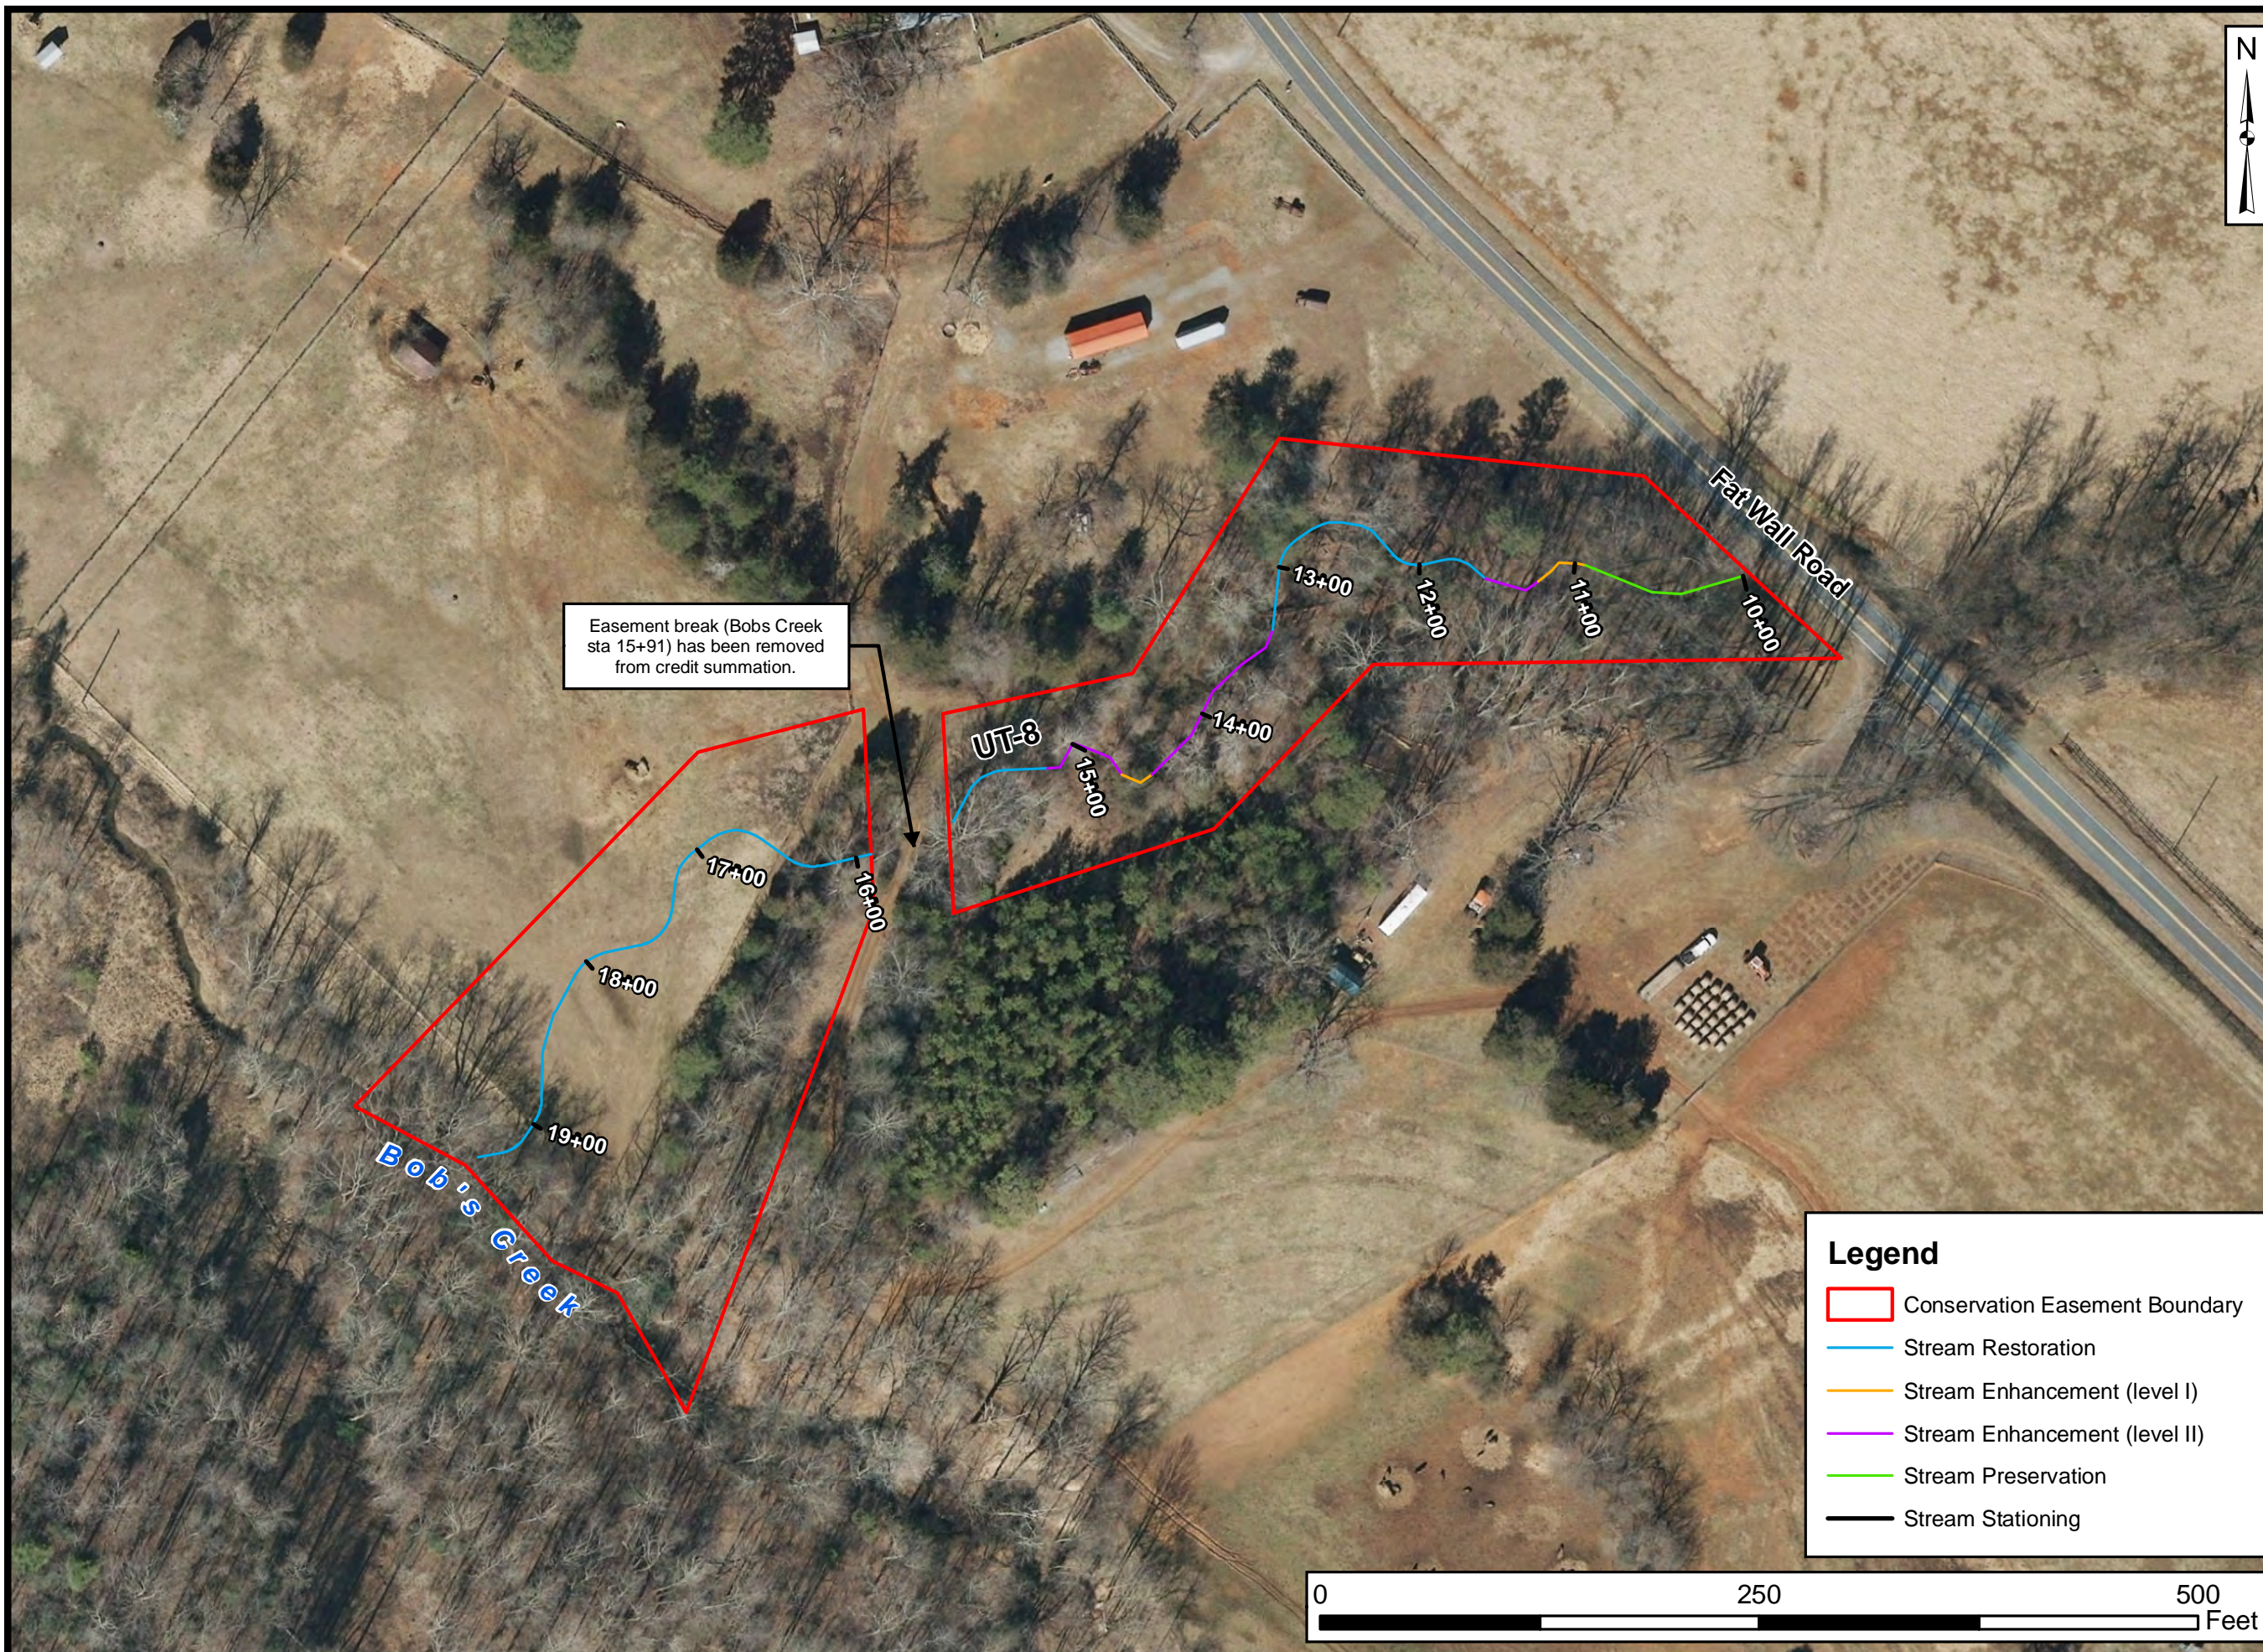
FIGURE
3A

Easement break (Bobs Creek sta 15+91) has been removed from credit summation.

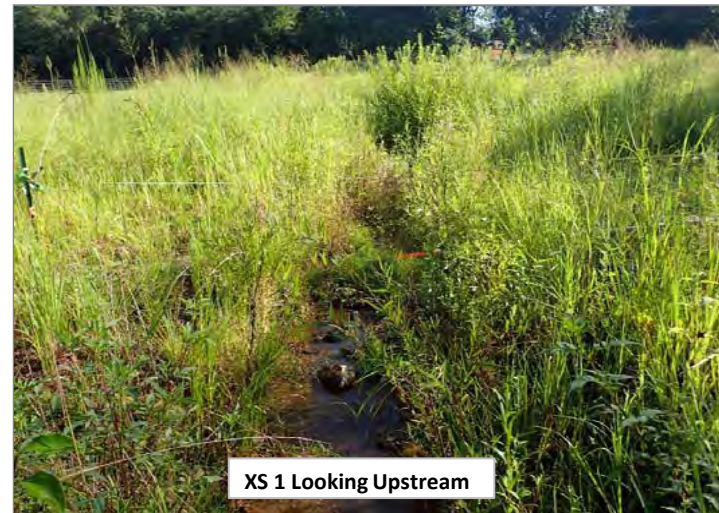
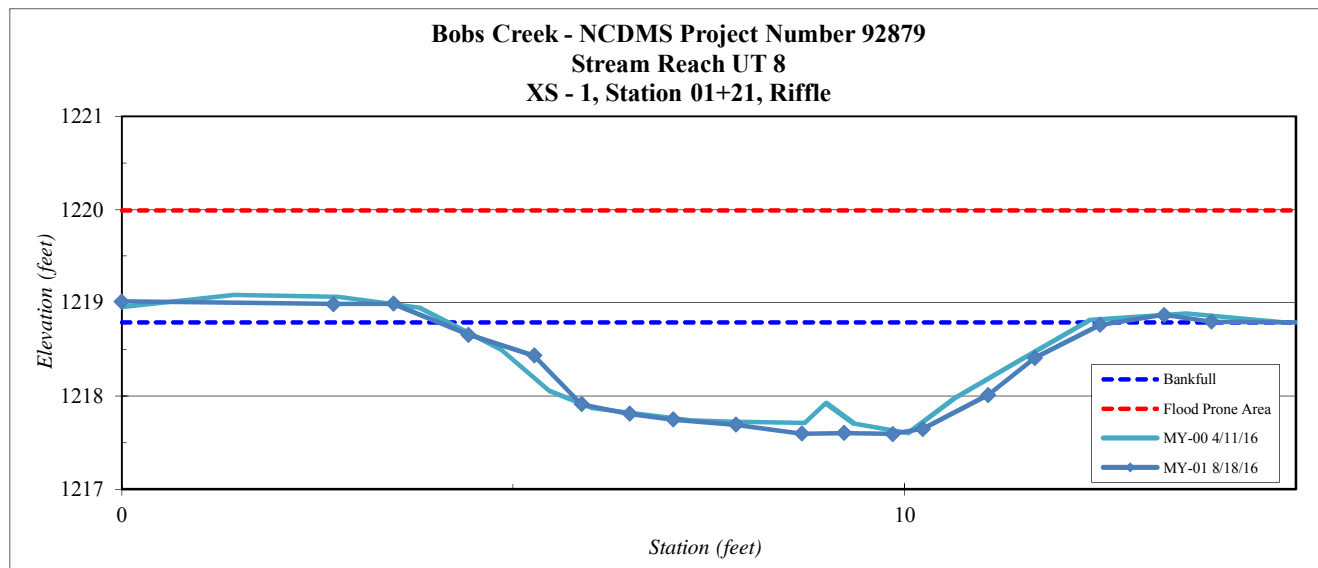
Site	Bobs Creek - UT 8
Project Number:	92879
XS ID	XS - 1, Riffle
Reach	UT 8
Date:	8/18/2016
Field Crew:	Perkinson, Jernigan

SUMMARY DATA	
Bankfull Elevation:	1218.8
Bankfull Cross-Sectional Area:	6.7
Bankfull Width:	8.7
Flood Prone Area Elevation:	1220.0
Flood Prone Width:	100.0
Max Depth at Bankfull:	1.2
Mean Depth at Bankfull:	0.8
W / D Ratio:	11.3
Entrenchment Ratio:	11.5
Bank Height Ratio:	1.0

Stream Type	E
--------------------	---

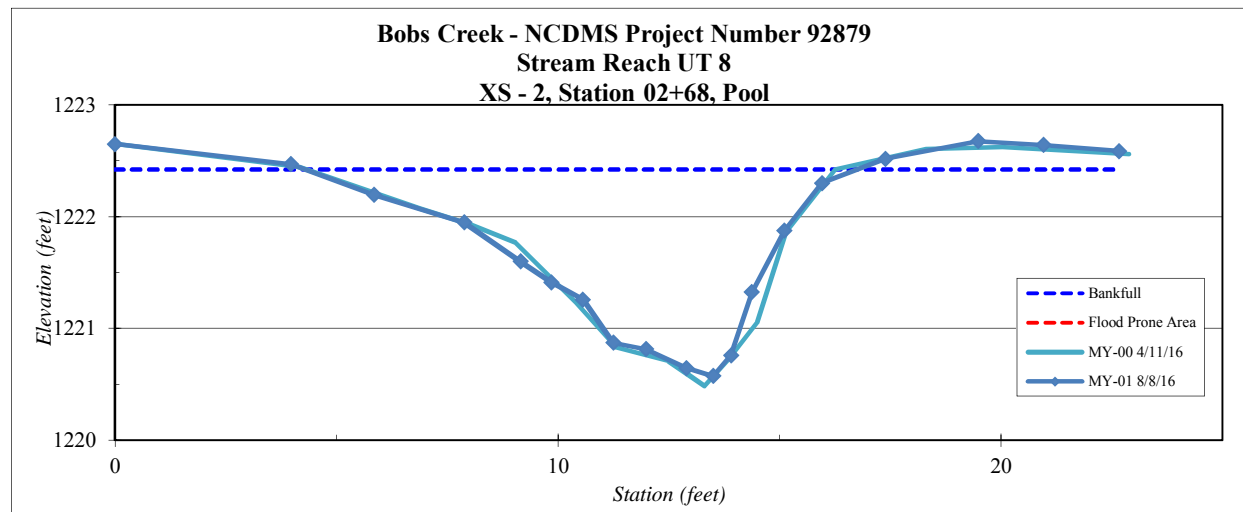
Site	Bobs Creek - UT 8
Project Number:	92879
XS ID	XS - 2, Pool
Reach	UT 8
Date:	8/18/2016
Field Crew:	Perkinson, Jernigan

Stream Type	E
--------------------	---

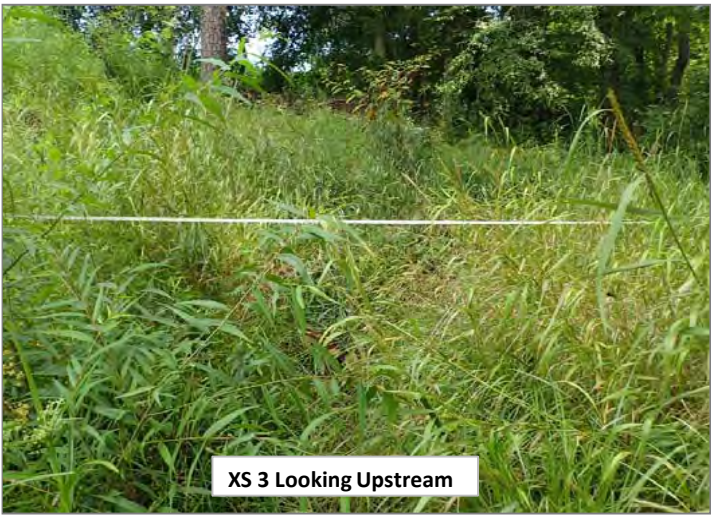
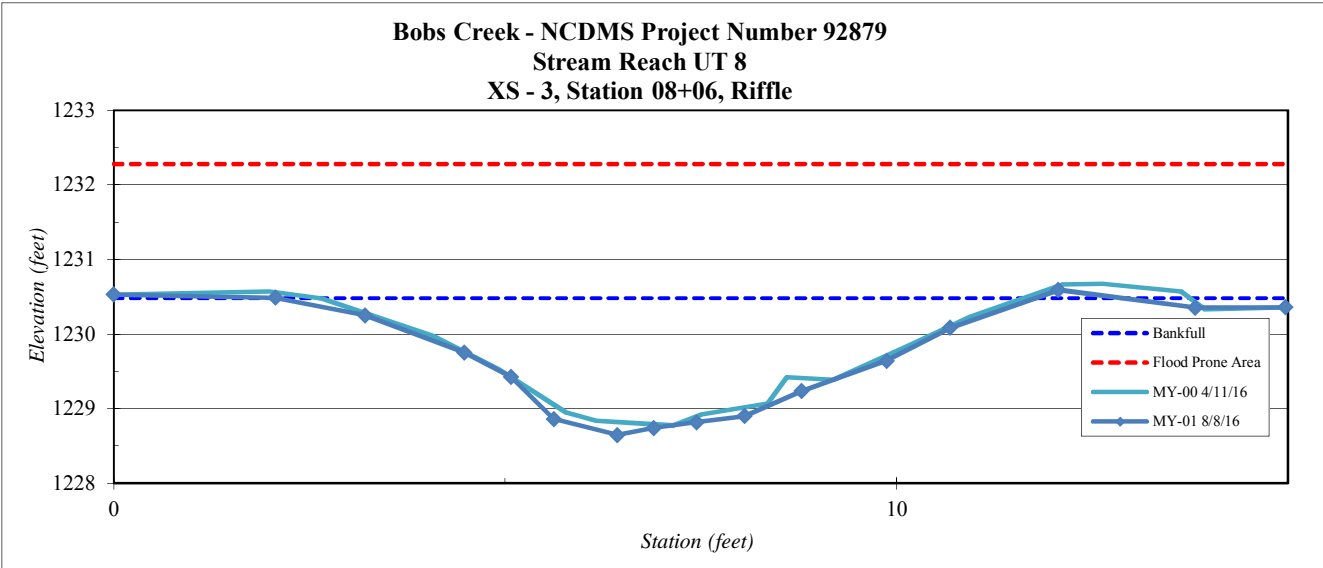
Site	Bobs Creek - UT 8
Project Number:	92879
XS ID	XS - 3, Riffle
Reach	UT 8
Date:	8/18/2016
Field Crew:	Perkinson, Jernigan

Stream Type	E
--------------------	---

SUMMARY DATA	
Bankfull Elevation:	1230.5
Bankfull Cross-Sectional Area:	9.0
Bankfull Width:	9.7
Flood Prone Area Elevation:	1232.3
Flood Prone Width:	100.0
Max Depth at Bankfull:	1.8
Mean Depth at Bankfull:	0.9
W / D Ratio:	10.5
Entrenchment Ratio:	10.3
Bank Height Ratio:	1.0

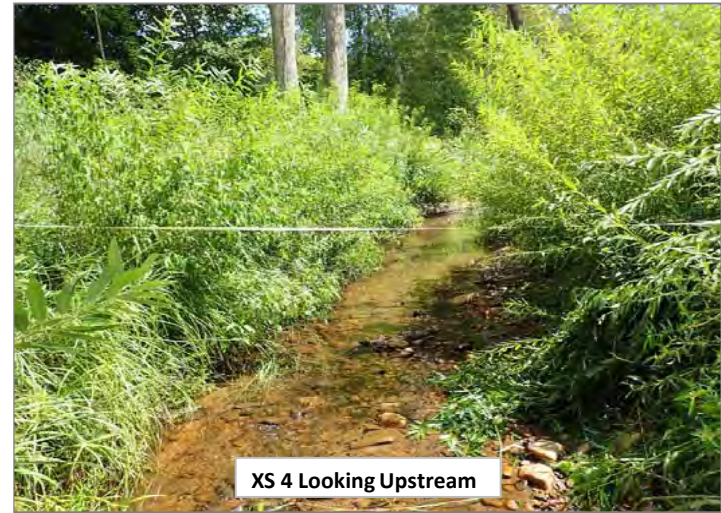
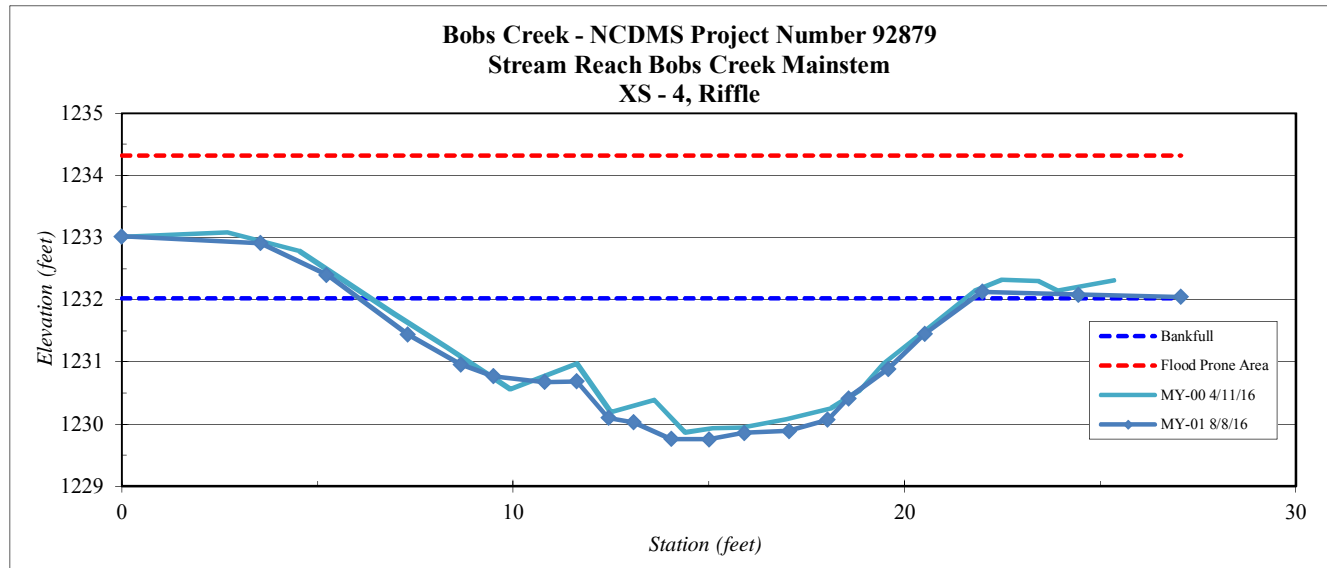
Site	Bobs Creek
Project Number:	92879
XS ID	XS - 4, Riffle
Reach	Bobs Creek
Date:	8/18/2016
Field Crew:	Perkinson, Jernigan

SUMMARY DATA	
Bankfull Elevation:	1232.0
Bankfull Cross-Sectional Area:	22.0
Bankfull Width:	15.7
Flood Prone Area Elevation:	1234.3
Flood Prone Width:	150.0
Max Depth at Bankfull:	2.3
Mean Depth at Bankfull:	1.4
W / D Ratio:	11.2
Entrenchment Ratio:	9.6
Bank Height Ratio:	1.0

Stream Type	E
--------------------	---

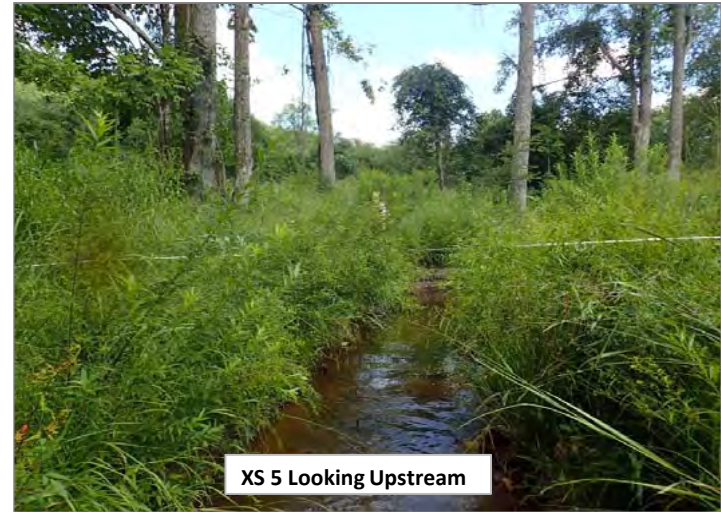
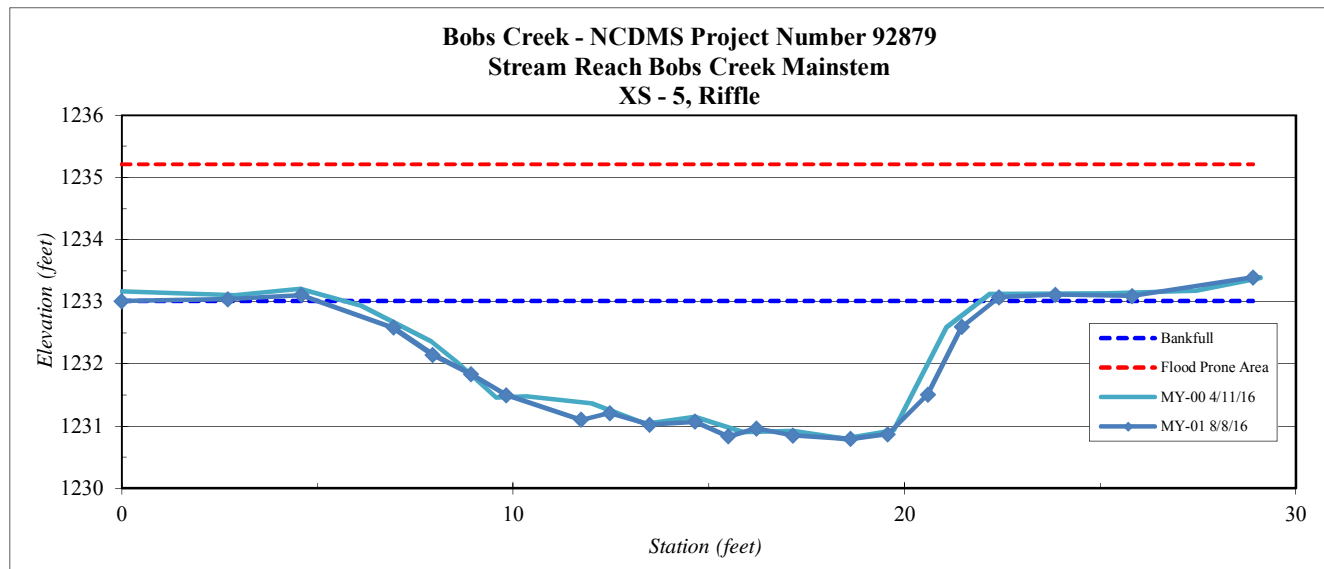
Site	Bobs Creek
Project Number:	92879
XS ID	XS - 5, Riffle
Reach	Bobs Creek
Date:	8/18/2016
Field Crew:	Perkinson, Jernigan

SUMMARY DATA	
Bankfull Elevation:	1233.0
Bankfull Cross-Sectional Area:	25.5
Bankfull Width:	17.3
Flood Prone Area Elevation:	1235.2
Flood Prone Width:	150.0
Max Depth at Bankfull:	2.2
Mean Depth at Bankfull:	1.5
W / D Ratio:	11.7
Entrenchment Ratio:	8.7
Bank Height Ratio:	1.0

Stream Type	E
--------------------	---

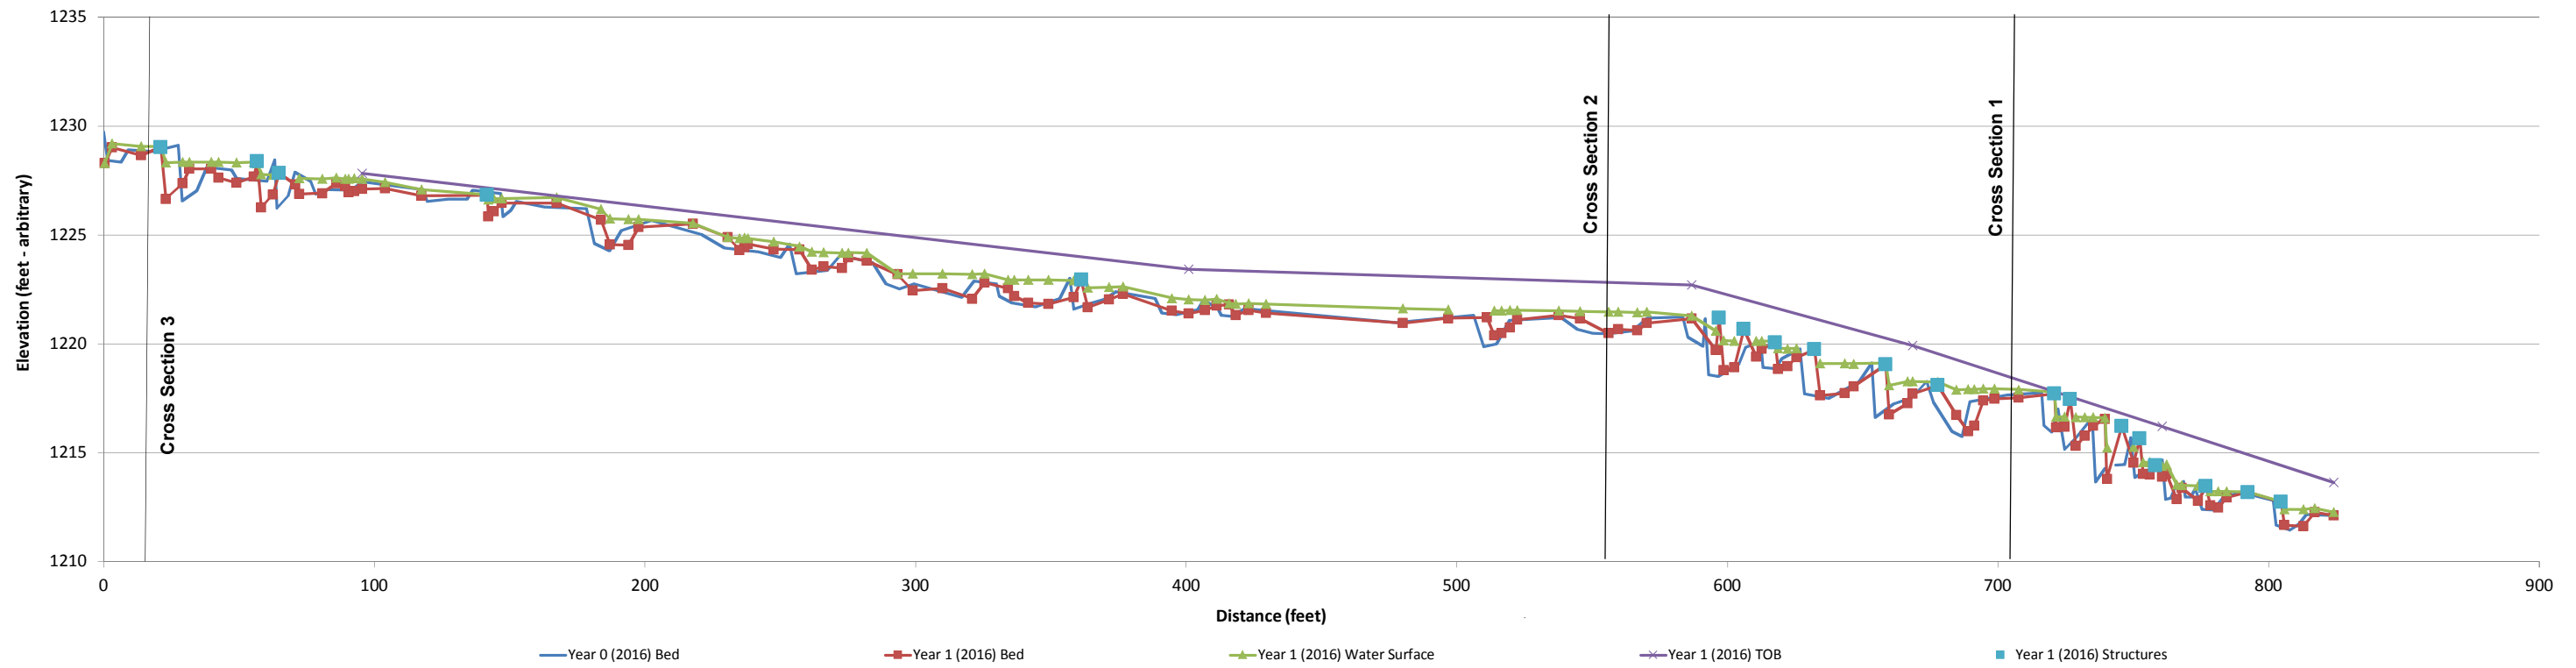
Bobs Creek Year 1 (2016) Profile - Tributary 8 Station 00+00 to 09+00

2016	2016	2017	2018	2019
Avg. Water Surface Slope	0.0212	0.0210			
Riffle Length	17	20			
Avg. Riffle Slope	0.0172	0.0175			
Pool Length	15	13			
Pool to Pool Spacing	26	28
