**FINAL**  
**YEAR 3 (2018) ANNUAL**  
**MONITORING REPORT**

**BOBS CREEK**  
**STREAM MITIGATION SITE**

NCDMS Project No. 92879  
Contract No. D09023S  
USACE Action ID No. SAW-2009-917 & NCDWR Project No. 10-0122  
SCO No. 08-07308-01  
McDowell County, North Carolina

Data Collection: May-November 2018  
Submission: November 2018

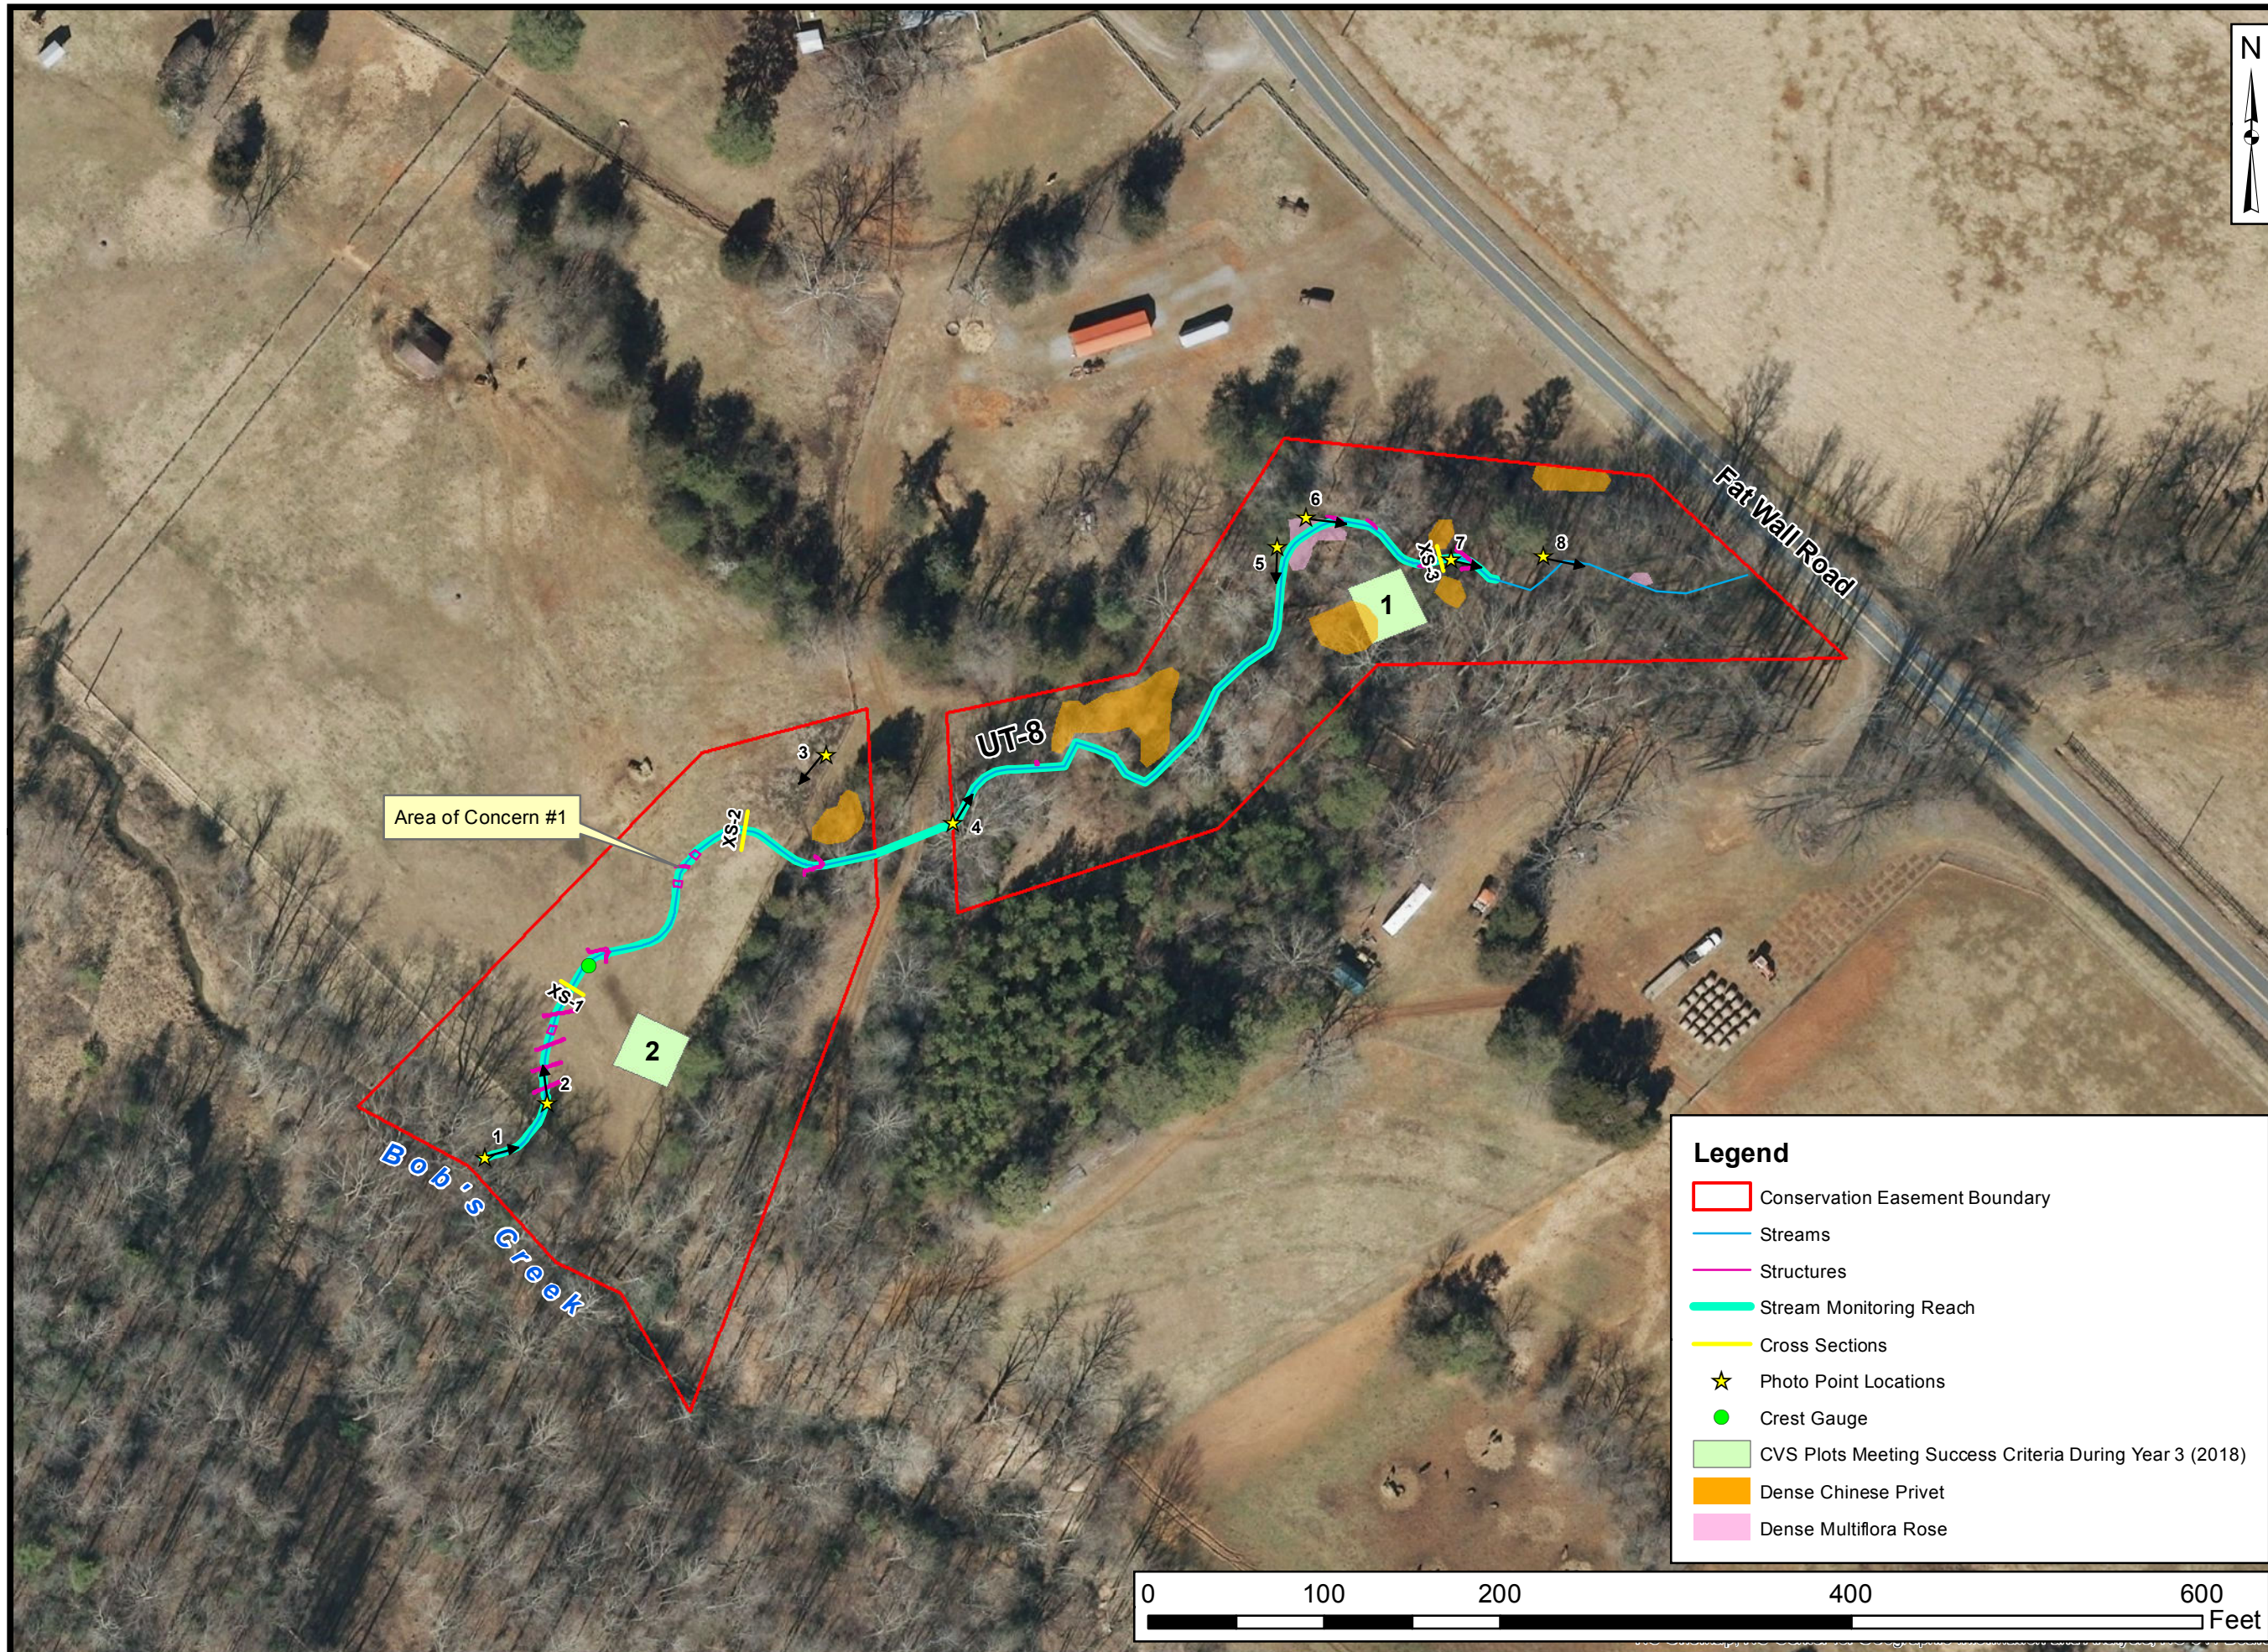
**FIGURE**  
**2A**

Several dense populations of Chinese privet (*Ligustrum sinense*) and multiflora rose (*Rosa multiflora*) were observed along the upstream portion of UT-8 (Figure 2A, Appendix B). Additional areas of privet and multiflora rose were observed scattered throughout Site restoration reaches in quantities below mapping threshold. NCDMS plans to treat invasive species during year 4 (2019), and Axiom will monitor these areas to determine the success of the treatments.
