FINAL
YEAR 4 (2019) ANNUAL
MONITORING REPORT

BOBS CREEK
STREAM MITIGATION SITE

NCDMS Project No. 92879
Contract No. D09023S
USACE Action ID No. SAW-2009-917 & NCDWR Project No. 10-0122
SCO No. 08-07308-01
McDowell County, North Carolina

Data Collection: May-November 2019
Submission: January 2020

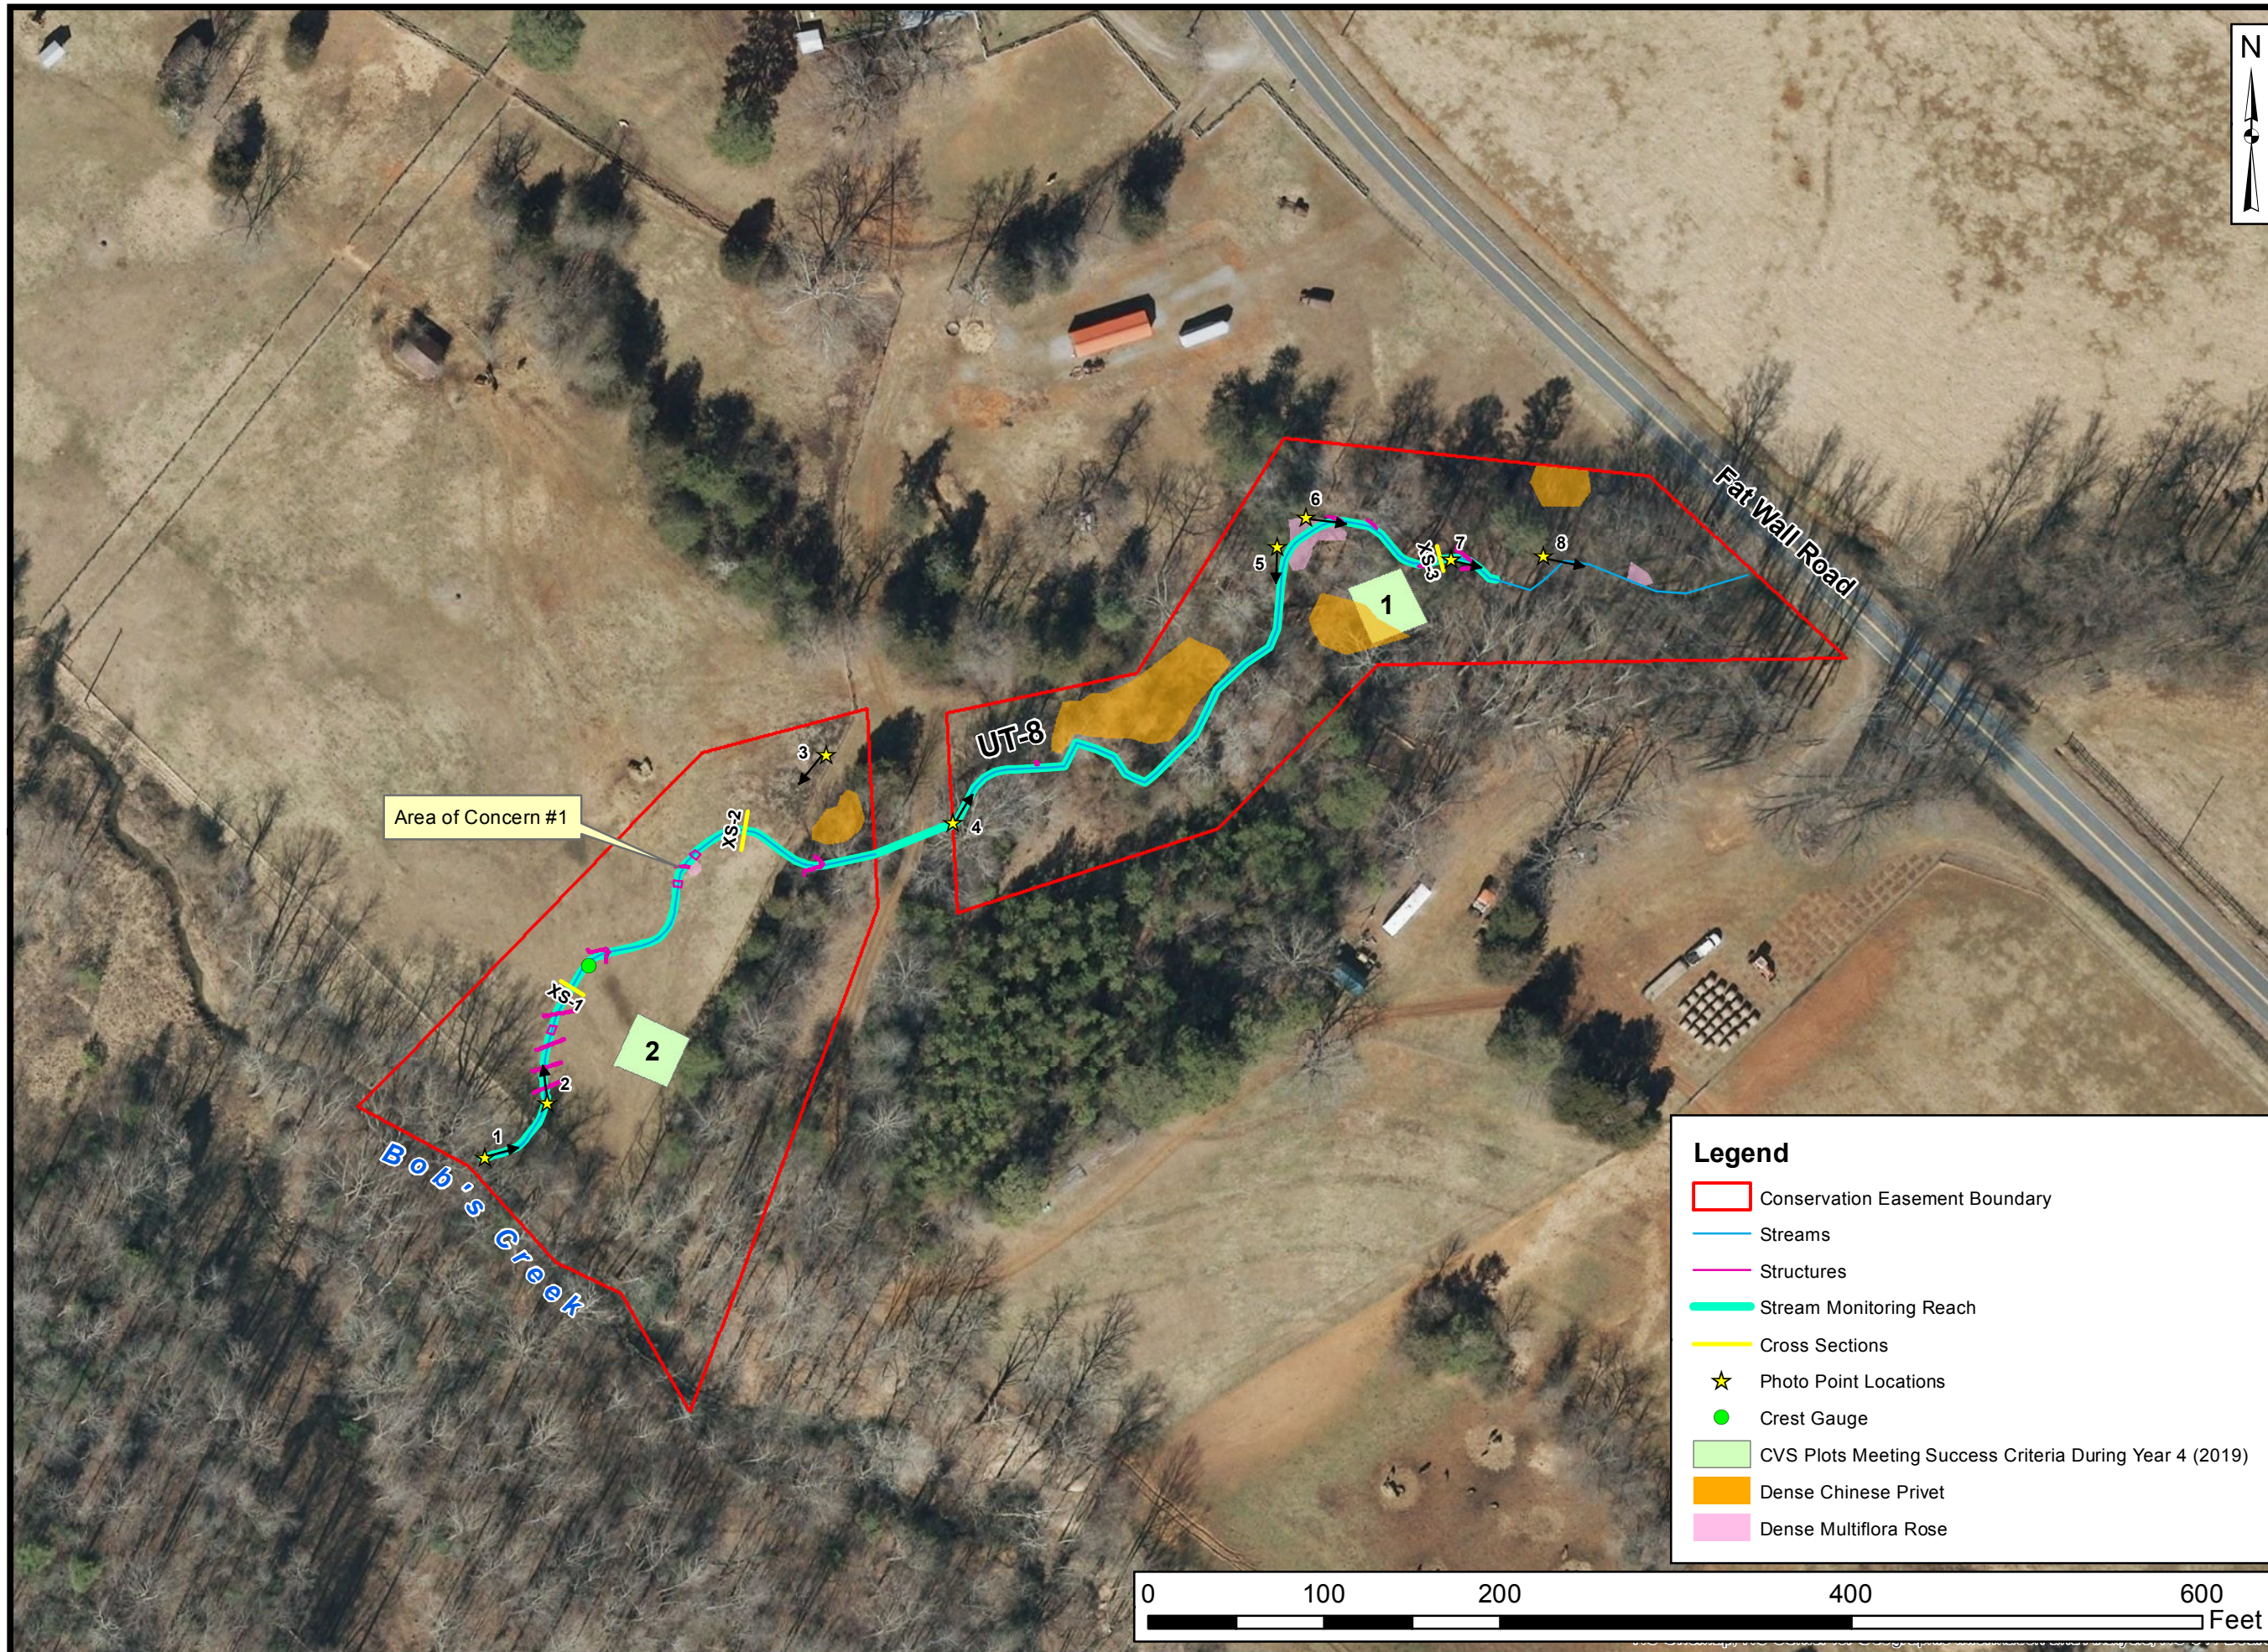
FIGURE 2A

One stream area of concern was observed during year 4 (2019) monitoring. A log cross vane on the downstream reach of UT-8 to Bobs Creek is compromised and appears to be piping (Area of Concern #1). This currently does not appear to be an immediate threat to stream stability, but it is not functioning as designed. This stream area of concern is depicted on Figure 2A (Appendix B). Year 4 (2019) stream measurements indicate that site streams are meeting success criteria.

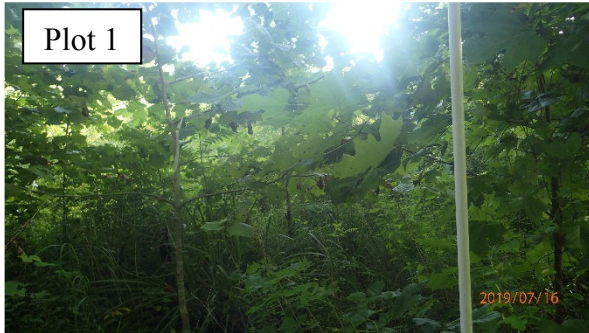
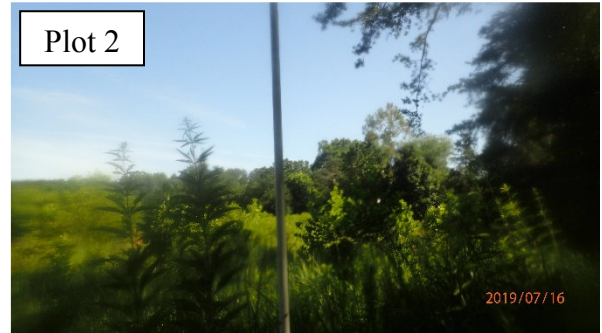
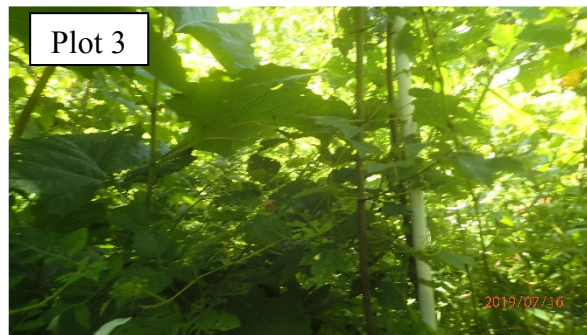
**Bobs Creek
Vegetation Monitoring Photographs
Taken July 2019**

- Vegetation: Discussion on page 3 refers to Year 3 stem counts and success criteria. Text also indicates all vegetation plots met success criteria in MY4, but this is not the case. Plot 3 just missed the MY4 success criteria by 7 stems per acre, but it did meet when volunteers are included. Please update paragraph to reflect MY4 conditions.
*This paragraph was edited to include a discussion of the year 4 vegetation data. It indicates that site vegetation is meeting success criteria and that 2 of the 3 plots met success criteria based on planted stems alone; however, when including naturally recruited stems of sycamore (*Platanus occidentalis*), tulip poplar (*Liriodendron tulipifera*), and black cherry (*Prunus serotina*), plot 3 is well above success criteria.*

Vegetation Plot ID	Vegetation Survival Threshold Met?	Tract Mean
1	Yes	67%
2	Yes	
3	No

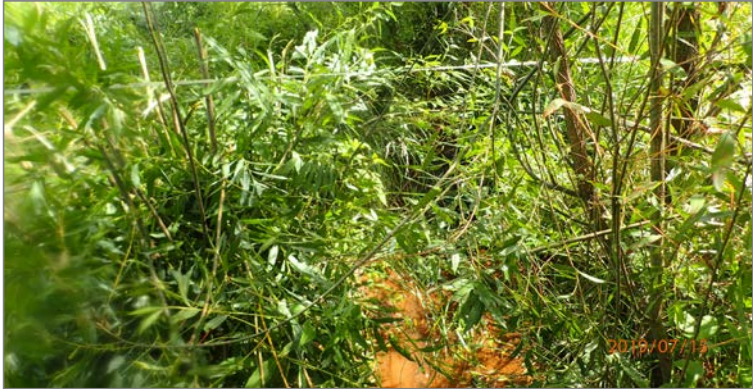
Site	Bobs Creek - UT 8
Project Number:	92879
XS ID	XS - 1, Riffle
Reach	UT 8
Date:	7/16/2019
Field Crew:	Perkinson, Lewis

SUMMARY DATA	
Bankfull Elevation:	1218.8
Bankfull Cross-Sectional Area:	6.4
Bankfull Width:	10.8
Flood Prone Area Elevation:	1220.0
Flood Prone Width:	100.0
Max Depth at Bankfull:	1.2
Low Bank Height:	1.3
Mean Depth at Bankfull:	0.6
W / D Ratio:	18.2
Entrenchment Ratio:	9.3
Bank Height Ratio:	1.1

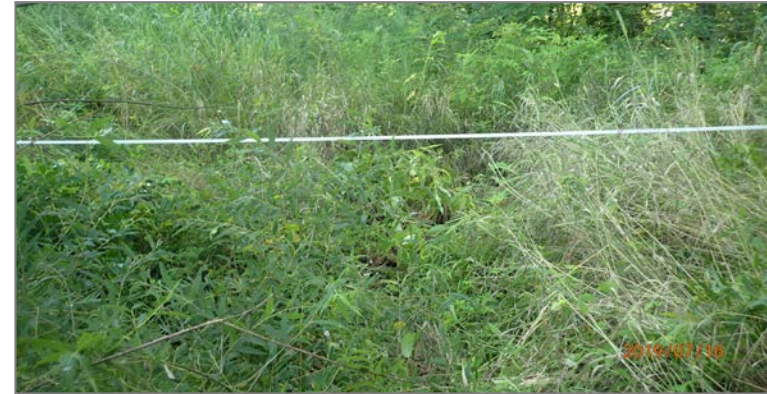
Site	Bobs Creek - UT 8
Project Number:	92879
XS ID	XS - 2, Pool
Reach	UT 8
Date:	7/16/2019
Field Crew:	Perkinson, Lewis

SUMMARY DATA	
Bankfull Elevation:	1222.5
Bankfull Cross-Sectional Area:	9.5
Bankfull Width:	19.6
Flood Prone Area Elevation:	NA
Flood Prone Width:	NA
Max Depth at Bankfull:	1.6
Low Bank Height:	1.7
Mean Depth at Bankfull:	0.5
W / D Ratio:	NA
Entrenchment Ratio:	NA
Bank Height Ratio:	1.1

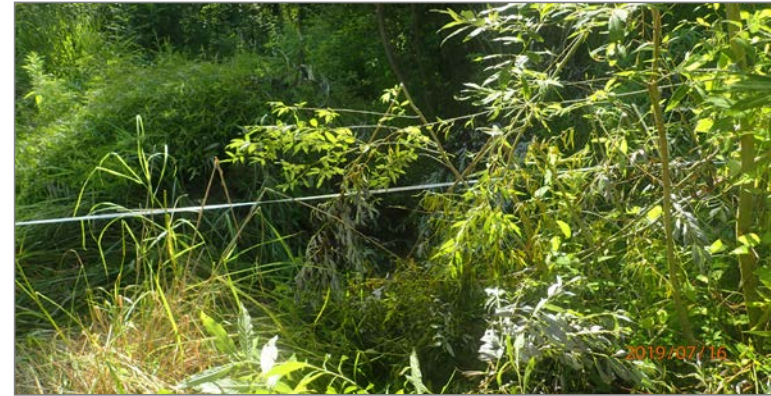
Site	Bobs Creek - UT 8
Project Number:	92879
XS ID	XS - 3, Riffle
Reach	UT 8
Date:	7/16/2019
Field Crew:	Perkinson, Lewis

SUMMARY DATA	
Bankfull Elevation:	1230.3
Bankfull Cross-Sectional Area:	8.8
Bankfull Width:	9.0
Flood Prone Area Elevation:	1232.2
Flood Prone Width:	100.0
Max Depth at Bankfull:	1.9
Low Bank Height:	2.1
Mean Depth at Bankfull:	1.0
W / D Ratio:	9.2
Entrenchment Ratio:	11.1
Bank Height Ratio:	1.1

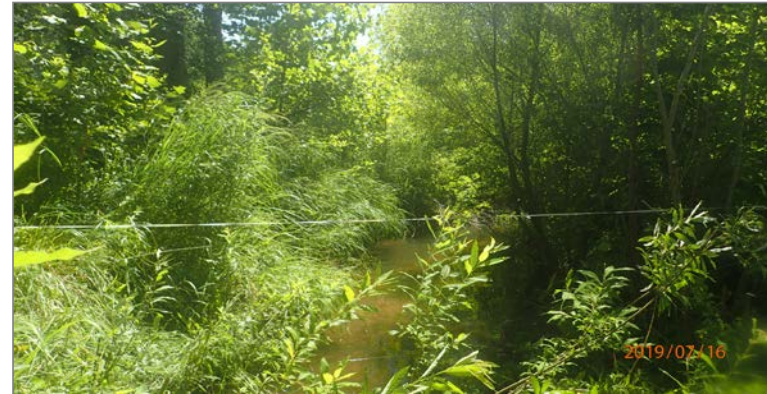
Site	Bobs Creek
Project Number:	92879
XS ID	XS - 4, Riffle
Reach	Bobs Creek
Date:	7/16/2019
Field Crew:	Perkinson, Lewis

SUMMARY DATA	
Bankfull Elevation:	1231.5
Bankfull Cross-Sectional Area:	20.7
Bankfull Width:	12.9
Flood Prone Area Elevation:	1233.9
Flood Prone Width:	150.0
Max Depth at Bankfull:	2.4
Low Bank Height:	2.9
Mean Depth at Bankfull:	1.6
W / D Ratio:	8.0
Entrenchment Ratio:	11.6
Bank Height Ratio:	1.2

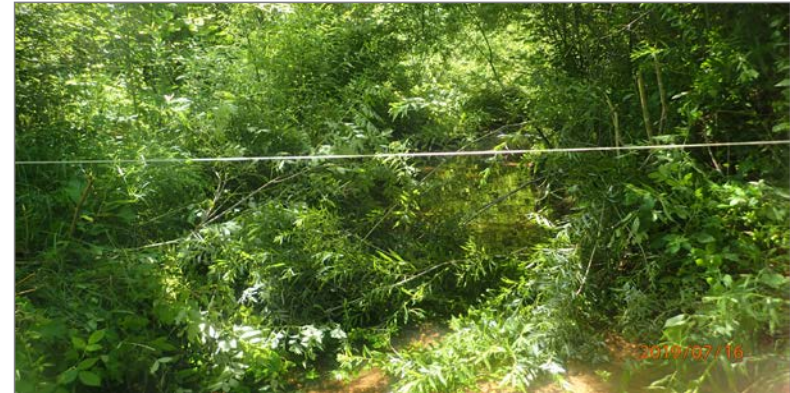
Site	Bobs Creek
Project Number:	92879
XS ID	XS - 5, Riffle
Reach	Bobs Creek
Date:	7/16/2019
Field Crew:	Perkinson, Lewis

SUMMARY DATA	
Bankfull Elevation:	1232.7
Bankfull Cross-Sectional Area:	25.2
Bankfull Width:	15.3
Flood Prone Area Elevation:	1235.0
Flood Prone Width:	150.0
Max Depth at Bankfull:	2.3
Low Bank Height:	2.6
Mean Depth at Bankfull:	1.6
W / D Ratio:	9.3
Entrenchment Ratio:	9.8
Bank Height Ratio:	1.1

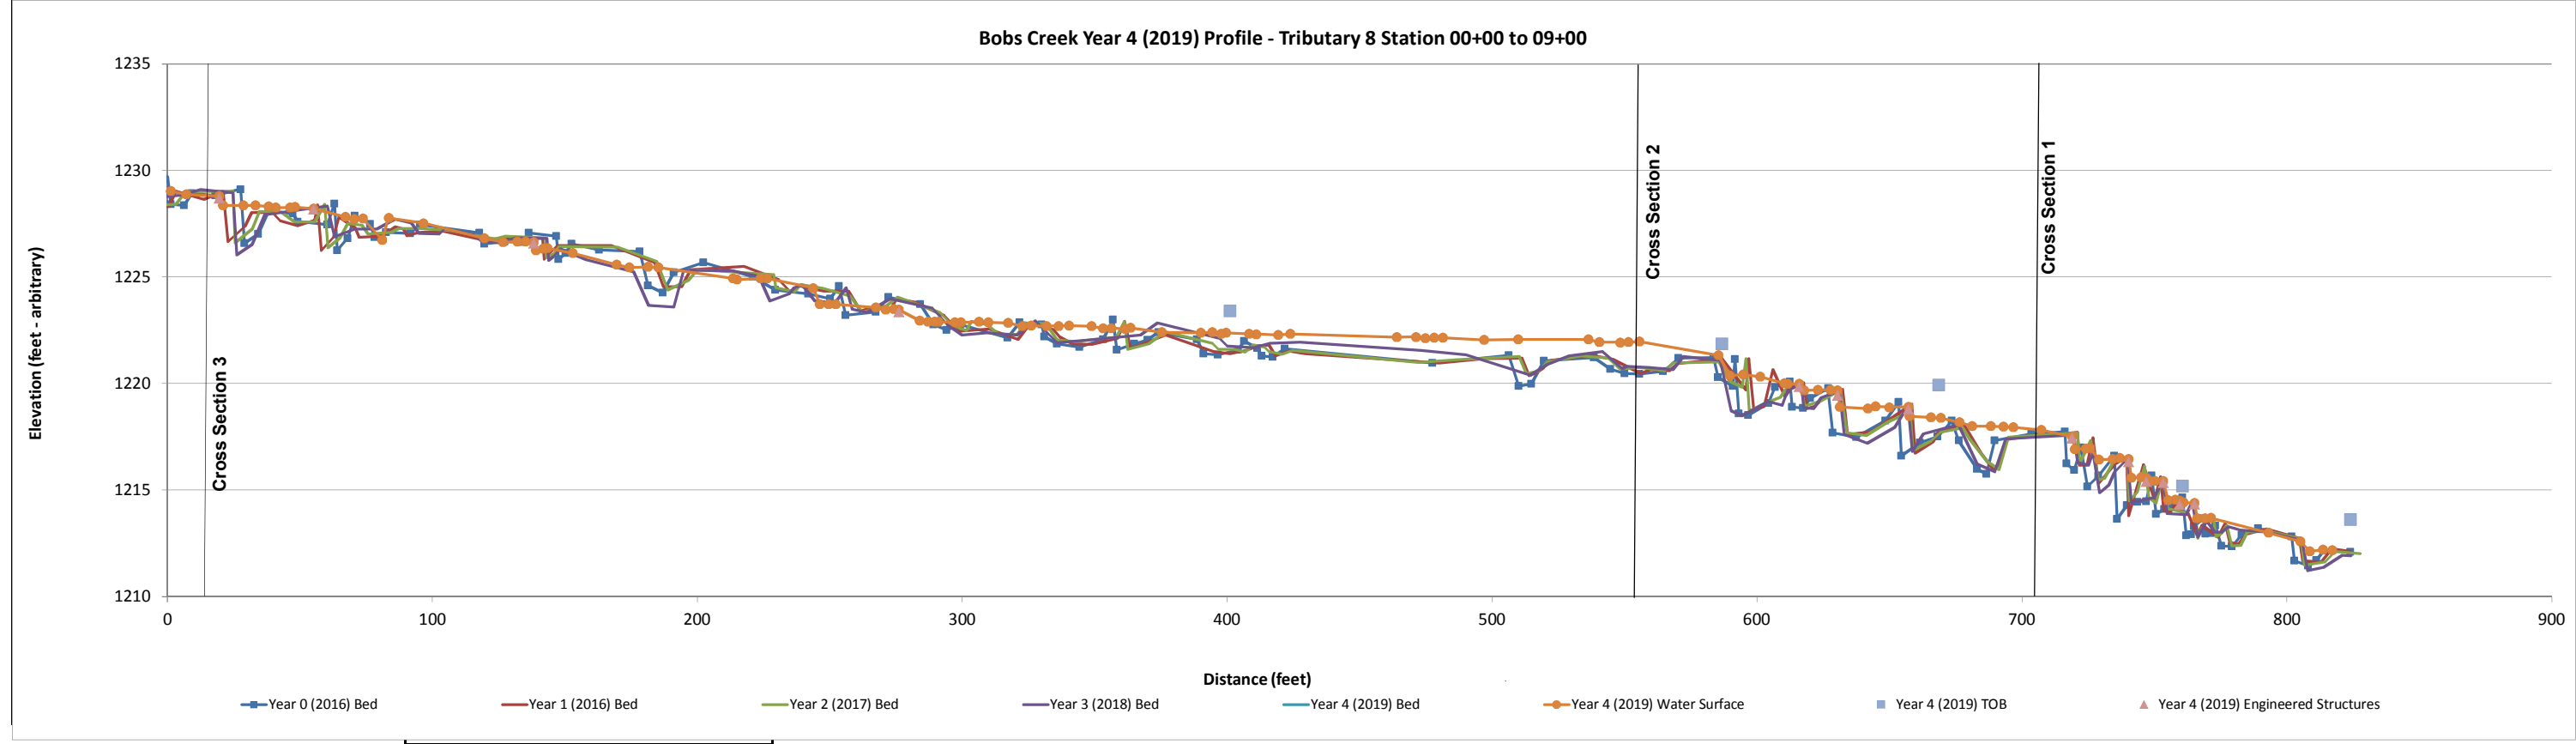
Project Name Bobs Creek - Profile
Reach UT 8 Station 00+00 - 09+00
Feature Profile
Date 7/16/19
Crew Perkinson, Radecki

2016	2016	2017	2018	2019
Avg. Water Surface Slope	0.0212	0.0210	0.0211	0.0223	0.0206
Riffle Length	17	20	17	16	18
Avg. Riffle Slope	0.0172	0.0175	0.0132	0.0195	0.0166
Pool Length	15	13	12	17	12
Pool to Pool Spacing	26	28	26	30	26

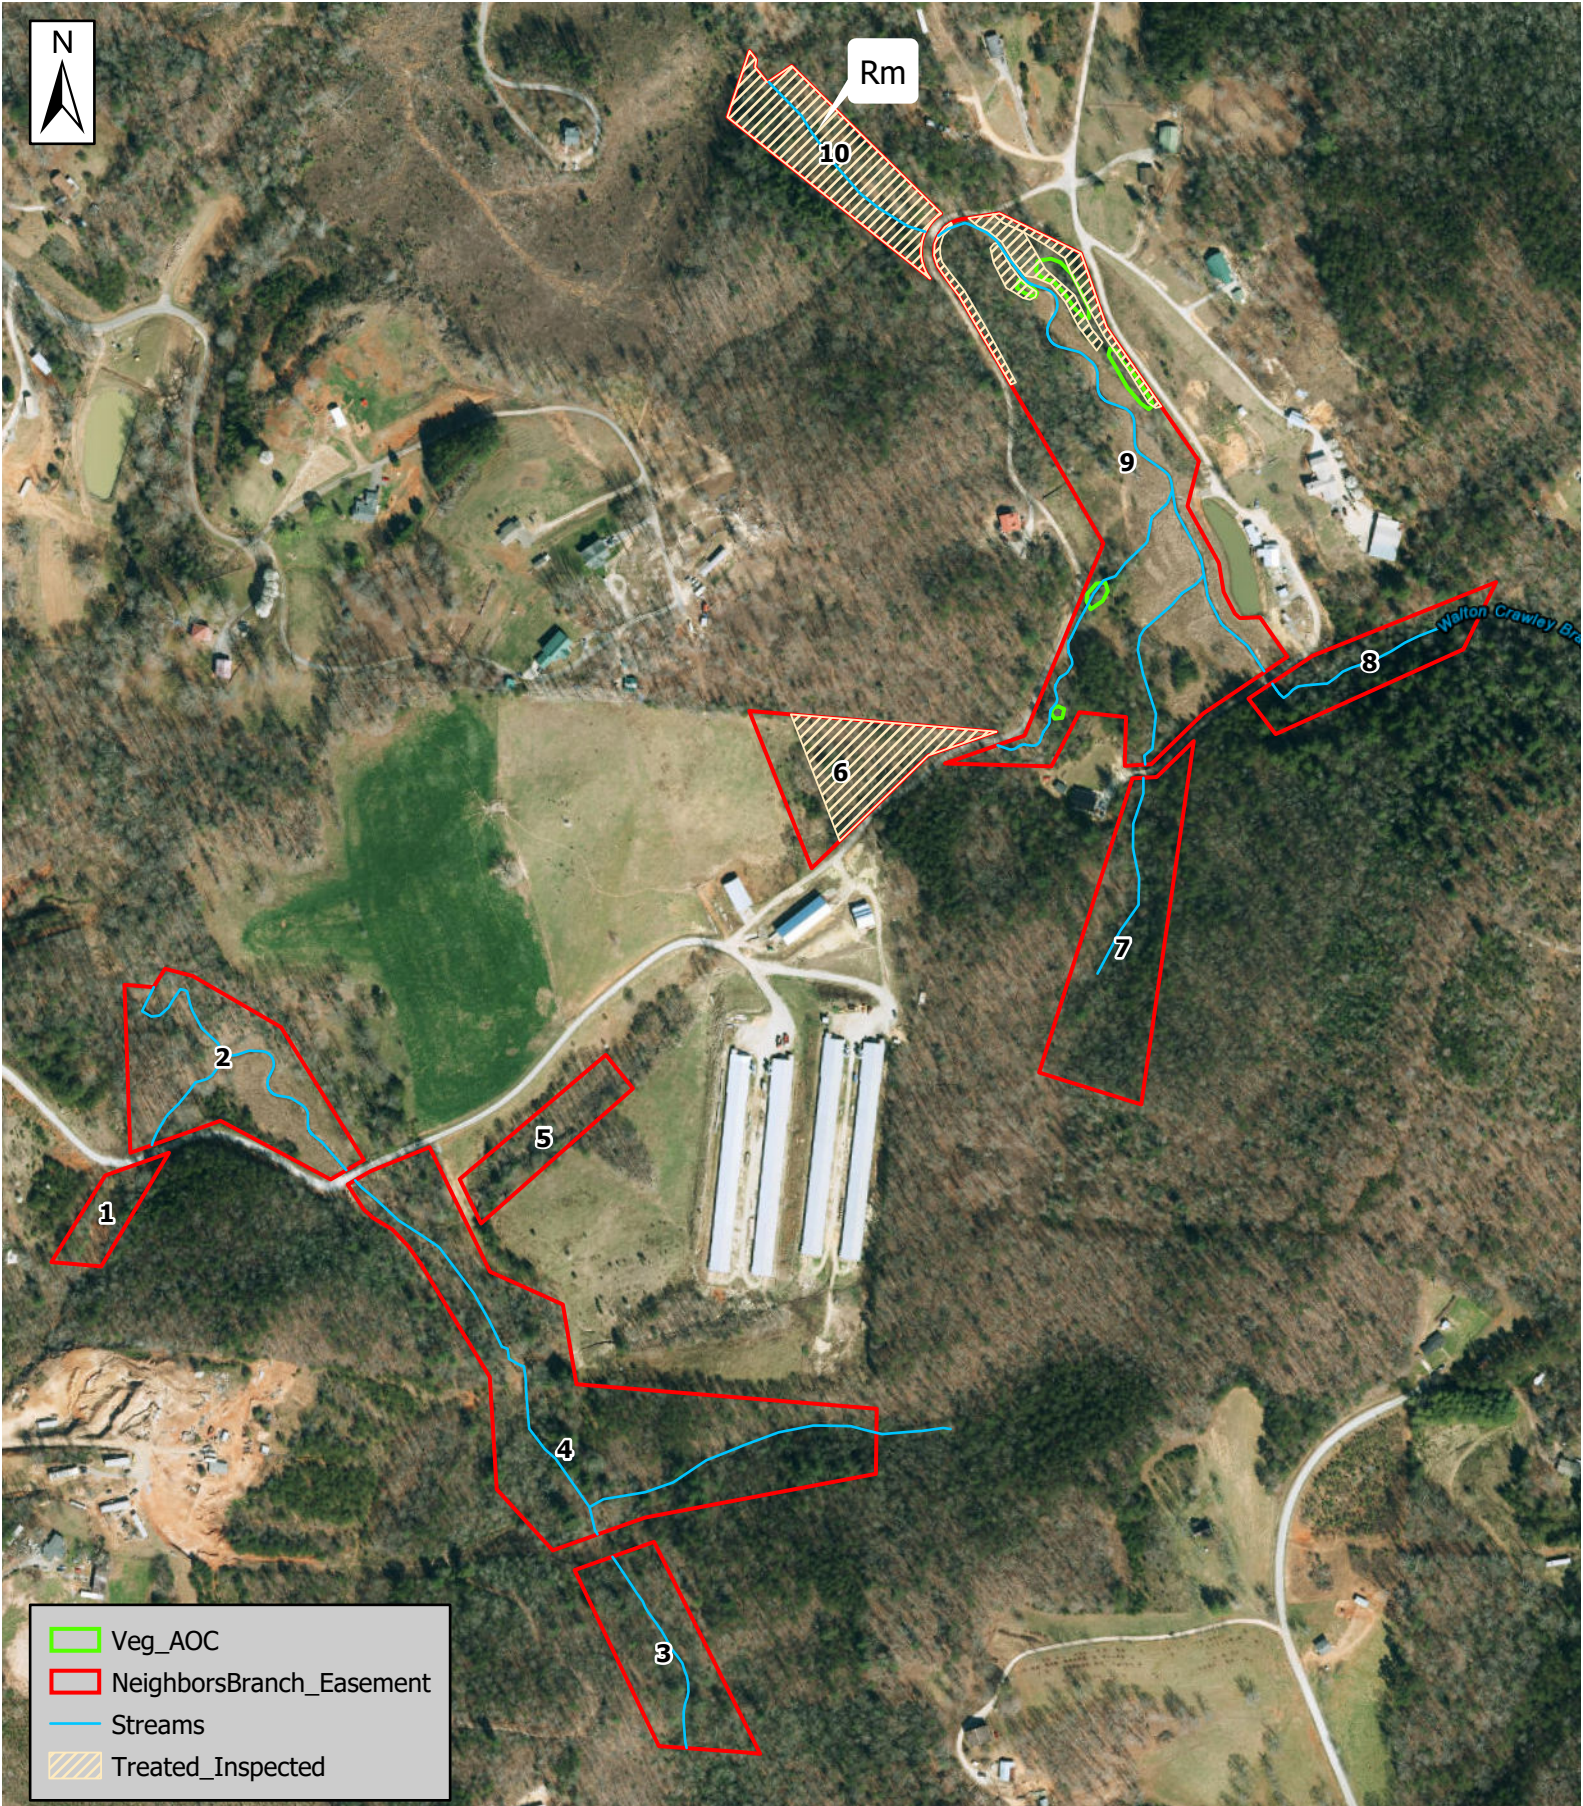
A kudzu patch along the road between polygon 9 and 10 was foliar sprayed using 4% triclopyr (Element 3A). The patch extends uphill towards the private residence and was sprayed along the eastern side of the road up to the point where the easement diverges from the gravel road. Polygon 10 was inspected and only two small stems of multi-flora rose were found and stump treated using 50% glyphosate.

Hack and squirt and cut stump application continued in polygon 6 on *Ailanthus*. Approximately $\frac{3}{4}$ of the stems have been treated. Some stems remain untreated towards the uphill part of the polygon.

In total 8 gallons of 3% glyphosate, 4 gallons of 4% triclopyr, and 21 ounces of 50% glyphosate were used.
