**FINAL**  
**YEAR 5 (2020) ANNUAL**  
**MONITORING REPORT**

**BOBS CREEK**  
**STREAM MITIGATION SITE**

NCDMS Project No. 92879  
Contract No. D09023S  
USACE Action ID No. SAW-2009-917 & NCDWR Project No. 10-0122  
SCO No. 08-07308-01  
McDowell County, North Carolina

Data Collection: May-November 2020  
Submission: January 2021

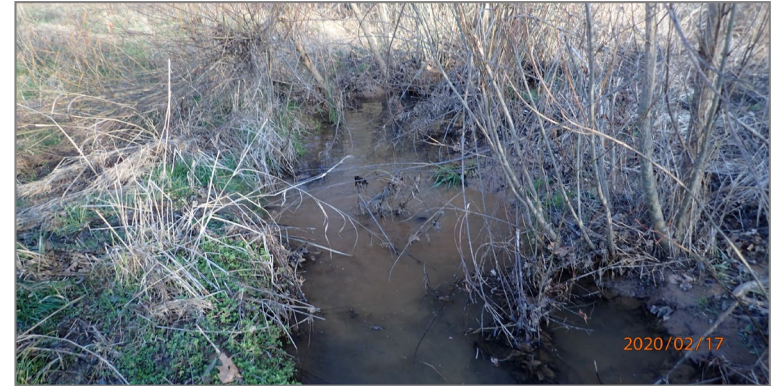
XS 2 Looking Upstream

SUMMARY DATA	
Bankfull Elevation:	1222.5
LTOB Elevation:	1222.5
Bankfull Cross-Sectional Area:	9.5
Bankfull Width:	20.9
Flood Prone Area Elevation:	NA
Flood Prone Width:	NA
Max Depth at Bankfull:	1.6
Low Bank Height:	1.6
Mean Depth at Bankfull:	0.5
W / D Ratio:	NA
Entrenchment Ratio:	NA
Bank Height Ratio:	1.0

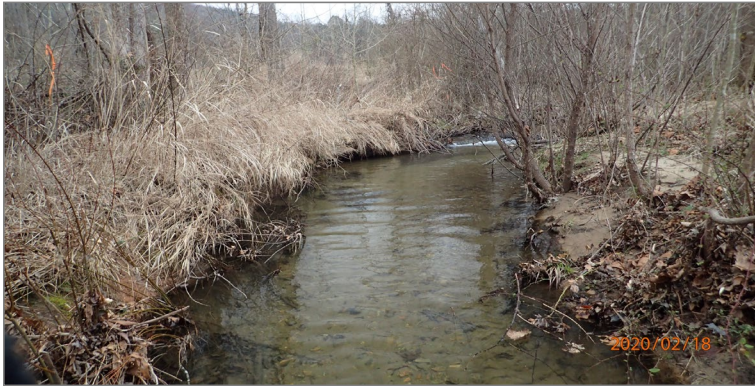
XS 4 Looking Upstream

<b>SUMMARY DATA</b>	
<b>Bankfull Elevation:</b>	1231.6
<b>LTOB Elevation:</b>	1231.5
<b>Bankfull Cross-Sectional Area:</b>	20.7
<b>Bankfull Width:</b>	12.7
<b>Flood Prone Area Elevation:</b>	1233.9
<b>Flood Prone Width:</b>	150.0
<b>Max Depth at Bankfull:</b>	2.3
<b>Low Bank Height:</b>	2.2
<b>Mean Depth at Bankfull:</b>	1.6
<b>W / D Ratio:</b>	7.8
<b>Entrenchment Ratio:</b>	11.8
<b>Bank Height Ratio:</b>	1.0

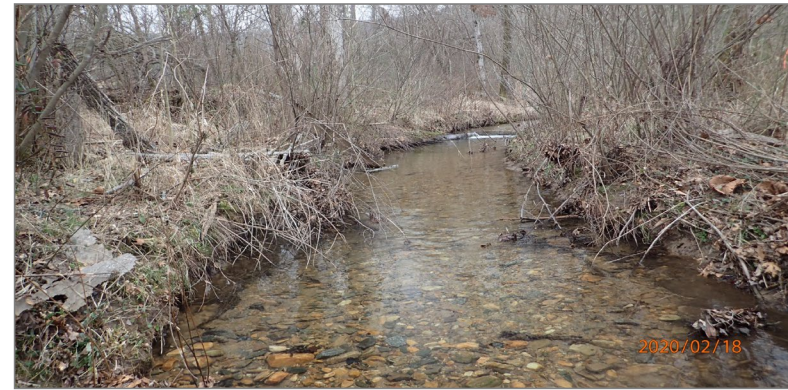
XS 5 Looking Upstream

SUMMARY DATA	
<b>Bankfull Elevation:</b>	1232.5
<b>LTOB Elevation:</b>	1232.5
<b>Bankfull Cross-Sectional Area:</b>	25.2
<b>Bankfull Width:</b>	13.8
<b>Flood Prone Area Elevation:</b>	1234.9
<b>Flood Prone Width:</b>	150.0
<b>Max Depth at Bankfull:</b>	2.4
<b>Low Bank Height:</b>	2.4
<b>Mean Depth at Bankfull:</b>	1.8
<b>W / D Ratio:</b>	7.6
<b>Entrenchment Ratio:</b>	10.9
<b>Bank Height Ratio:</b>	1.0

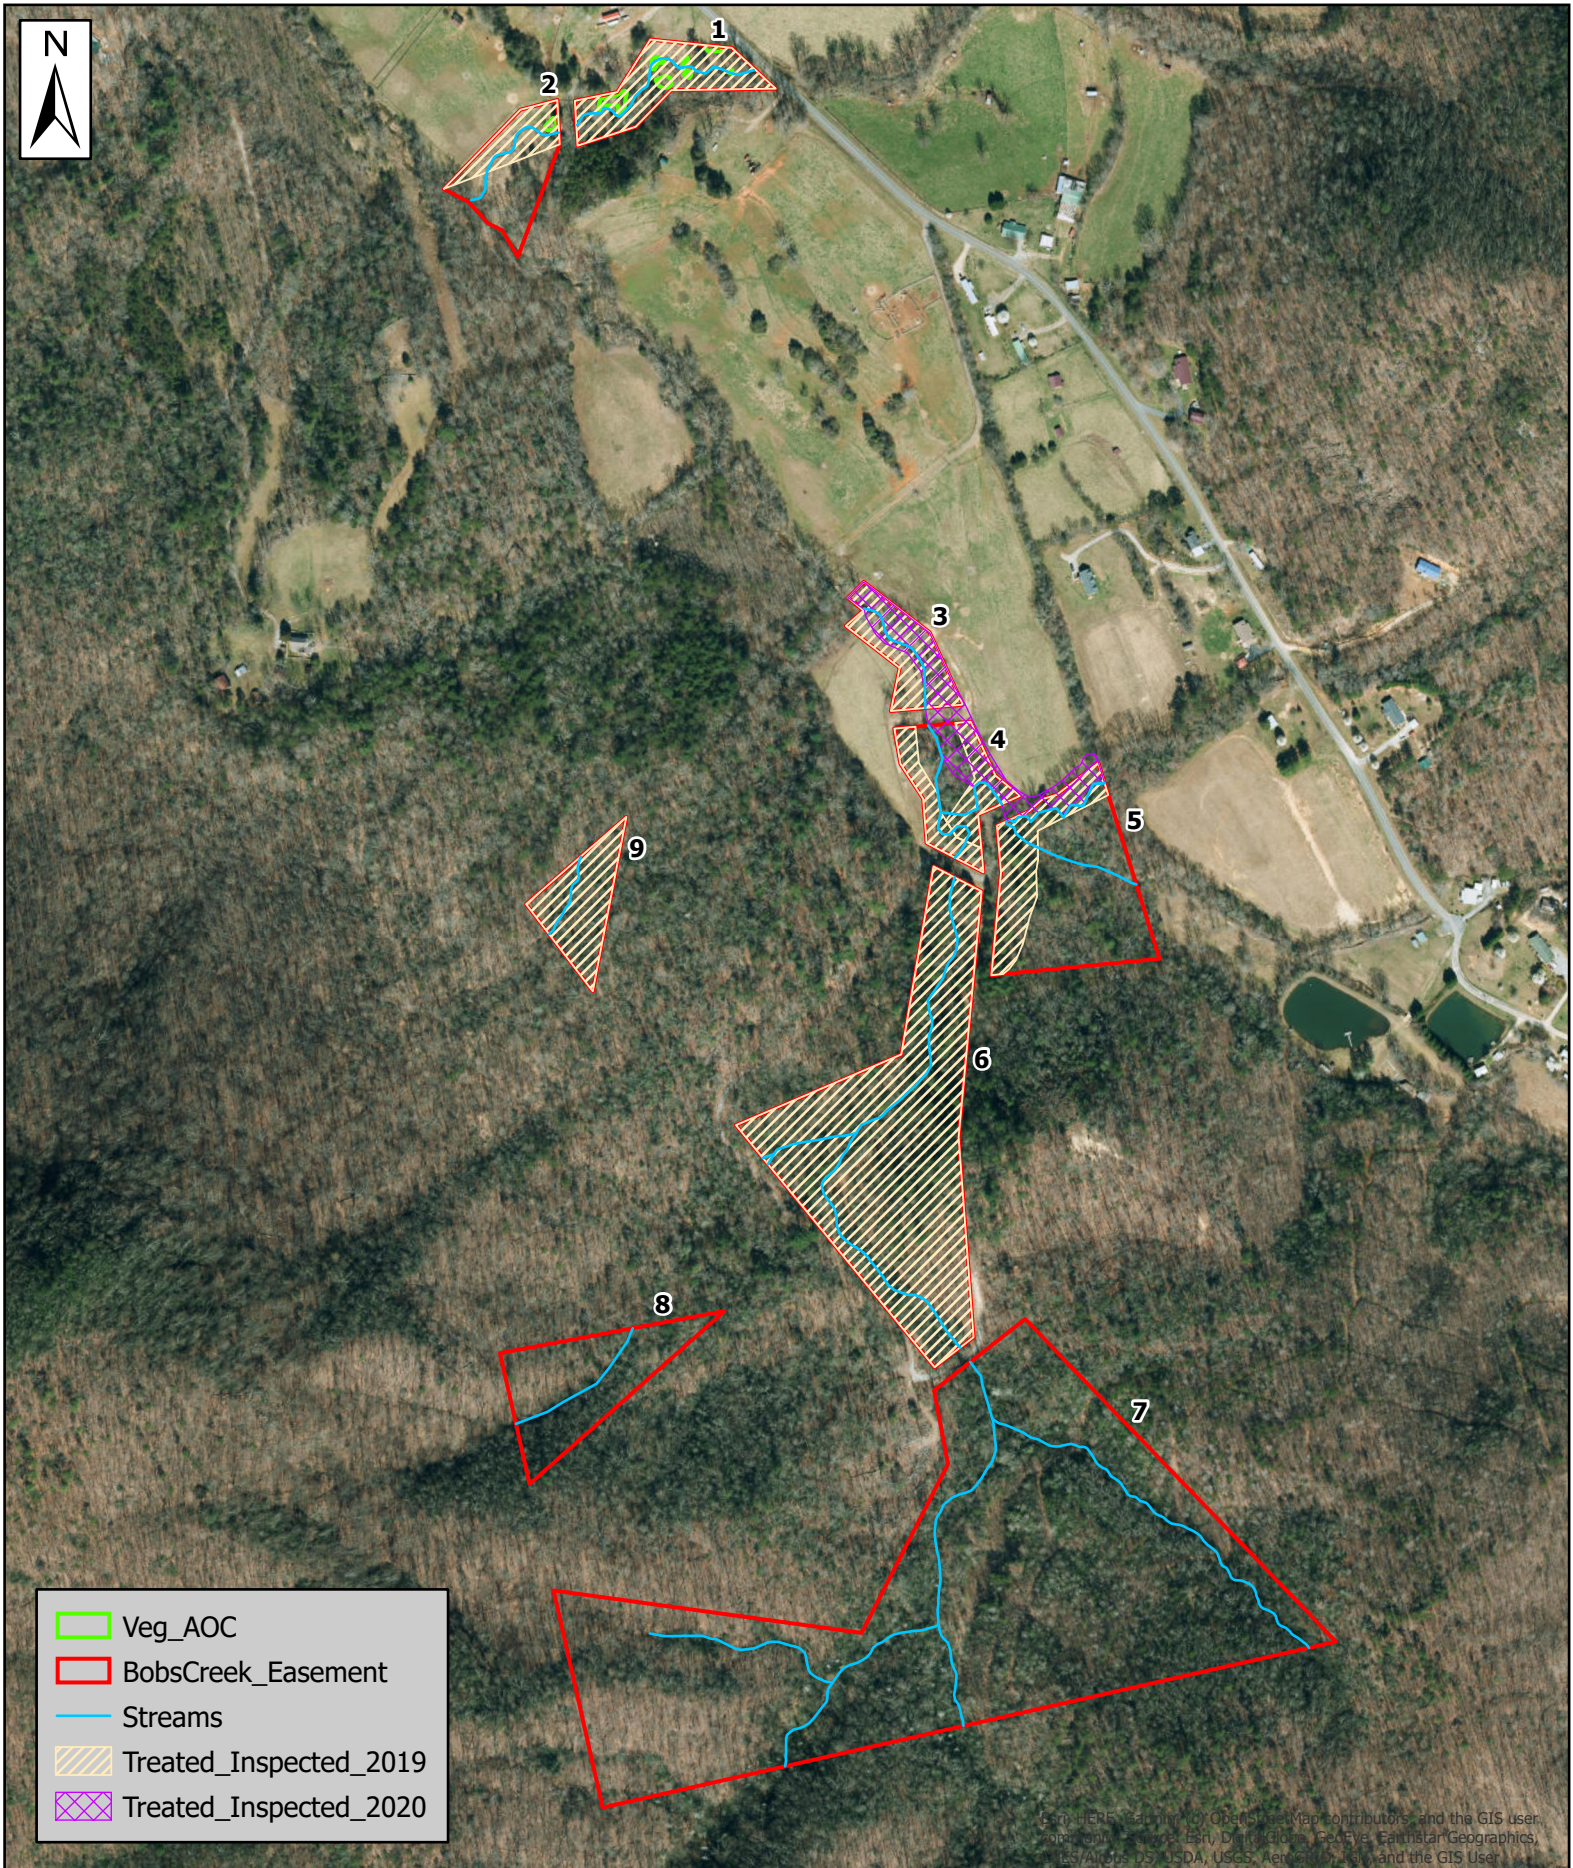
We next applied foliar spray at Bob's Creek along the mainstem and along the border of the easement in polygons 3, 4, and 5. Multi-flora rose was the main target species although some privet was encountered and sprayed. 8 gallons of 3% glyphosate was applied at Bob's Creek.
