ANNUAL MONITORING REPORT BOLD RUN

STREAM AND BUFFER RESTORATION WAKE COUNTY, NORTH CAROLINA (EEP Project Number 439)

Monitoring Year 2 of 5 (2008)

December 2008

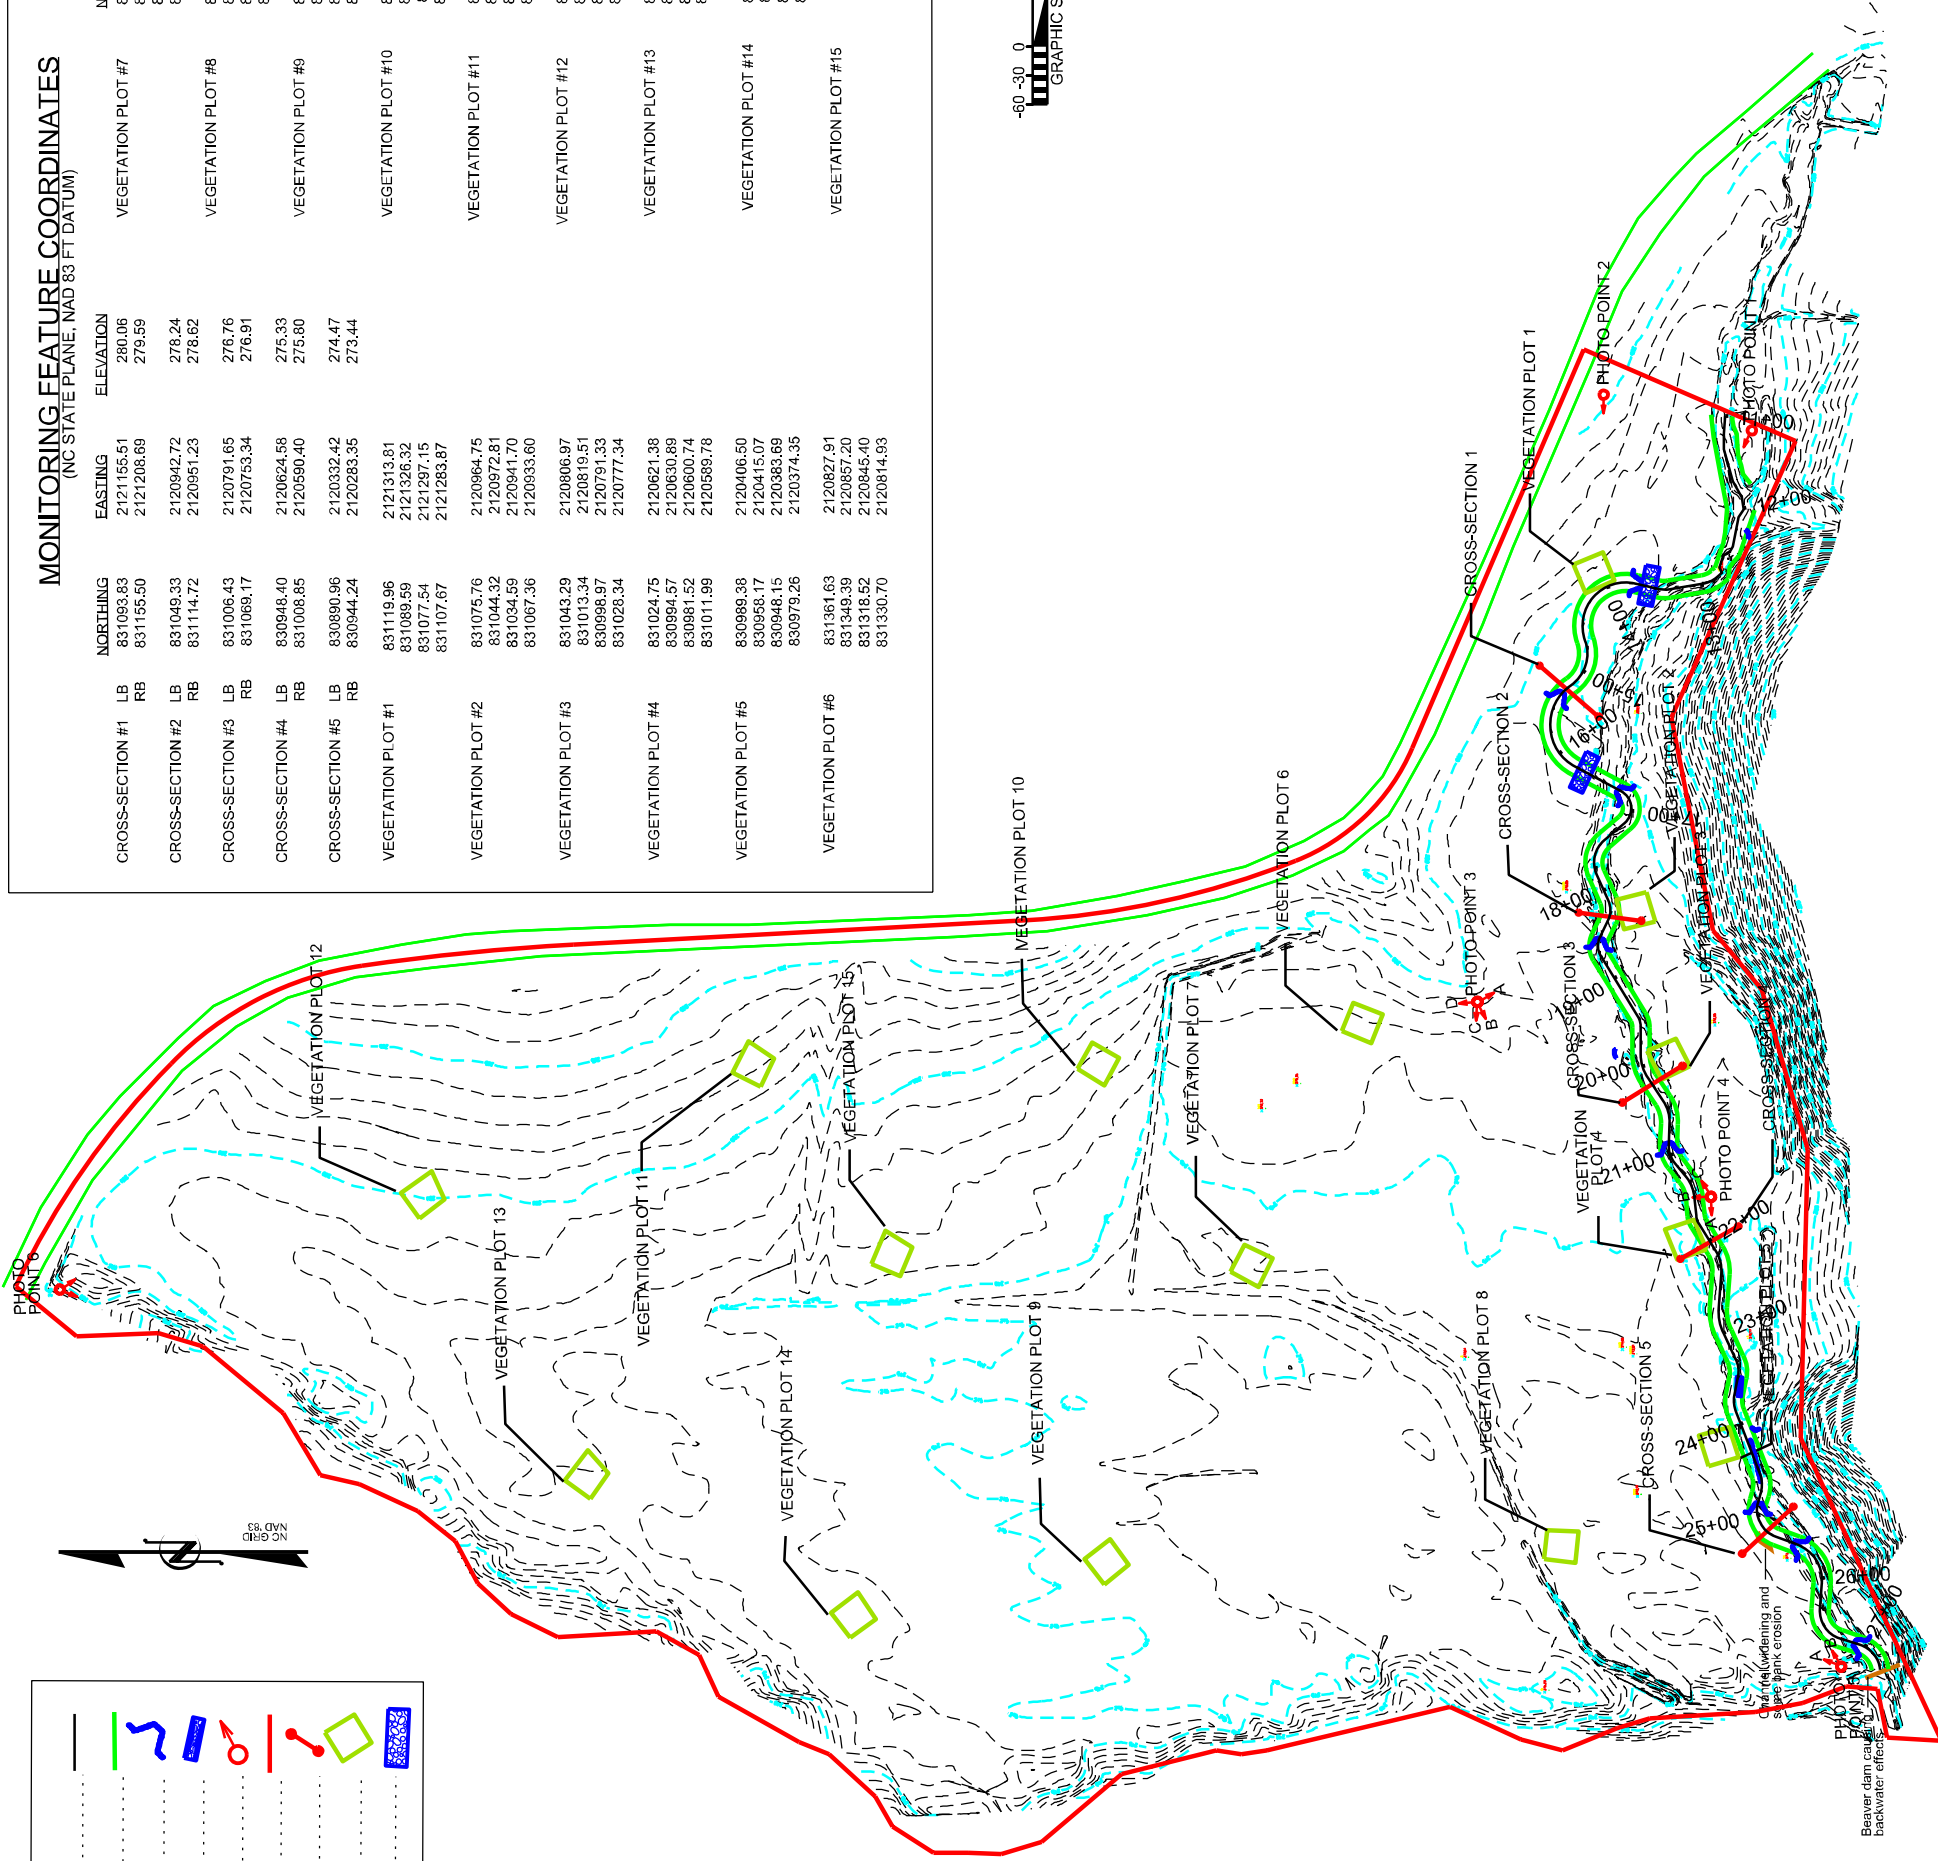
APPENDIX C
FIGURE C1. MONITORING PLAN VIEW

Stream problem areas documented within the Site during the year 2 (2008) monitoring year consisted of a large beaver dam at the downstream extent of the Site near the confluence with New Light Creek and an area of stream widening and bank erosion near cross-section 5. Beaver activity has resulted in backwater effects from the beaver dam. Proactive maintenance measures including the removal of existing beaver dams and beaver is recommended, as necessary. Stream problem areas are summarized in Table B1 and documented in photographs in Appendix B and are depicted in Figure C1 in Appendix C.
