ANNUAL MONITORING REPORT BOLD RUN

STREAM AND BUFFER RESTORATION WAKE COUNTY, NORTH CAROLINA (EEP Project Number 439)

Monitoring Year 4 of 5 (2010)

February 2011

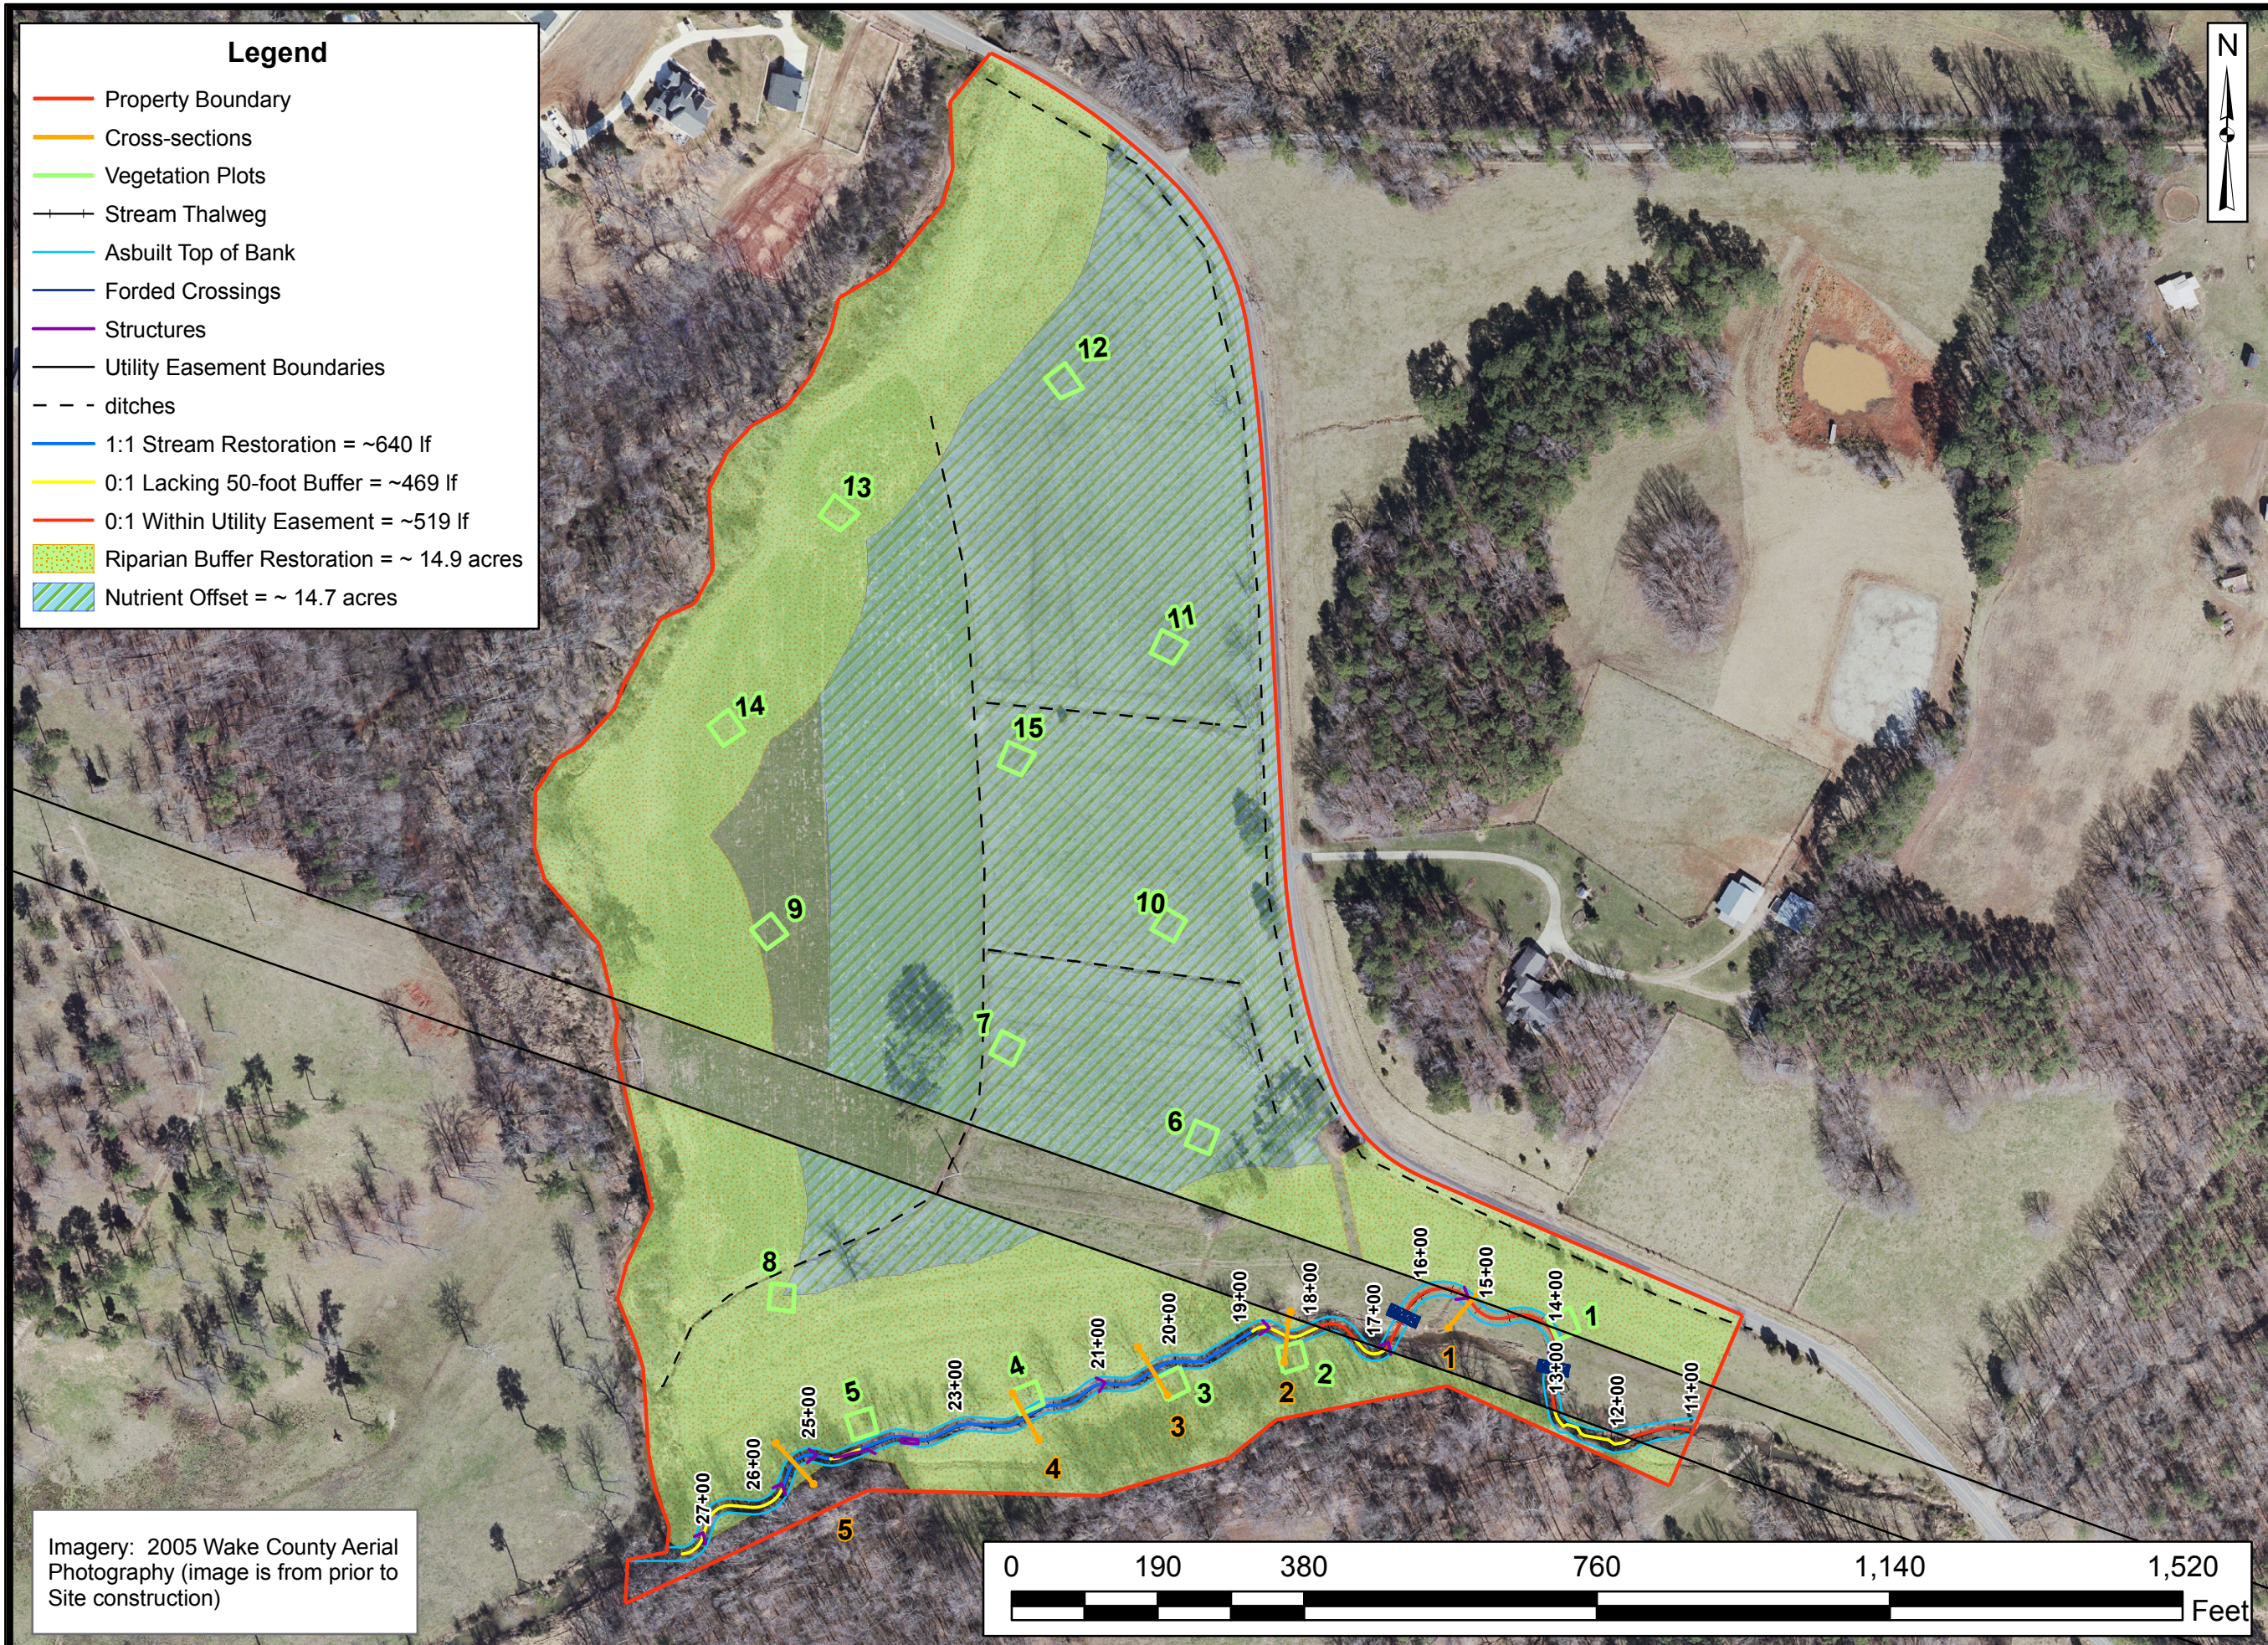
CURRENT CONDITIONS PLAN VIEW

In summary, the Site achieved success criteria for vegetation and stream attributes in the Fourth Monitoring Year (2010). Summary information and data related to the occurrence of items such as beaver or encroachment and statistics related to performance of various project and monitoring elements can be found in table and figures within this report's appendices. Narrative background and supporting information formerly found in these reports can be found in the mitigation and restoration plan documents available on EEPs website. All raw data supporting the tables and figures in the appendices is available from EEP upon request.
