# Monitoring Report Year 2

**Bowman**  
**(Mt. Pleasant Creek Restoration Project)**  
**DMS Project Number 44**  
**401: DWR 07-2252v2**  
**404: SAW-2008-01382**

**Randolph County, North Carolina**

**Monitoring Data Collected: July-October 2018**

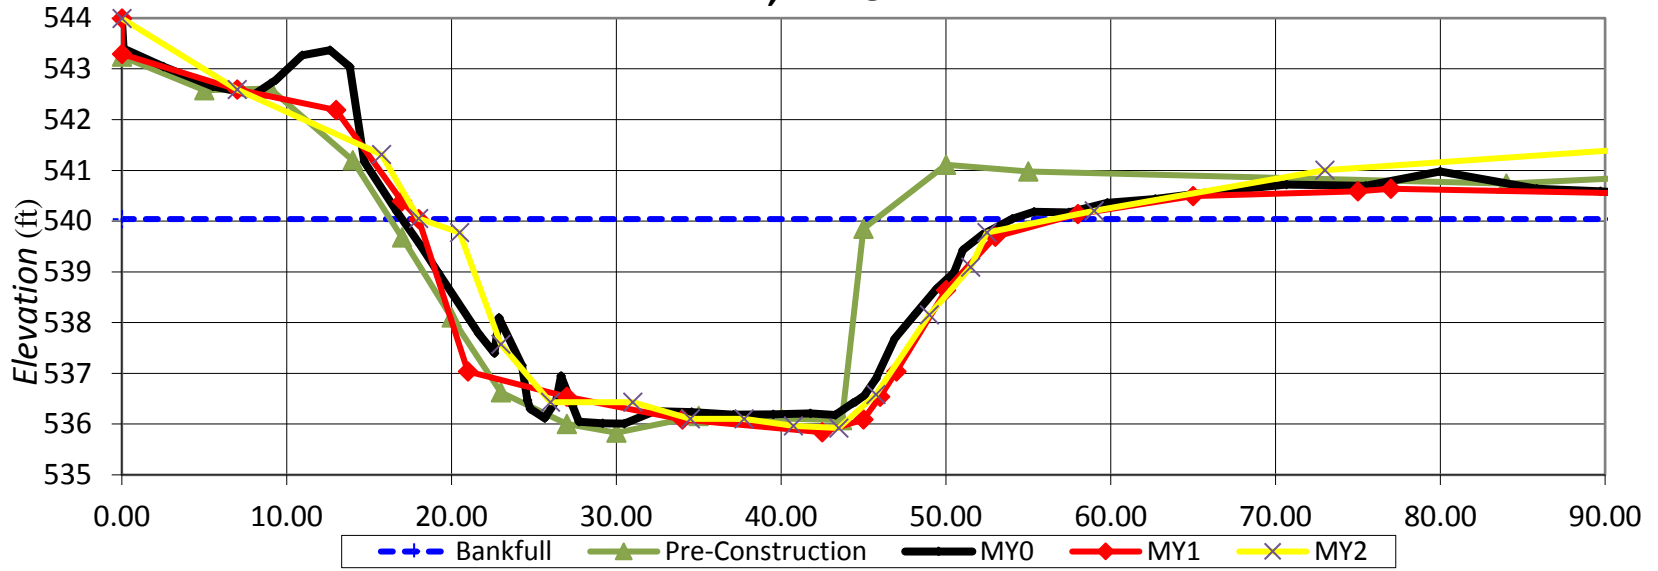
### Bowman Site, Cape Fear River Basin X4, Riffle

Dimension and Substrate	Cross-Section 4 (Riffle), Station 17+25						
	Pre	Base	MY1	MY2	MY3	MY4	MY5
Based on fixed baseline elevation							
Bankfull Width (ft)	28	37.4	40.0	41.0			
Floodprone Width (ft)	>100	>100	>100	>100			
Bankfull Mean Depth (ft)	3	2.9	2.8	2.5			
Bankfull Max Depth (ft)	3.9	4.2	4.2	4.1			
Bankfull Cross-Sectional Area (ft <sup>2</sup> )	83.5	109.5	111.1	102.0			
Bankfull Width/Depth Ratio	9.4	12.8	14.4	16.5			
Bankfull Entrenchment Ratio	1.1	3.3	3.1	3.0			
Bankfull Bank Height Ratio	1.4	1.1	1.1	0.8
