**MONITORING YEAR 3, 4, AND 5 REPORT**  
**BOWLIN-PEAK CREEK MITIGATION SITE**

Ashe County, North Carolina

EEP Project Number: 92606  
Contract Number: D06082; Task Order: 06NW01-1

Period Covered: July 2009 - June 2012

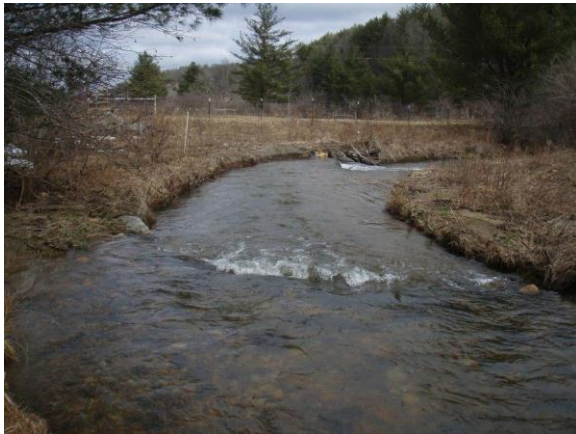
The log cross-vane at site SPA MY4-2 and the eroding left stream bank at site SPA MY3&4-3 have yet to stabilize. However, these issue areas represent approximately 1% of the total bank footage and the impact associated with repairs involving heavy equipment is not warranted.

SPA MY3&4-3, eroding left bank:  
14 Mar 10.

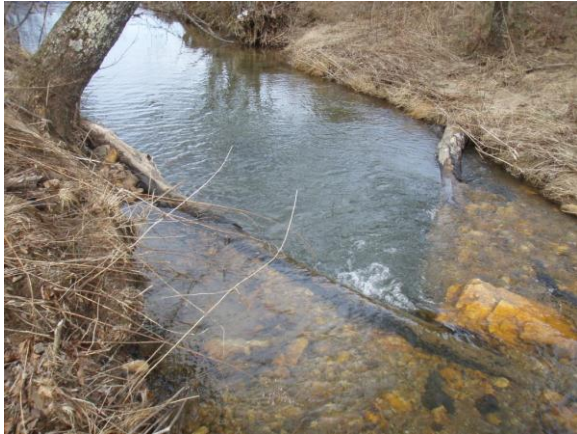
One additional medium priority problem area was identified in MY4 and subsequently in MY5. The log cross vane at station 6+47 located downstream of the beaver dam (Appendix B Section 1: photo SPA MY4-2) was damaged after a winter 2010 storm event. It is suspected that water falling over the dam had greater stream power, moved larger substrate in the stream channel, deepened the stream channel below the log cross vane and resulted in water piping under the right vane arm. The right stream bank only migrated 0.5ft since MY3 and appears stable.

SPA MY4-2, piping under right vane arm, 3 Feb 11

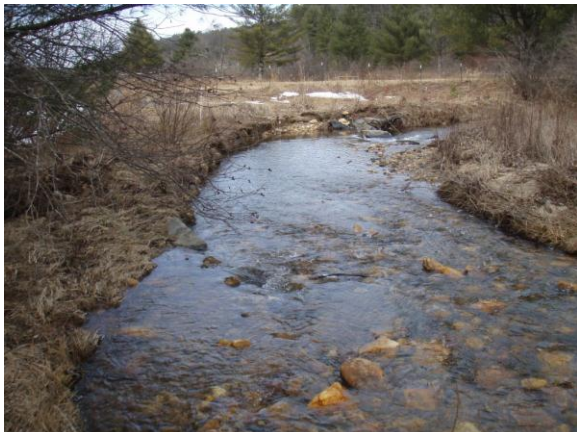
SPA MY4-3, eroding left bank, 3 Feb 11.

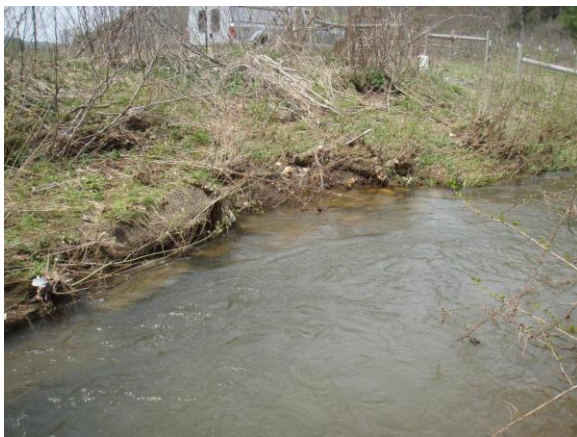
SPA MY4-5, eroding left bank, 19 Apr 11.

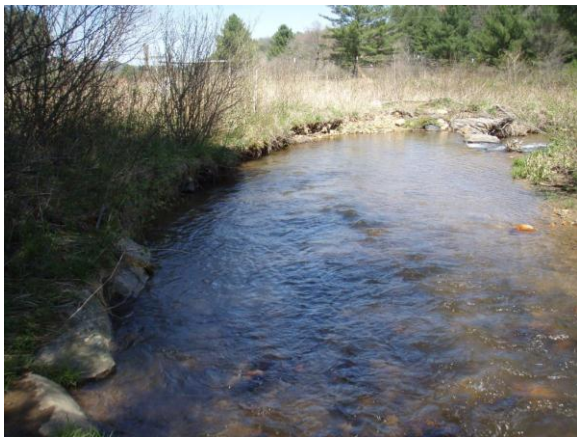
SPA MY5-2, eroding left bank, 9 Apr 12.

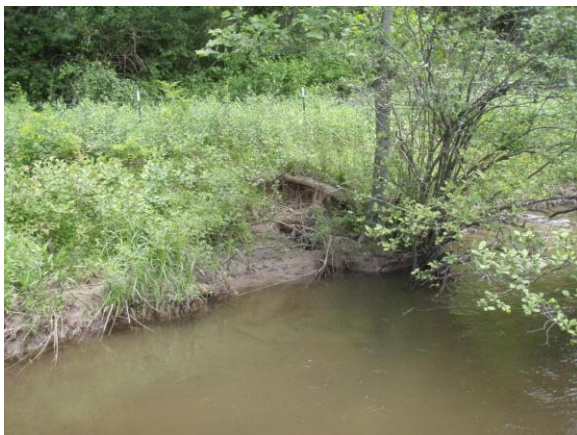
SPA MY5-5, eroding right bank from beaver activity, 21 May 12.

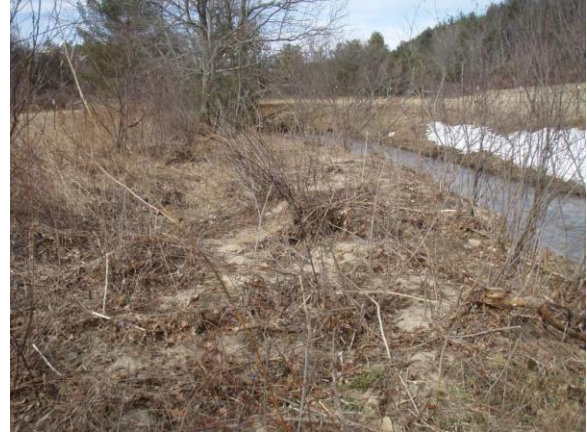
BF2, sediment and rack line on top of  
bankfull bench: 03 Feb 11.
