MY2 MONITORING REPORT

BRAHMA SITE

Alamance County, North Carolina

DMS Project No. 100092

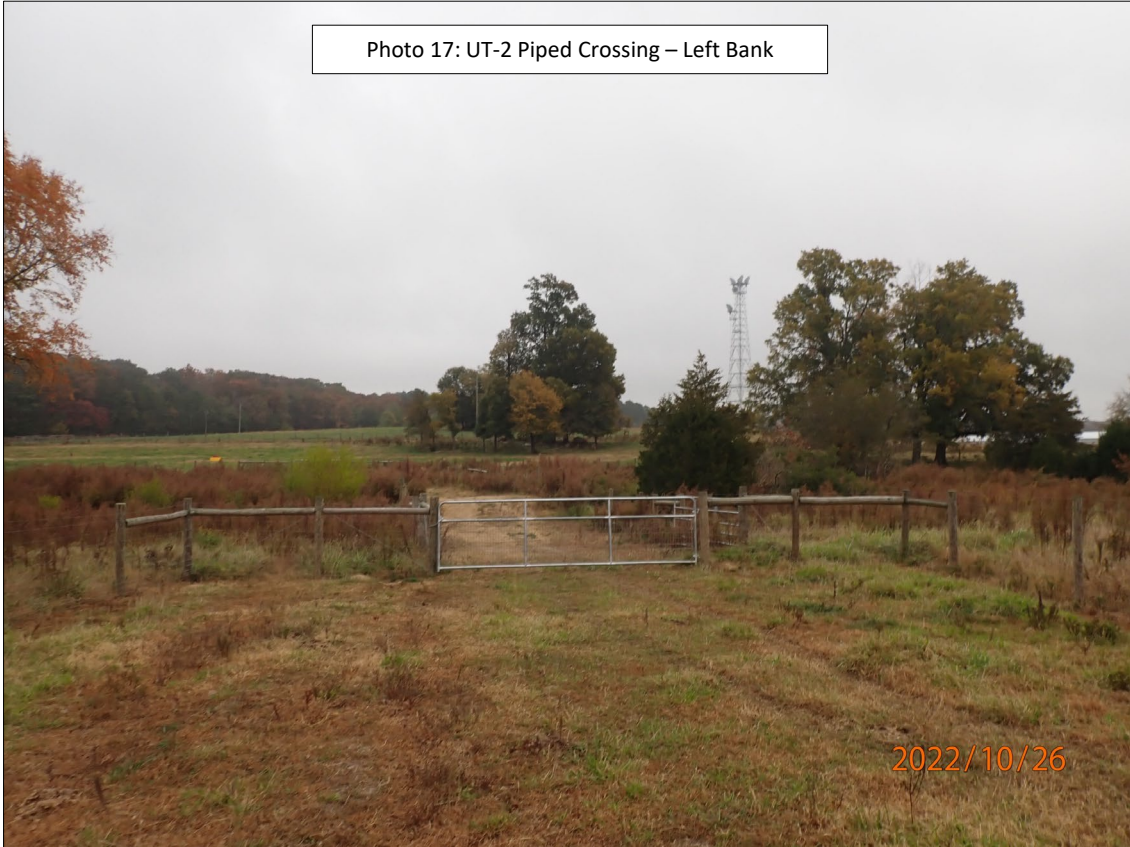
Photo 17: UT-2 Piped Crossing – Left Bank
