Briles Stream Restoration Monitoring Report Year 3 of 5 (2011) FINAL

Randolph County, North Carolina

Project ID No. 047

Submitted November 2011

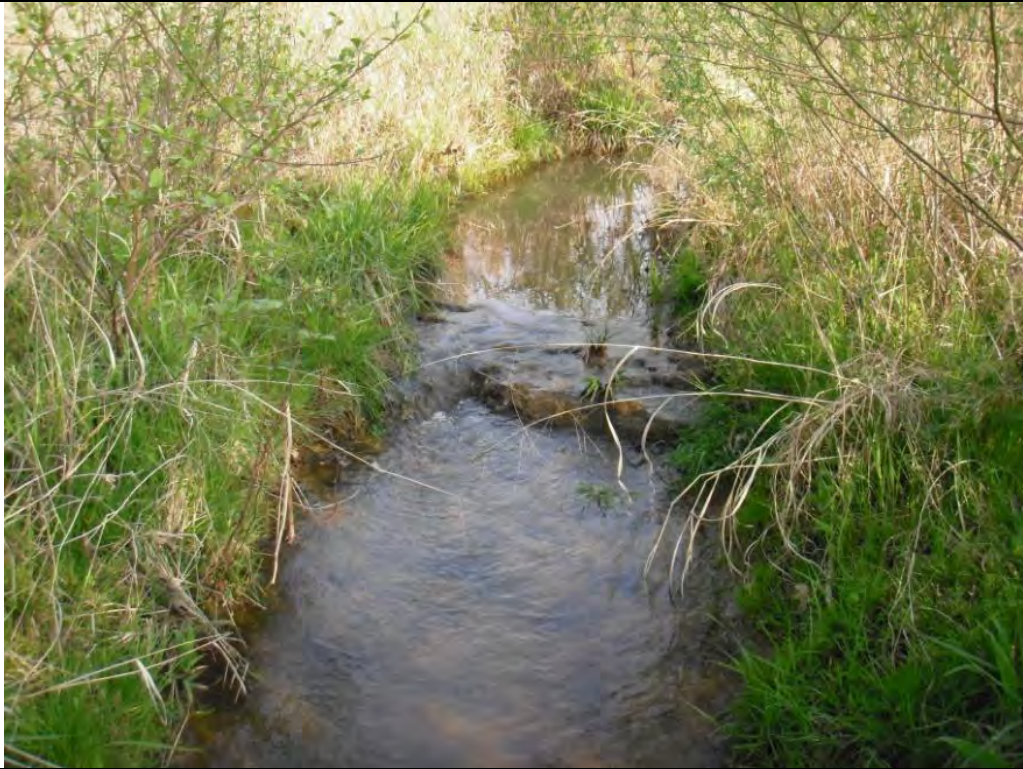
SP2: Head cut at STA 15+25
Taken: April 2011

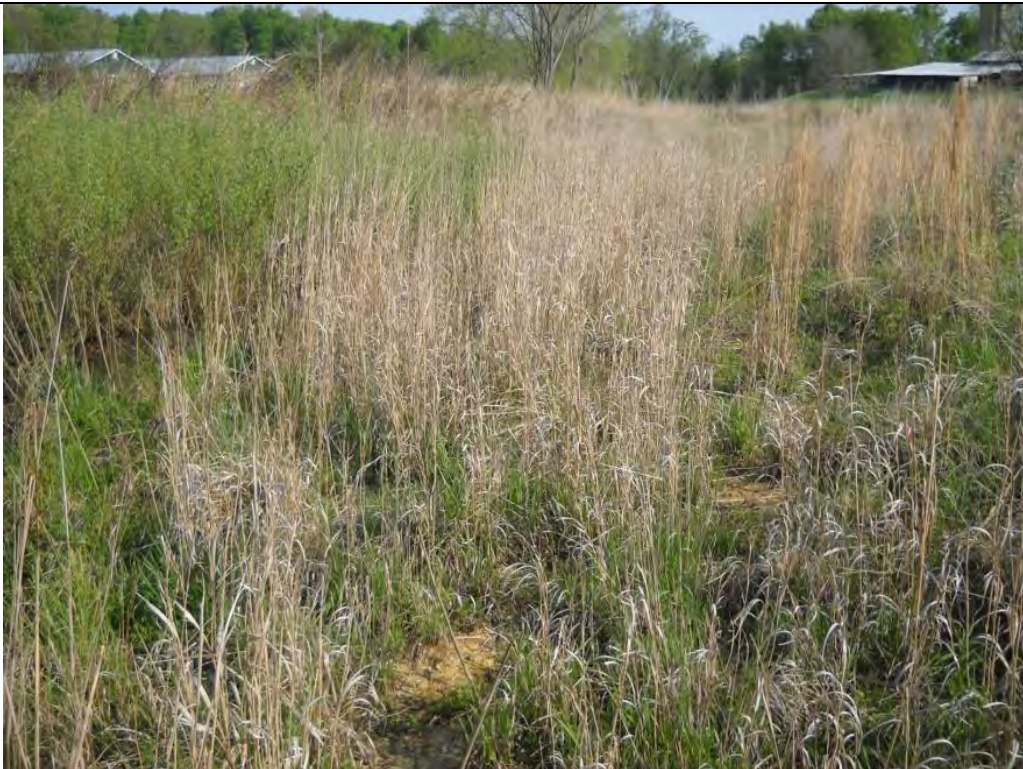
VP1: Weak woody stem growth on Reach UTJC1
Taken: April 2011

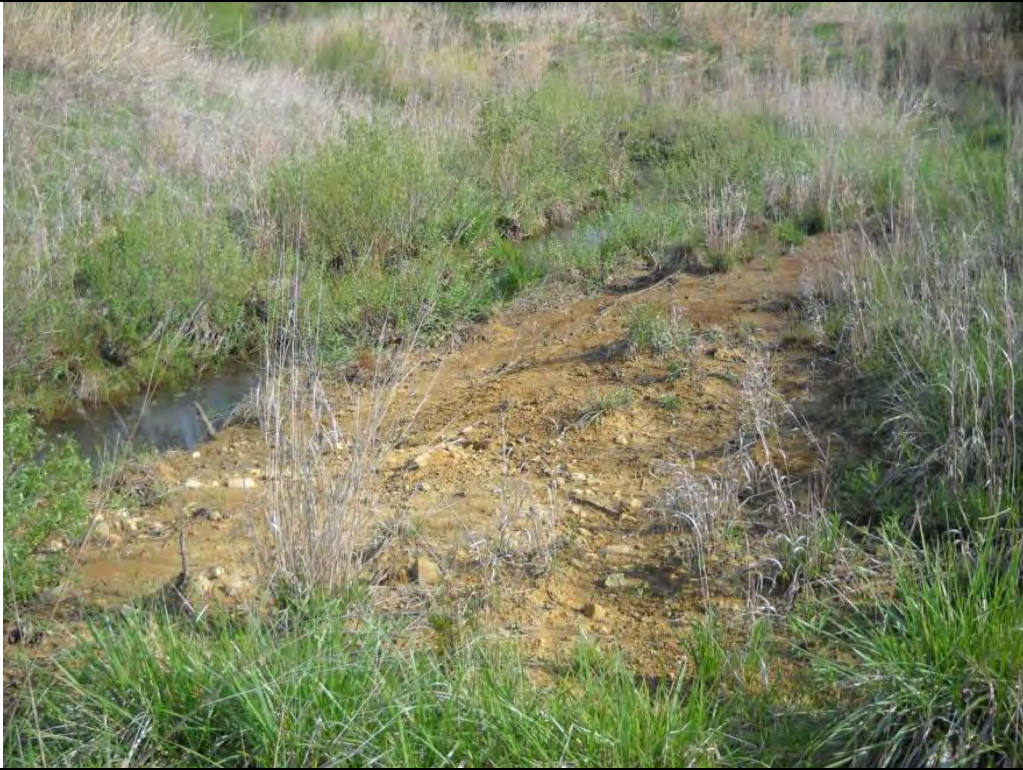
VP2: Bare bench on Reach UTJC1 (STA 20+00)
Taken: April 2011
