FINAL
ANNUAL MONITORING REPORT
YEAR 5 (2013)
BRILES STREAM RESTORTION SITE
RANDOLPH COUNTY, NORTH CAROLINA
(EEP Project No. 047, Contract No. 004809)
Construction Completed November 2007

January 2014

Prepared by:
Axiom Environmental, Inc.
218 Snow Avenue
Raleigh, North Carolina 27603

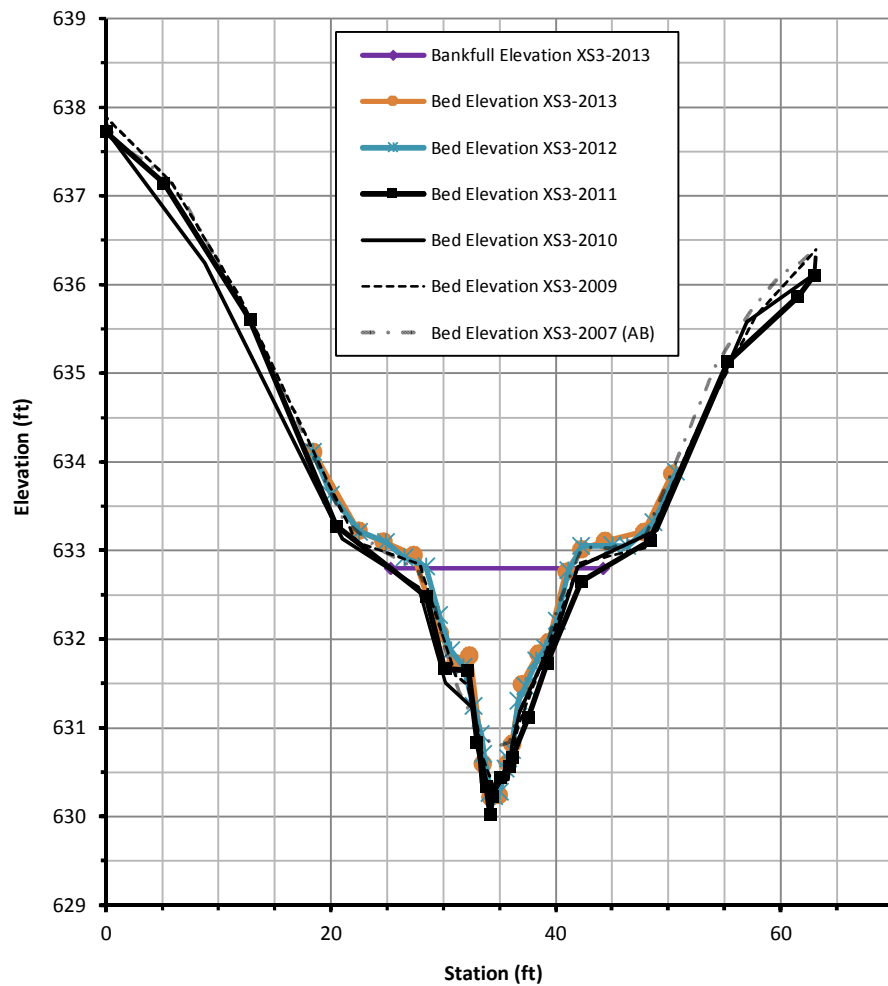
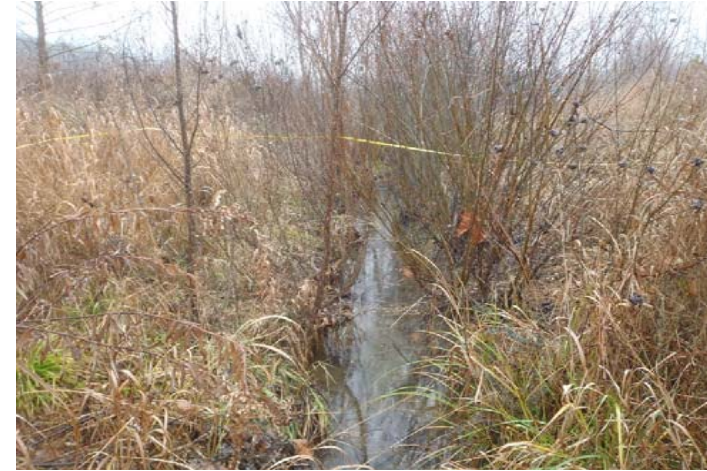
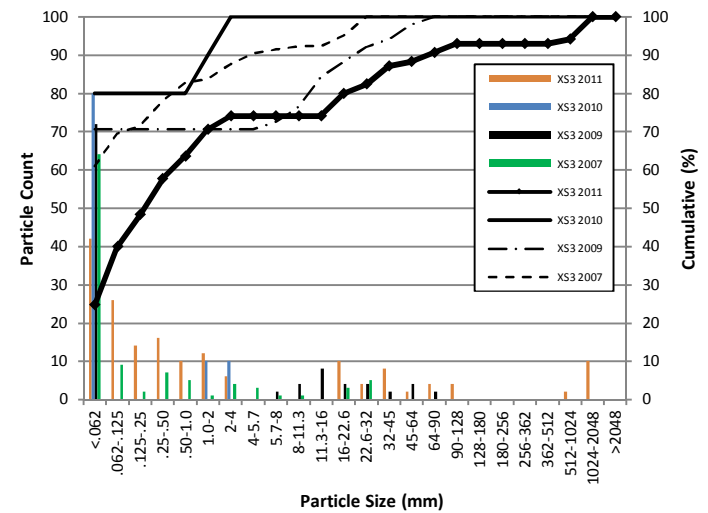
ID	Year	Phase	Facet Type	Wbkf	Abkf	Dbkf
XS3	2007	AB	Pool	14.2	16.2	1.1
XS3	2009	MY1	Pool	14.1	17.9	1.3
XS3	2010	MY2	Pool	13.6	16	1.2
XS3	2011	MY3	Pool	18.9	19.7	1
XS3	2012	MY4	Pool	12.9	16.1	1.3
XS3	2013	MY5	Pool	13.5	16.2	1.2

ID	Year	Phase	d50(mm)	d84(mm)
XS3	2007	AB	--	1.05
XS3	2009	MY1	--	11.2
XS3	2010	MY2	0.04	1.4
XS3	2011	MY3	0.3	36.6
XS3	2012	MY4	--	--
XS3	2013	MY5	--	--

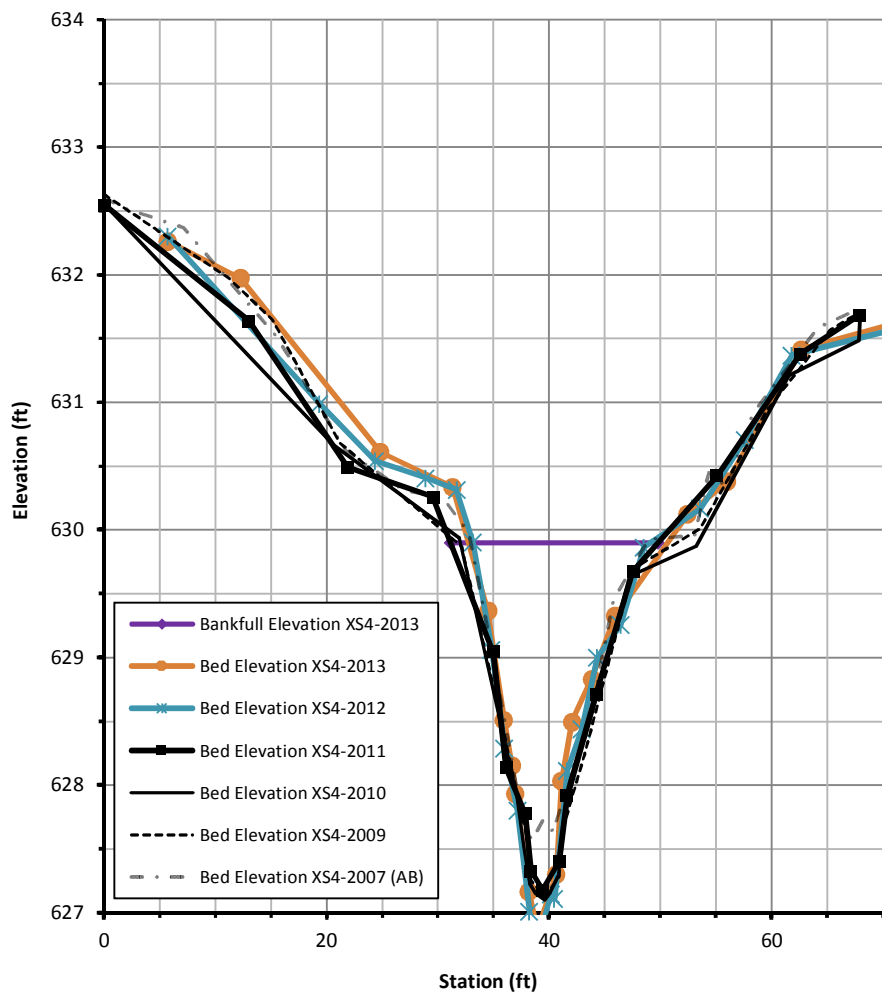
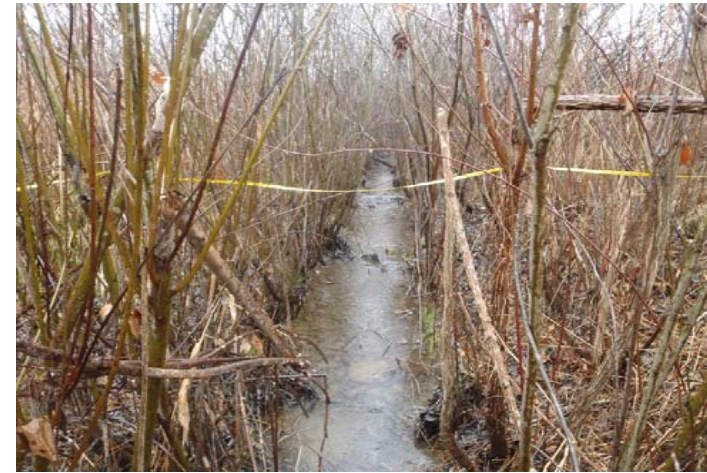
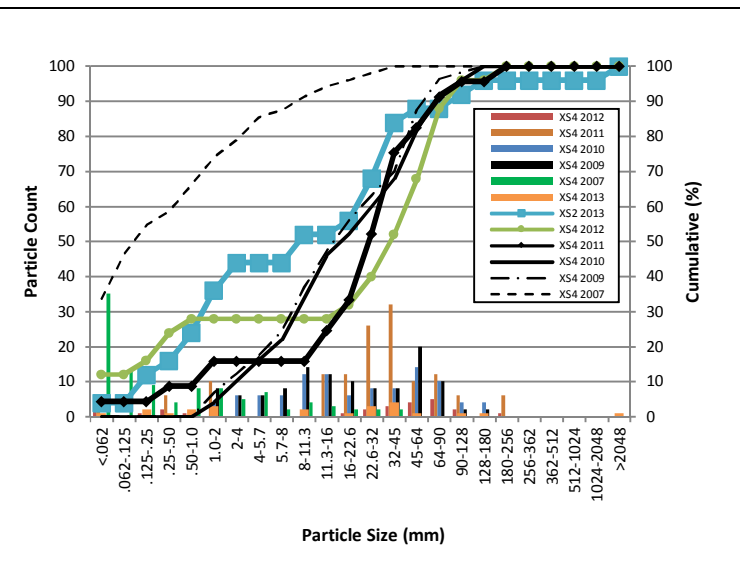
ID	Year	Phase	Facet Type	Wbkf	Abkf	Dbkf
XS4	2007	AB	Riffle	15.8	19.8	1.3
XS4	2009	MY1	Riffle	15	20.2	1.4
XS4	2010	MY2	Riffle	14.5	19.1	1.3
XS4	2011	MY3	Riffle	18.6	22.6	1.2
XS4	2012	MY4	Riffle	15.4	21.8	1.4
XS4	2013	MY5	Riffle	17.5	20.7	1.2

ID	Year	Phase	d50(mm)	d84(mm)
XS4	2007	AB	0.09	3.5
XS4	2009	MY1	12.7	42.2
XS4	2010	MY2	20.4	69.2
XS4	2011	MY3	30.9	68.2
XS4	2012	MY4	42.5	84
XS4	2013	MY5	9.4	42

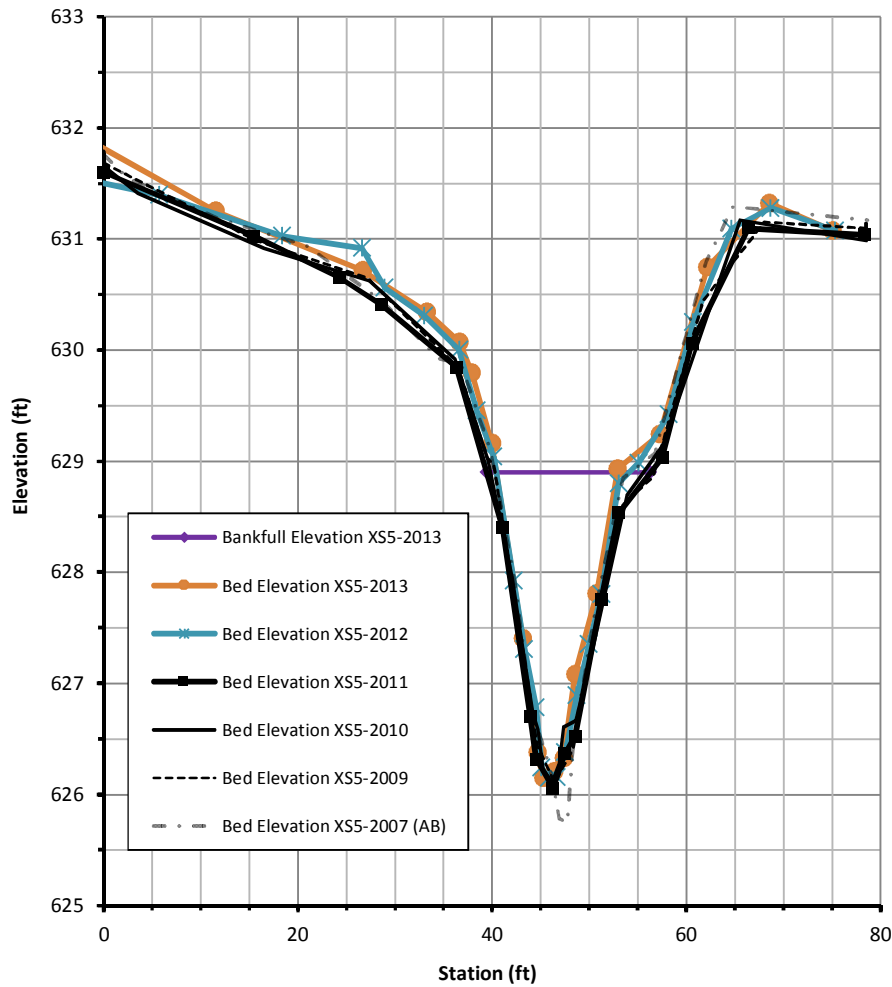
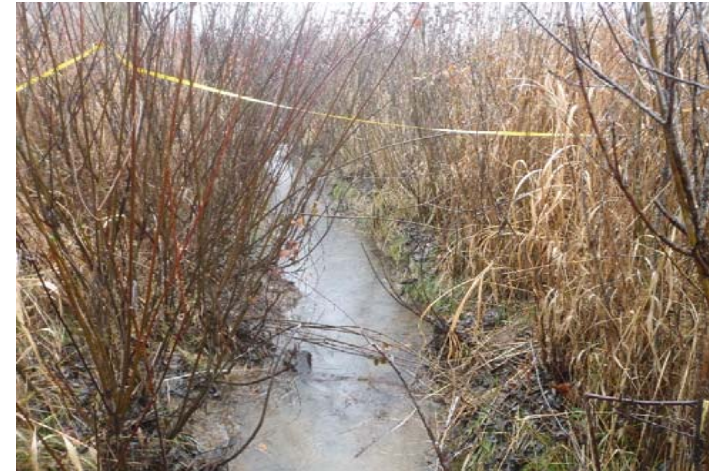
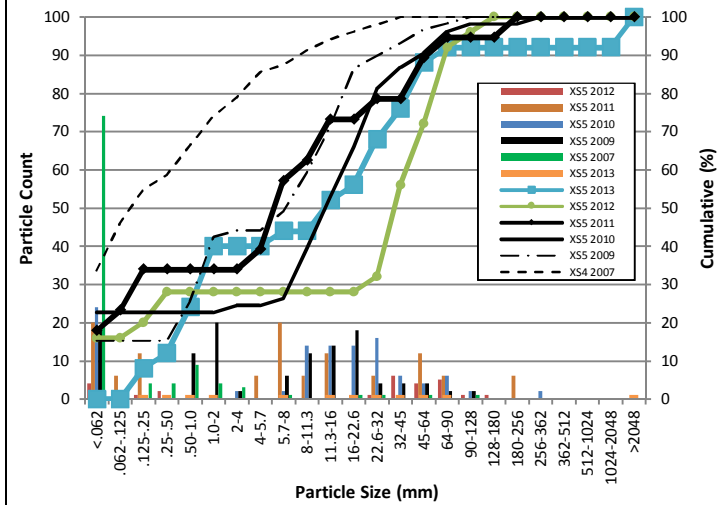
ID	Year	Phase	Facet Type	Wbkf	Abkf	Dbkf
XS5	2007	AB	Riffle	14	21.4	1.5
XS5	2009	MY1	Riffle	12.7	18.2	1.4
XS5	2010	MY2	Riffle	13.6	19.1	1.4
XS5	2011	MY3	Riffle	16.9	23	1.4
XS5	2012	MY4	Riffle	15.3	22.2	1.5
XS5	2013	MY5	Riffle	14.2	21.1	1.5

ID	Year	Phase	d50(mm)	d84(mm)
XS5	2007	AB	--	0.37
XS5	2009	MY1	5.9	15.3
XS5	2010	MY2	15	38.6
XS5	2011	MY3	7.1	54.6
XS5	2012	MY4	41.3	79
XS5	2013	MY5	12.1	47

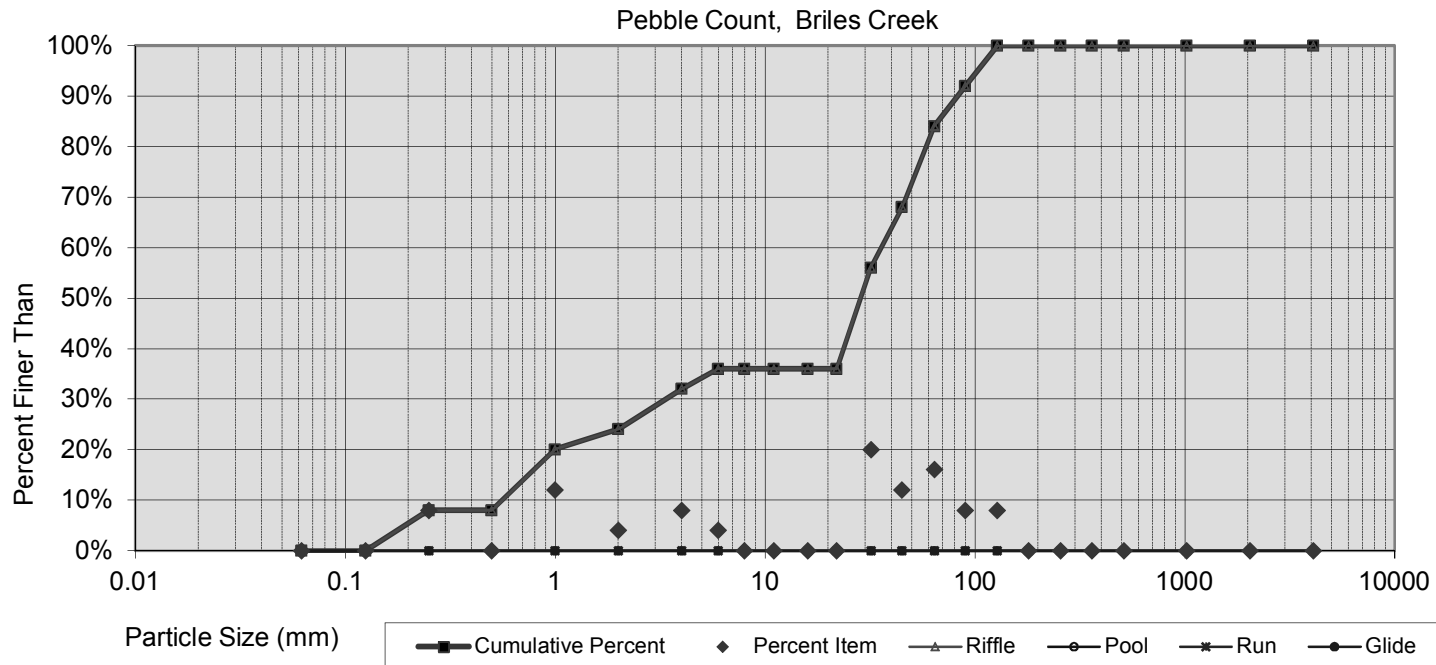
Note: **Cross Section 1**

Size percent less than (mm)					Percent by substrate type					
D16	D35	D50	D84	D95	silt/clay	sand	gravel	cobble	boulder	bedrock
0.794	5.42	28.6	64	103	0%	24%	60%	16%	0%	0%

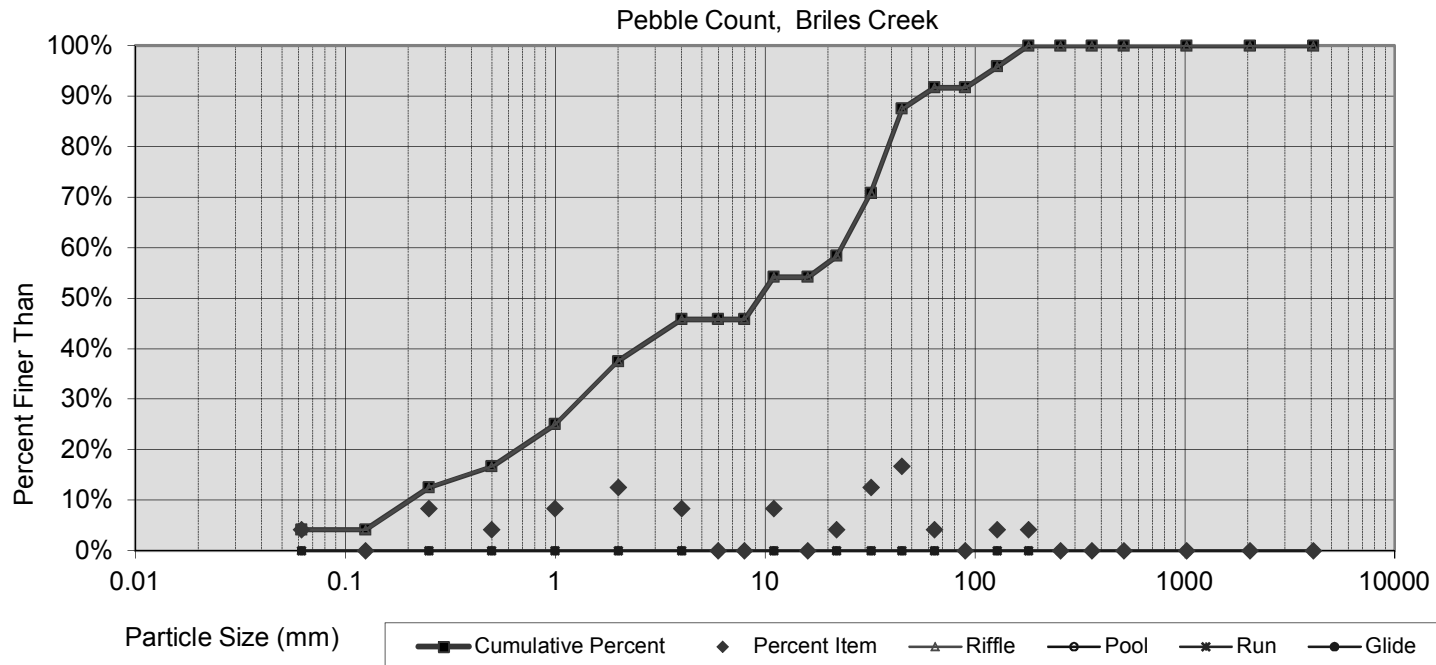
Note: **Cross Section 4**

Size percent less than (mm)					Percent by substrate type					
D16	D35	D50	D84	D95	silt/clay	sand	gravel	cobble	boulder	bedrock
0.448	1.74	9.4	42	119	4%	32%	52%	8%	0%	4%

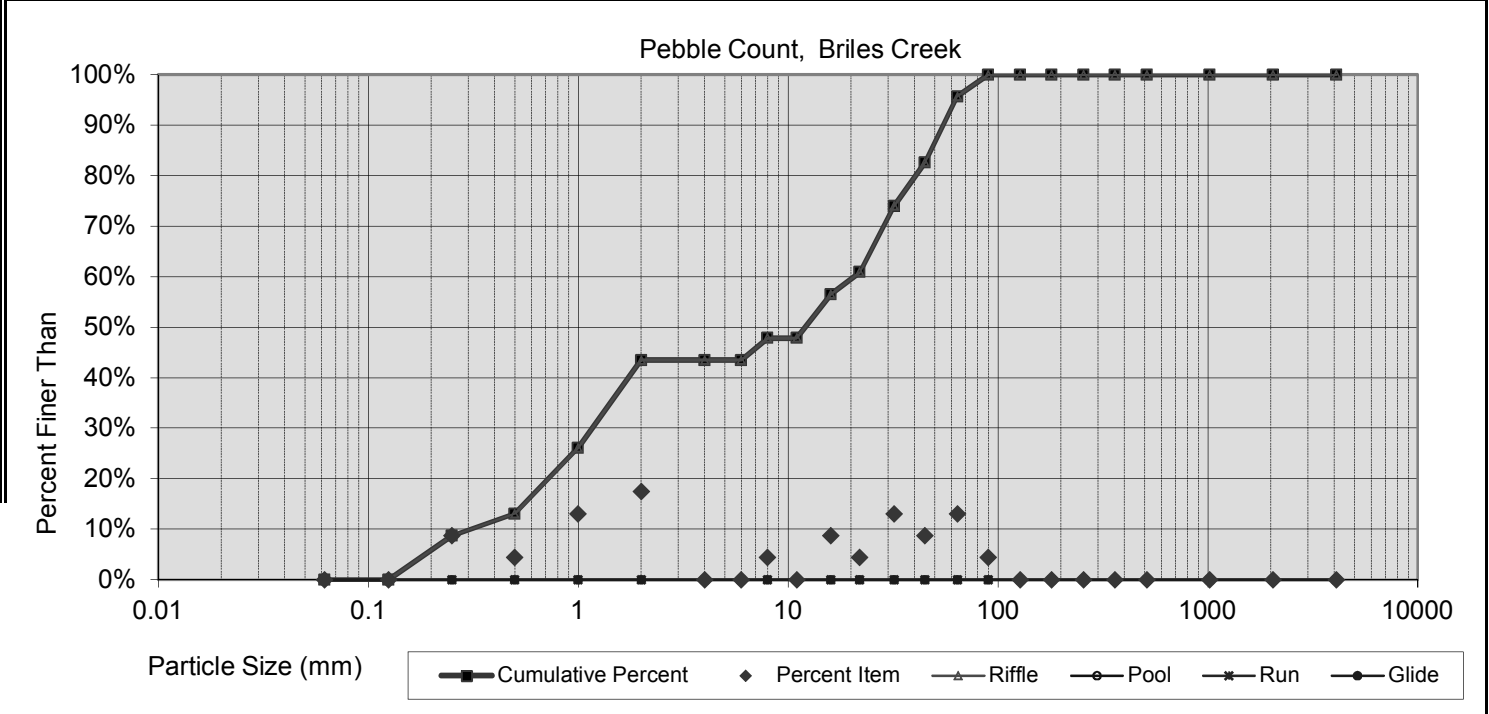
Note:	Cross Section 5

Size percent less than (mm)					Percent by substrate type					
D16	D35	D50	D84	D95	silt/clay	sand	gravel	cobble	boulder	bedrock
0.585	1.43	12.1	47	63	0%	40%	48%	4%	0%	8%
