**Brown Bark Park
Stream Restoration Monitoring Report
EEP Project # 52
Monitoring Year – 03
2007**

February 2008

In 2004, the North Carolina Ecosystem Enhancement Program (EEP) conducted stream restoration at Brown Bark Park within the Buffalo Creek Watershed in Greensboro, North Carolina. The 0.3-mi² watershed is located within the USGS 14-digit HUC 03030002020040 and the NCDWQ Sub-basin 03-06-02 of the Cape Fear River Basin. The project restored approximately 2,834 linear feet of channel. The design was developed to address vertical instability and the lack of bed variability. The restoration plan called for correcting these problems by stabilizing stream banks, installing in-stream structures, adjusting the stream planform, and replanting the riparian areas with native vegetation. Project construction occurred in 2004. This report describes the results from the third year of monitoring that took place in 2007.

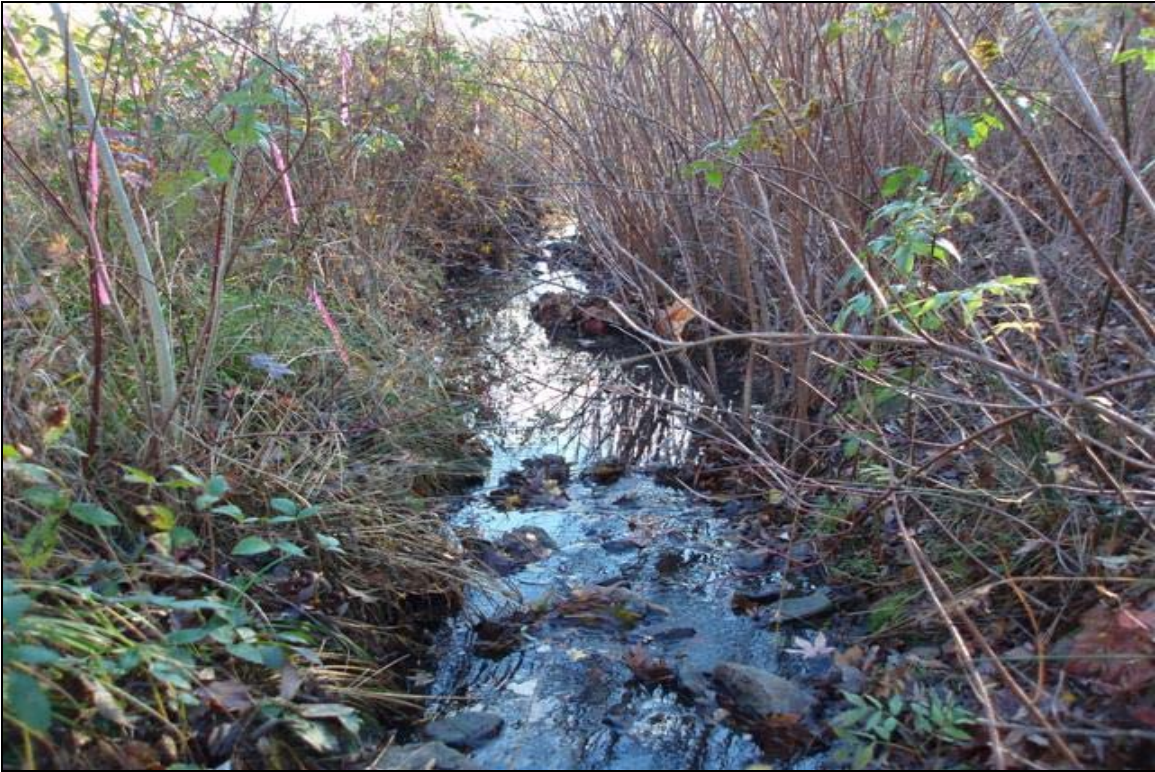
Plot 1 Photo – Taken from Photo Point #3, Buffer Plot #1 and the Live Stake Plot are on the left side of the stream. 11/27/07 - MY 03.

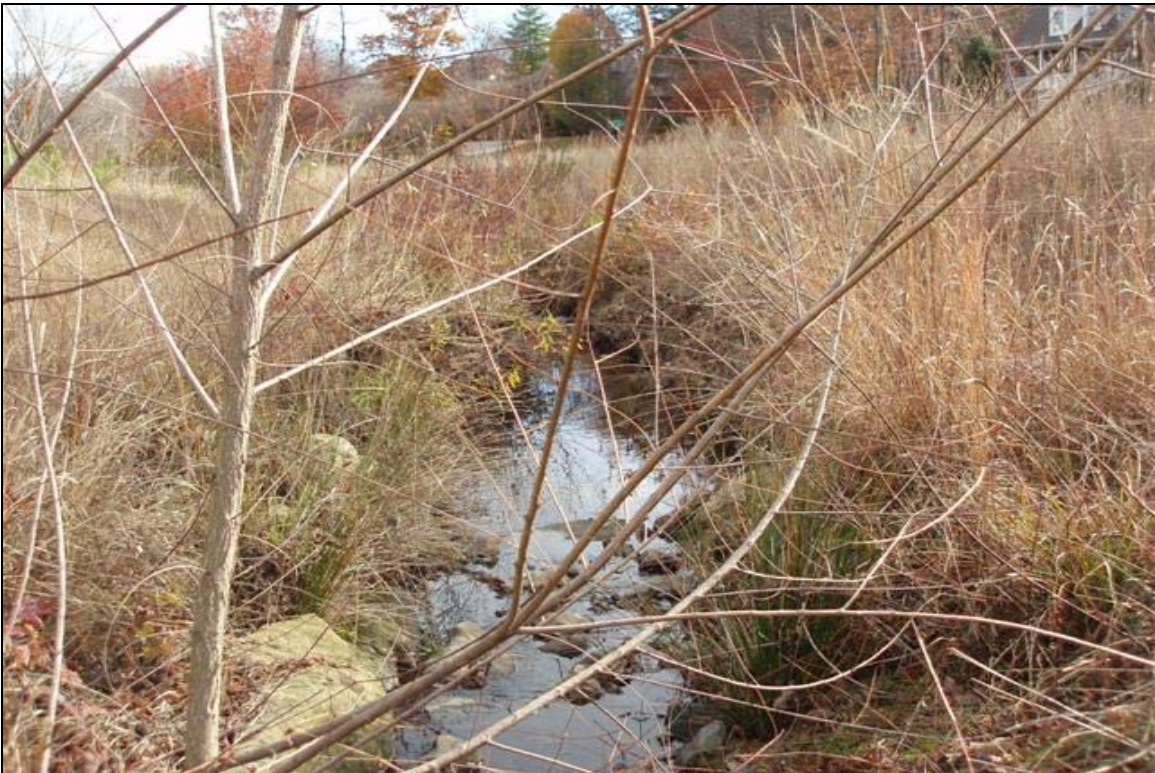
Plot 2 Photo – Taken from Photo Point #28, Buffer Plot #2 is on the left side of the stream. 11/27/07 - MY 03.

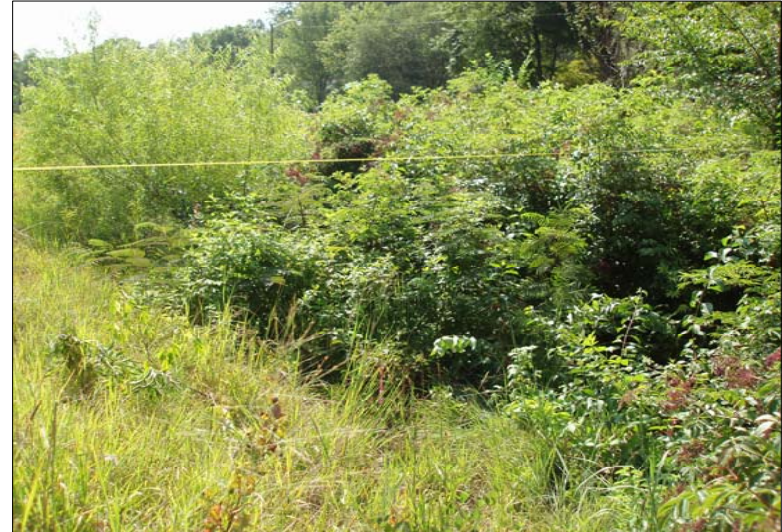
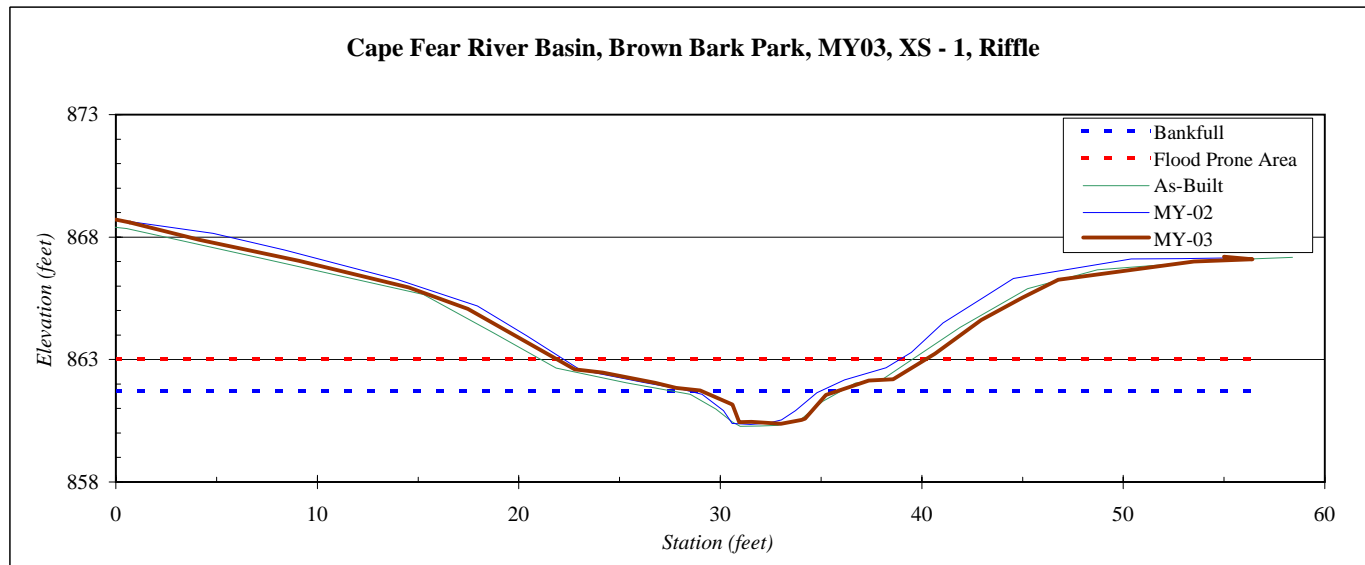
River Basin:	Cape Fear
Watershed:	Brown Bark Park, MY03
XS ID	XS - 1, Riffle
Drainage Area (sq mi):	0.3
Date:	7/31/2007
Field Crew:	B. Roberts, Z. Mrynca

SUMMARY DATA	
Bankfull Elevation:	861.7
Bankfull Cross-Sectional Area:	5.3
Bankfull Width:	5.7
Flood Prone Area Elevation:	863.0
Flood Prone Width:	18.4
Max Depth at Bankfull:	1.3
Mean Depth at Bankfull:	0.9
W / D Ratio:	6.2
Entrenchment Ratio:	3.2
Bank Height Ratio:	1.0

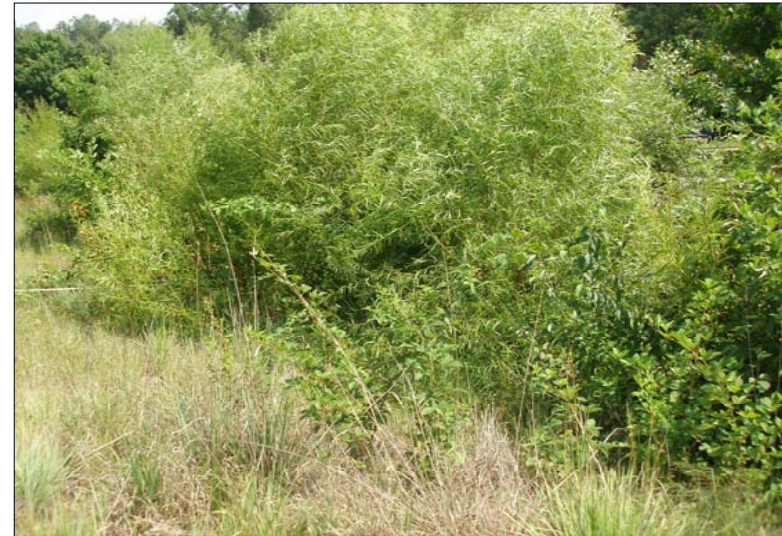
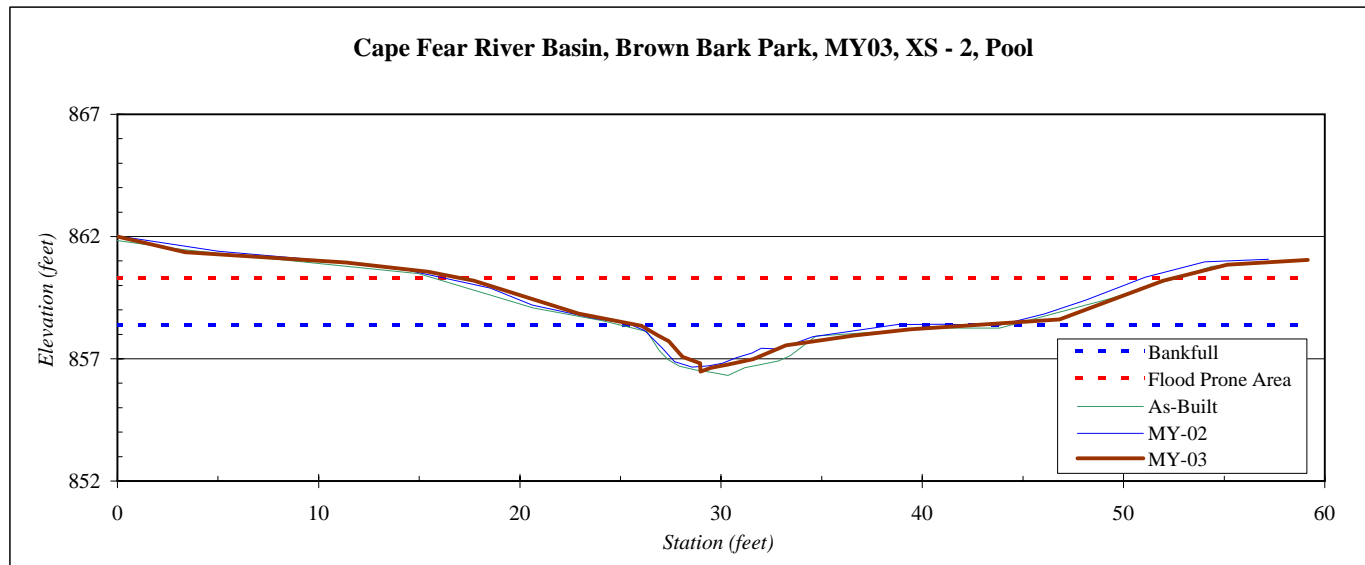
Cape Fear River Basin, Brown Bark Park, MY03, XS - 2, Pool

SUMMARY DATA	
Bankfull Elevation:	858.4
Bankfull Cross-Sectional Area:	12.1
Bankfull Width:	17.3
Flood Prone Area Elevation:	860.3
Flood Prone Width:	35.8
Max Depth at Bankfull:	1.9
Mean Depth at Bankfull:	0.7
W / D Ratio:	24.7
Entrenchment Ratio:	2.1
Bank Height Ratio:	1.0

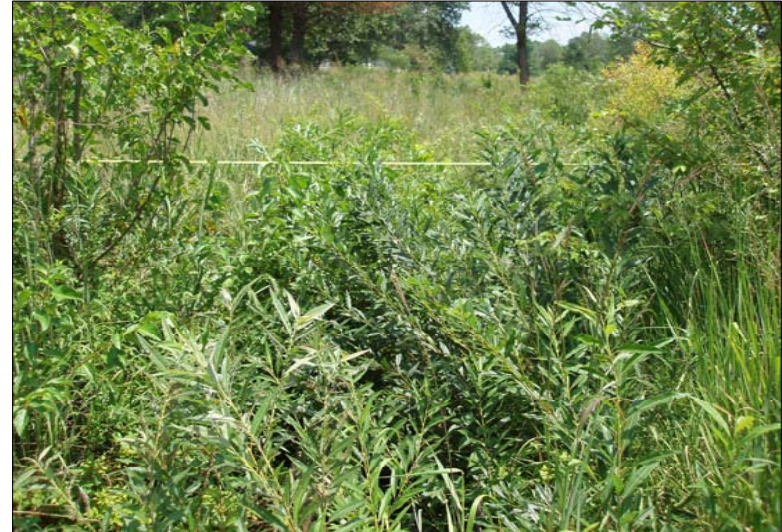
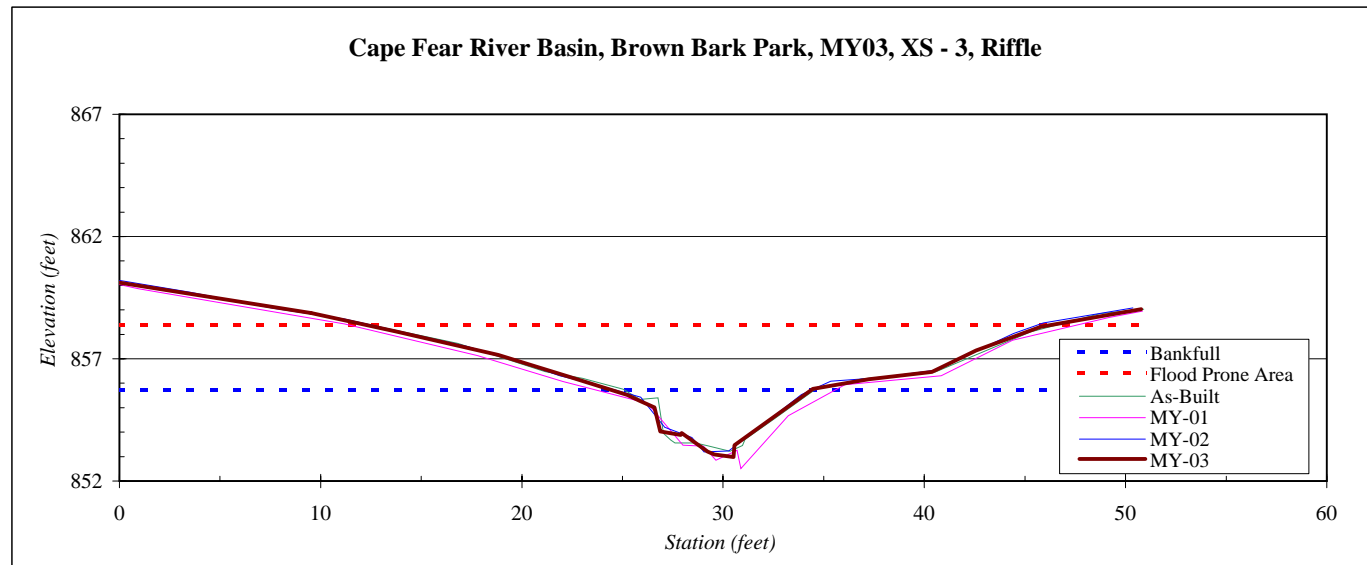
River Basin:	Cape Fear
Watershed:	Brown Bark Park, MY03
XS ID	XS - 3, Riffle
Drainage Area (sq mi):	0.3
Date:	8/1/2007
Field Crew:	B. Roberts, Z. Mrynca

SUMMARY DATA	
Bankfull Elevation:	855.7
Bankfull Cross-Sectional Area:	13.3
Bankfull Width:	9.8
Flood Prone Area Elevation:	858.4
Flood Prone Width:	34.5
Max Depth at Bankfull:	2.7
Mean Depth at Bankfull:	1.4
W / D Ratio:	7.2
Entrenchment Ratio:	3.5
Bank Height Ratio:	1.0

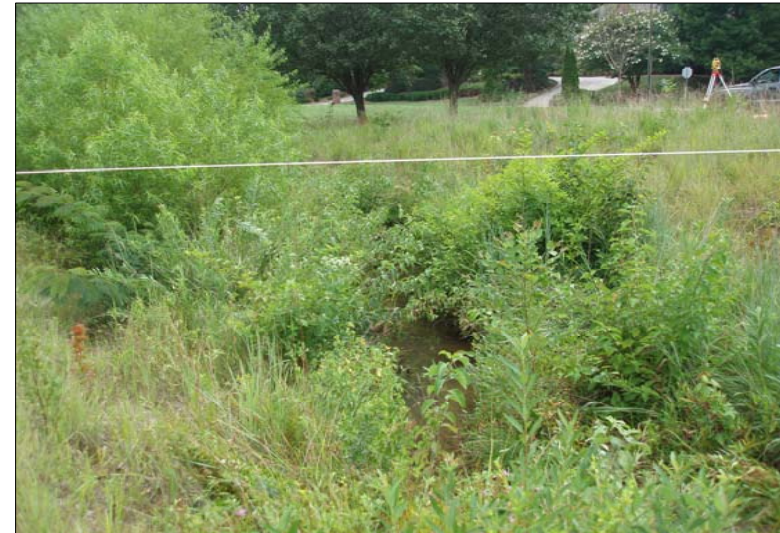
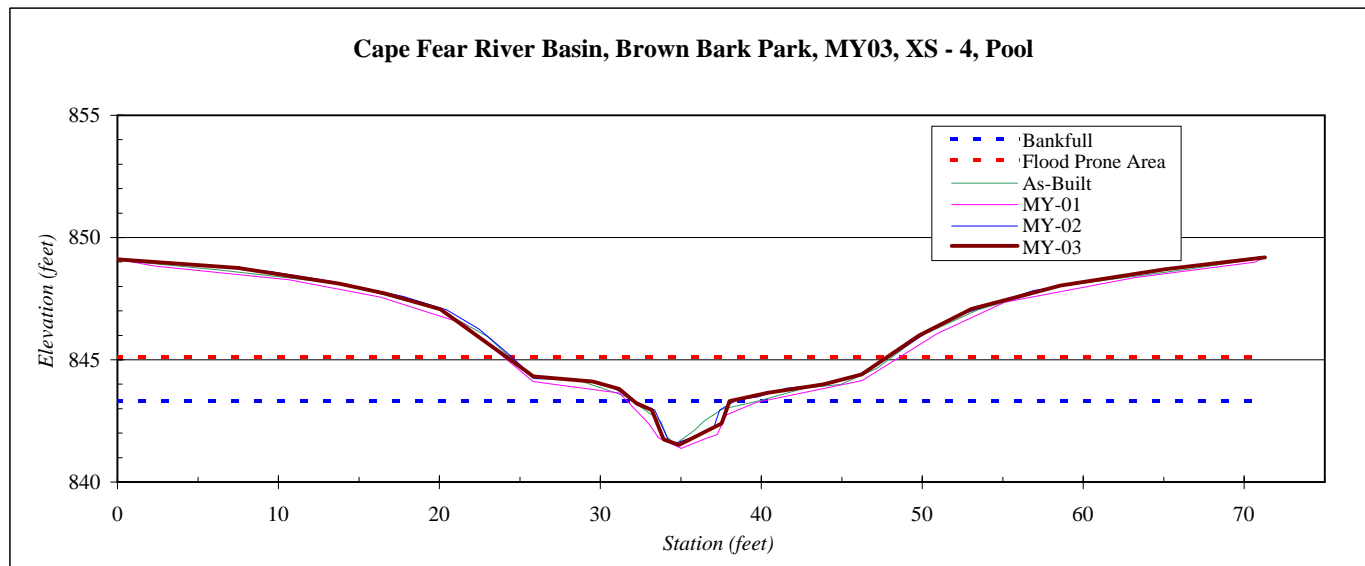
Cape Fear River Basin, Brown Bark Park, MY03, XS - 4, Pool

SUMMARY DATA	
Bankfull Elevation:	843.3
Bankfull Cross-Sectional Area:	6.3
Bankfull Width:	5.9
Flood Prone Area Elevation:	845.1
Flood Prone Width:	23.5
Max Depth at Bankfull:	1.8
Mean Depth at Bankfull:	1.1
W / D Ratio:	5.6
Entrenchment Ratio:	4.0
Bank Height Ratio:	1.0

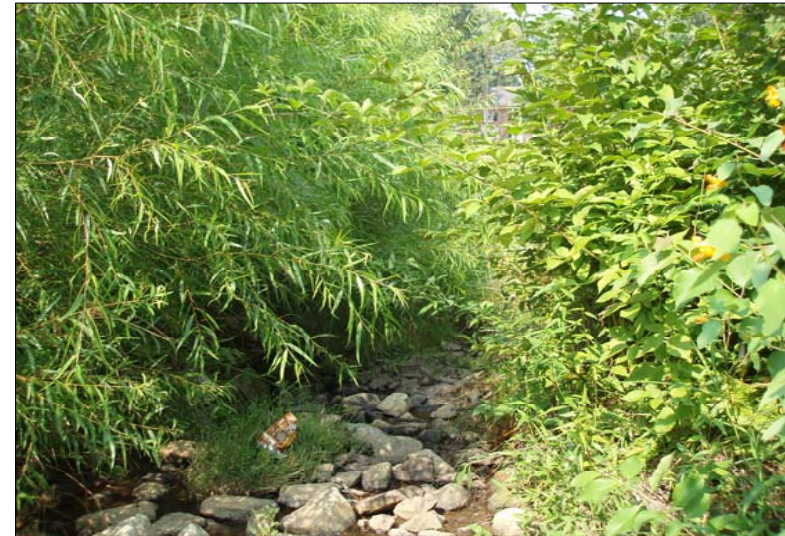
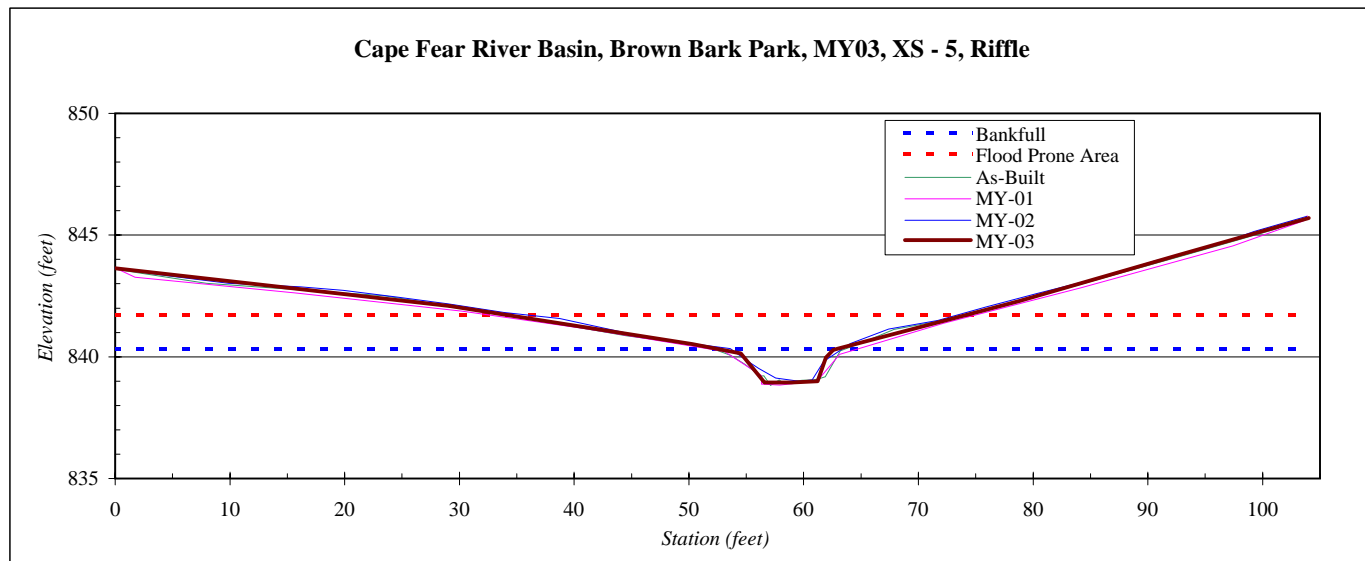
Cape Fear River Basin, Brown Bark Park, MY03, XS - 5, Riffle

SUMMARY DATA	
Bankfull Elevation:	840.3
Bankfull Cross-Sectional Area:	8.6
Bankfull Width:	10.0
Flood Prone Area Elevation:	841.7
Flood Prone Width:	38.6
Max Depth at Bankfull:	1.4
Mean Depth at Bankfull:	0.9
W / D Ratio:	11.5
Entrenchment Ratio:	3.9
Bank Height Ratio:	1.0

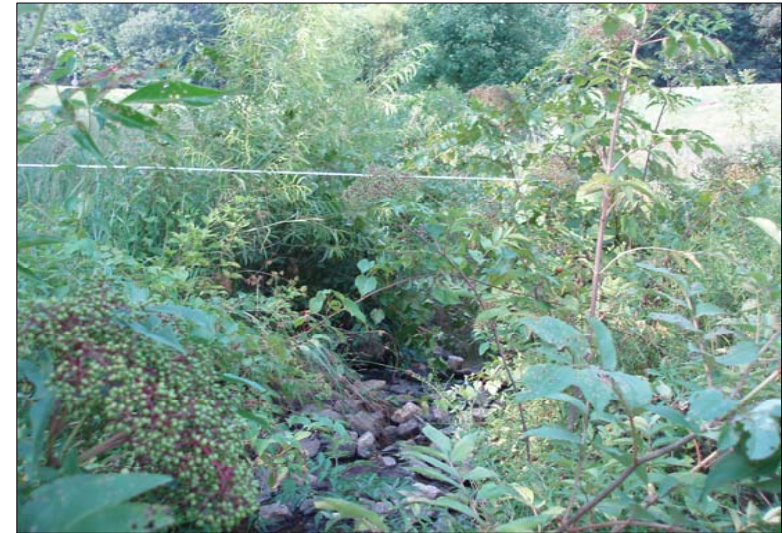
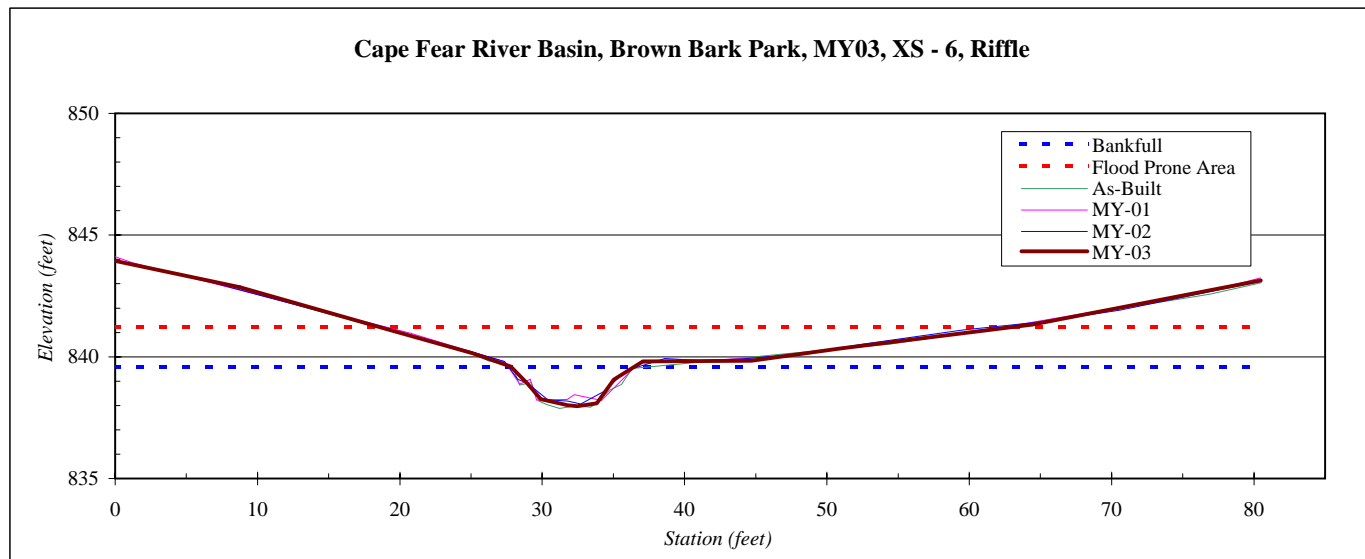
Cape Fear River Basin, Brown Bark Park, MY03, XS - 6, Riffle

SUMMARY DATA	
Bankfull Elevation:	839.6
Bankfull Cross-Sectional Area:	9.0
Bankfull Width:	8.7
Flood Prone Area Elevation:	841.2
Flood Prone Width:	44.6
Max Depth at Bankfull:	1.6
Mean Depth at Bankfull:	1.0
W / D Ratio:	8.4
Entrenchment Ratio:	5.1
Bank Height Ratio:	1.0
