**Brown Bark Park  
Stream Restoration Monitoring Report  
EEP Project # 52  
Monitoring Year – 04  
2008**

**March 2009**

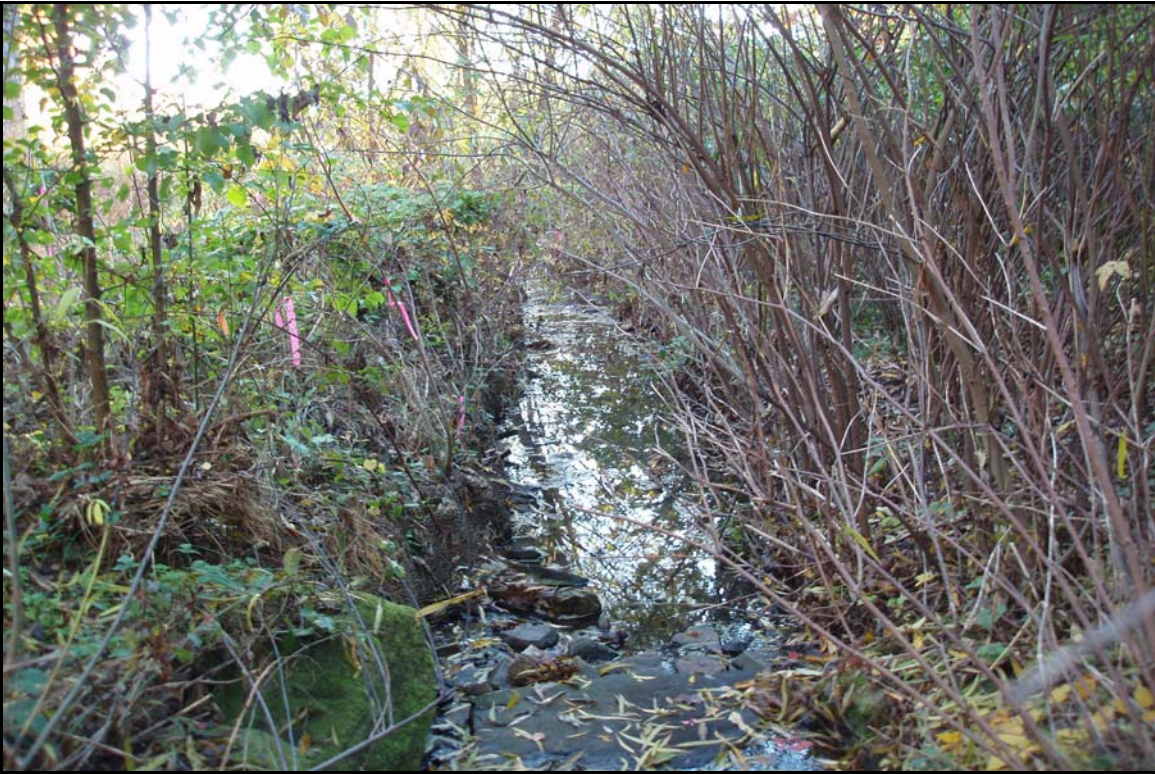
Plot 1 Photo – Taken from Photo Point #3, Buffer Plot #1 and the Live Stake Plot are on the left side of the stream. 11/7/08 - MY 04

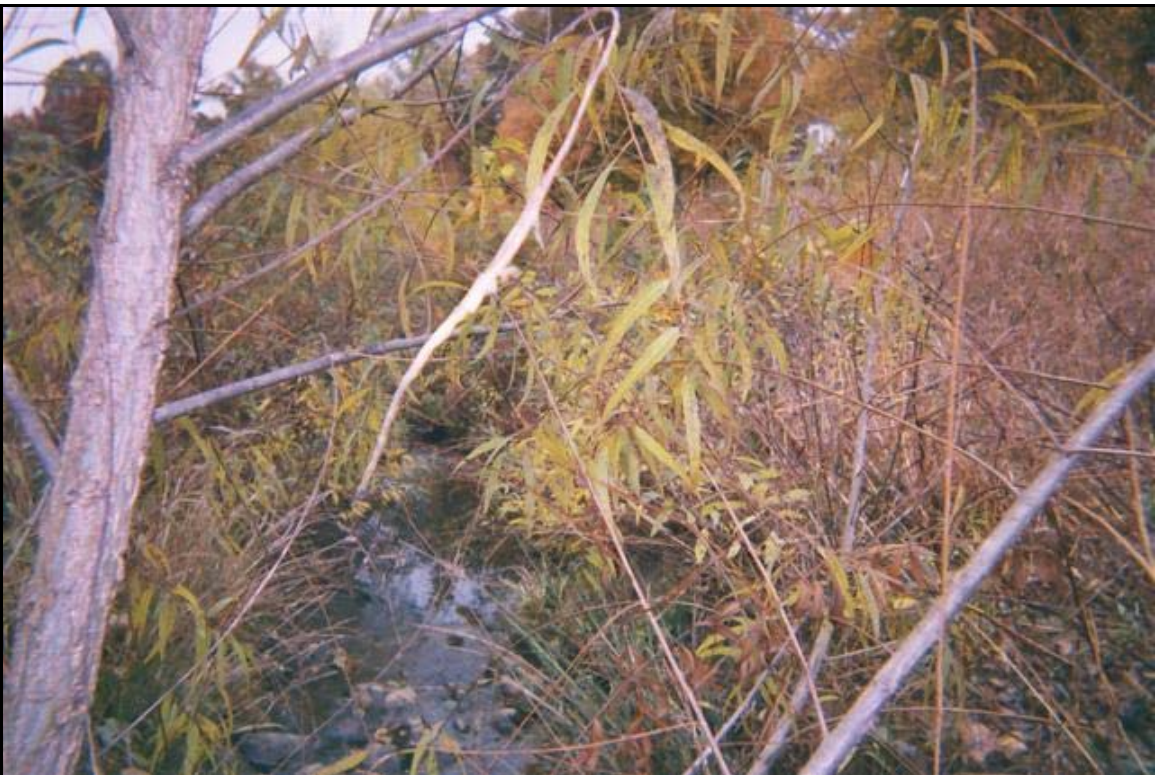
Plot 2 Photo – Taken from Photo Point #28, Buffer Plot #2 is on the left side of the stream. 11/5/08 - MY 04
