BROWN BRANCH STREAM RESTORATION

FIRST YEAR MONITORING REPORT

May 2004

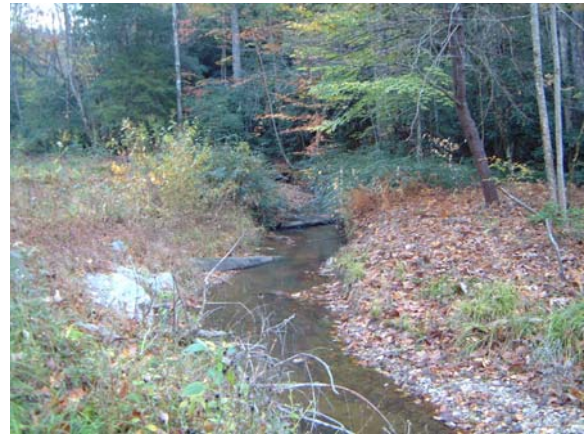
Photograph NM-4. Looking upstream at buried log vane from as-built Station ~49+25.

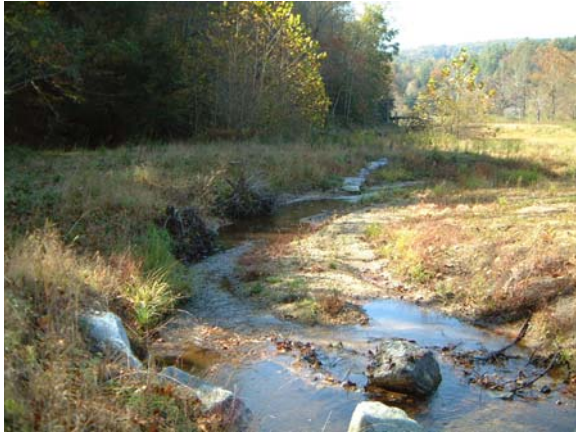
Photograph NM-49. Looking downstream at rootwads and rock vane from as-built Station ~10+00.

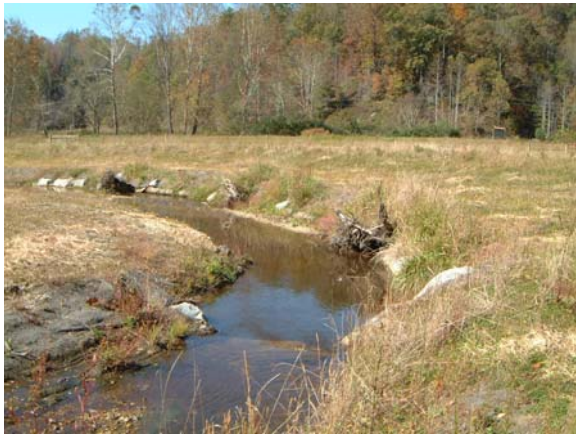
Photograph NM-51. Looking downstream at cross vane and rootwads from as-built Station ~9+00.

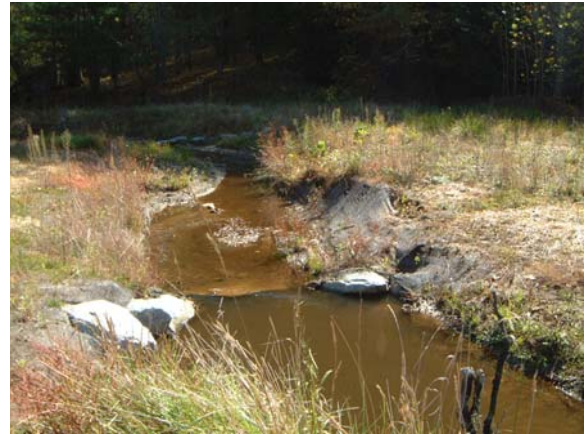
Photograph NM-52. Looking upstream at rock vane and rootwads from as-built Station ~8+75.

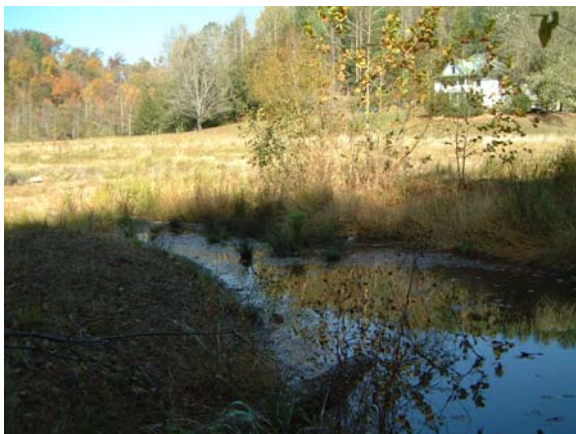
Photograph NM-53. Looking north across wetland near as-built Station ~8+00.

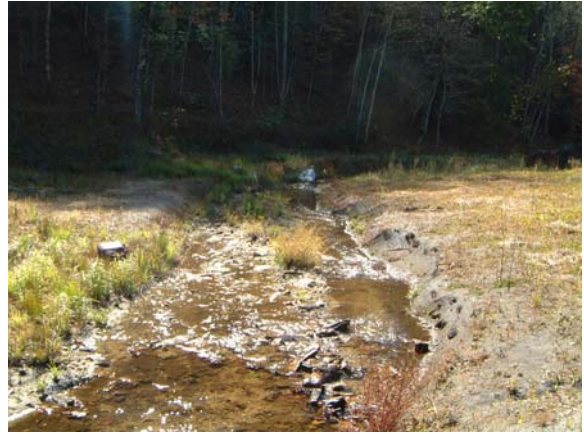
Photograph NM-56. Looking downstream along riffle from as-built Station ~8+00.

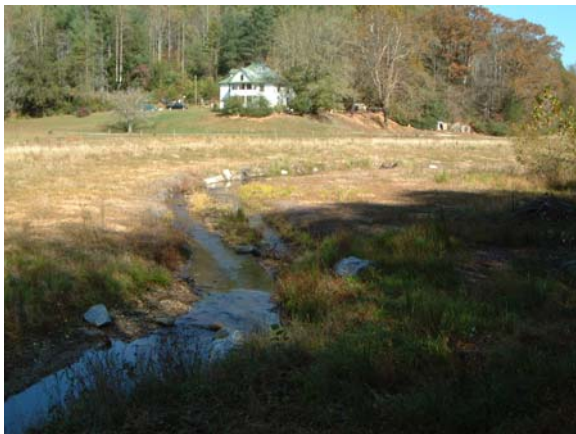
Photograph NM-59. Looking upstream at rock "J" vane from as-built Station ~6+80.

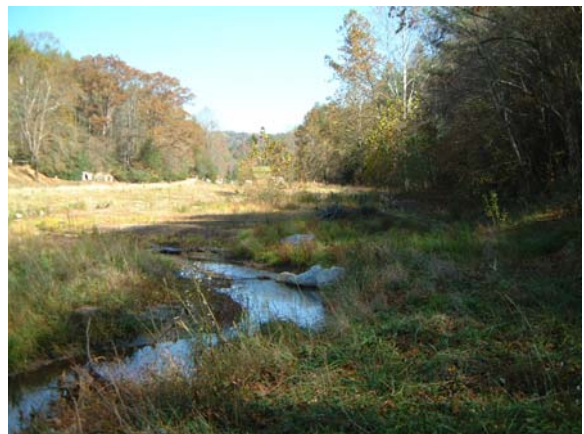
Photograph NM-60. Looking upstream at rock "J" vane and wetland from as-built Station ~ 6+50.

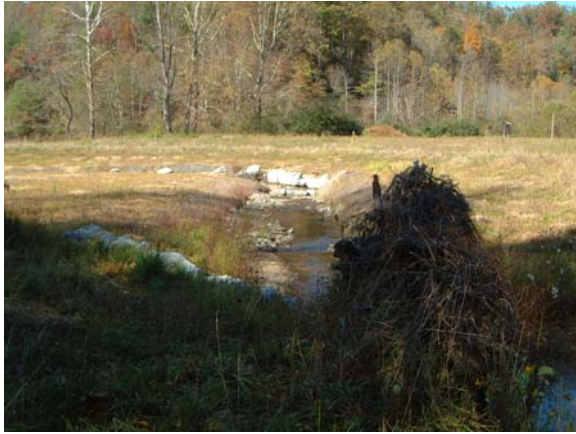
Photograph NM-61. Looking downstream at rootwads and rock toe protection from as-built Station ~6+50.

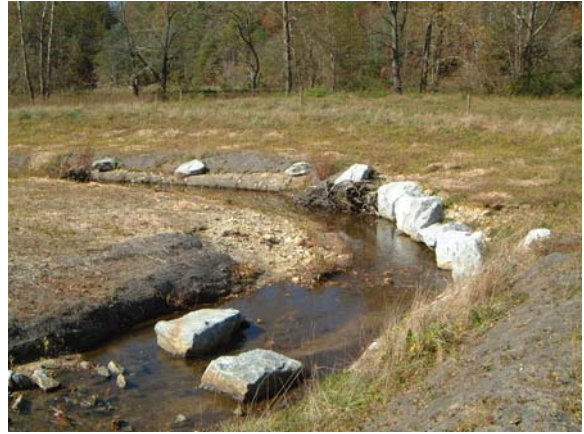
Photograph NM-62. Looking downstream at rock "J" vane, rock toe protection, and rootwad from as-built Station ~5+50.

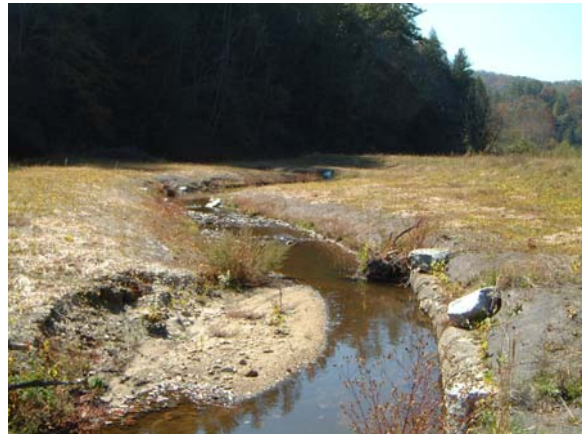
Photograph NM-64. Looking downstream at log toe protection and rootwad from as-built Station ~5+25.

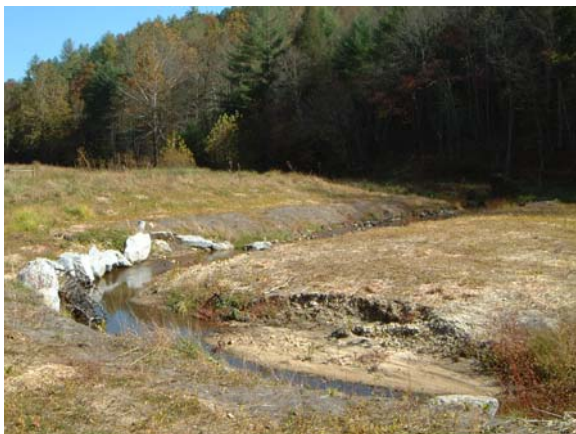
Photograph NM-65. Looking upstream at log toe protection, rootwad, and rock vane from as-built Station ~4+50.

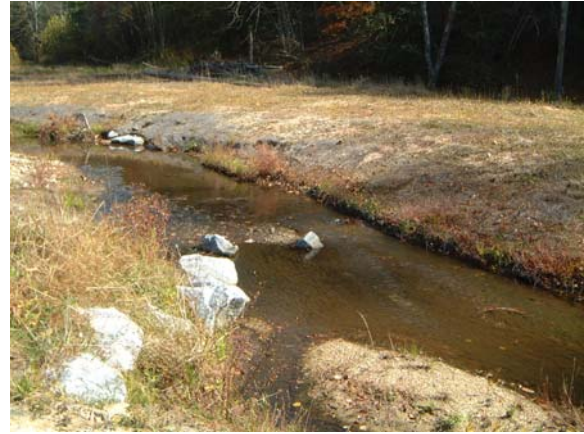
Photograph NM-68. Looking upstream at rock "J" vane from as-built Station ~3+25.

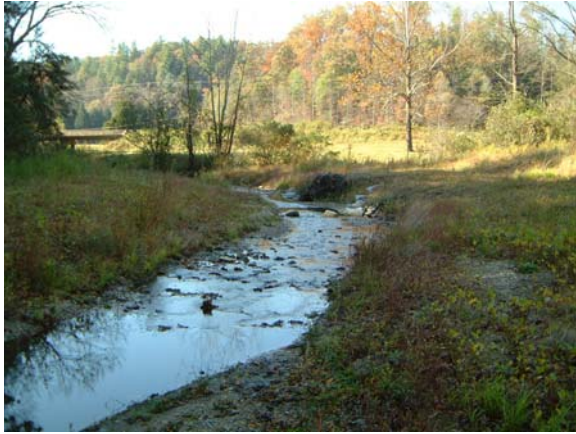
Photograph NM-73. Looking downstream at rock “J” vane and rootwad from as-built Station ~1+00.

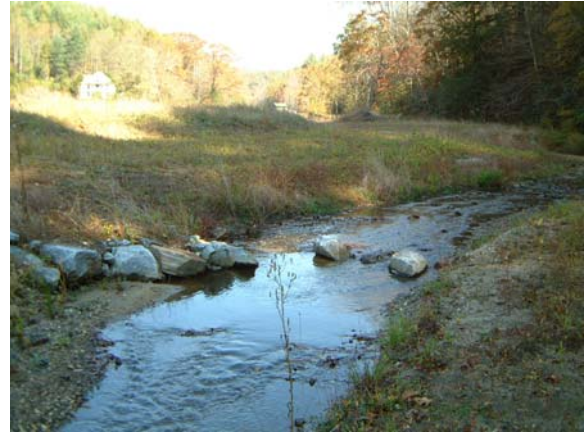
Photograph NM-74. Looking upstream at rock “J” vane from as-built Station ~0+85.

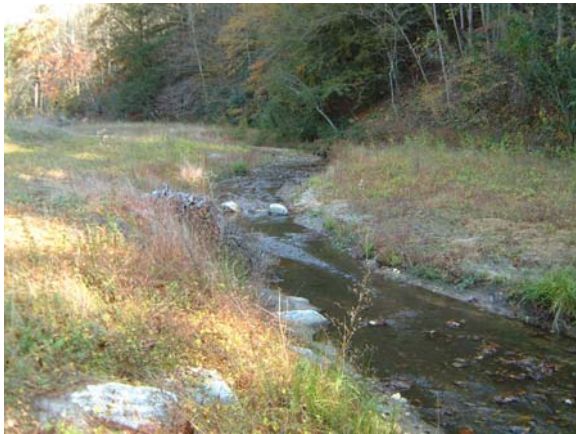
Photograph NM-75. Looking upstream at rock vane and rootwad from as-built Station ~0+65.

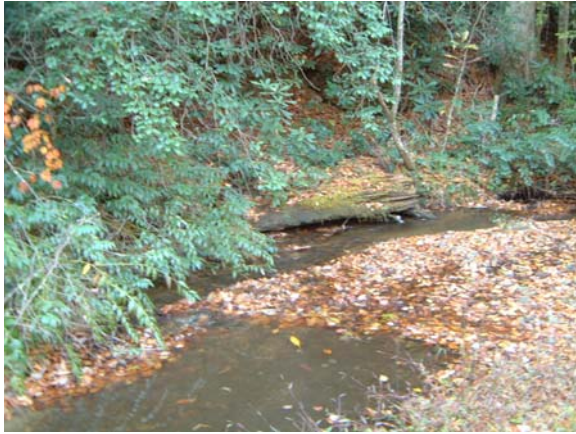
Looking downstream at existing log and channel from as-built Station ~50+00.

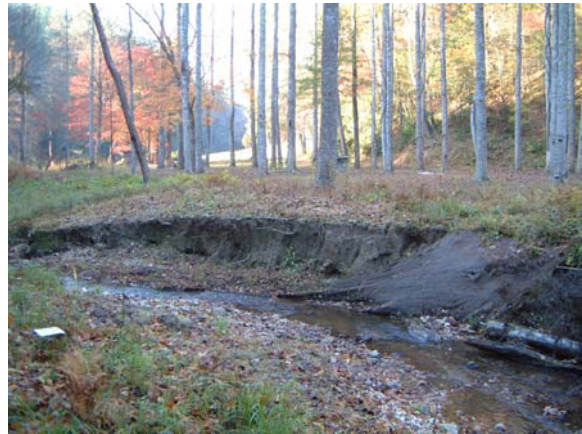
Looking downstream at bank erosion from as-built Station ~47+00.

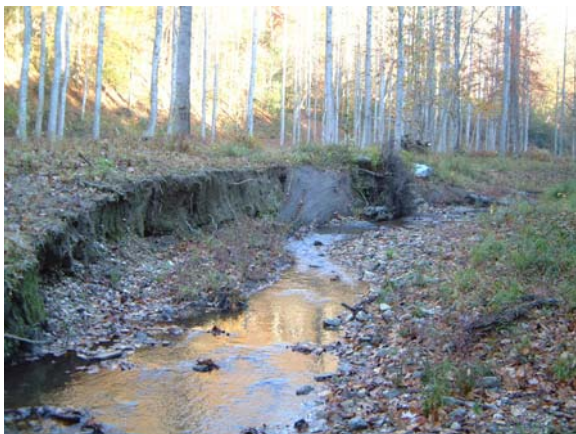
Looking upstream at bank erosion from as-built Station ~46+50.

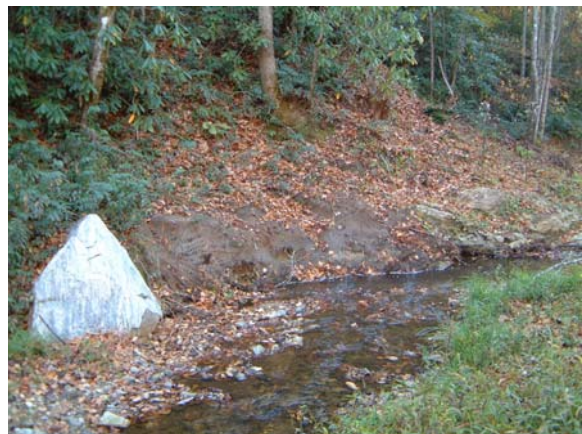
Looking downstream at bank erosion from as-built Station ~46+00.

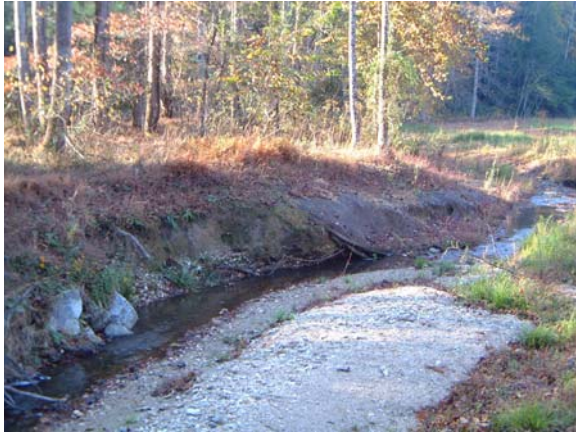
Looking downstream at erosion from as-built Station ~44+00.

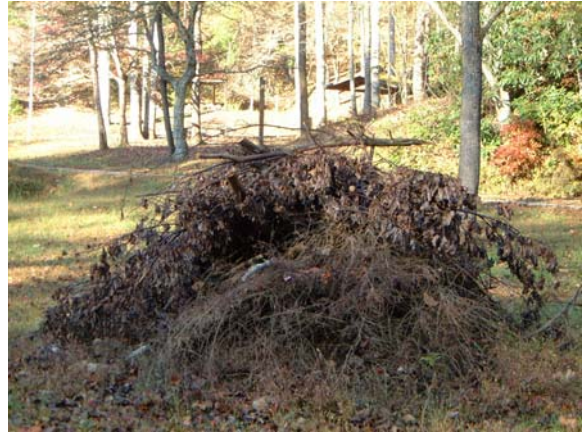
Looking at birds in brush pile from as-built Station ~44+00.

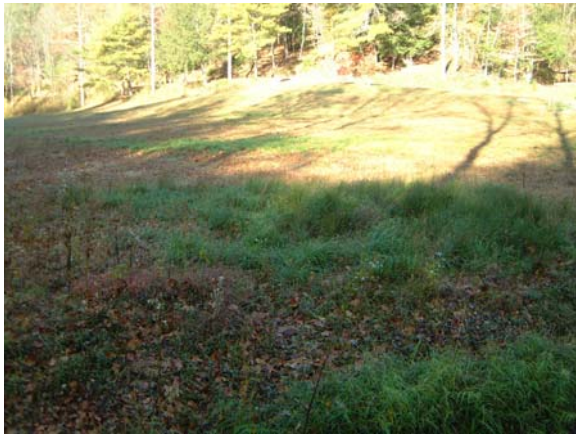
Looking at floodplain depression with wetland plants from as-built Station ~42+50.

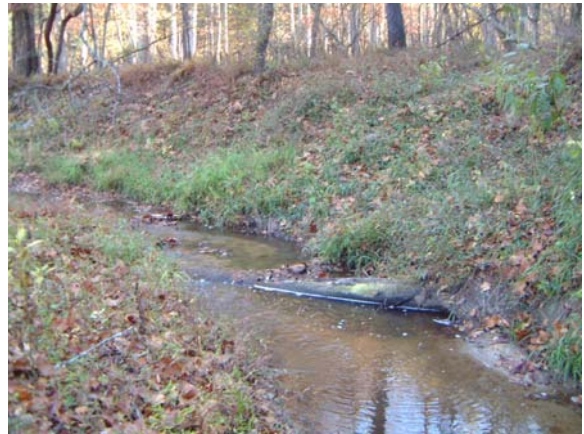
Of the many structures used to protect streambanks (e.g., rock toe protection, rock J vane, log toe protection, rootwad), log vanes seem to have been the least successful. At many locations, scour has occurred at the end of the log originally buried under the thalweg such that the cut end is visible. The log vanes are not currently unstable or undercut, but the degradation of the channel bed in the vicinity of the log vane could become more pronounced with time, and should be monitored closely during the next monitoring period. Log toe protection looks very good, with the exception of one location where a log has shifted from its footer log. Rock toe protection, rock J vanes, and rock cross vanes are also functioning well, except in a few locations where overland flow has scoured out soil on the upslope side.

Looking upstream at log vane at as-built Station ~41+50.

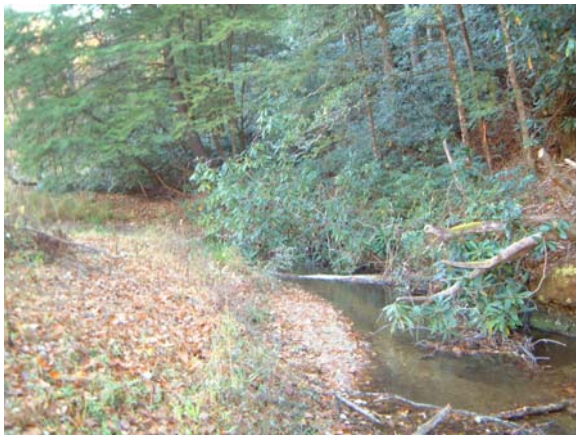
Looking upstream at stable banks in meander at as-built Station ~38+00.

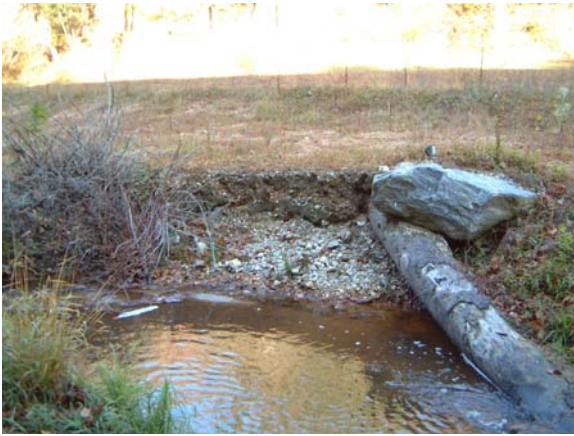
Looking downstream at erosion between rootwad and log vane at as-built Station ~36+00.

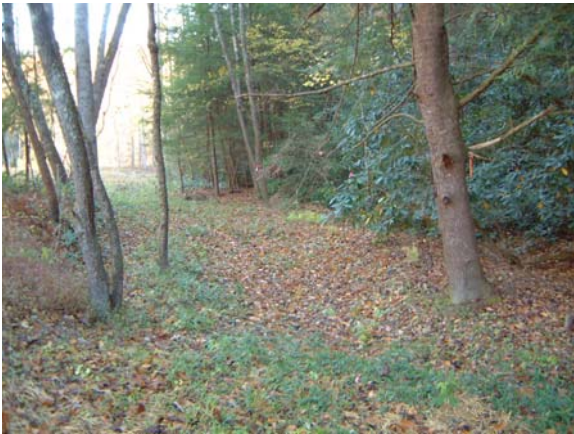
Looking upstream at dry oxbow wetland at as-built Station ~36+00.

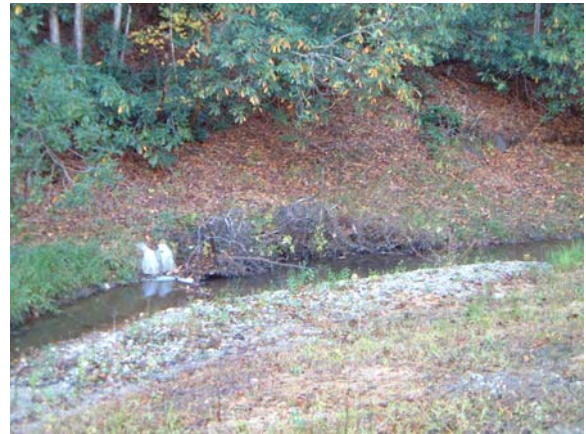
Looking downstream at rootwads from as-built Station ~35+00.

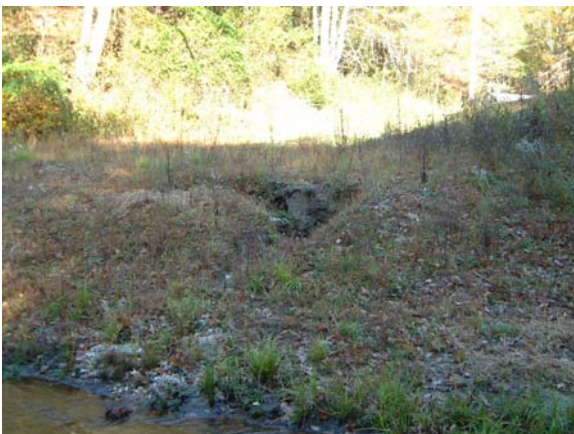
Looking downstream at gully erosion at as-built Station ~31+10.

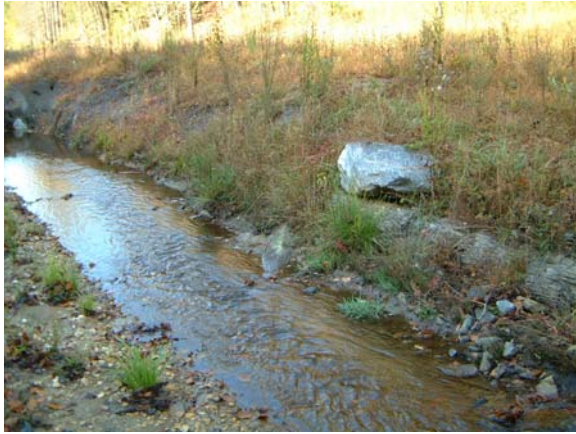
Looking downstream at log vane from as-built Station ~30+25.

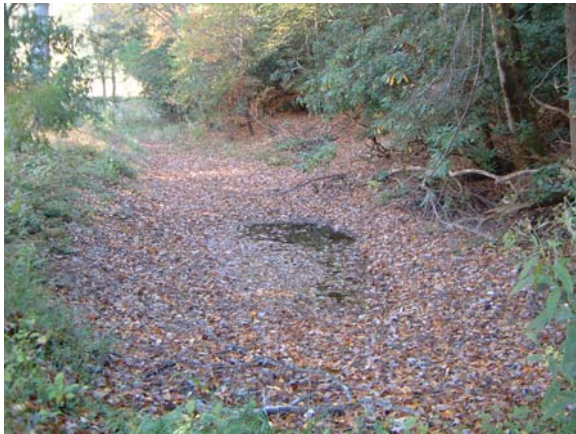
Looking upstream at oxbow wetland with no plants at as-built Station ~29+00.

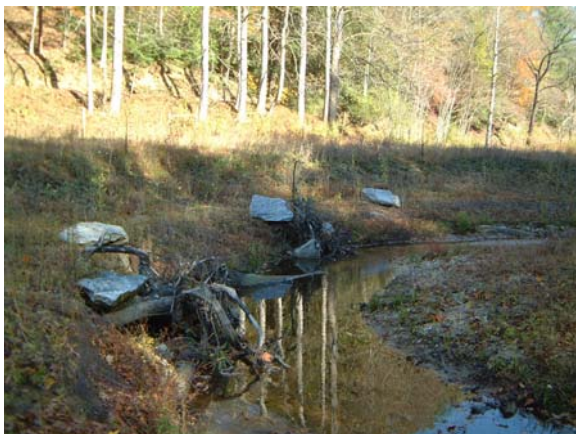
Looking upstream at erosion behind rootwads at as-built Station ~24+00.

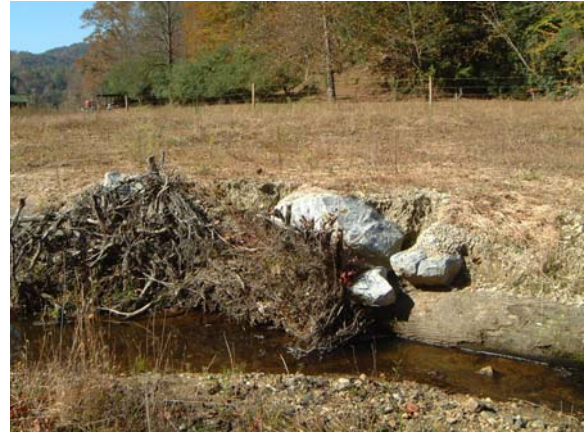
Looking downstream at erosion behind rootwads at as-built Station ~22+00.

25+25 – 25+00, L/B & R/B	Severe bank erosion on L/B, lack of vegetation on both banks.	Remove matting, regrade, reseed, re-mat, and replant.
23+50 – 21+75, L/B & R/B	Lack of vegetation. Small rill.	Fill small rill at 22+80. Remove matting, reseed, replace matting, and replant 15' wide corridor on each bank above bankfull elevation.
21+75, R/B	Large gully	Remove matting. Fill gully to return to grade, reseed, replace matting, and replant (containerized plants preferred).
18+75 – 19+00, R/B	Lack of vegetation, bank erosion	Reseed and replant 15-foot wide corridor on bank above bankfull.
17+75 – 16+75, R/B	Bank erosion, large gully	Fill gully at 17+50, R/B to grade. Plant live stakes along meander. Reseed, place matting, and revegetate.
14+25 – 13+50	Bank erosion	Plant live stakes along meander.
12+50 – 12+00, L/B	Severe bank erosion	Plant live stakes.
11+90 – 11+25, L/B & R/B	Lack of vegetation, local bank erosion	Reseed and revegetate both banks (containerized plants preferred).

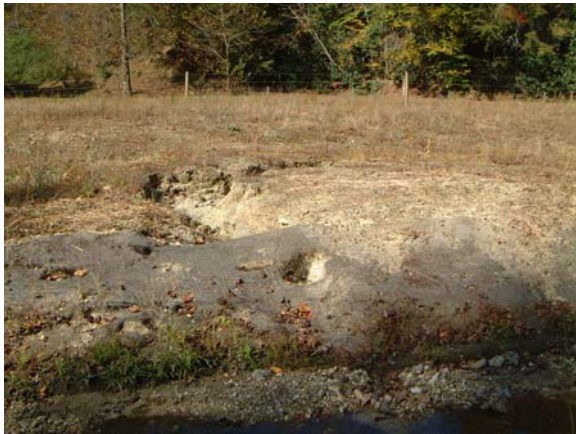
Gully erosion on right bank at as-built Station ~21+75.

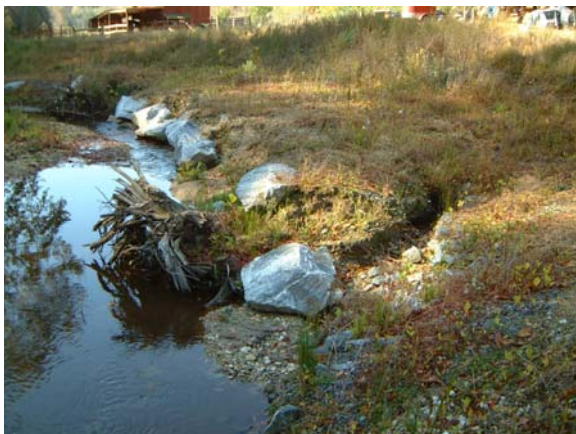
Looking downstream gully erosion at as-built Station ~17+25.

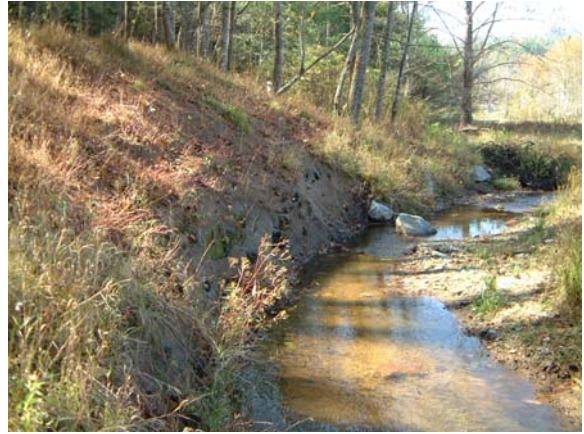
Looking downstream at erosion on left bank from as-built Station ~12+50.

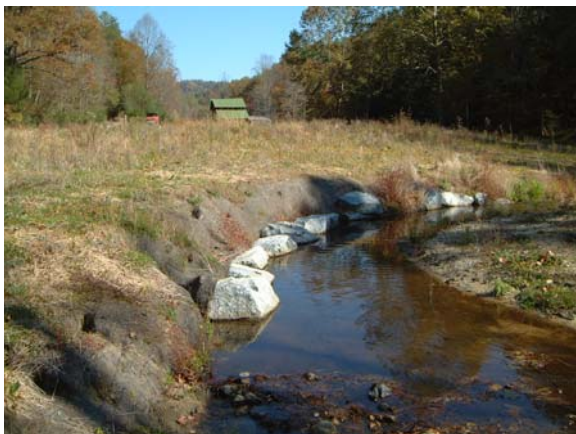
Looking upstream at rolled rocks at as-built Station ~11+00.

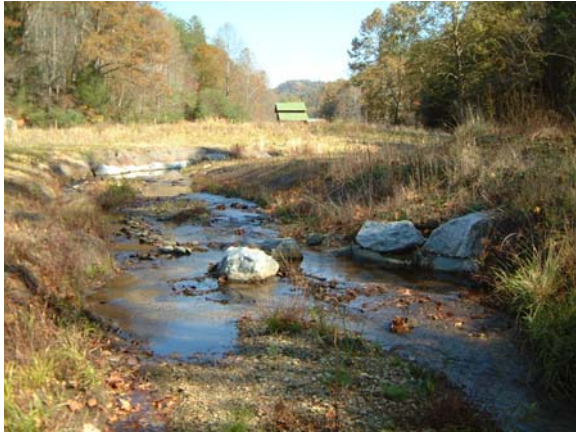
Looking upstream at channel widening and rock "J" vane from as-built Station ~10+25.

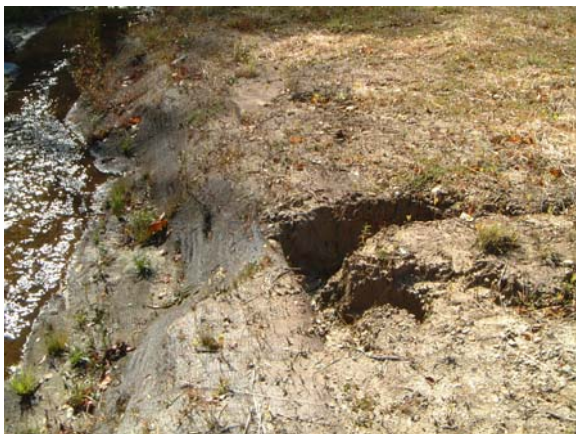
Looking downstream at gully erosion at as-built Station ~7+25.

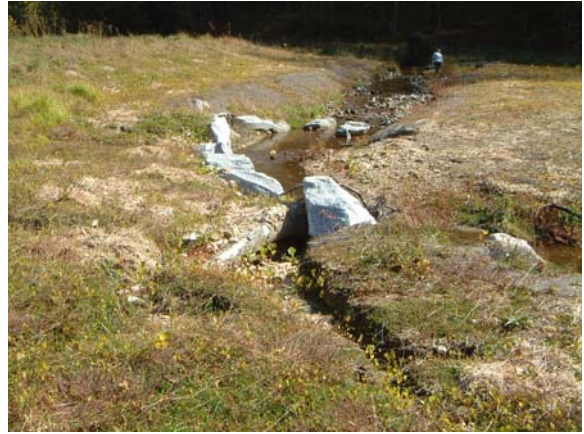
Looking upstream at gully erosion at as-built Station ~5+25.

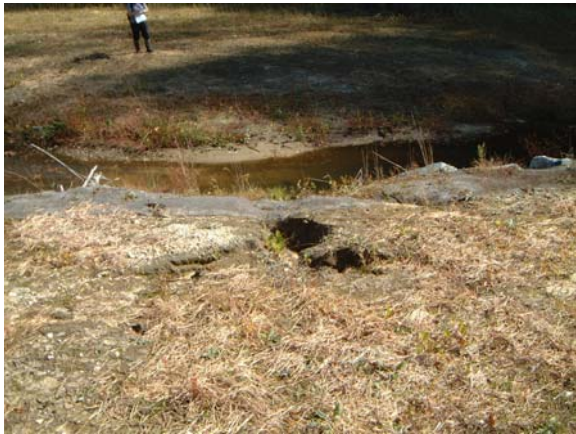
Looking downstream at gully erosion at as-built Station ~3+00.

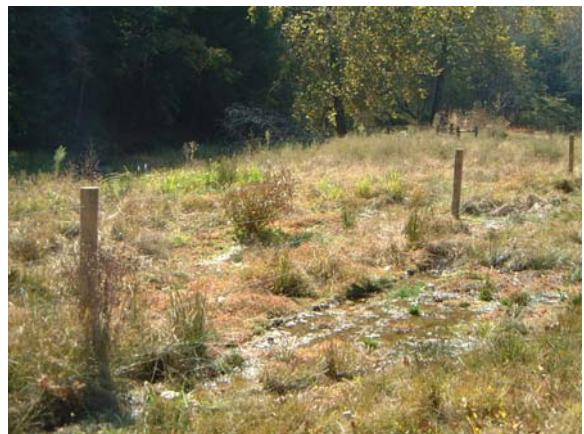
Looking downstream at wet depression from grading near barn at as-built Station ~16+00.

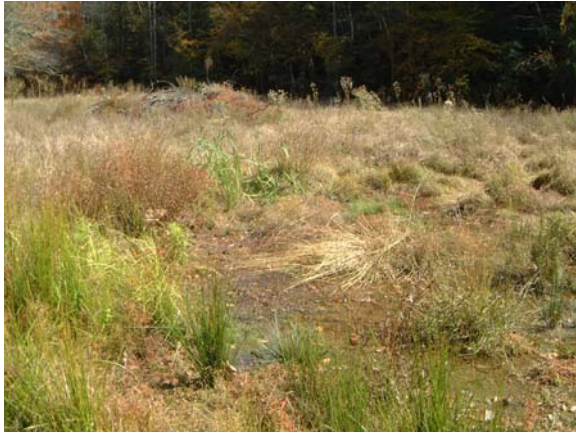
Looking upstream at wet depression from grading near barn at as-built Station ~16+00.
