Brown Branch Stream Restoration (Anita Alta 4-H Camp) 2004 Annual Monitoring Report

February, 2005

2004 Brown Branch Monitoring Abstract

This is the 2nd year of the 5-year monitoring plan for Brown Branch.

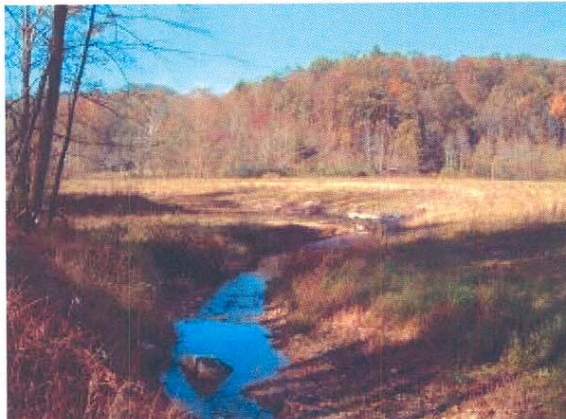
Photo Station #17. Looking downstream from as-built Station ~12+50. Tributary confluence to left. Rock has rolled from bank into channel from left.

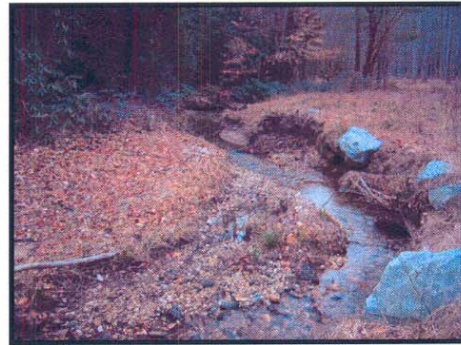
STA 0+30 Bank Erosion Right Bank Looking Downstream

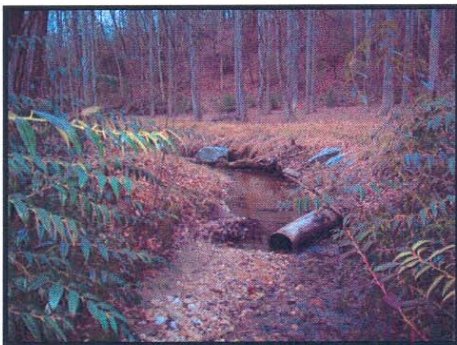
STA 1+25 Down-cut Streambed at a Single Vane Looking Downstream

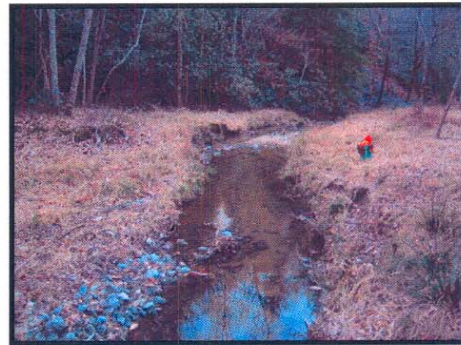
STA 2+00 Bank Erosion Looking Downstream

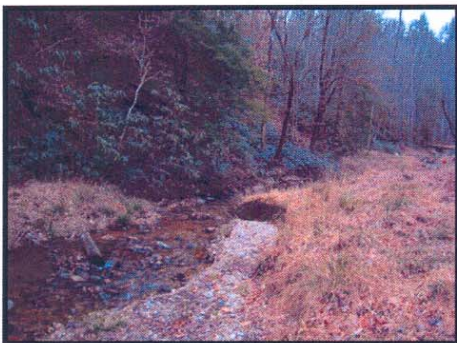
STA 2+90 Bank Blowout and Forming Bench Looking Downstream

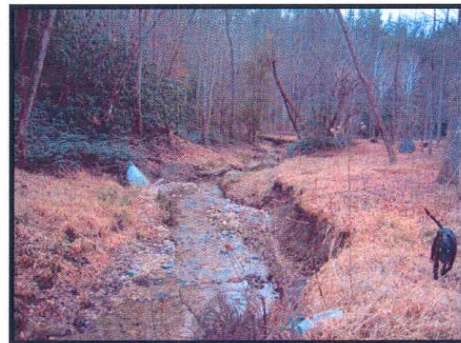
Bank erosion has been noted at fourteen locations on the restored reach of this stream. There are two areas of major bank erosion due to the in-channel shearing forces on the stream at station 4+40 and station at 7+00. The first area or major bank erosion occurred at station 4+20 to 4+60 there is a 40 ft long area of severe bank erosion on the right bank the bank has an extreme BEHI and is actively eroding. This erosion is captured by the surveyed cross-section #1 and is photo documented. The actively eroding bank height is 4.2 ft with a vertical non-protected bank. The second area of severe bank erosion occurred at station 6+80 to 7+20 there is a 40 ft long area of severe bank erosion on the left bank the bank has an extreme BEHI and is actively eroding. The actively eroding bank height is 6.5 ft with a vertical non-protected bank. The remainder of the bank erosion issues could be described as being caused by circulations behind a root wad or as occurring downstream on the outside of a meander bend. These causes or bank erosion will be investigated with future surveys and research. There are two areas of bank erosion due to overland seepage or flow at station 20+00 on the right bank and at station at 29+50 on the right bank. There are also three areas with an active mid-channel bar at station 40+10, at station 43+25 and at station at 44+50. At station 40+20 to 40+50 there is a 30 ft long mid channel bar. At station 43+10 to 43+60 there is a 50 ft long mid channel bar that. This mid-channel bar is captured by the surveyed cross-section #5 and is photo documented. At station 44+45 to 40+50 there is a 5 ft long mid channel bar that. These mid-channel bars will lead to future bank erosion and high near bank stress.

STA 4+00 Bank Erosion Right Bank Looking Downstream

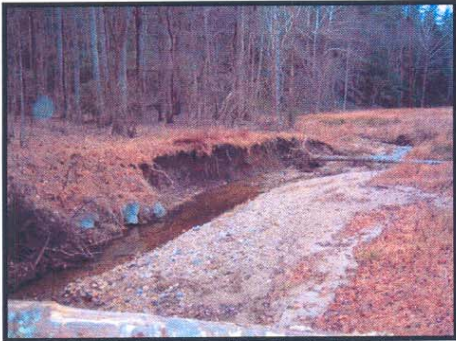
STA 6+75 Bank Erosion Left Bank Looking Downstream

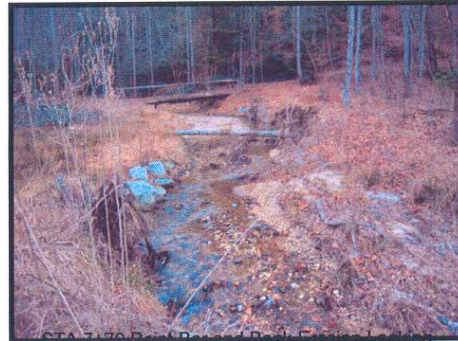
STA 7+70 Point Bar and Bank Erosion Looking Upstream

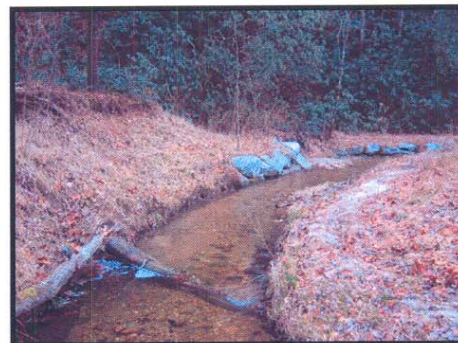
STA 9+70 Down-cut Log Sill Looking Downstream

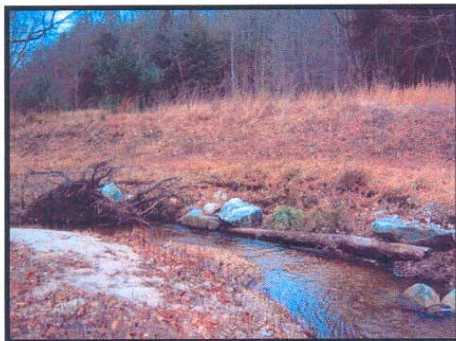
STA 14+75 Looking Downstream @BankErosion

- The site could benefit from larger containerized trees both for bank stability and aesthetics, although mitigation requirements are currently being met.
- It is recommended to stake in areas where erosion is problematic, particularly on outside meander bends.

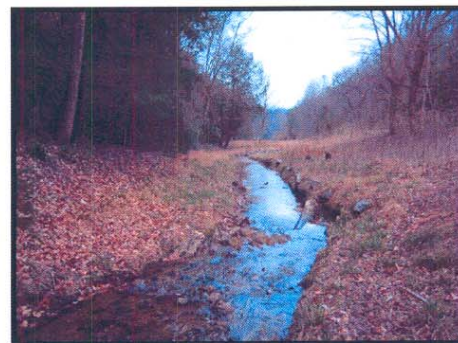
STA 16+50 Looking Downstream @ Single Log Vane and Bank Scour

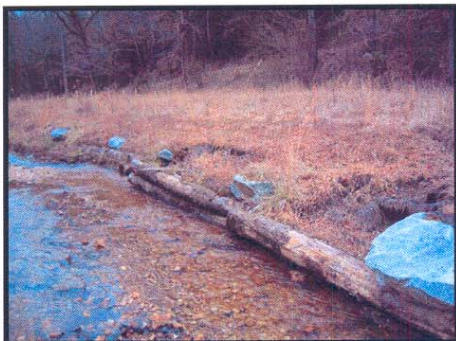
STA 20+70 Looking Downstream @Exposed Toe Log

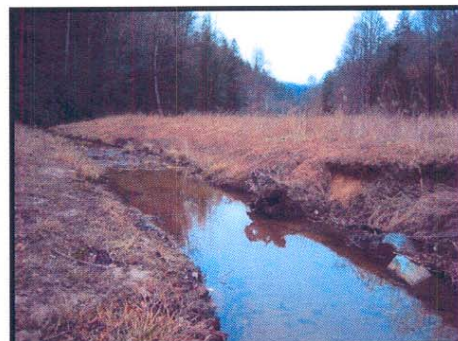
STA 21+30 Looking Downstream @ Bank Erosion Tight Radius of Curvature

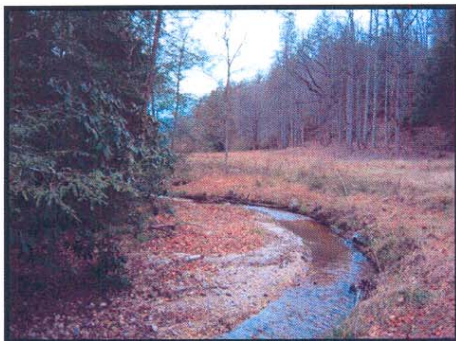
STA 23+10 Looking Downstream @A Good Point Bar

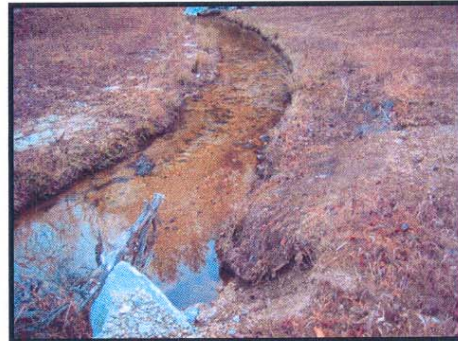
STA 29+00 Looking Downstream @Bank Erosion

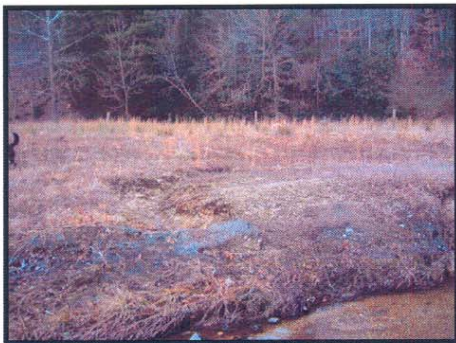
STA 30+20 Looking @ Left Bank Rill and Gully Erosion

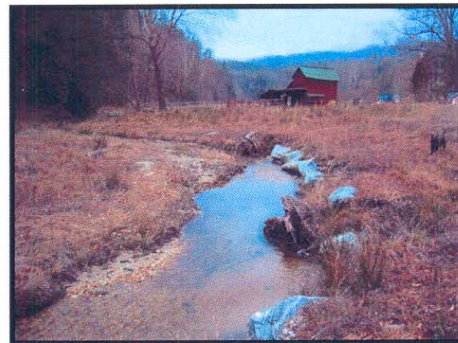
STA 33+25 Looking Downstream @Bank Erosion

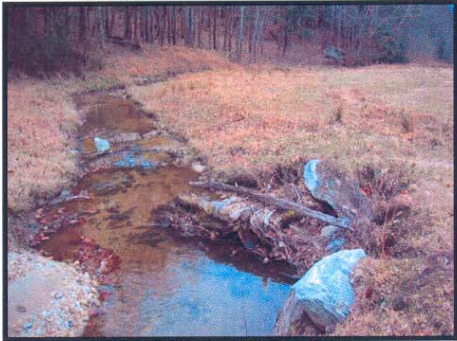
STA 36+90 Downstream @ Bank Erosion

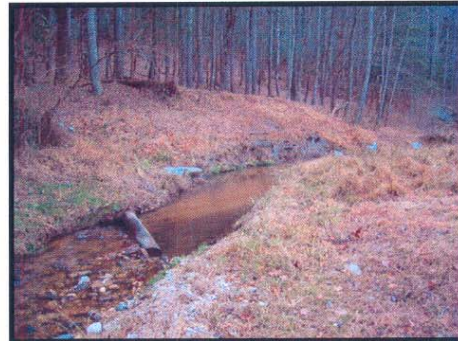
STA 37+40 Downstream @ Down-cut Log Vane

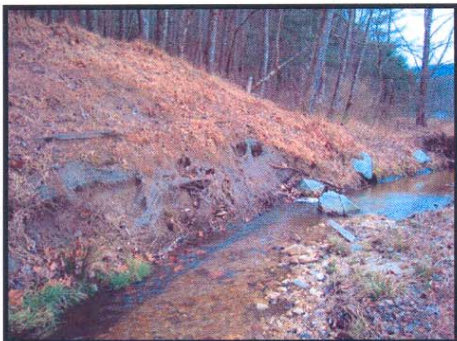
STA 38+50 Looking Downstream @ Valley Bank Erosion

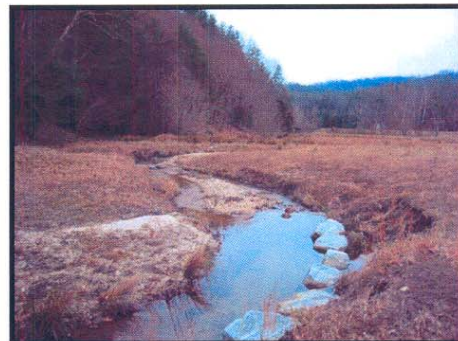
STA 39+70 Downstream @ Mid-Channel and Bank Erosion

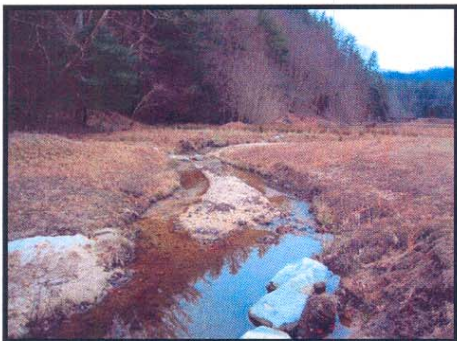
STA 39+90 Downstream @ Mid-Channel and Bank Erosion

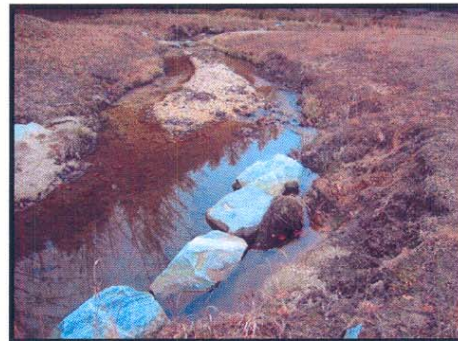
STA 39+90 Downstream Erosion

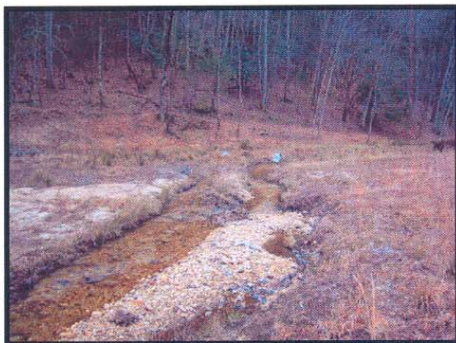
STA 43+10 Looking Downstream @Severe Mid-Channel Bar

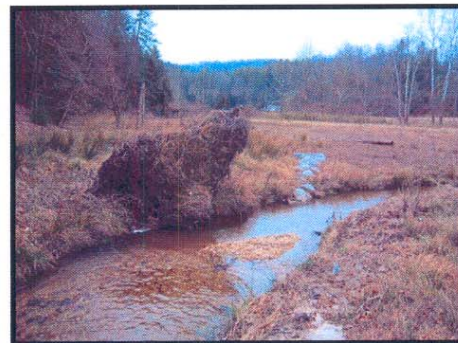
STA 44+00 Looking Downstream @High Root Wad and MCB
