Brown Branch Stream Restoration – Project #53 Fourth Annual Monitoring Report

Delivered to: NCDENR-Ecosystem Enhancement Program
1619 Mail Service Center
Raleigh, NC 27699-1619

Prepared by: MACTEC Engineering and Consulting, Inc.
3301 Atlantic Avenue
Raleigh, North Carolina 27604
(919) 876-0416

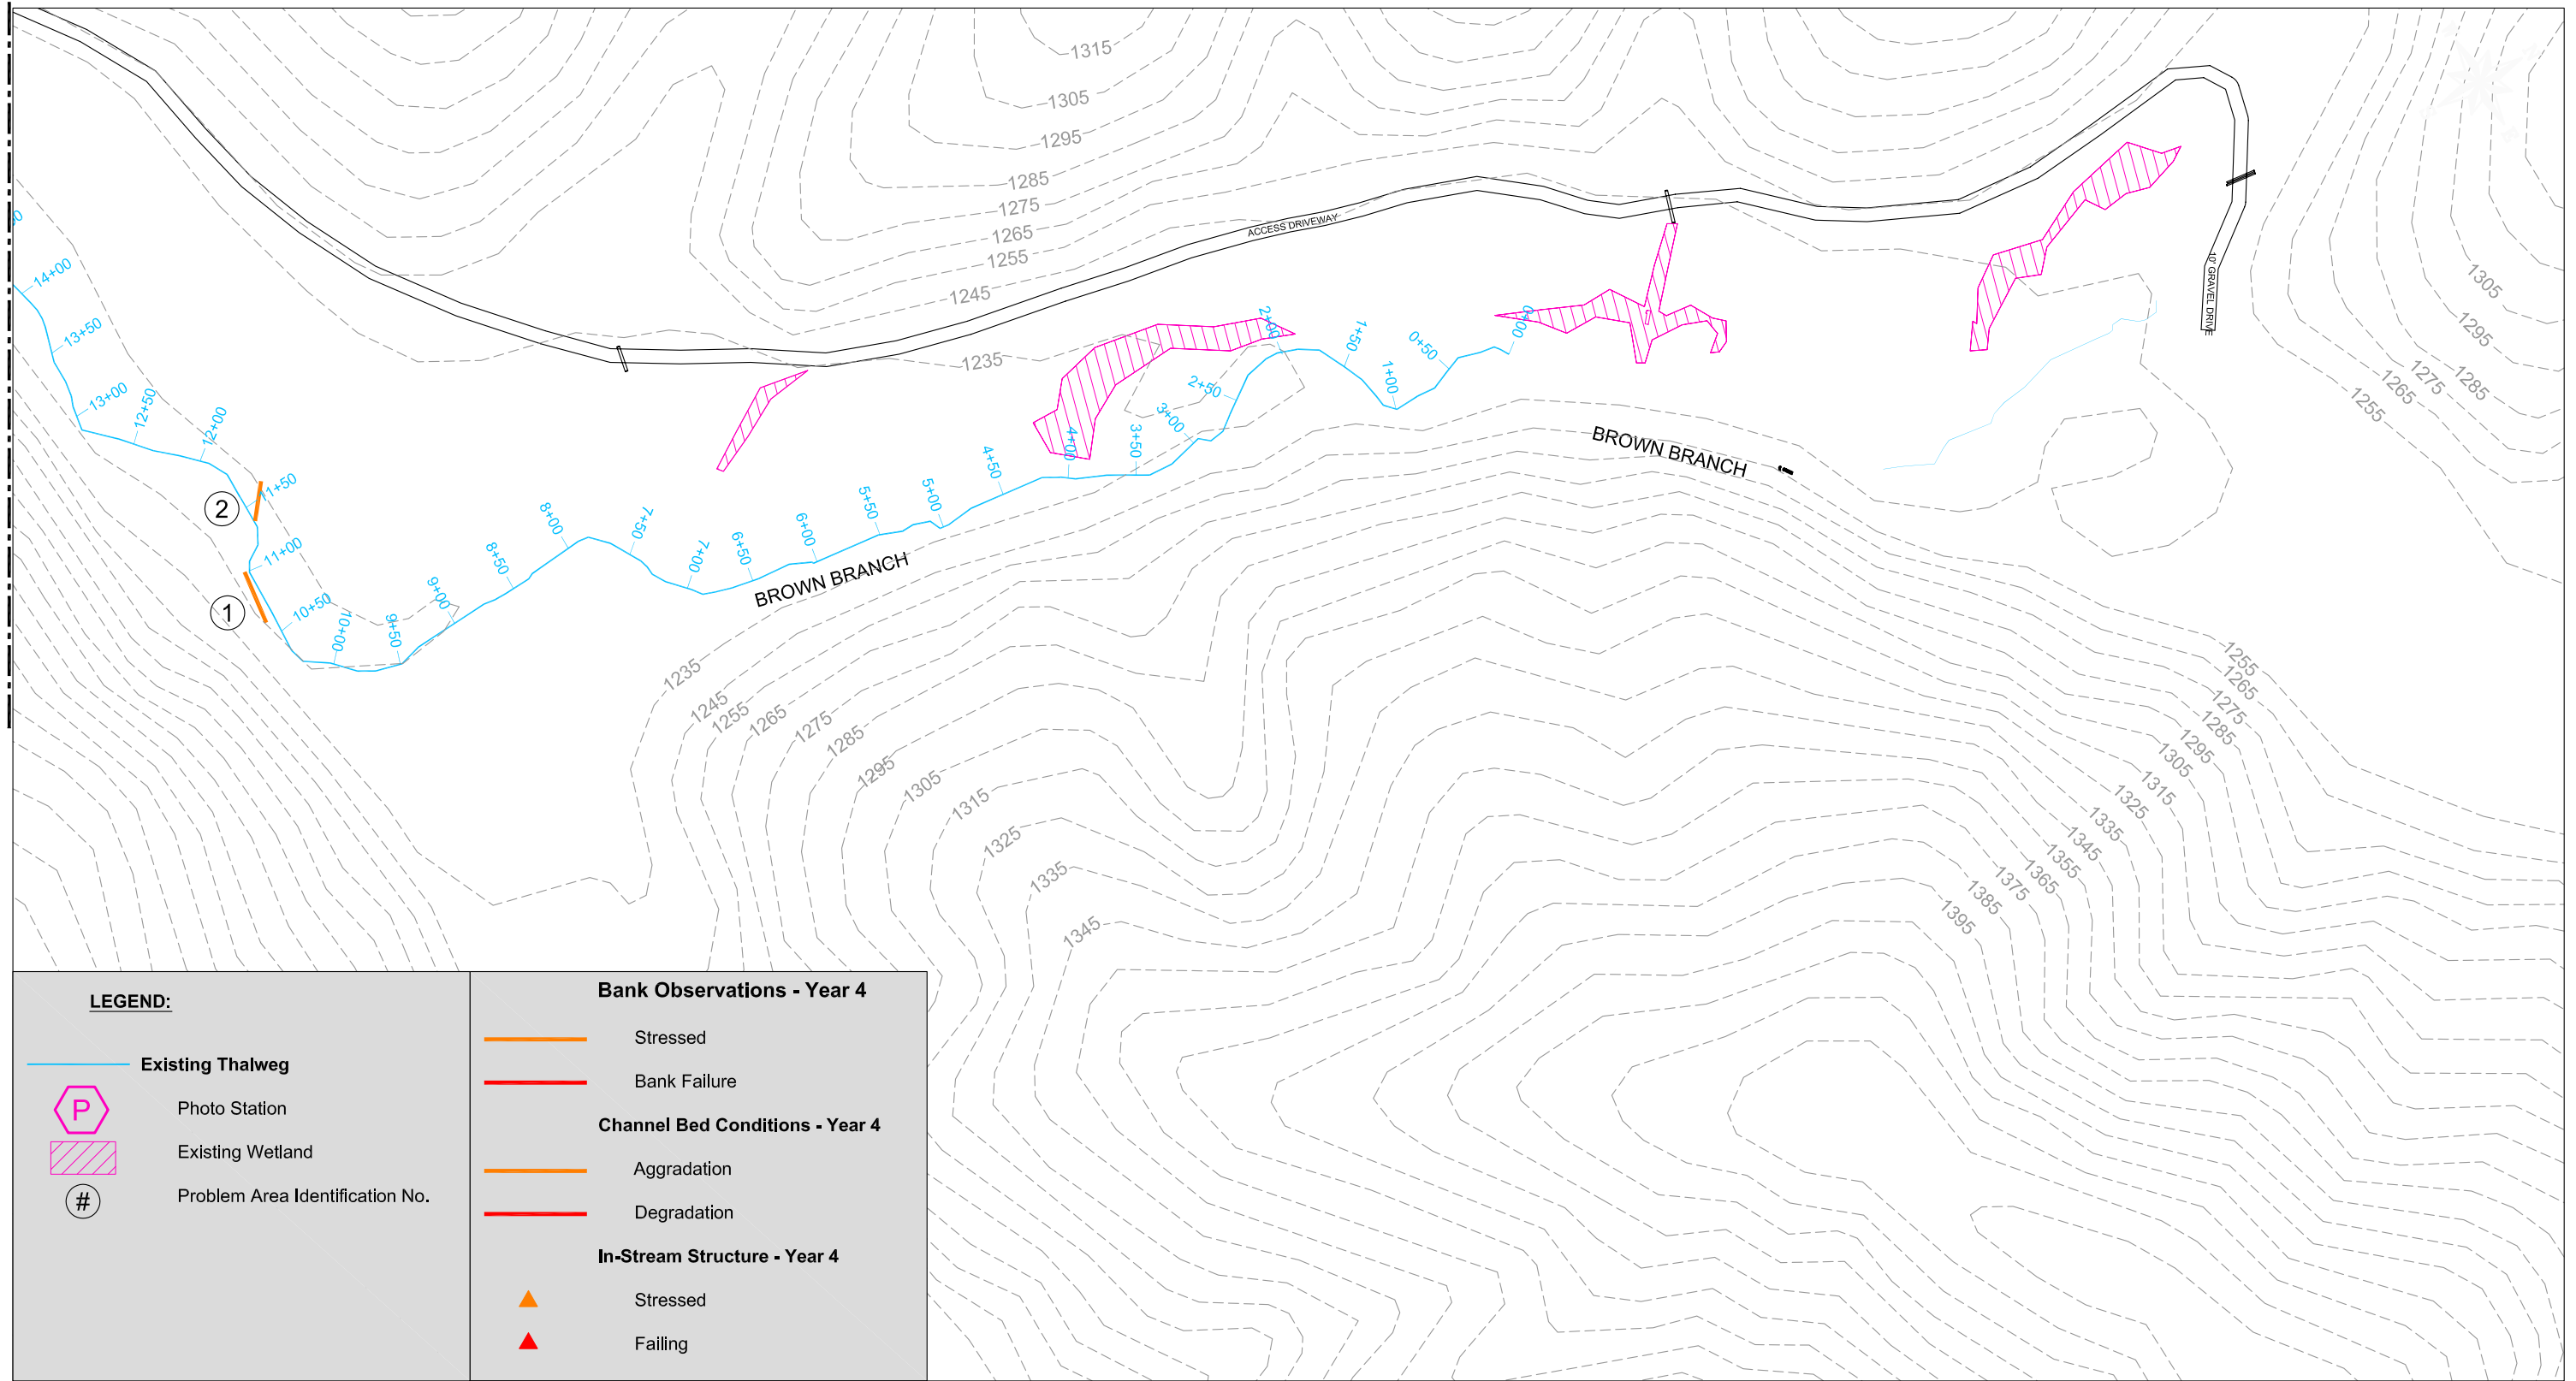
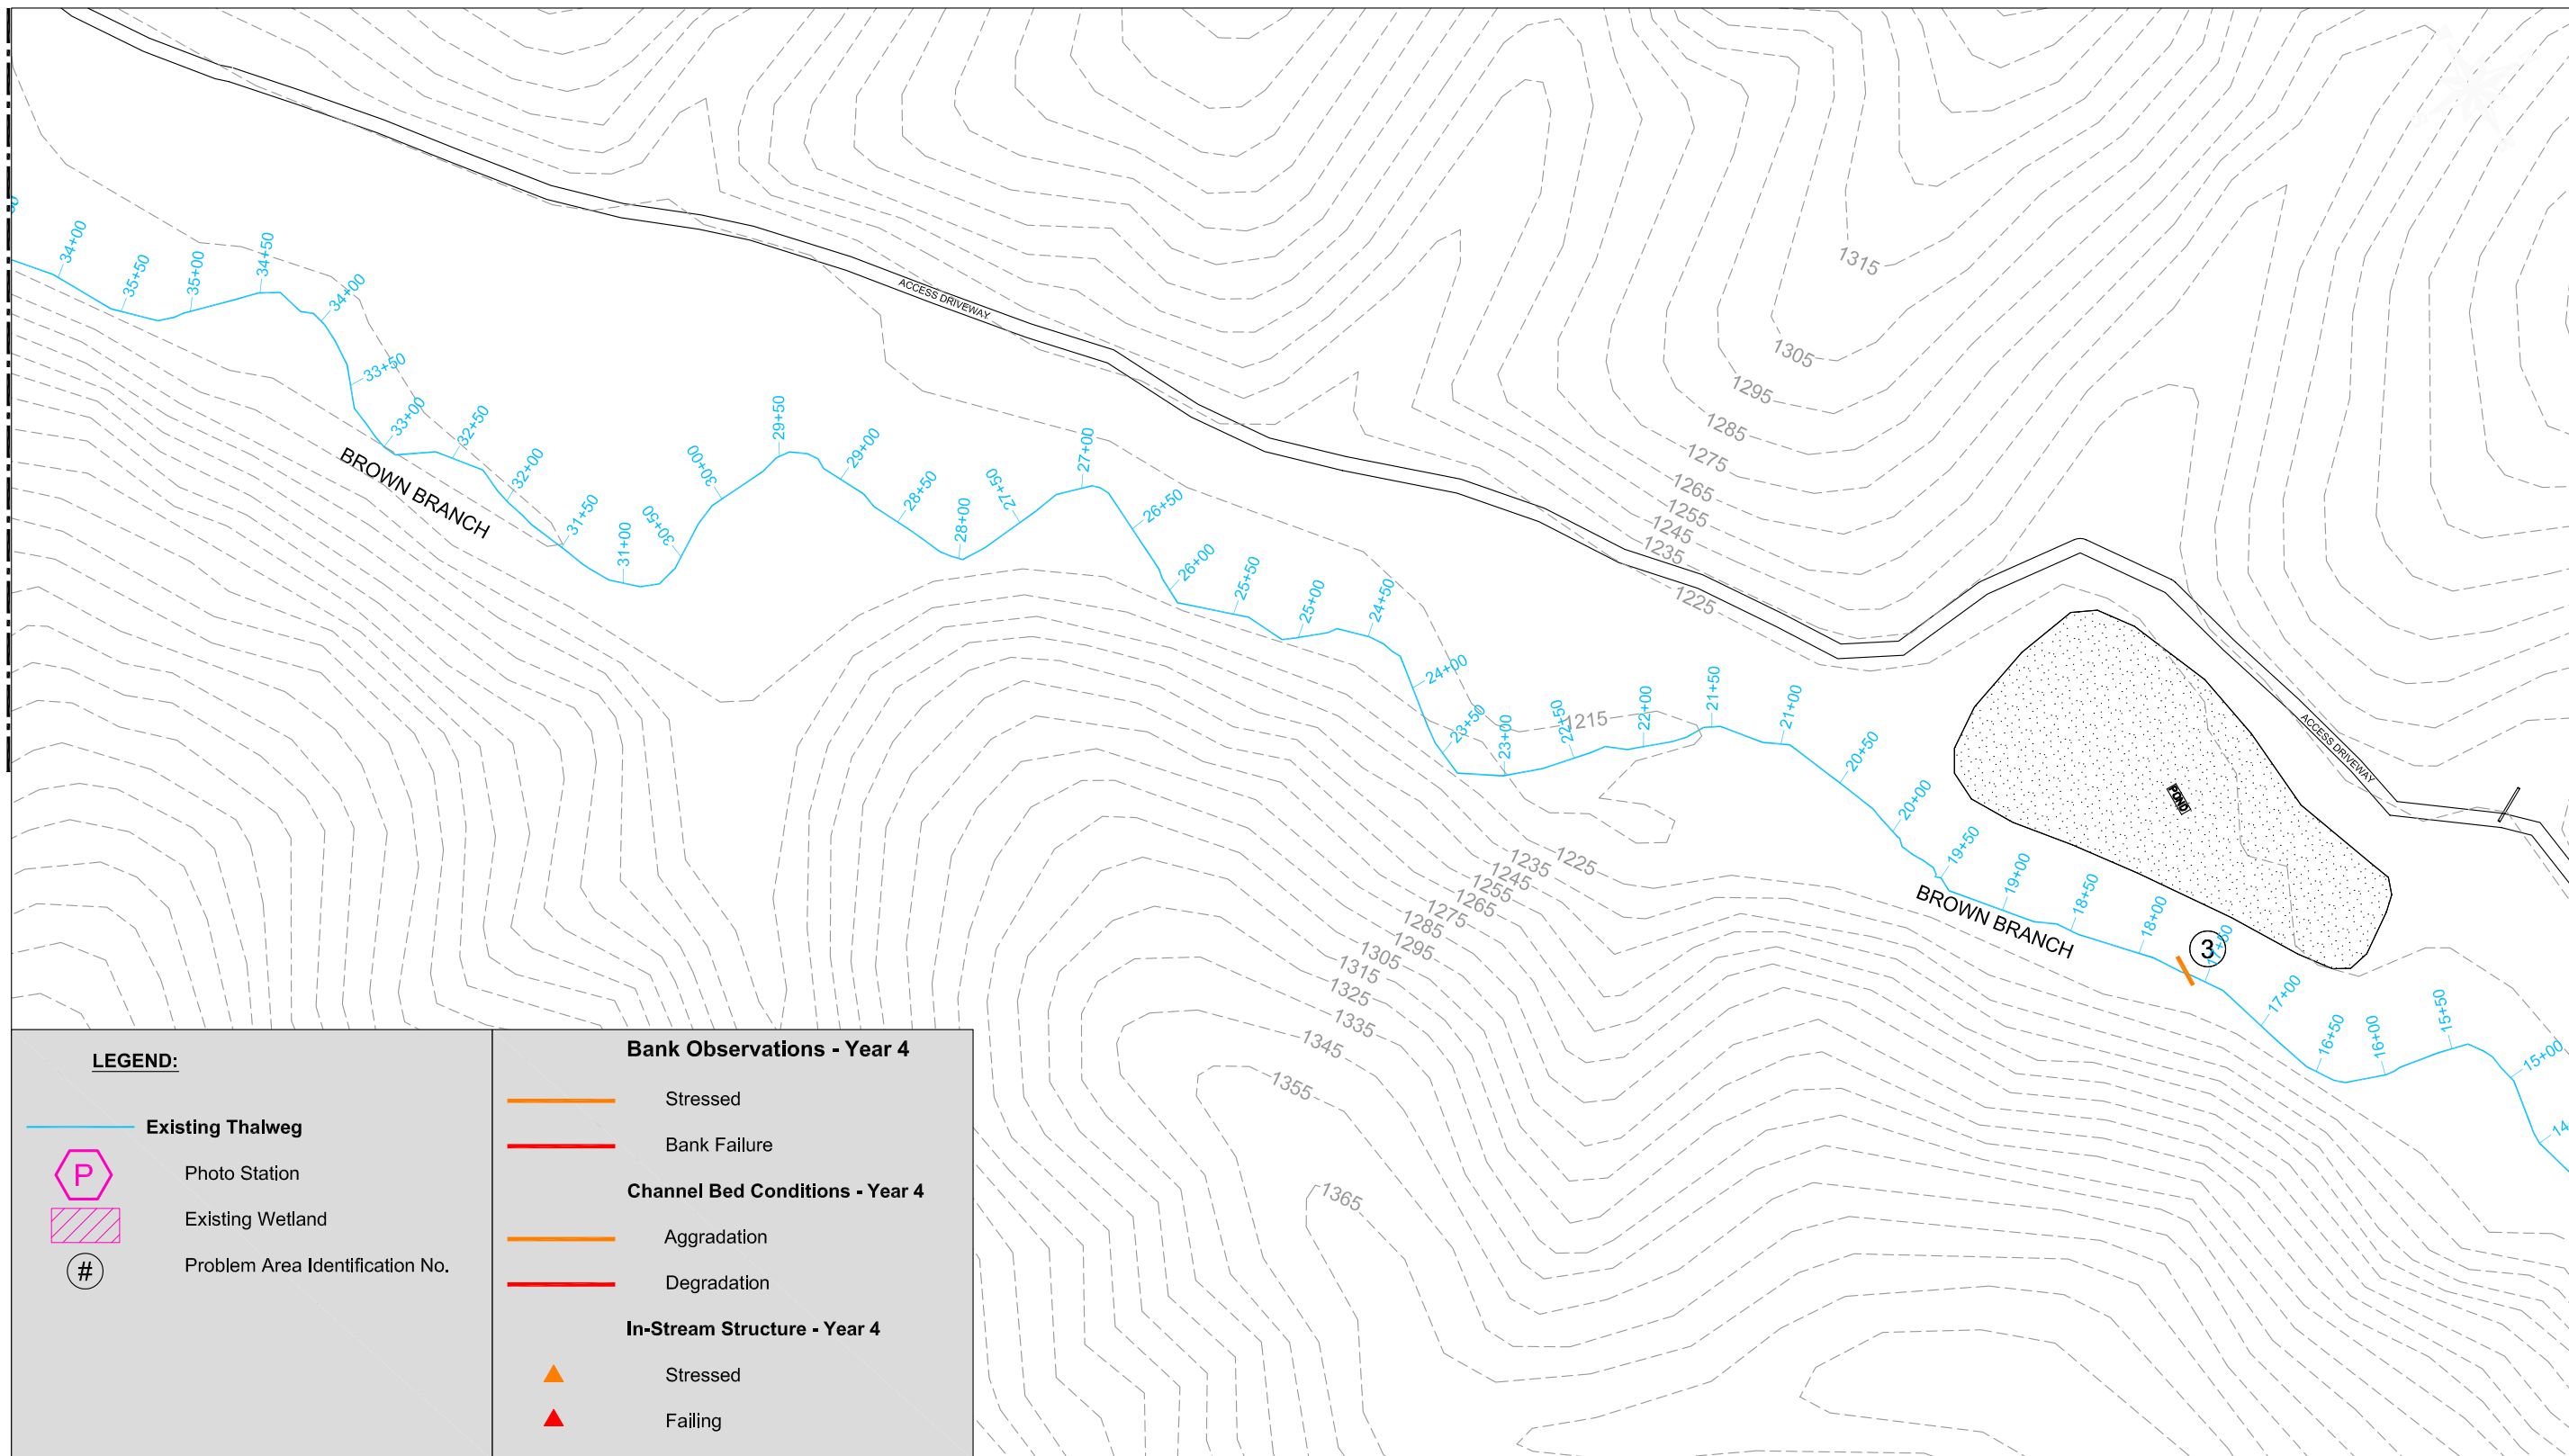
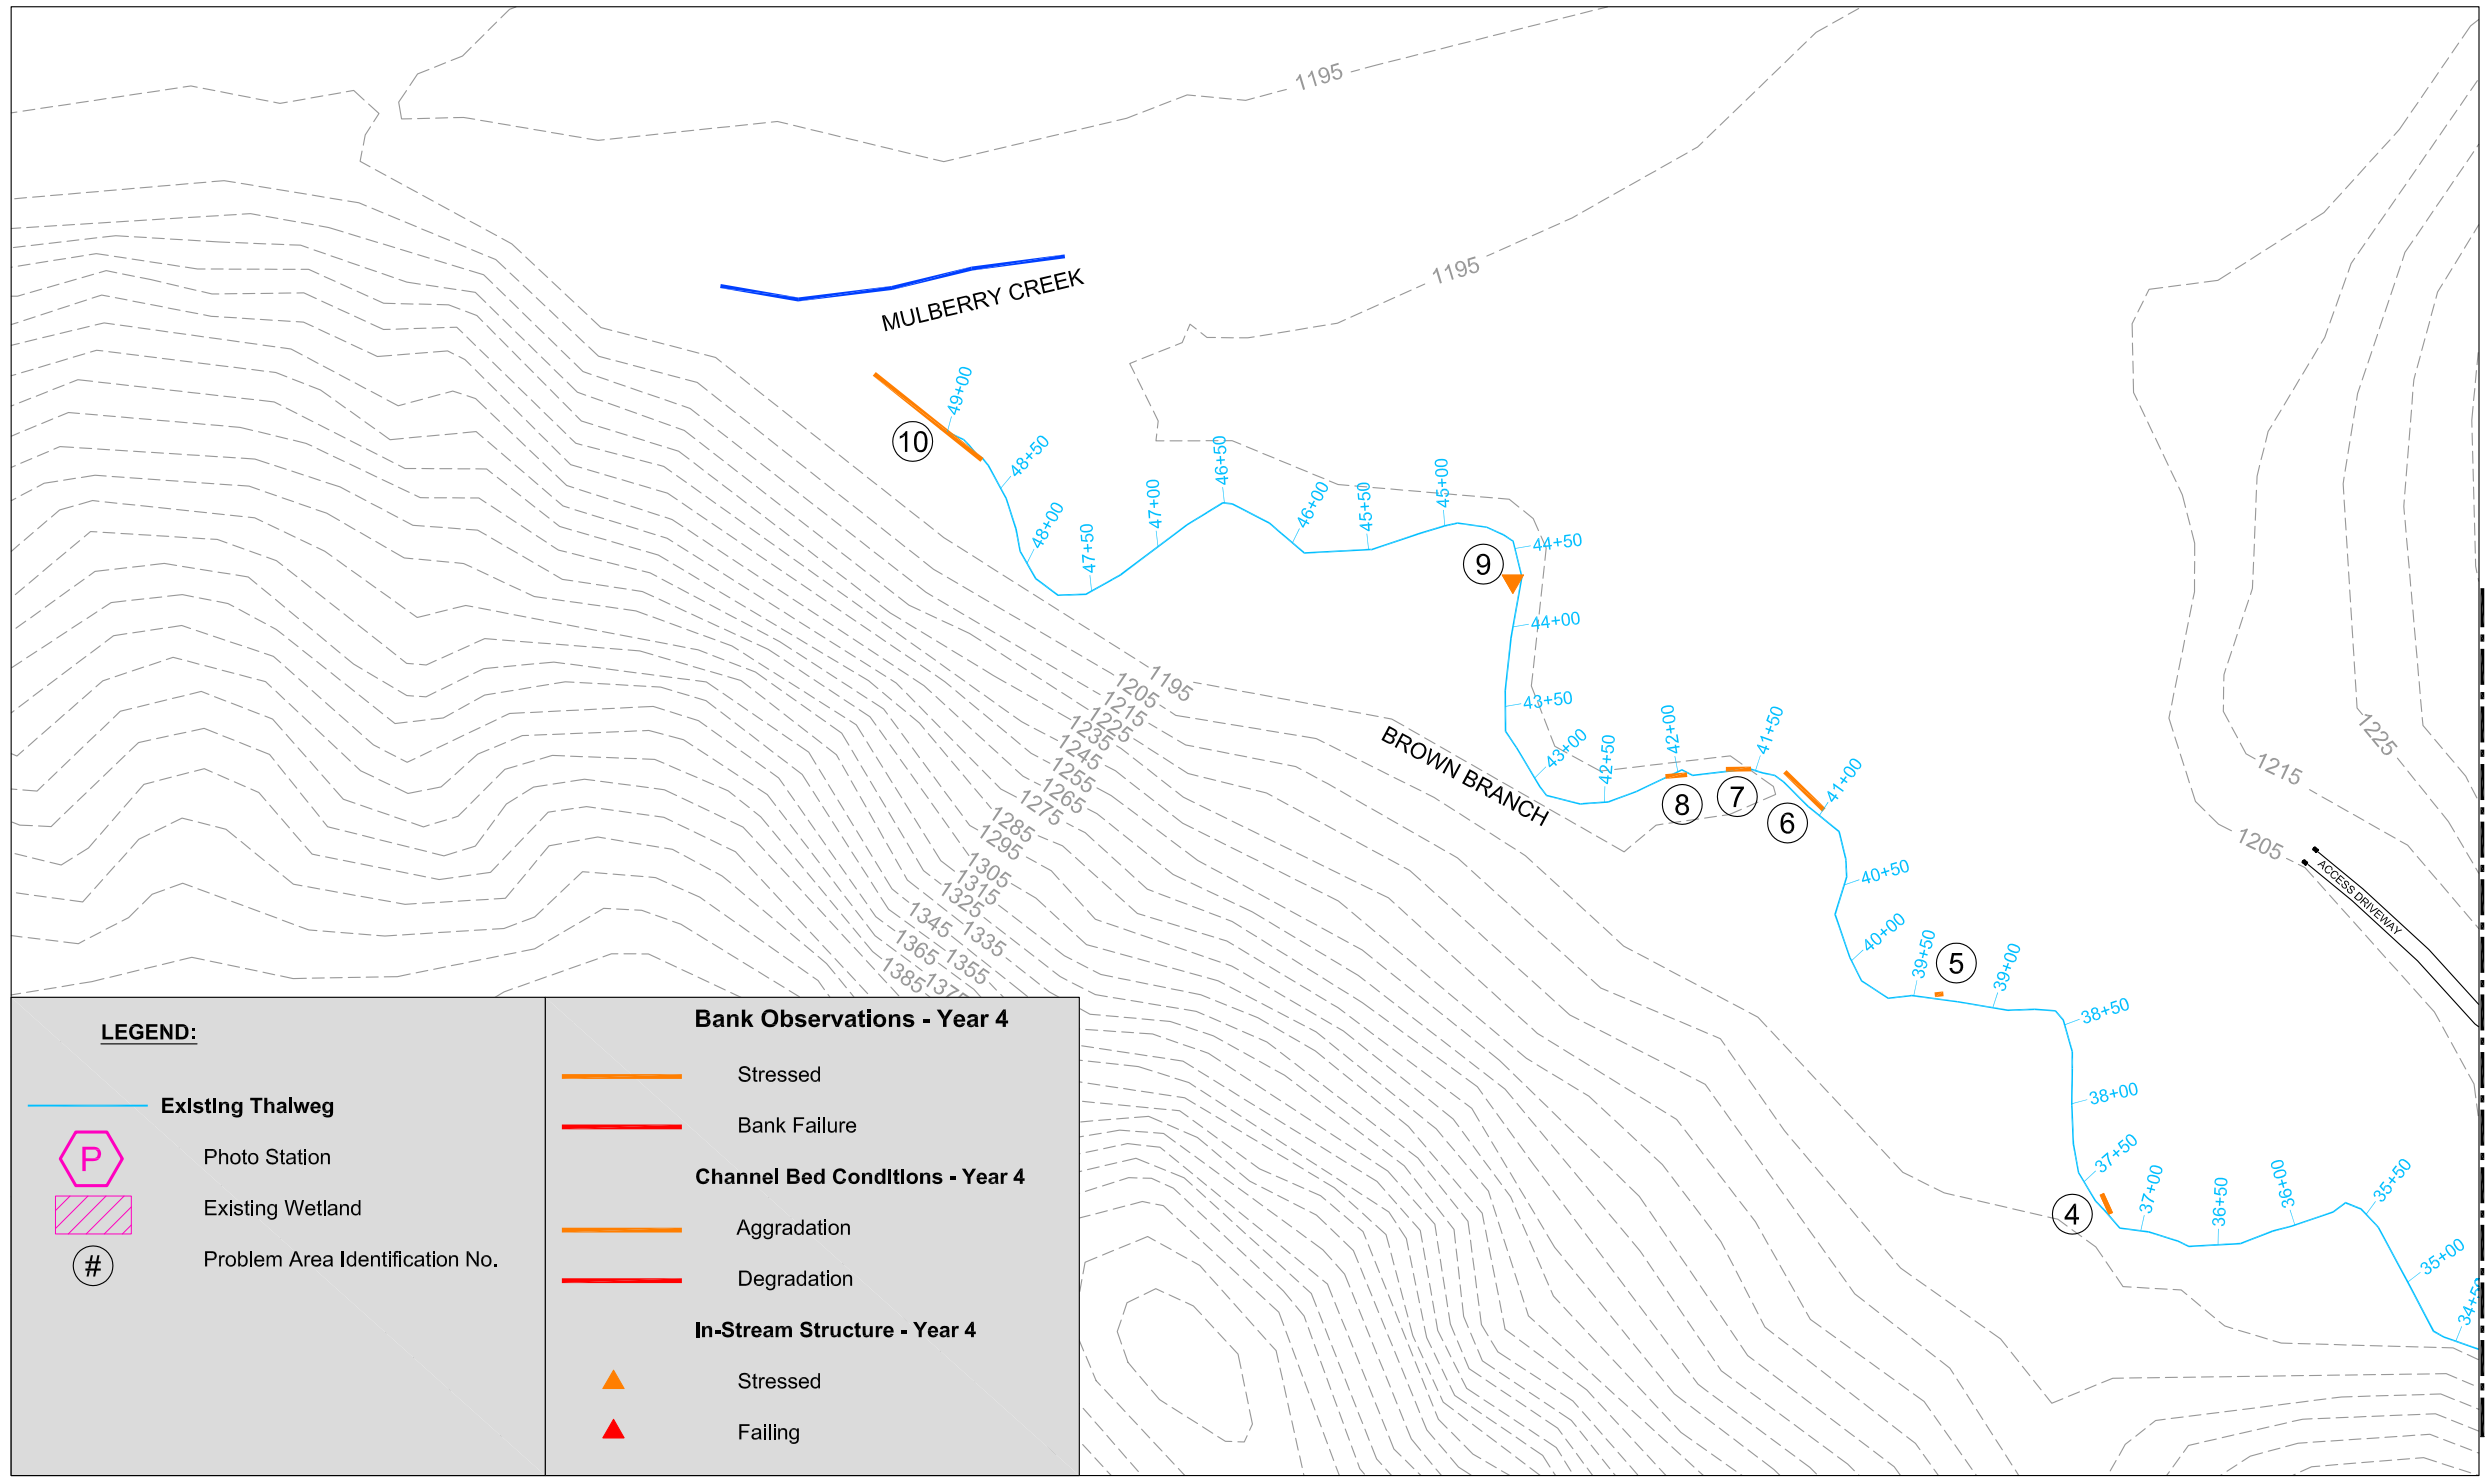
**PROBLEM AREA PLAN VIEW-
SEPTEMBER 2006**

Most problems located along the stream channel were due to the formation of mid-channel bars from aggradation. Other areas of concern were downstream of large tree falls located during the stream profile survey. Areas where trees had fallen into the stream are undergoing significant erosion and scour. Also, noted was the presence of two beaver dams located in the upper reach of Brown Branch above the restoration area.

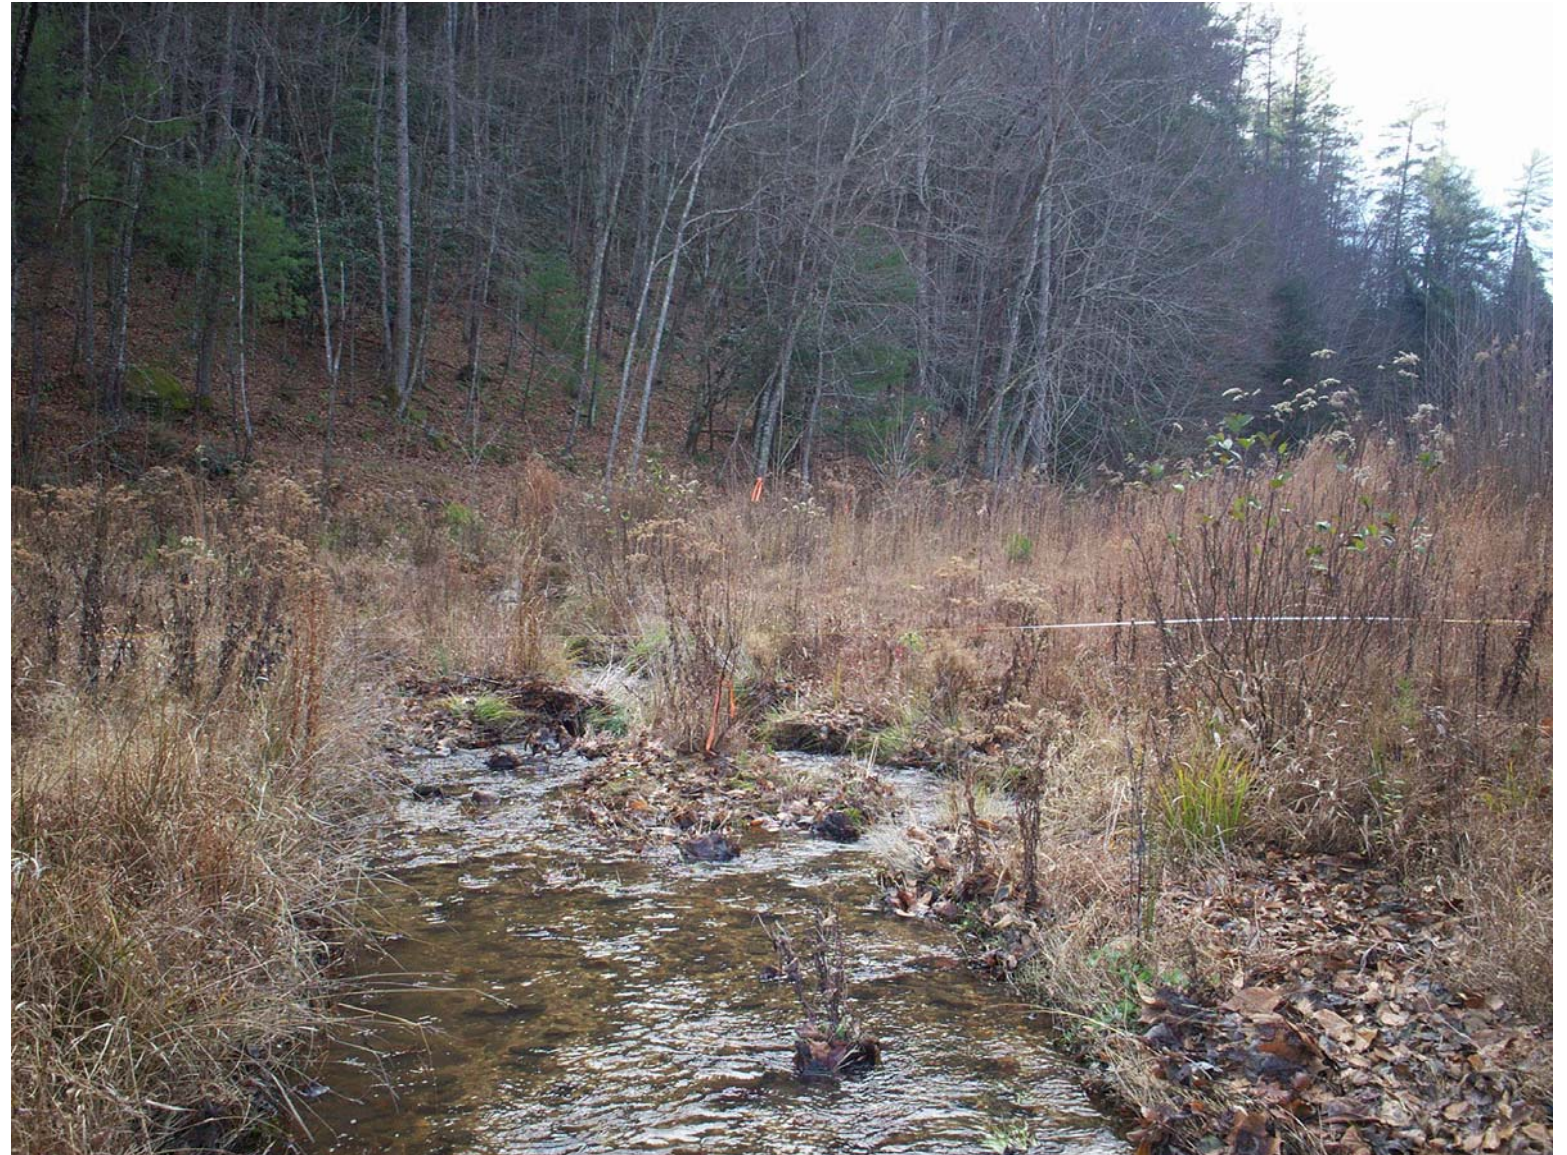
Photo of Cross-Section #5 - Looking Downstream

PHOTOLOG SHEET
Site: Brown Branch Problem Area
Caldwell County, North Carolina
Project No: 6470-06-1410.02
Date: October 2006
Photo #: 9
Photographed by: R.E. Spears
Description: Mid channel bar formation at cross-section 5.
