# **Brown Branch Stream Restoration – Project #53 Fifth Annual Monitoring Report**

Submitted to:

NCDENR-Ecosystem Enhancement Program  
1619 Mail Service Center  
Raleigh, NC 27699-1619

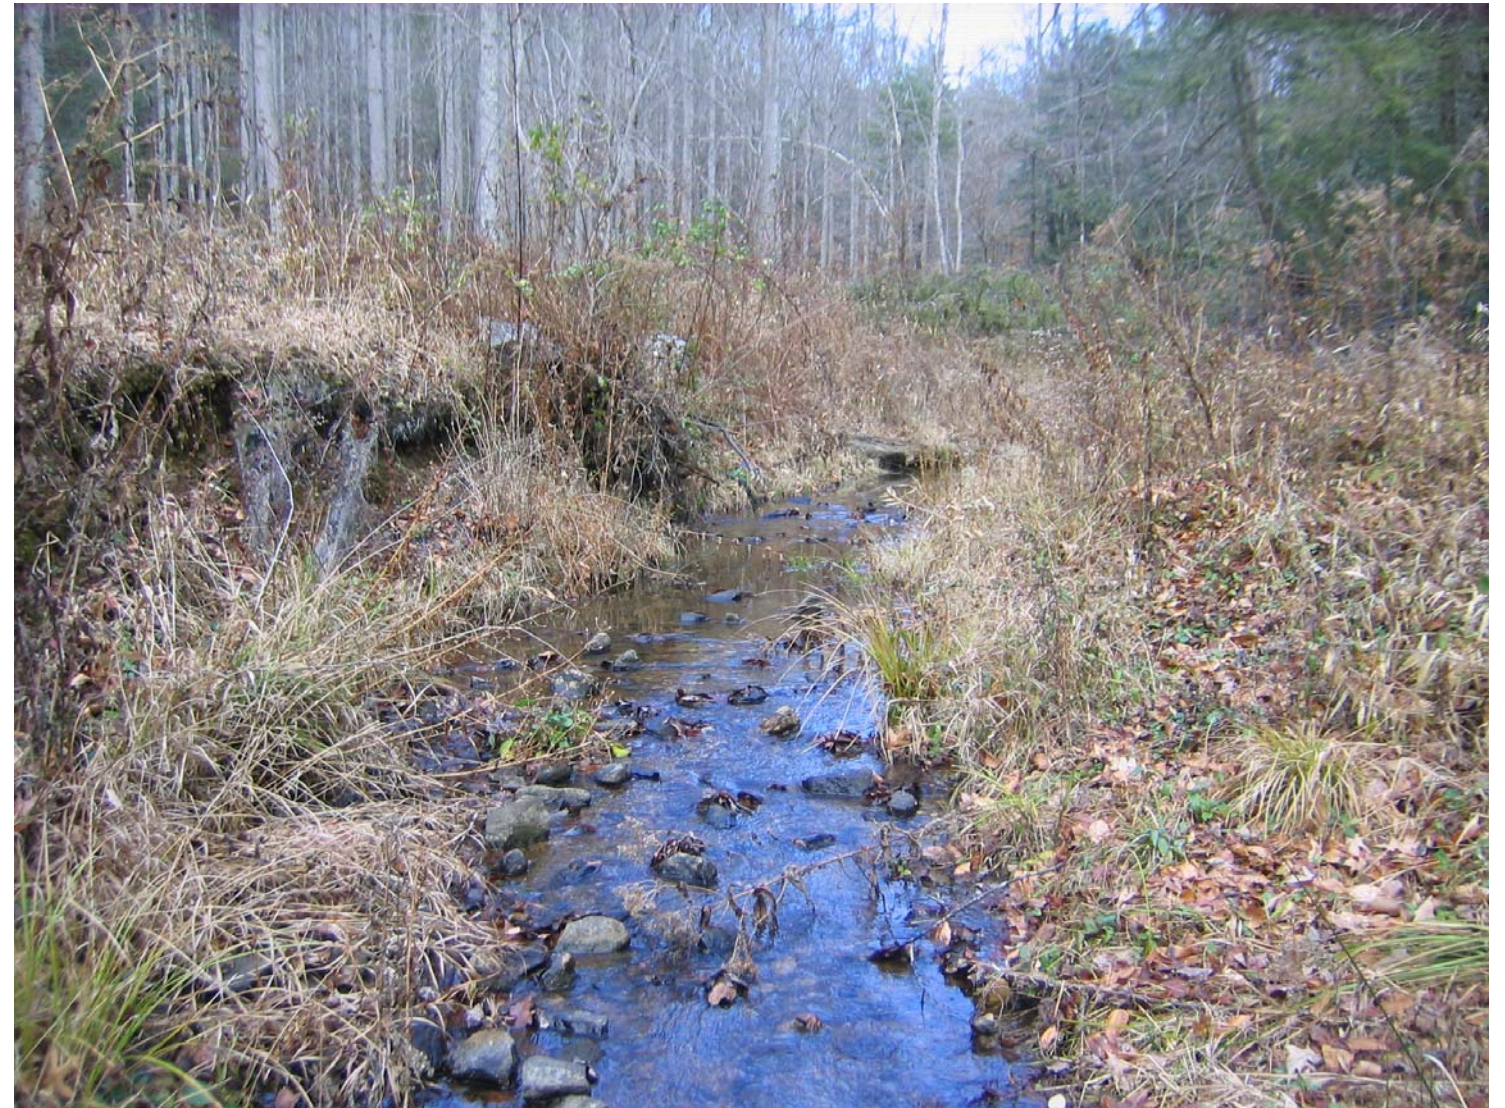
Photo (12-20-07) of Cross-Section #1 - Looking Upstream

Bankfull Area					
	As Built	MY2	MY3	MY4	MY5
Area	14.1	26.18	21.26	26.18	21.35
Width	12.2	16.5	15.2	16.5	17.7
Mean Depth	1.2	1.6	1.4	1.6	1.2
Max Depth	1.8	2.3	2.2	2.3	2.3
w/d ratio	10.6	10.4	10.9	10.4	14.7
FPW	>100	>100	>100	>100	>100
ER (greater than)	8.2	6.1	6.6	6.1	5.6
Stream Type	C	E	C	C	C

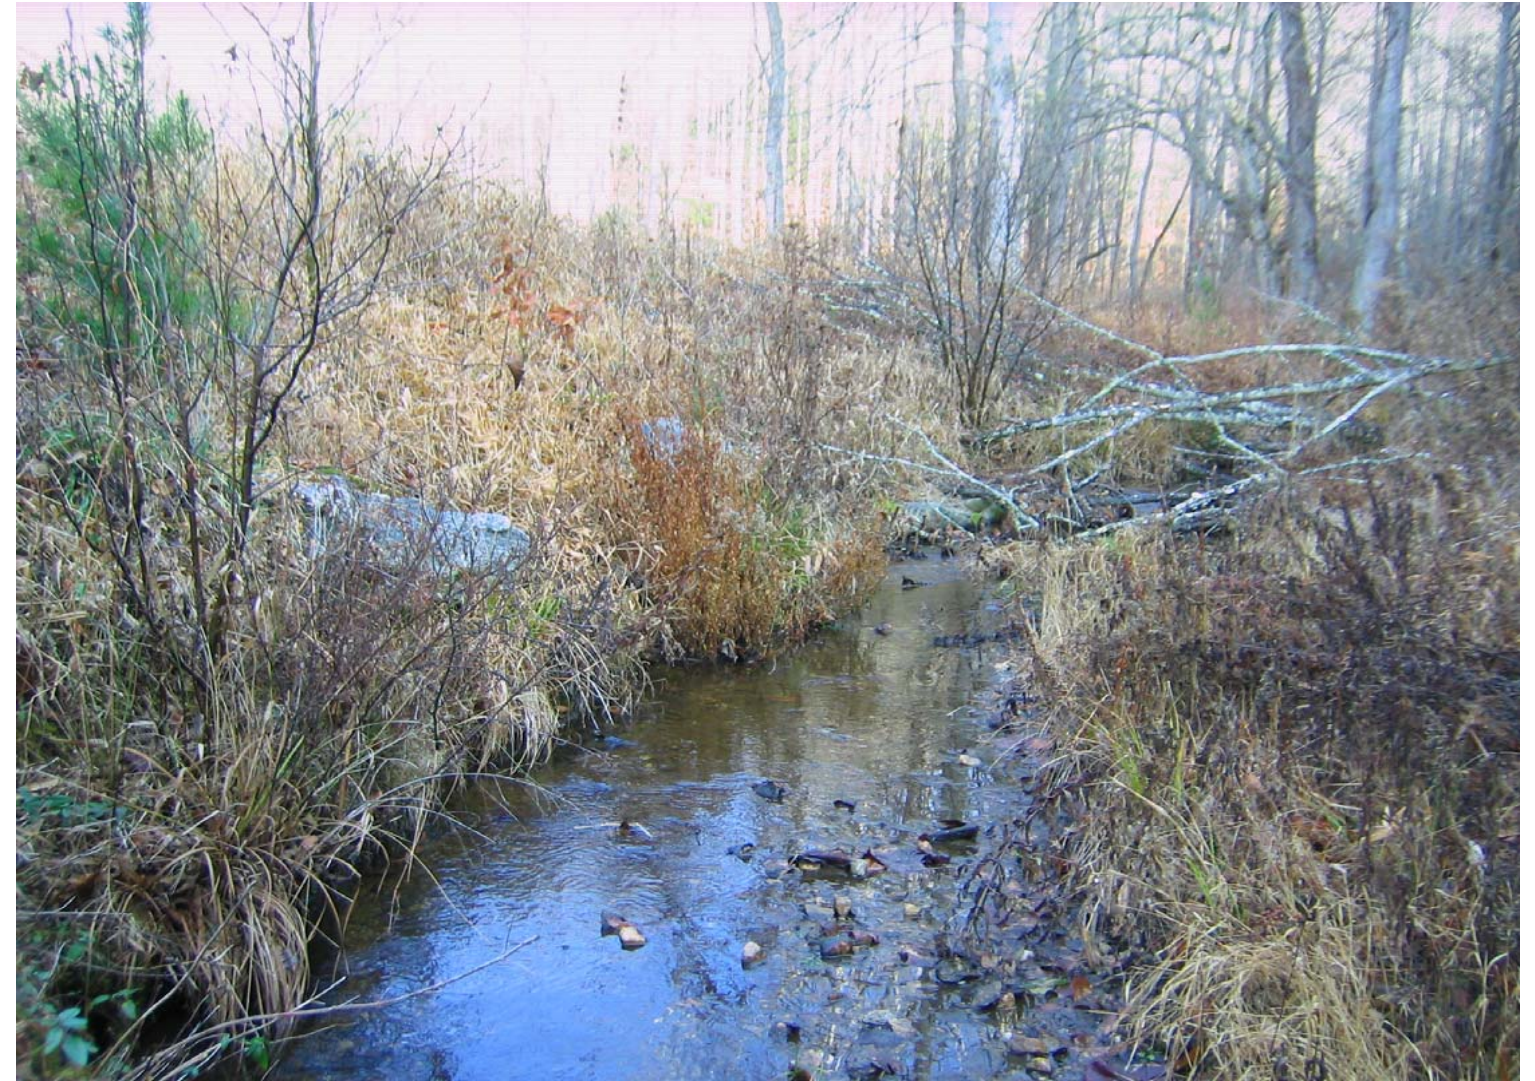
### Cross-Section #2 - Pool Station 10+70 Brown Branch

Photo (12-20-07) of Area 1 Cross-Section #2 - Looking downstream

Bankfull Area				
	As-Built	2003	2004	2006	2007
Area	16.1	24.10	21.36	21.8	19.0
Width	21.9	24.2	36.3	34.3	26.6
Mean Depth	0.7	1.0	0.6	0.6	0.7
Max Depth	1.8	1.7	1.9	1.6	1.7

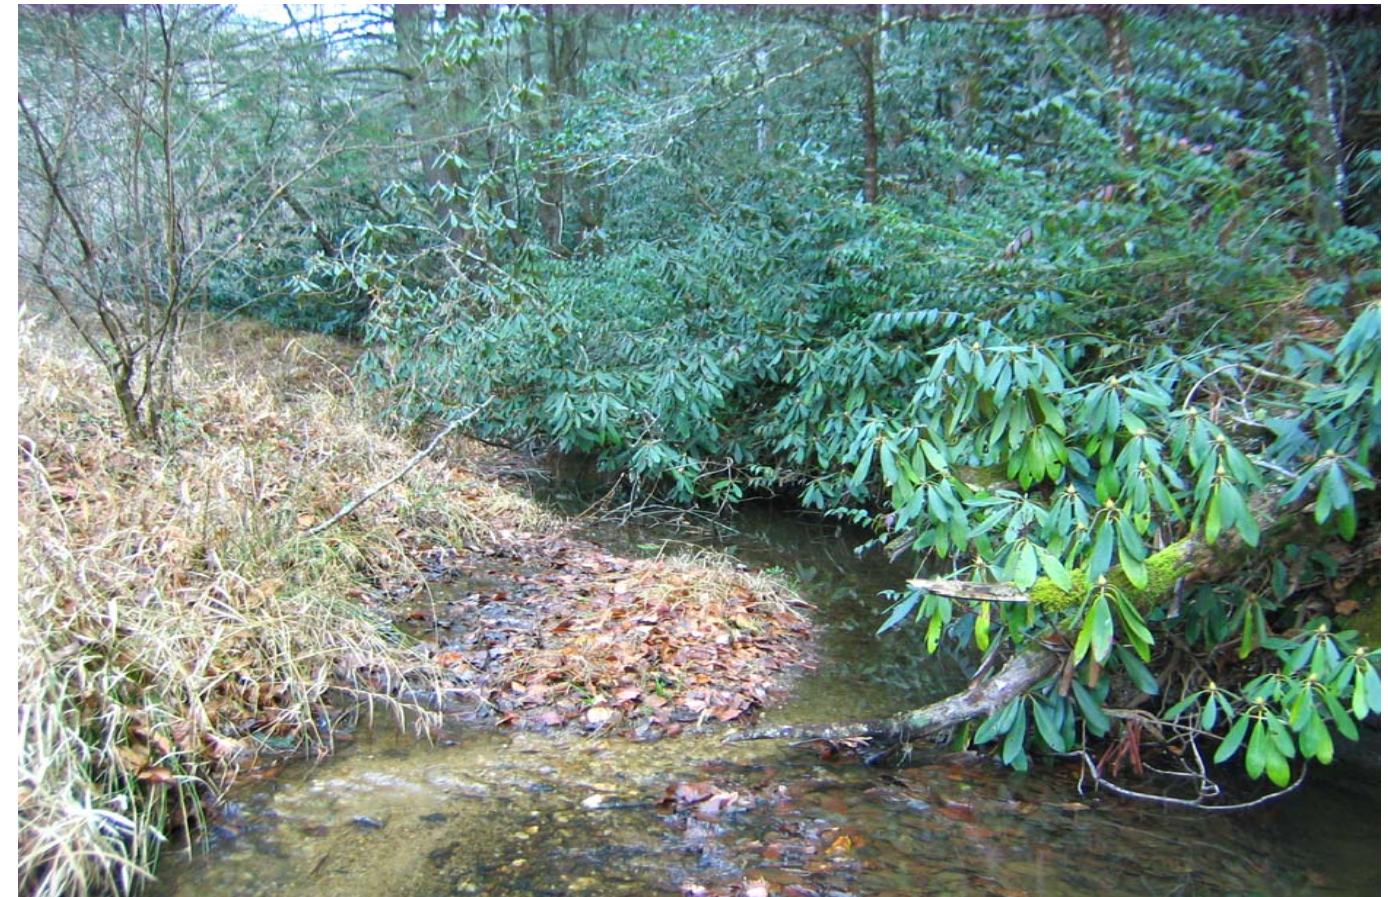
Photo (12-20-07) of Cross-Section #3 - Looking Upstream

Bankfull Area					
	As-Built	2003	2004	2006	2007
Area	15.8	15.98	14.21	14.96	14.02
Width	13.8	11.9	11.9	14.9	14.6
Mean Depth	1.1	1.3	1.19	1.00	0.96
Max Depth	1.7	1.7	1.8	1.8	1.9
w/d ratio	12.1	8.9	10.0	14.8	14.8
FPW		>100			
ER (greater than)	7.2	8.4	8.4	6.7	6.9
Stream Type	C	C	E	E	E

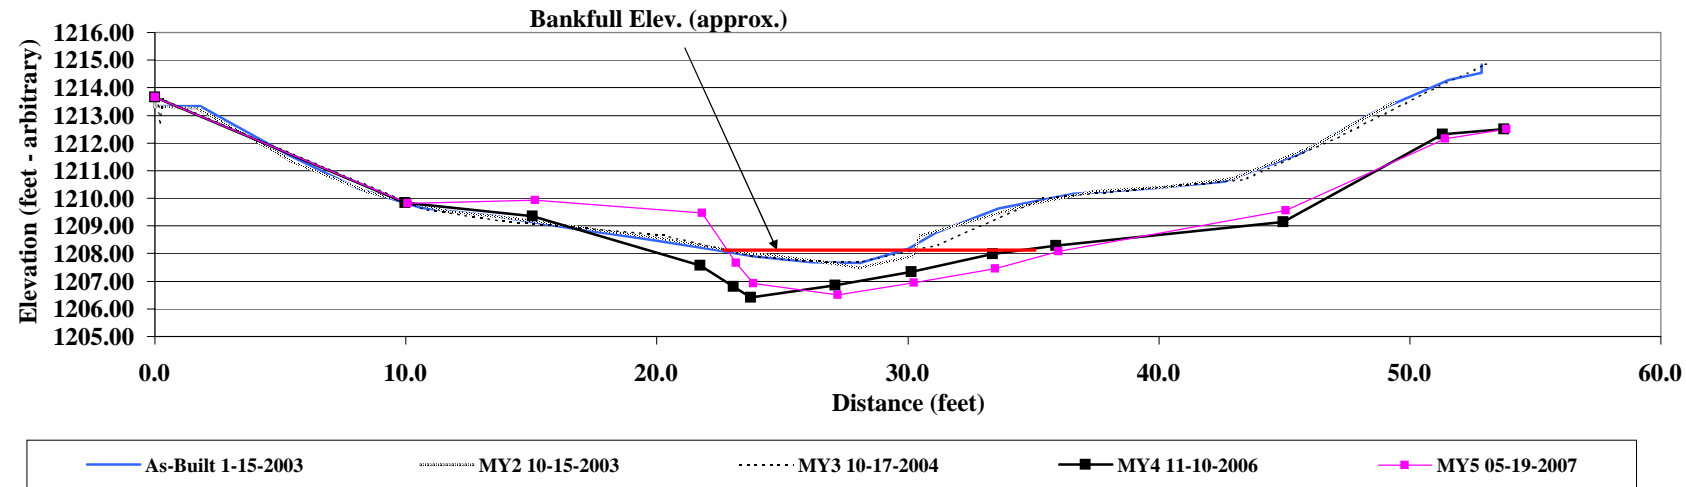
**Cross-Section #4 - Pool**  
**Brown Branch -- Station 19+40**

Bankfull Area					
	As-Built	2003	2004	2006	2007
Area	23.3	23.78	26.72	36.10	31.40
Width	23.0	25.8	32.7	20.9	29.9
Mean Depth	1.0	0.9	0.8	1.7	1.0
Max Depth	1.9	1.9	1.9	3.2	3.1

Photo (12-20-07) of Cross-Section #4 -  
 Looking Upstream

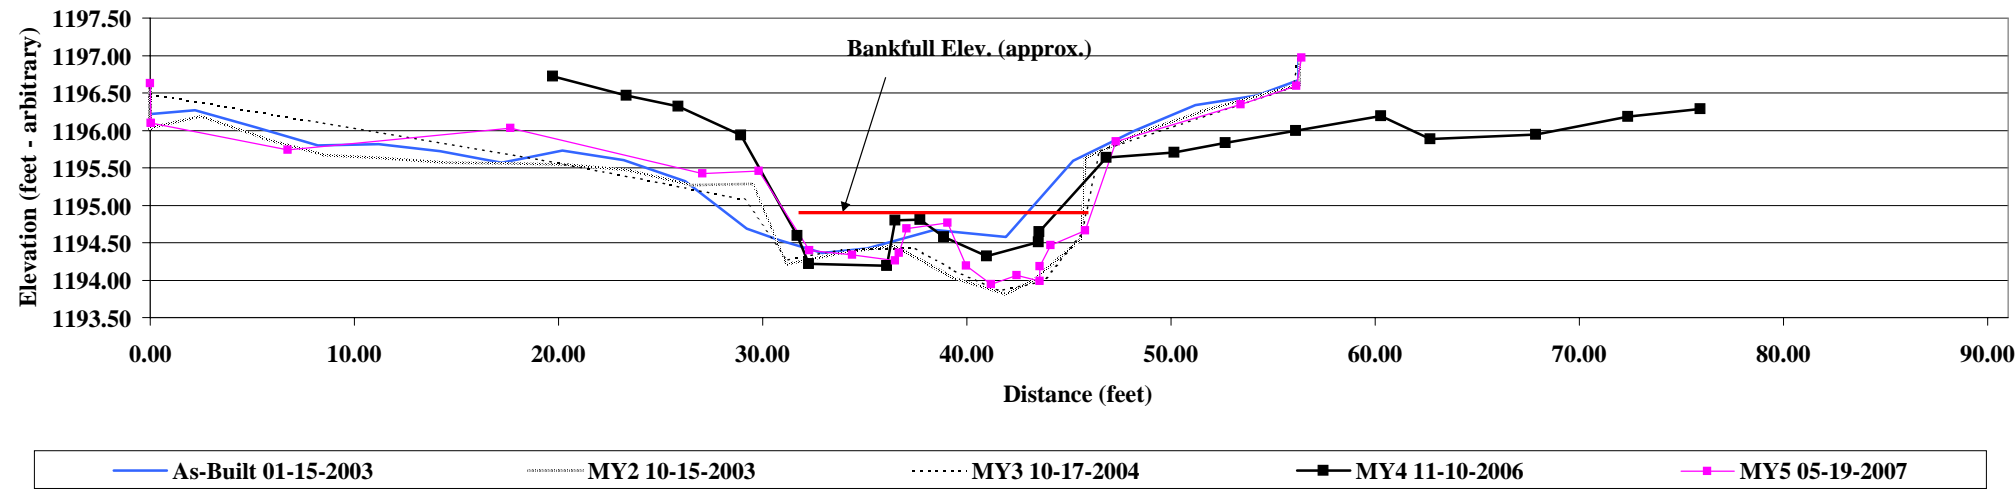
Cross-Section #5 - Riffle Station 43+00  
Brown Branch

Bankfull Area				
	As-Built	2003	2004	2006	2007
Area	9.7	14.92	15.12	11.54	15.92
Width	15.7	16.1	20.4	17.9	17.5
Mean Depth	0.6	0.9	0.7	0.6	0.9
Max Depth	1.0	1.5	1.5	1.1	1.6
w/d ratio	25.4	17.4	27.5	27.8	19.3
FPW		>100			
ER (greater than)	6.4	6.2	4.9	5.6	5.7
Stream Type	E	E	E	E	E

Photo (12-20-07) of Cross-Section #5 - Looking Downstream

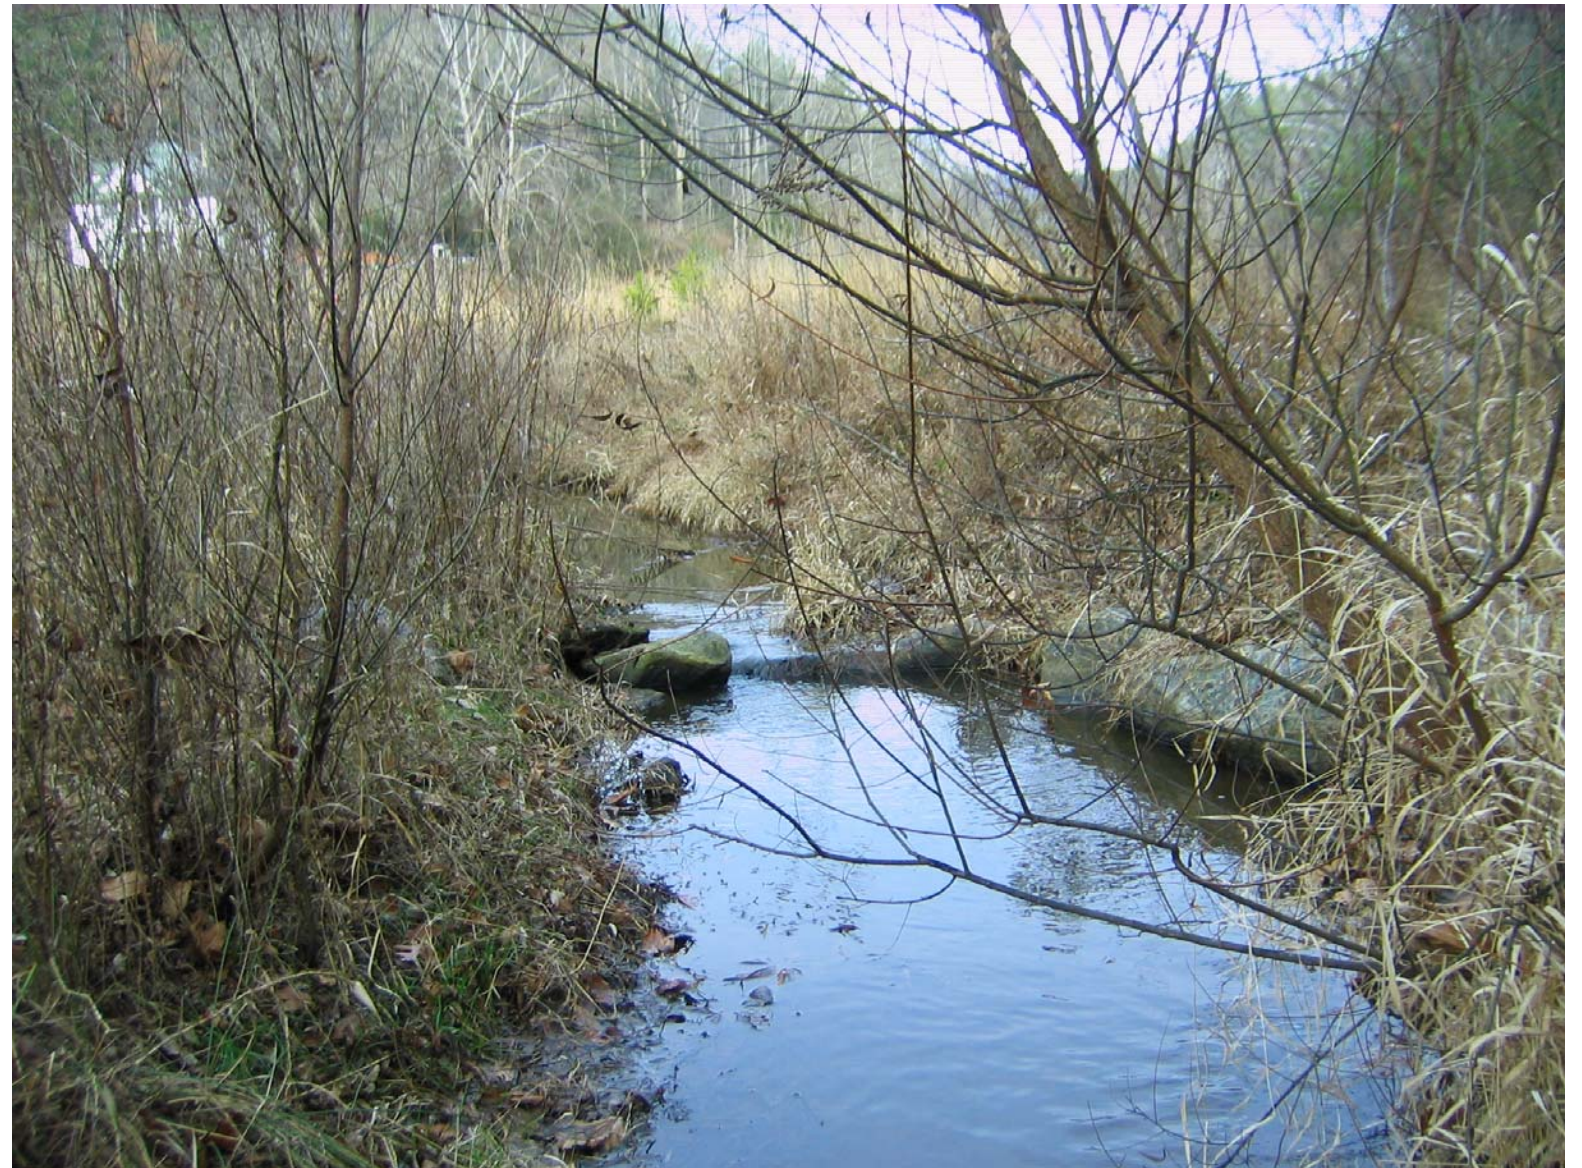
Bankfull Area				
	As-Built	2003	2004	2006	2007
Area	31.2	26.13	26.63	16.49	17.95
Width	26.2	28.6	26.1	20.6	21.0
Mean Depth	1.2	0.9	1.0	0.8	0.9
Max Depth	2.5	1.8	1.8	1.6	1.7

Photo (12-20-07) of Cross-Section #6 - Looking Upstream
