# Brown Creek Tributaries Restoration Project Final Year 1 Monitoring Report

DMS Project ID No. 95351, DEQ Contract No. 004641

Project Info:           Monitoring Year: 1 of 7  
                              Year of Data Collection: 2015 (vegetation) and 2016 (survey)  
                              Year of Completed Construction: 2015  
                              Submission Date: January 2017

Report Prepared and Submitted by Michael Baker Engineering, Inc.

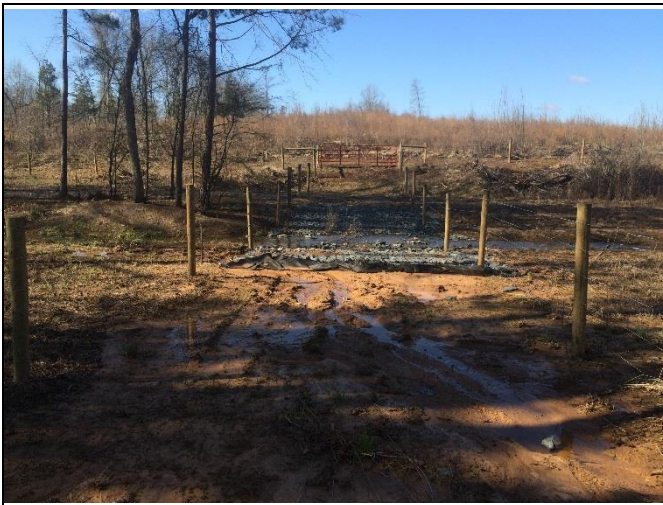
3) Reach UT4-R4b – Crossing erosion at Station 25+30

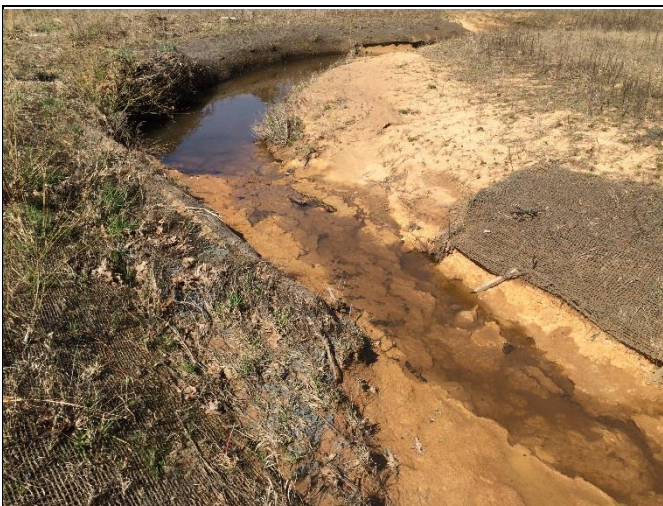
5) Reach UT4-R2 – Riffle scour at Station 28+75

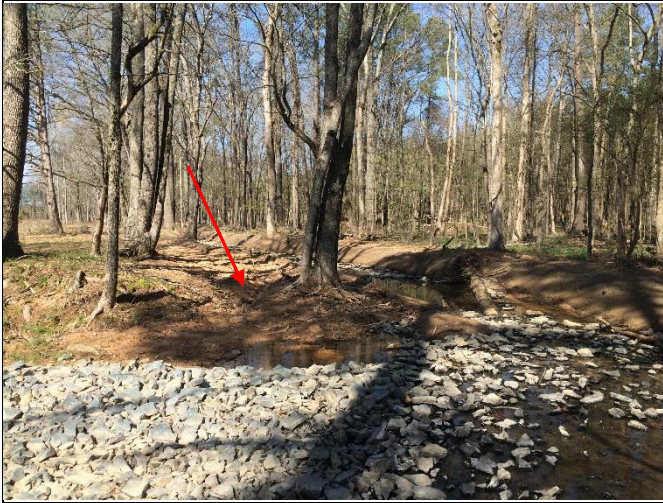
7) Reach UT4-R2 – Scour in floodplain, view downstream, Station 21+25

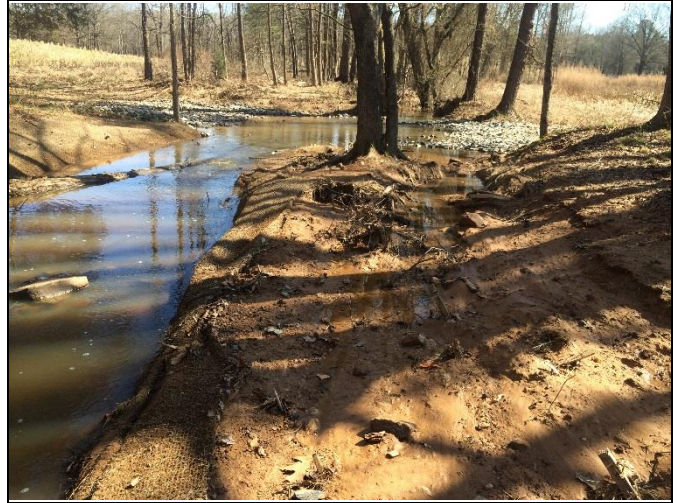
8) Reach UT4-R2 – Scour in floodplain, view upstream, Station 22+00
