Brown Creek Tributaries Restoration Project Final Year 2 Monitoring Report

DMS Project ID No. 95351, DEQ Contract No. 004641

Monitoring Year: 2 of 7
Year of Data Collection: 2016
Year of Completed Construction: 2015
Submission Date: January 2017

Report Prepared and Submitted by Michael Baker Engineering, Inc.

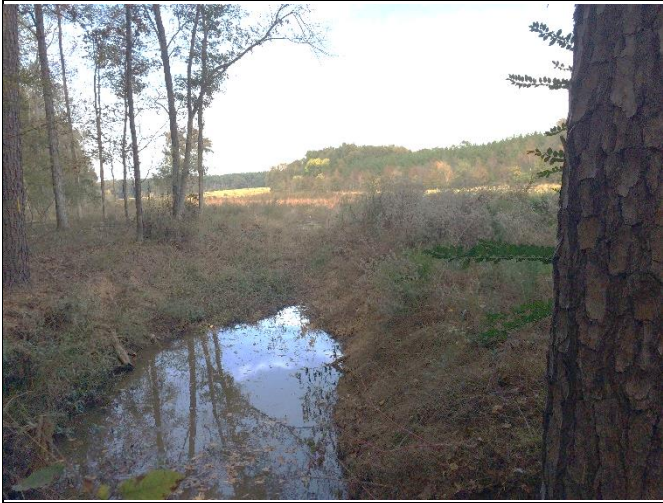
HC Reach 1, view downstream at Station 10+00

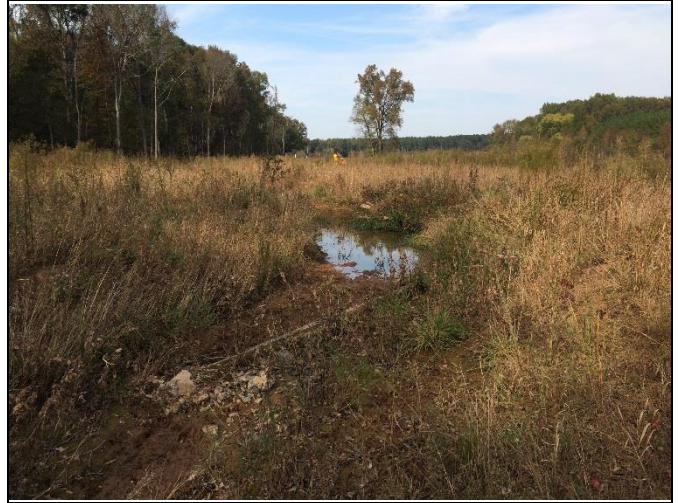
HC Reach 1, view downstream at Station 11+80

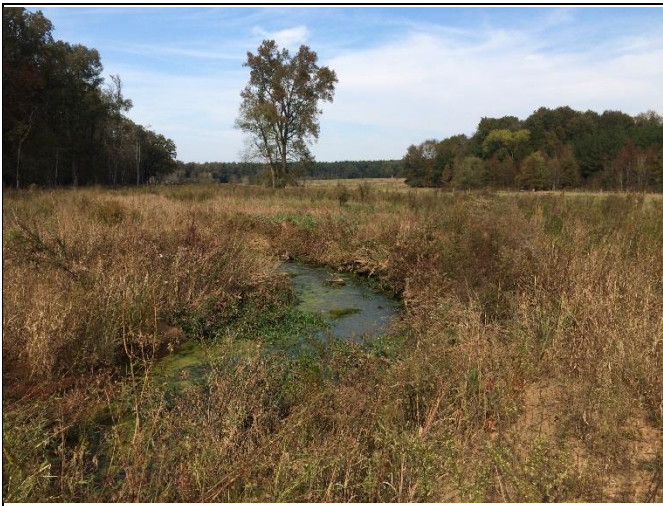
HC Reach 1, view downstream at Station 14+50

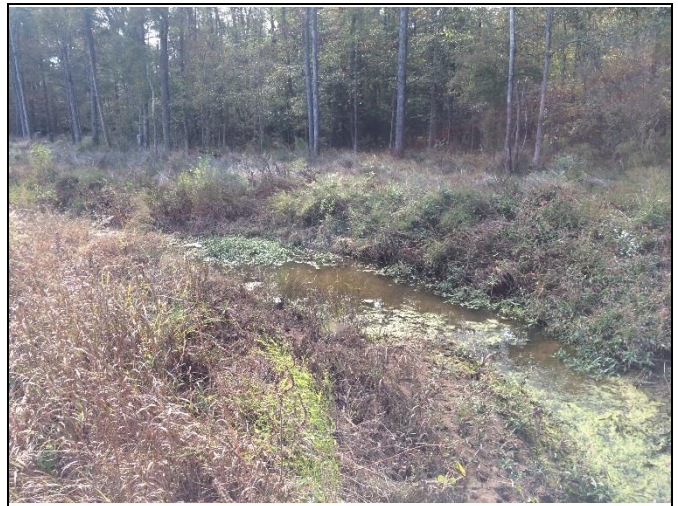
HC Reach 1, view upstream at Station 16+90

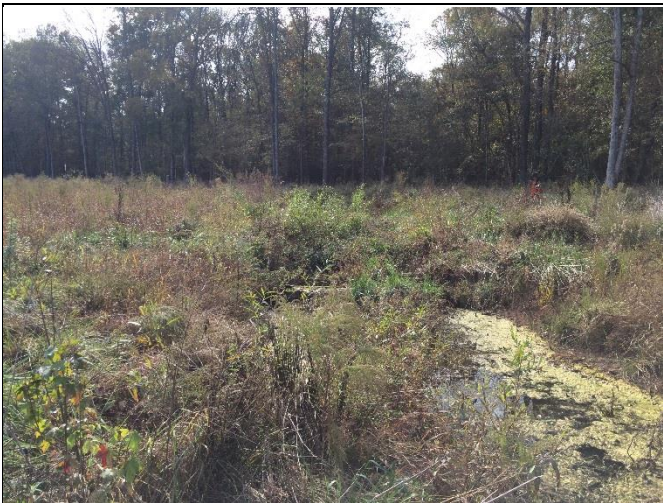
HC Reach 1, view upstream at Station 17+50

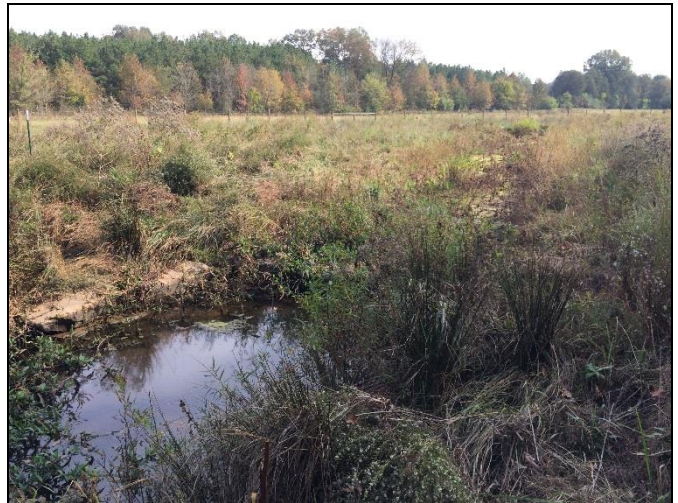
HC Reach 1, view upstream at Station 19+25

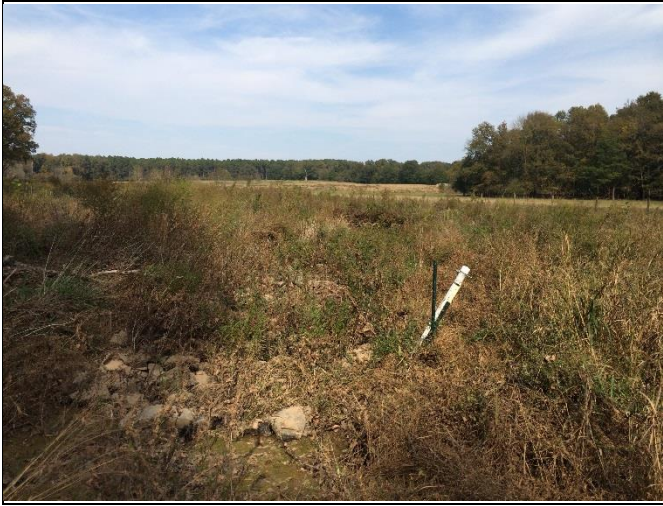
HC Reach 1, view downstream at Station 19+75

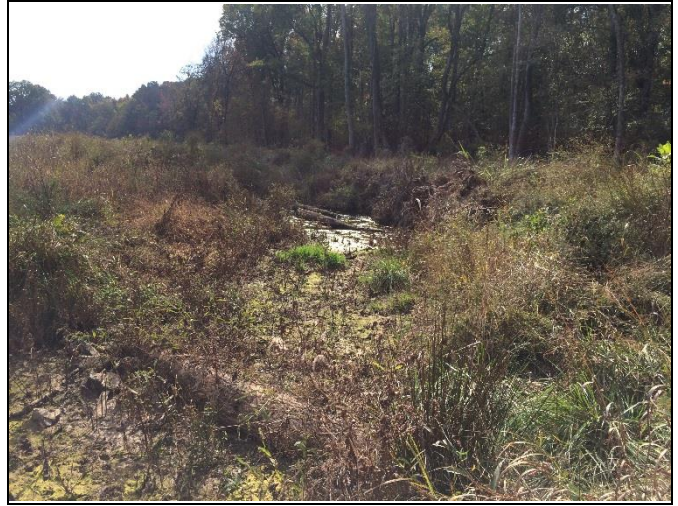
HC Reach 1, view upstream at Station 22+40

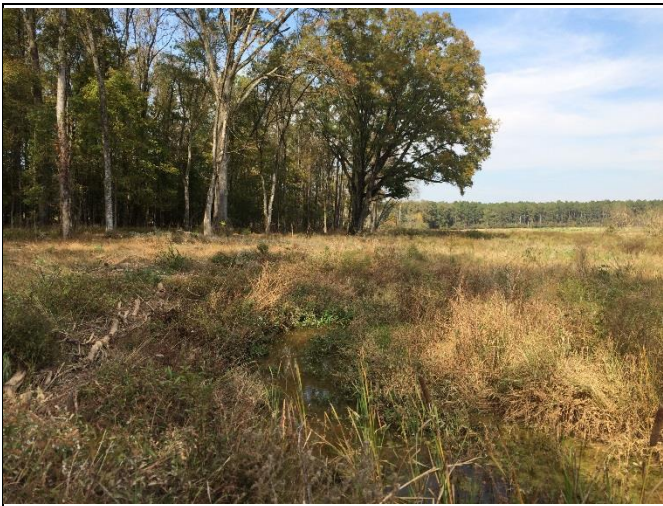
HC Reach 1, view downstream at Station 24+00

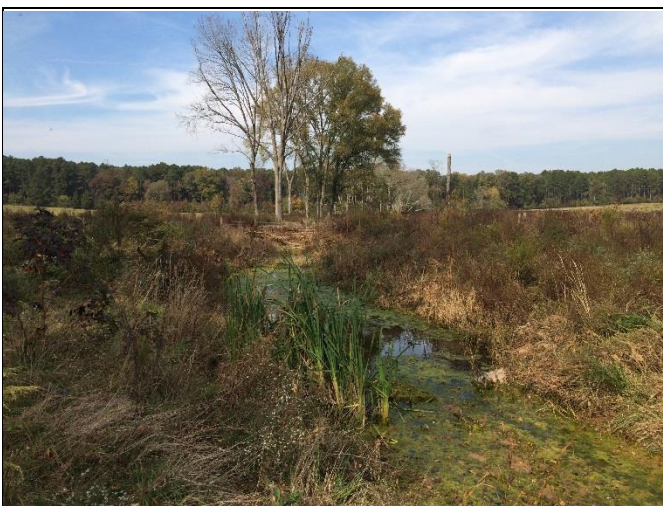
HC Reach 1, view downstream at Station 29+30

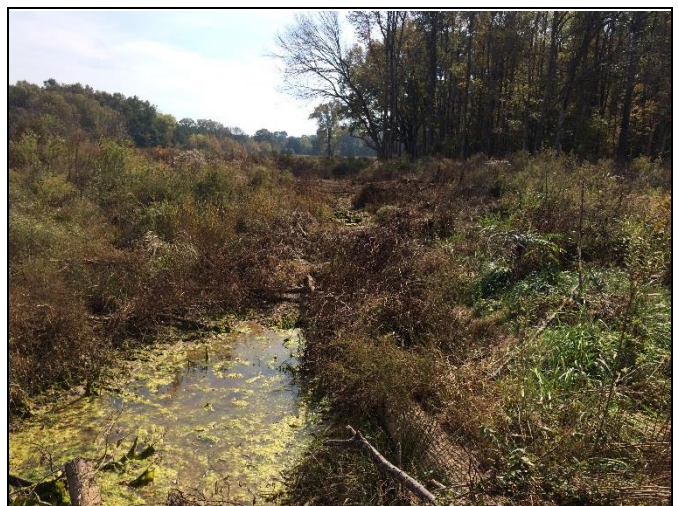
HC Reach 2, view upstream at Station 31+40

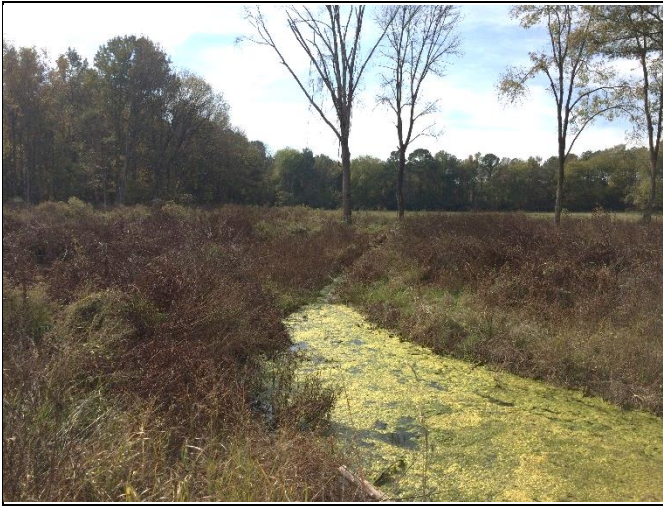
HC Reach 2, view upstream at Station 32+75

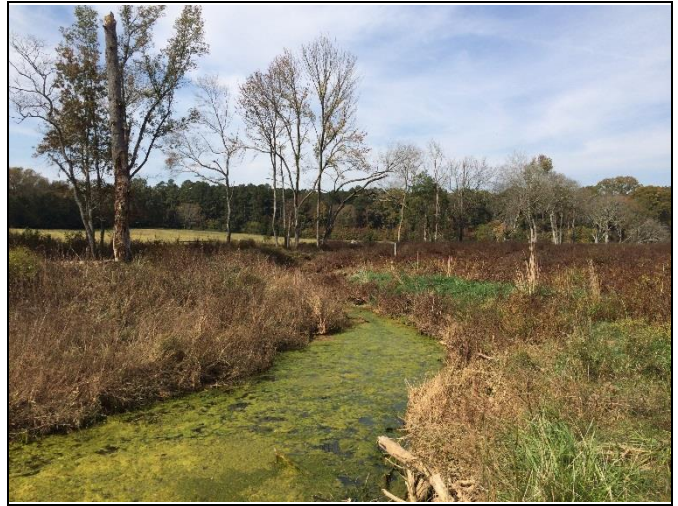
HC Reach 2, view downstream at Station 33+00

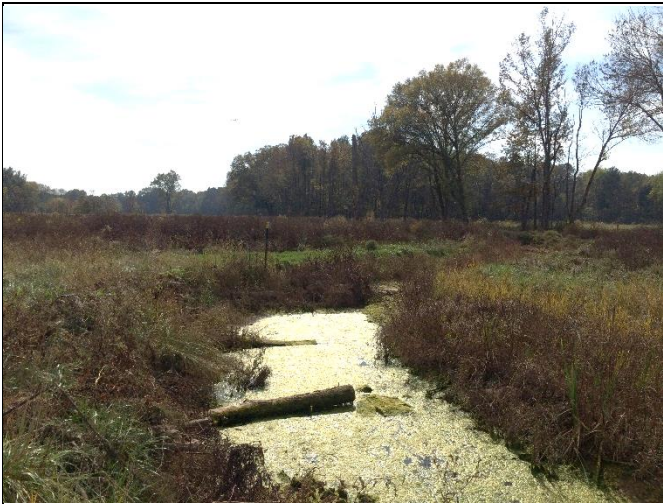
HC Reach 2, view upstream at Station 35+70

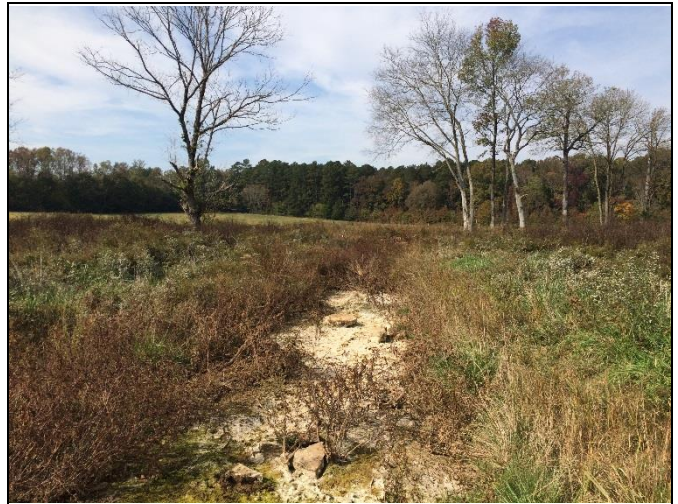
HC Reach 2, view downstream at Station 36+00

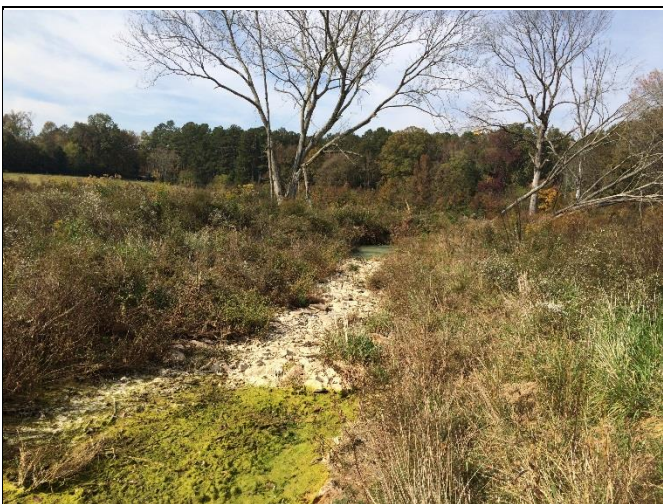
HC Reach 2, view downstream at Station 39+10

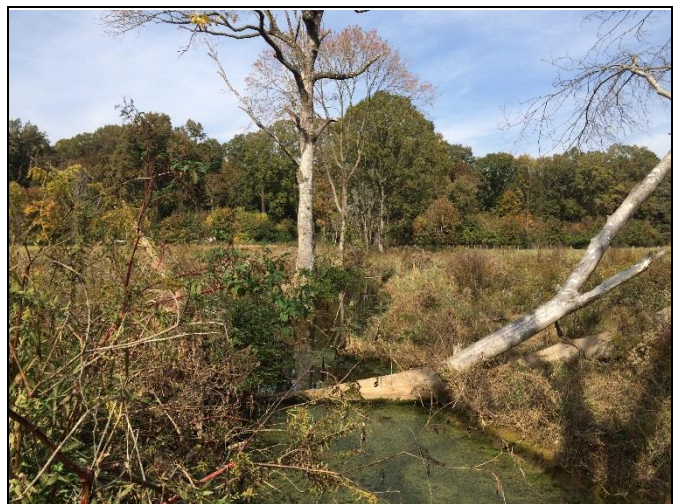
HC Reach 2, view downstream at Station 40+75

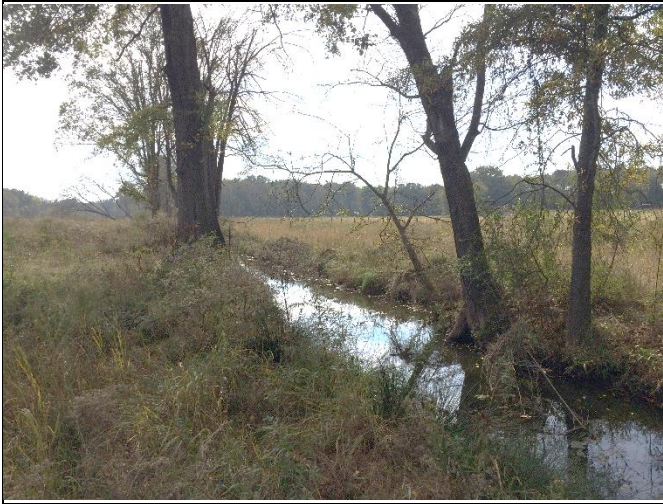
HC Reach 2, view upstream at Station 43+75

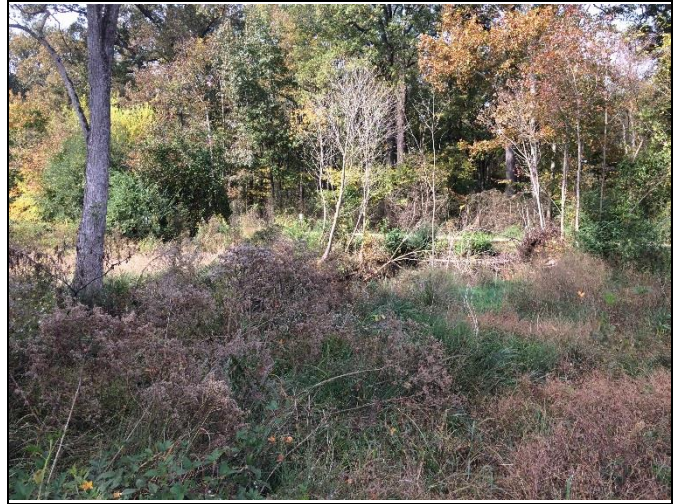
HC Reach 2, view downstream at Station 44+25

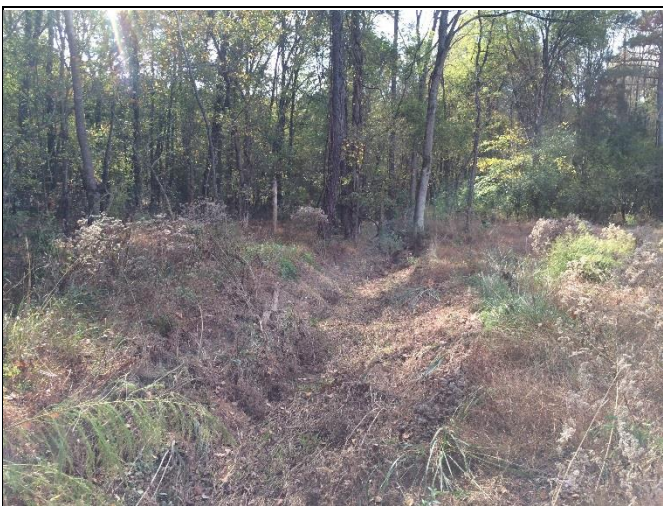
HC Reach 3, view upstream at Station 11+40

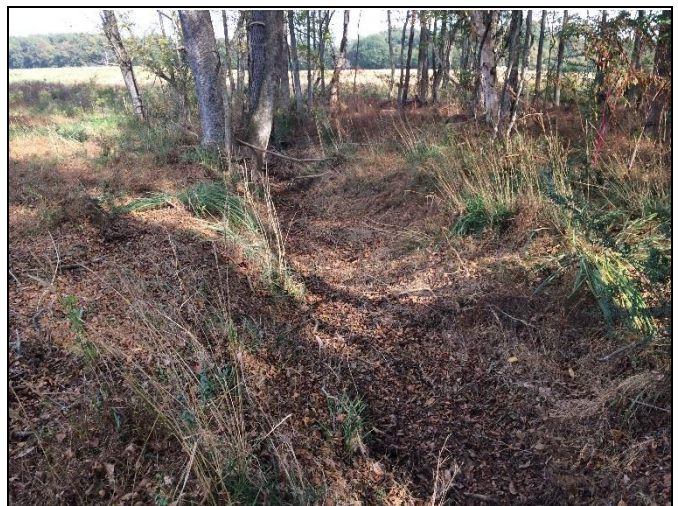
HC Reach 3, view downstream at Station 14+00

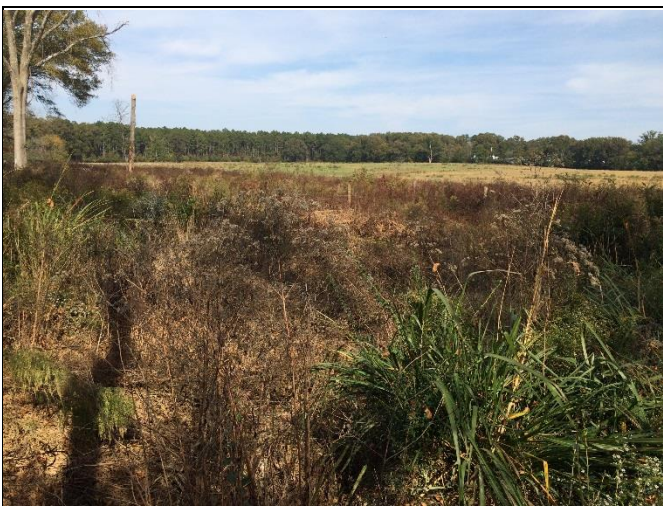
HC Reach 3, view downstream at Station 15+50

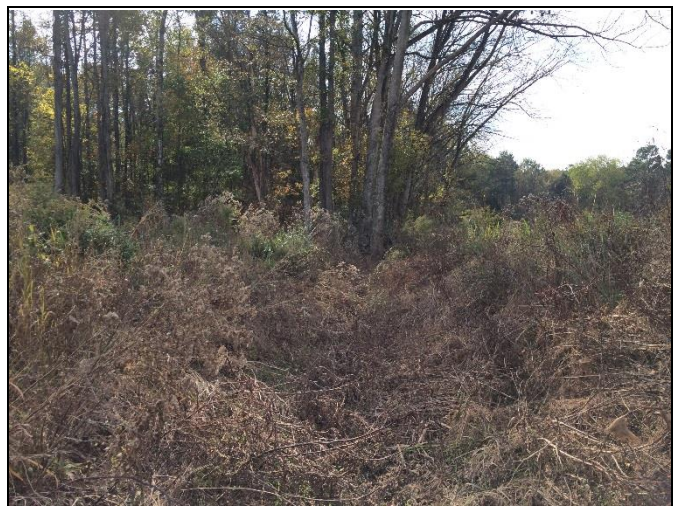
HC Reach 3, view upstream at Station 15+90

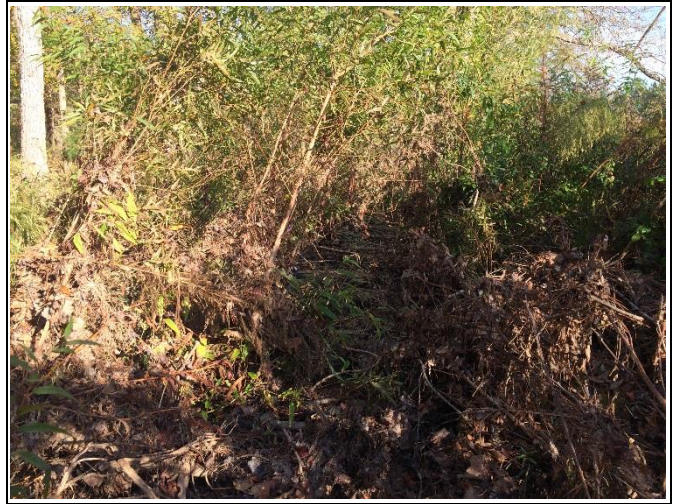
Reach UT4-R4a – View downstream, Station 12+40

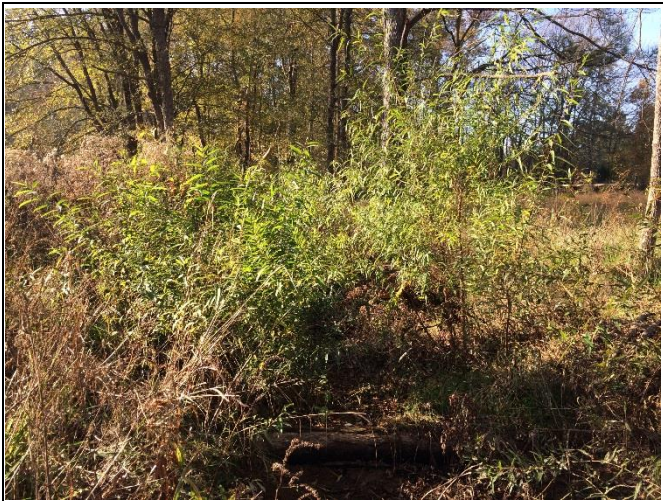
Reach UT4-R4a – View upstream, Station 13+20

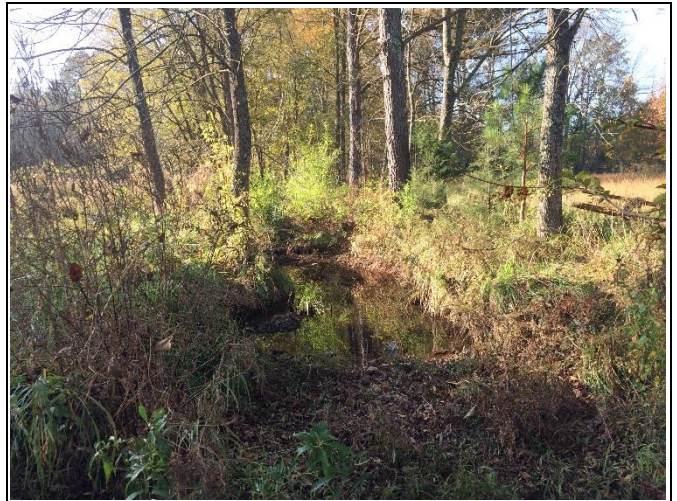
Reach UT4-R4a – View upstream, Station 14+00

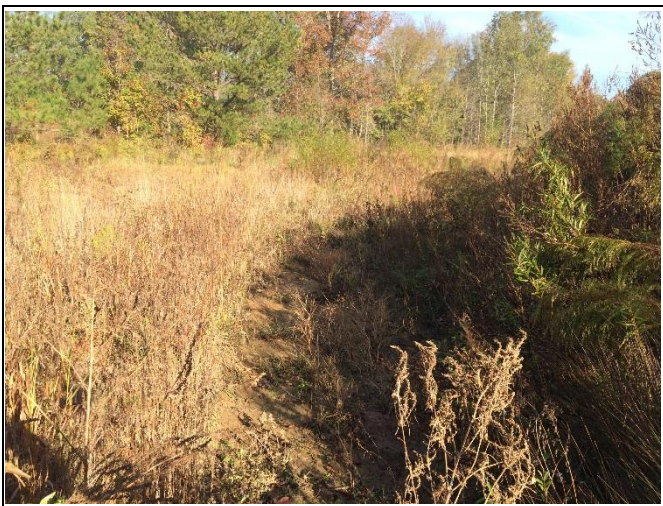
Reach UT4-R4b – View downstream, Station 14+75

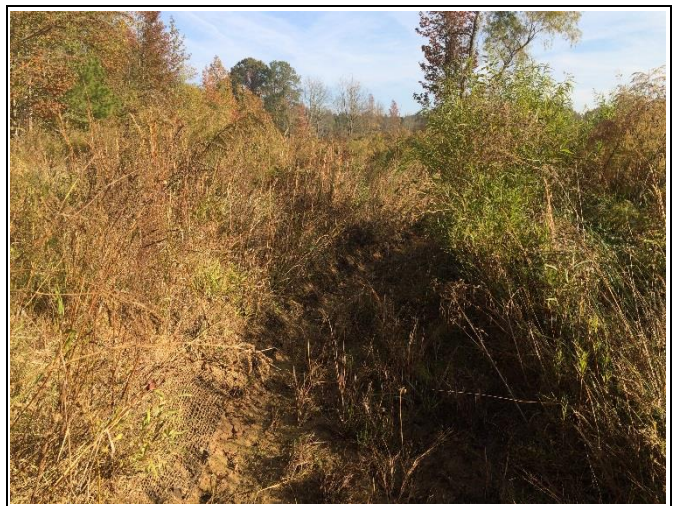
Reach UT4-R4b – View downstream, Station 17+00

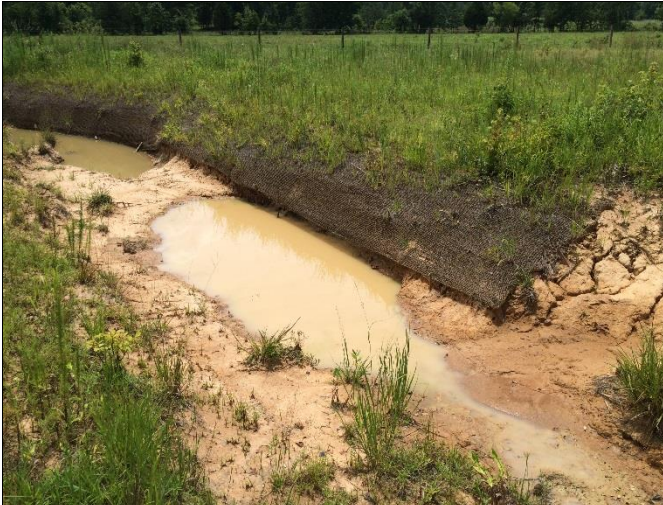
1) Reach UT4-R2: Bank erosion at Station 31+75

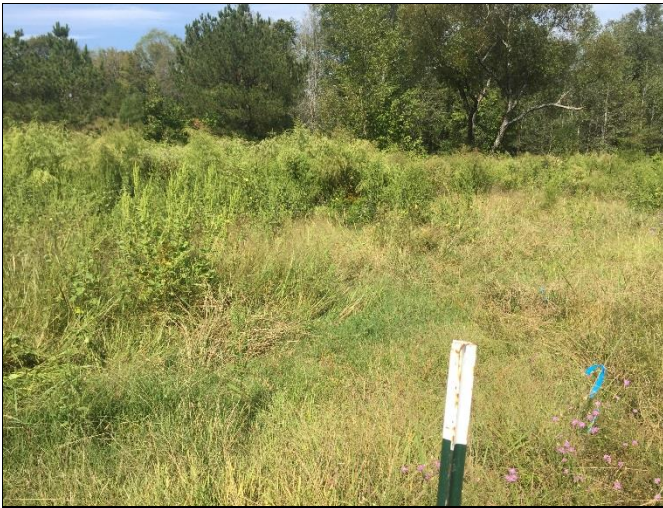
3) Reach UT4-R4b – Low planted stem densities around Veg Plot #7 (though area is vegetated and stable)
