Brown Creek Tributaries Restoration Project FINAL Year 3 Monitoring Report

Anson County, North Carolina

DMS Project ID No. 95351, DEQ Contract No. 004641

Monitoring Year: 3 of 7

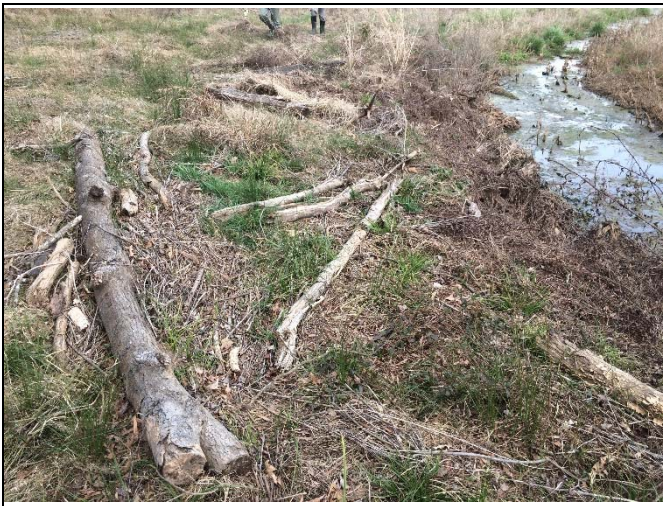
Reach HC-R1: Evidence of overbank flooding (rack lines and debris in floodplain).

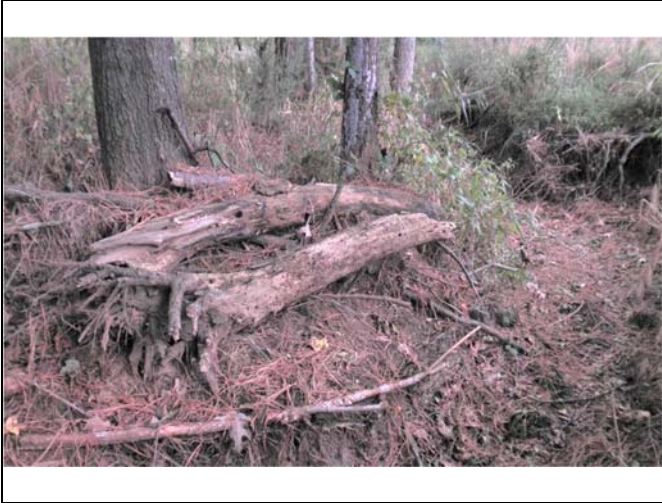
Reach UT4-R5b: Evidence of overbank flooding (rack lines and debris on bank)

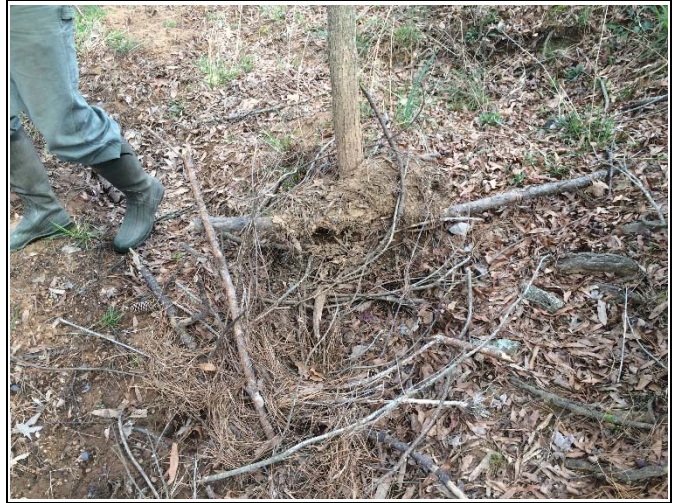
Reach UT4-R5b: Evidence of overbank flooding (rack lines and debris on bank)

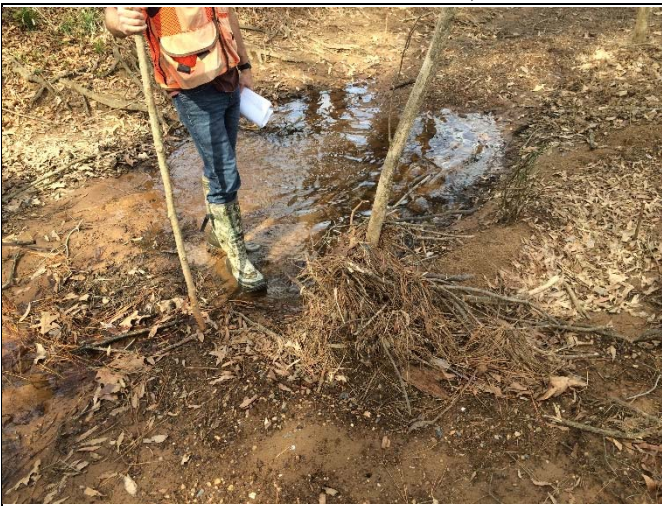
Reach UT4-R5b: Evidence of overbank flooding (rack line and debris jam)

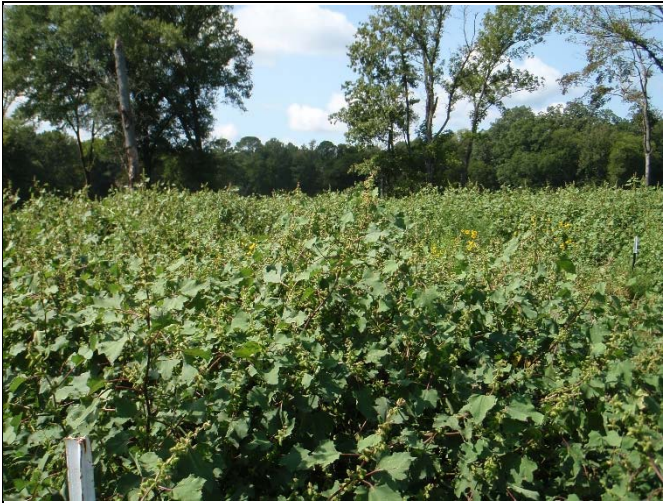
1) VPA: HC-R2, Low stem densities due to grass/weed pressure (especially from cocklebur shown here).

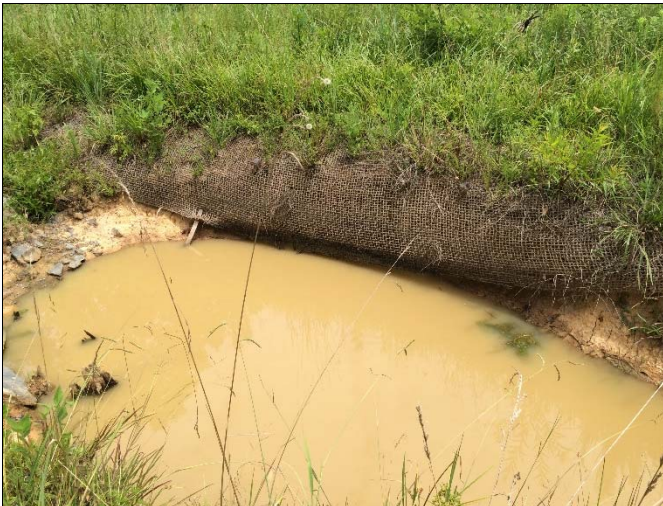
3) Reach UT4-R4b: Bank Erosion, Station 23+30 (BEFORE)
