# Brown Creek Tributaries Restoration Project Final Year 4 Monitoring Report

Anson County, North Carolina

DMS Project ID No. 95351, DEQ Contract No. 004641

Submission Date: December 2018

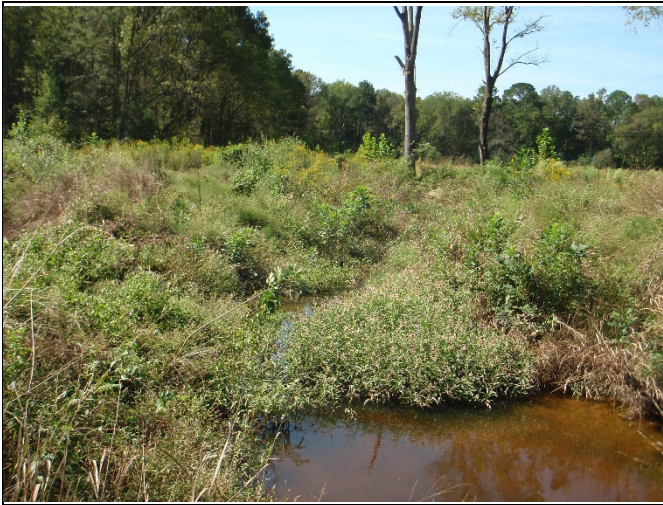
HC Reach 2, view upstream at Station 32+75

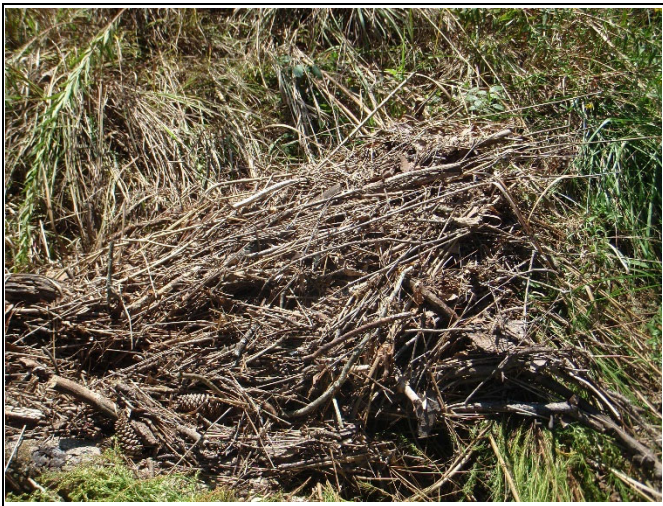
Reach HC-R1: Evidence of overbank flooding (wrack lines and debris in floodplain)

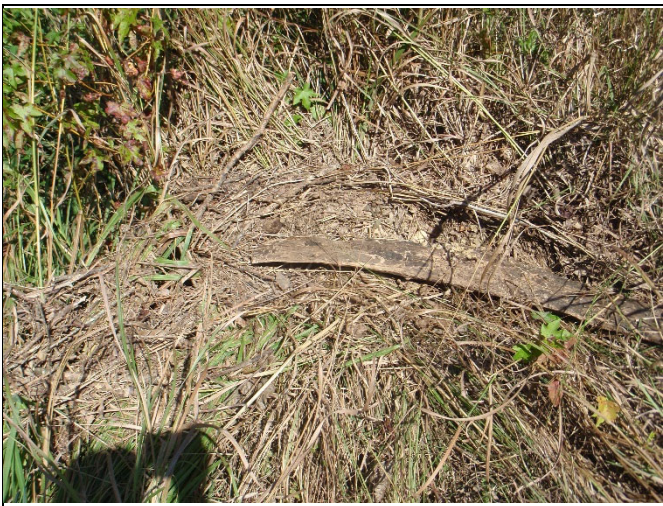
Reach HC-R2: Wrack lines and debris in floodplain

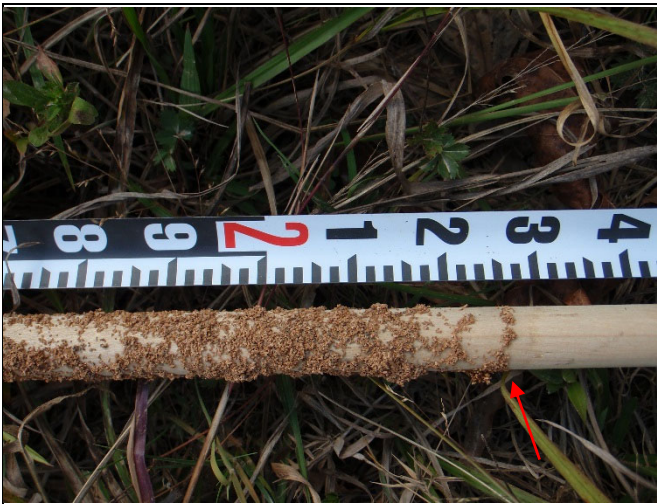
Reach UT4-R2: Overbank event of 2.26' (from Hurricane Florence on Sept. 15-17, 2018)

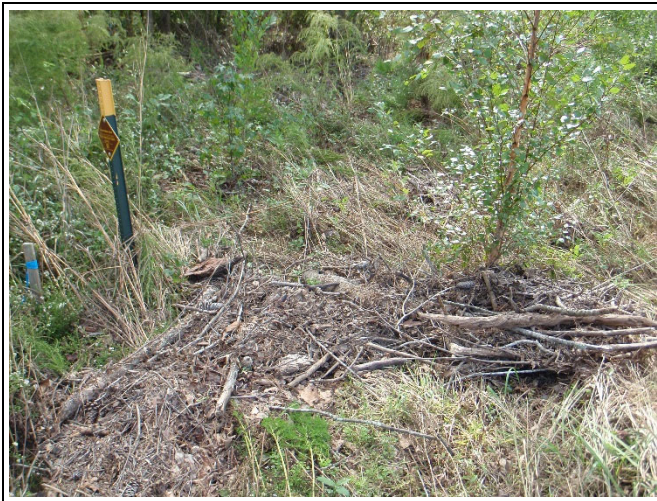
Reach UT4-R1b: Wrack lines and debris in floodplain

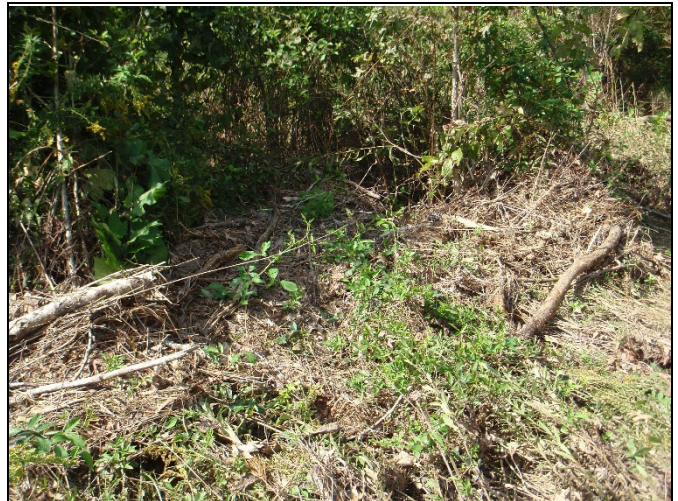
Reach UT4-R2: Wrack lines and debris in floodplain

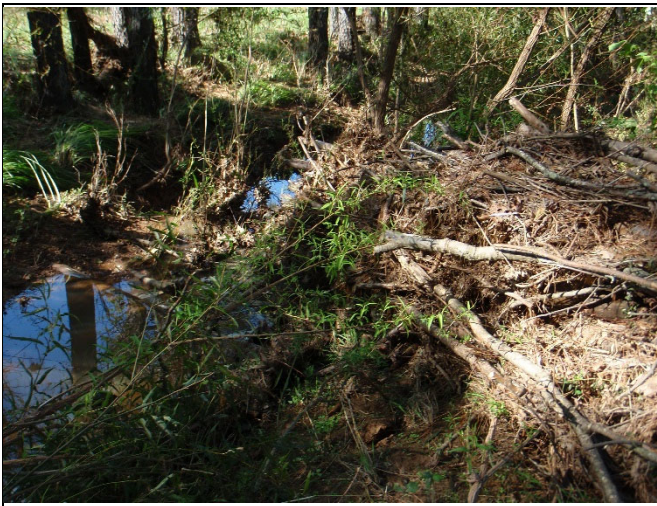
Reach UT4-R5b: Wrack lines and debris in floodplain
