Browns Summit Creek Restoration Project Year 7 Monitoring Report/Closeout Report

Guilford County, North Carolina

DMS Project ID No. 96313, DEQ Contract No. 5792

Project Info: Monitoring Year: 7 of 7
 Year of Data Collection: 2023
 Year of Completed Construction (including planting): 2017
 Submission Date: November 2023

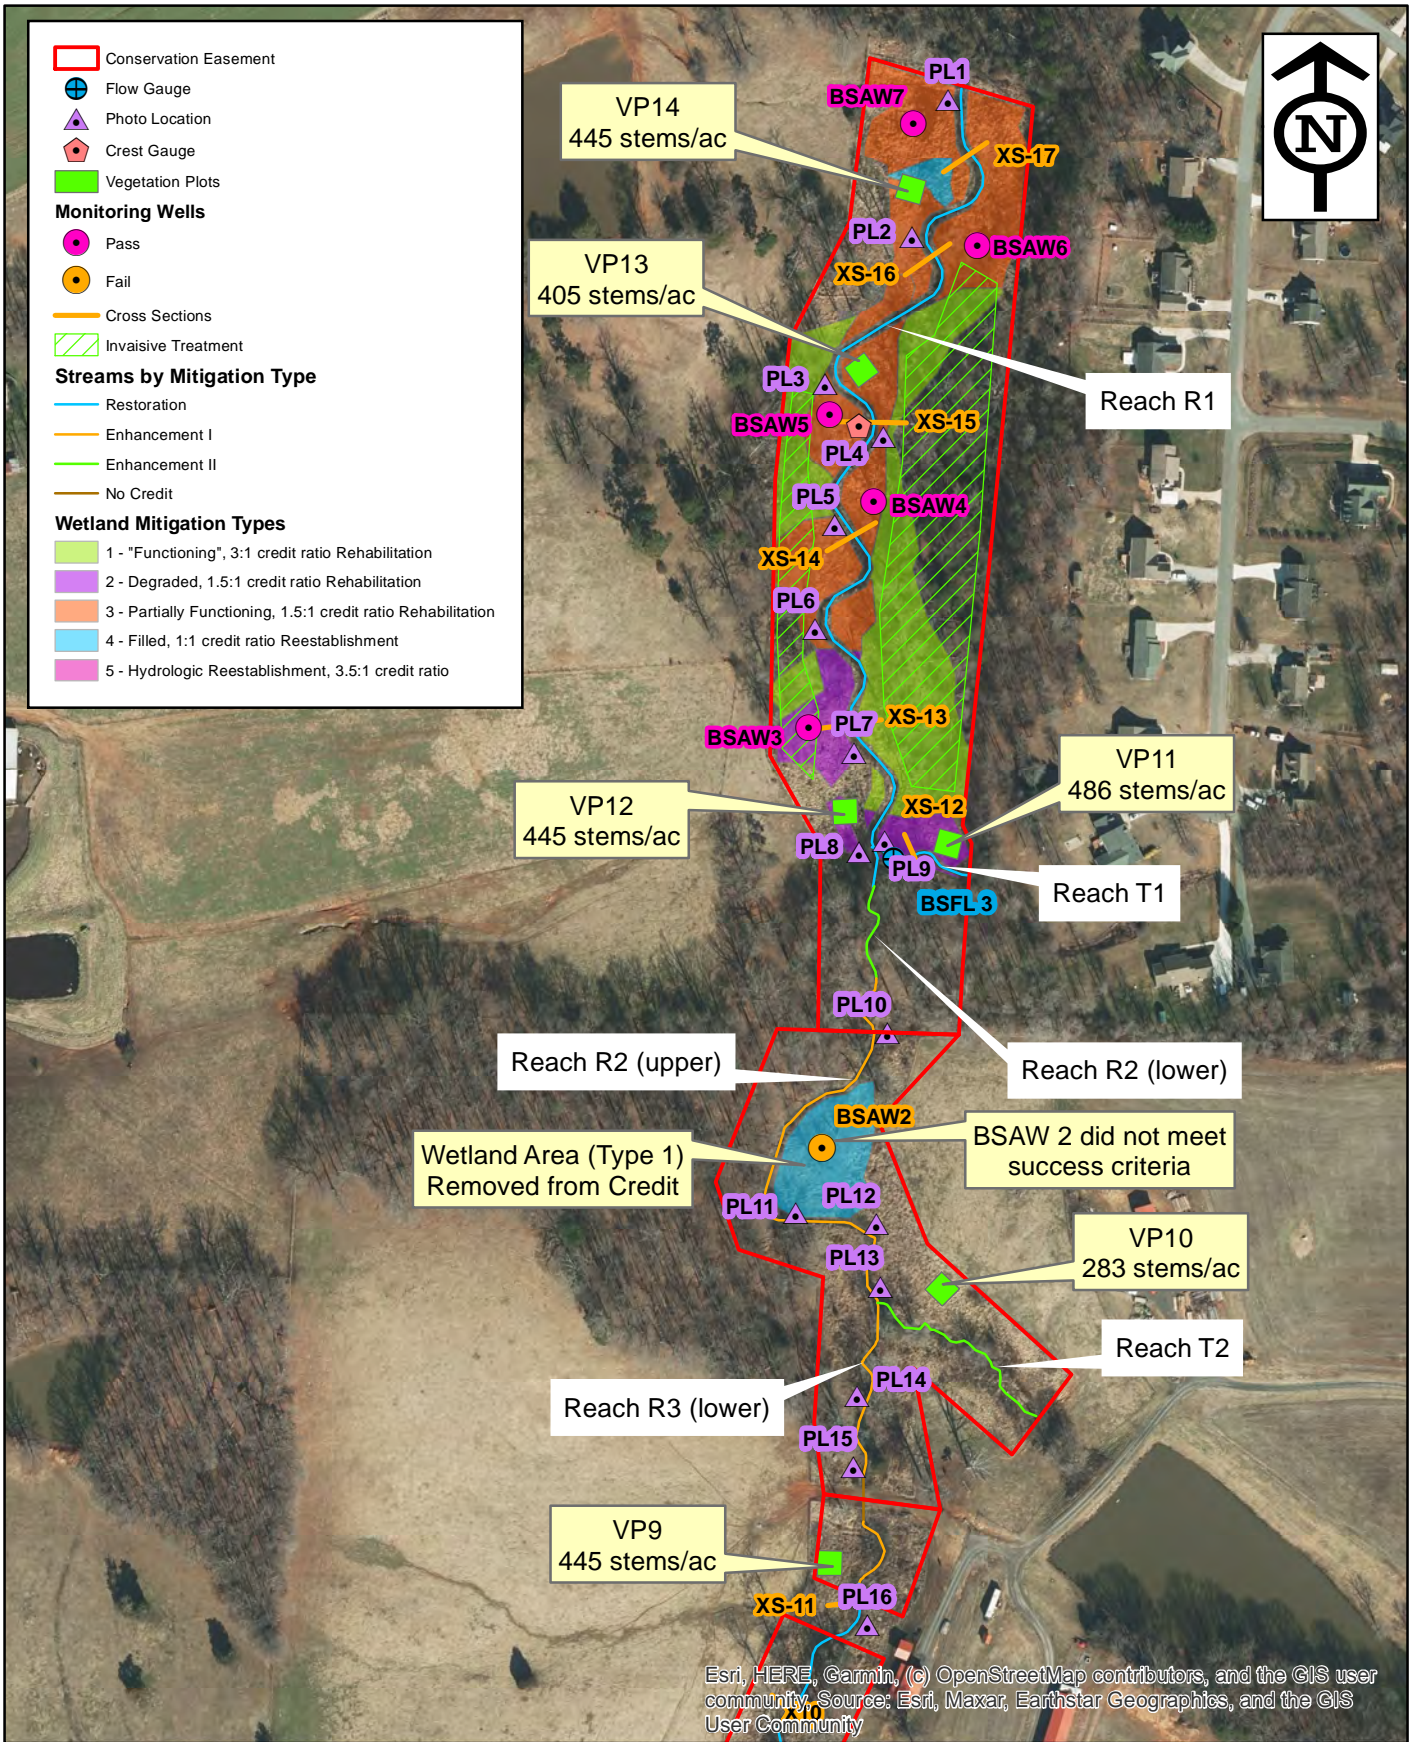
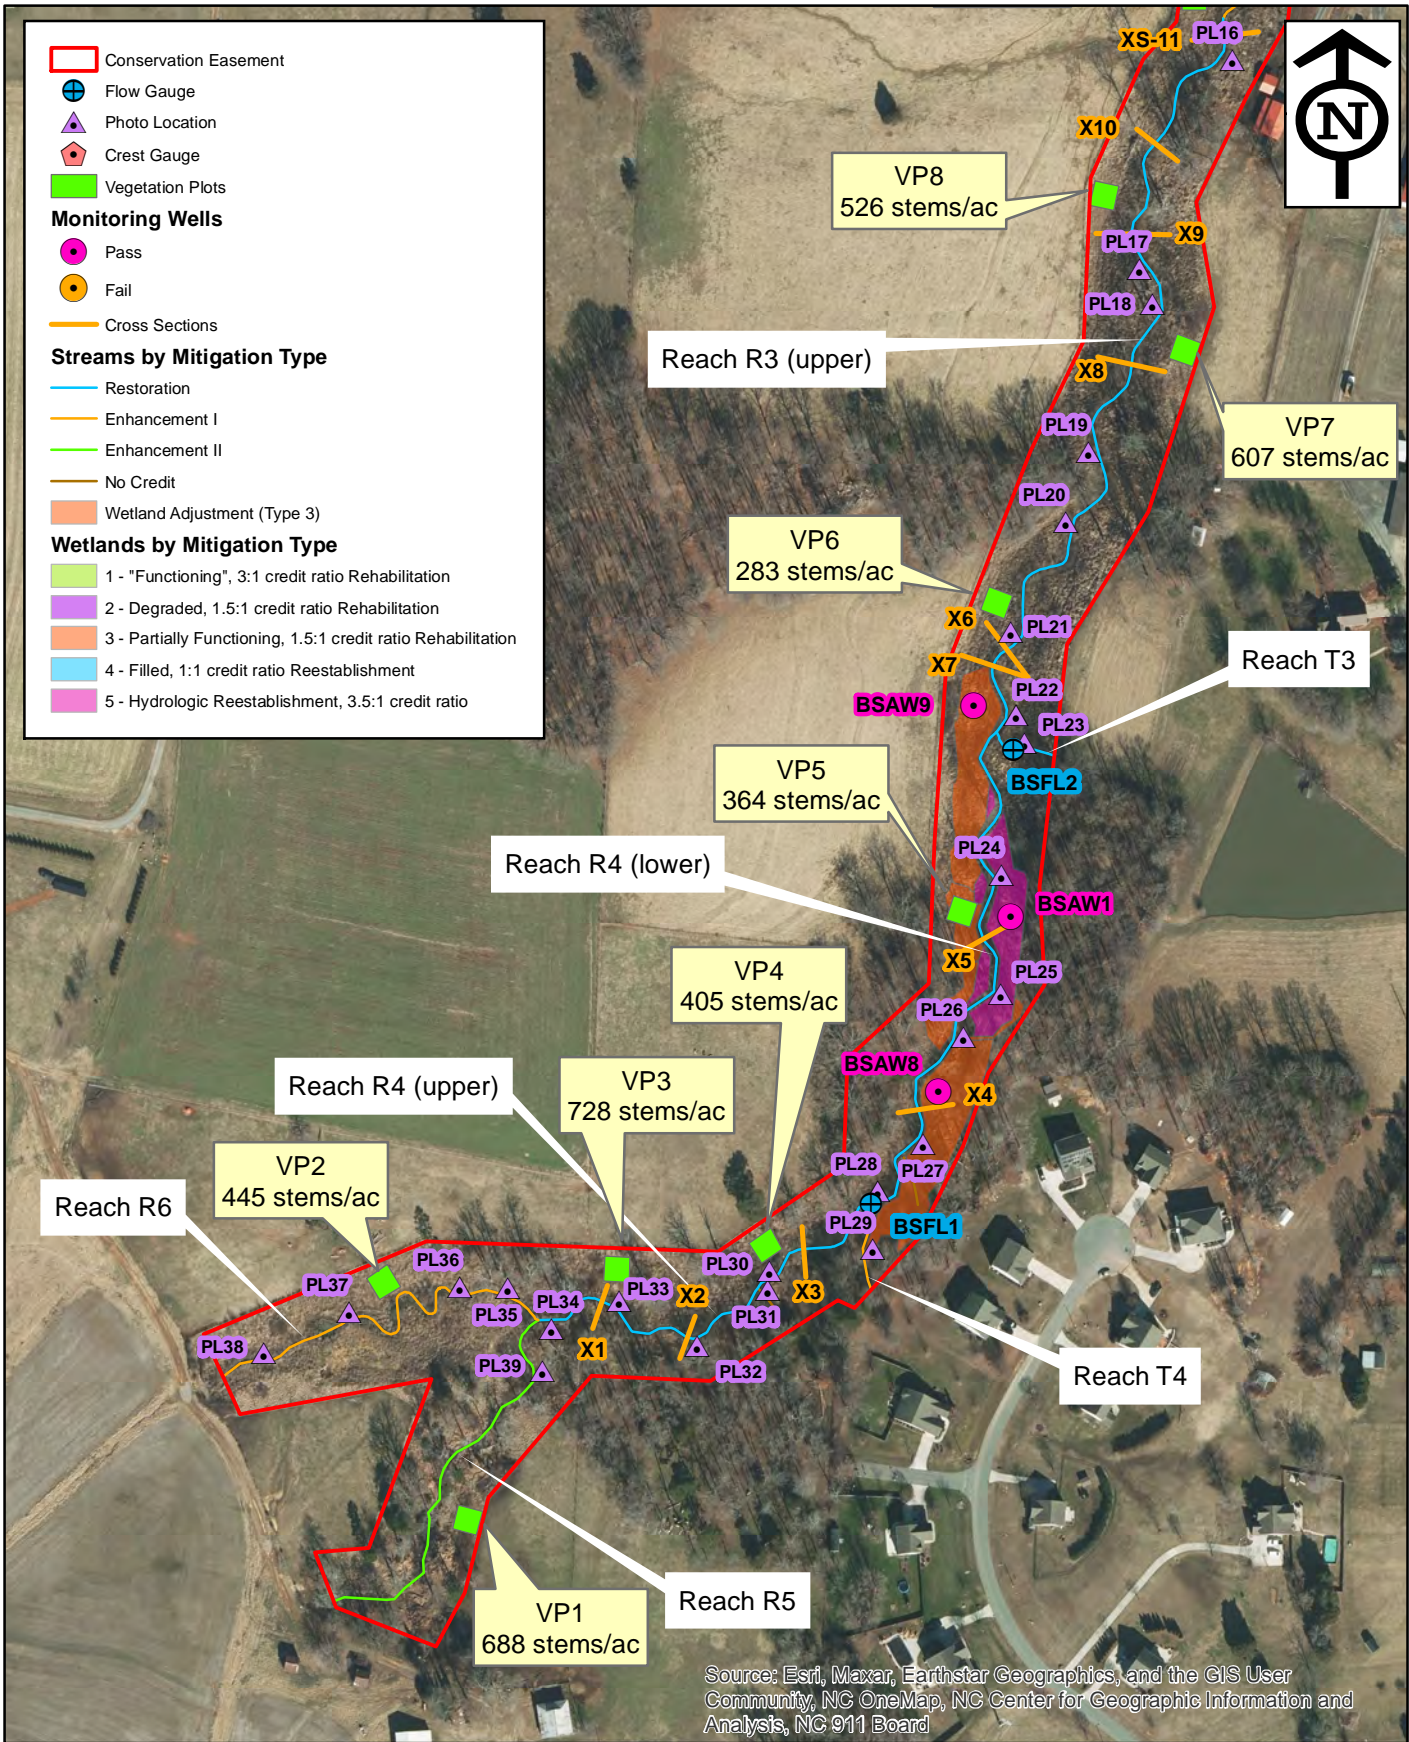
Comment: Figure 4.1 and 4.2: Please include the additional wetlands on the CCPV and note the wetland be removed from credit.

Response: Revision made as requested.

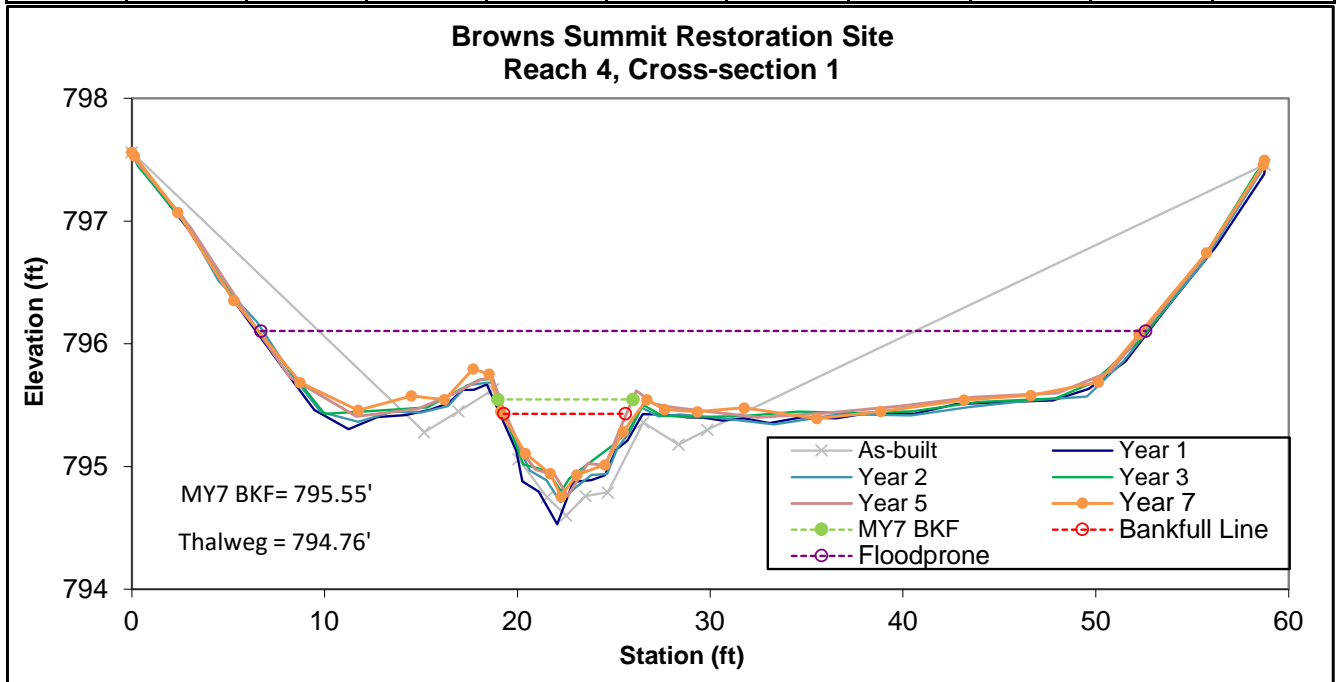
Permanent Cross-section 1
(Year 7 Data - Collected September 2023)

Feature	Stream Type	BKF Area	BKF Width	BKF Depth	Max BKF Depth	W/D	BH Ratio	ER	BKF Elev	TOB Elev
Riffle	C	2.4	7.0	0.4	0.7	19.4	1.0	6.6	795.43	795.55

Note: Per DMS/IRT request, bank height ratio is calculated by setting the current bankfull area to match the asbuilt bankfull area and dividing by the current max depth. Note: MY1 data is being utilized as asbuilt data due to poor quality asbuilt survey.

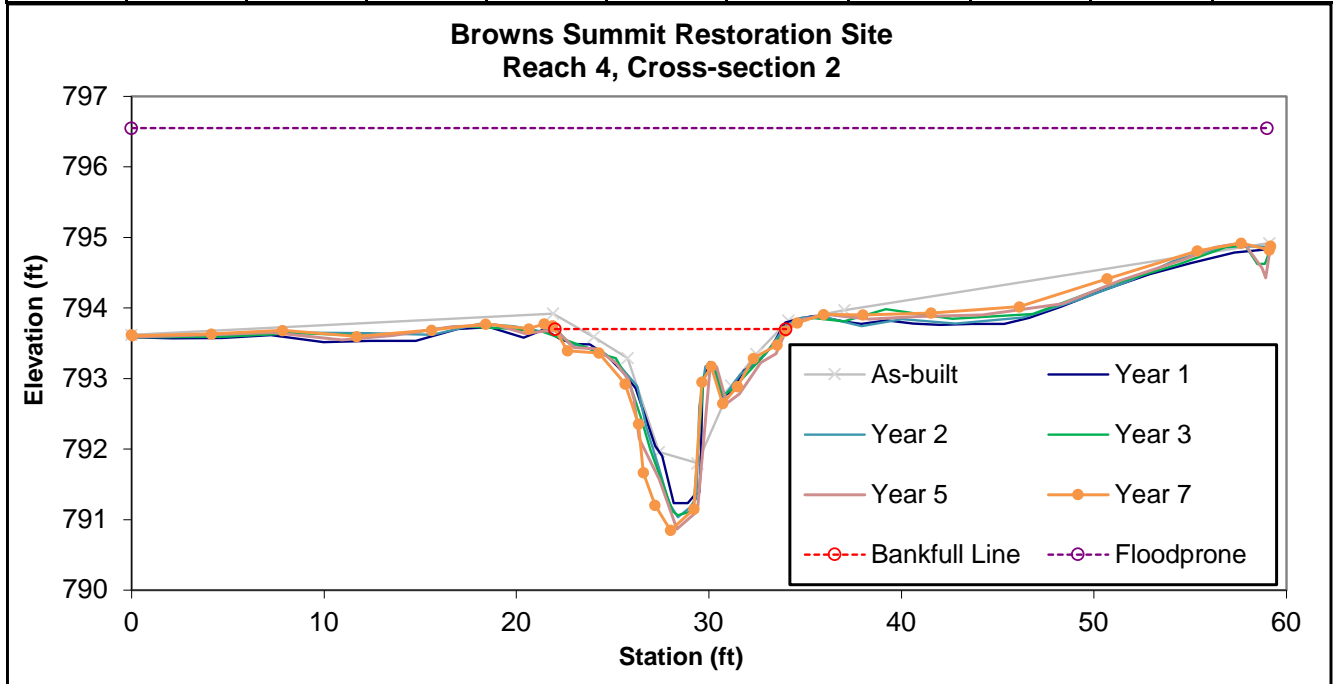
Permanent Cross-section 2
(Year 7 Data - Collected September 2023)

Feature	Stream Type	BKF Area	BKF Width	BKF Depth	Max BKF Depth	W/D	BH Ratio	ER	BKF Elev	TOB Elev
Pool	--	12.5	12.1	1.0	2.9	11.7	--	--	793.70	793.67

Note: MY1 data is being utilized as asbuilt data due to poor quality asbuilt survey.

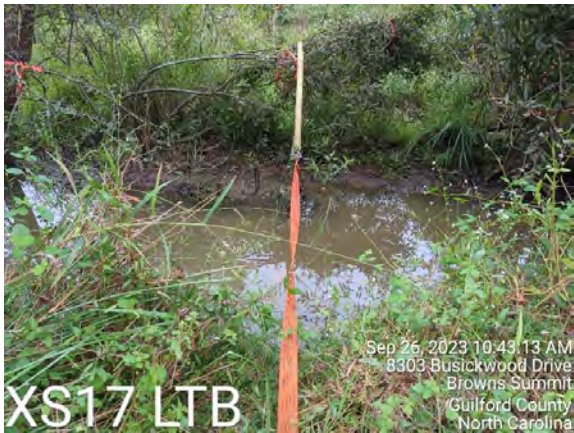
Permanent Cross-section 17
(Year 7 Data - Collected September 2023)

Looking at the Left Bank

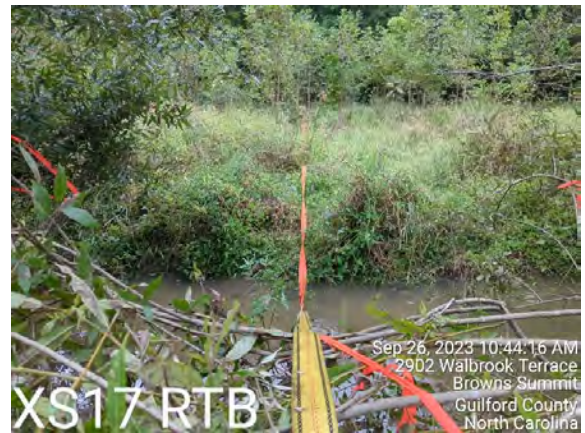
Looking at the Right Bank

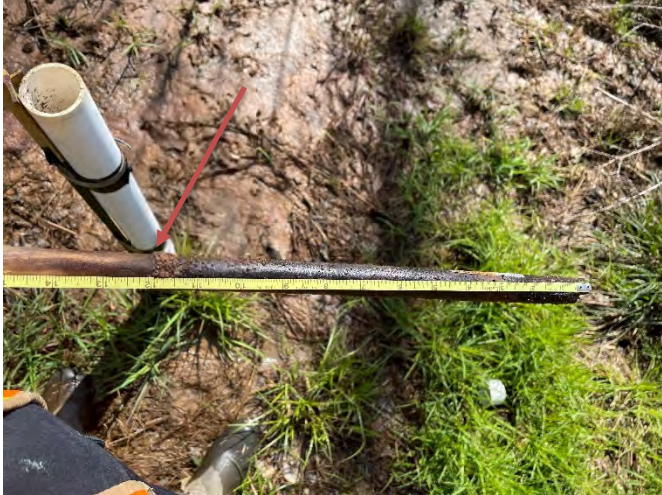
Manual Crest Gauge – Reading 3/16/23 (1.00')
