Browns Summit Creek Restoration Project Year 1 Monitoring Report

Guilford County, North Carolina

DMS Project ID No. 96313, DEQ Contract No. 5792

Project Info: Monitoring Year: 1 of 7
 Year of Data Collection: 2017
 Year of Completed Construction (including planting): 2017
 Submission Date: January 2018

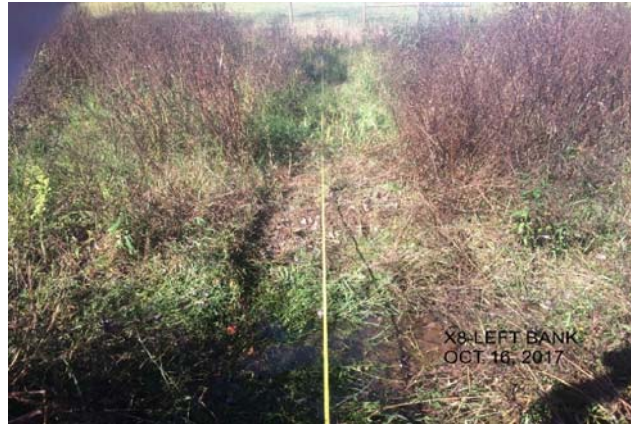
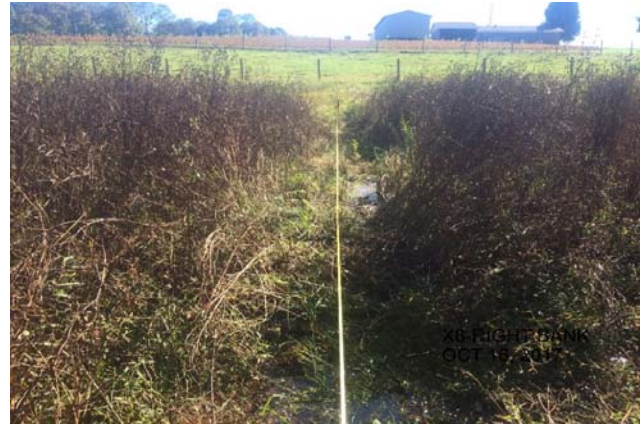
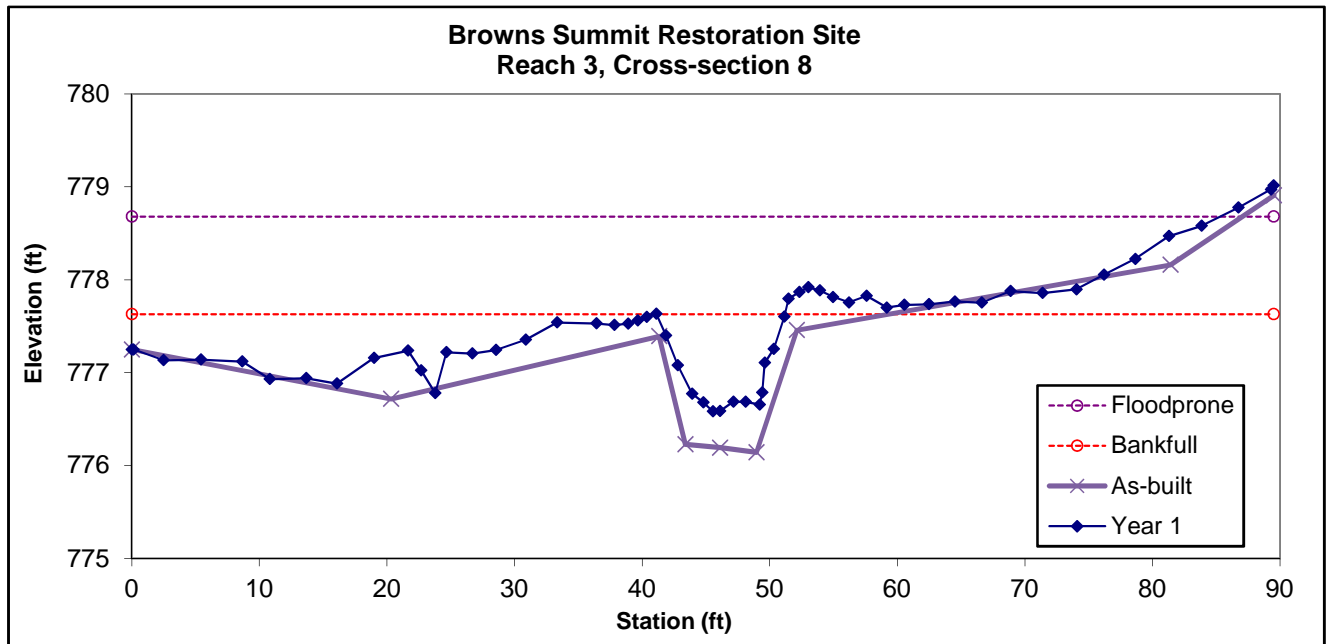
Permanent Cross-section 8

Feature	Stream Type	BKF Area	BKF Width	BKF Depth	Max BKF Depth	W/D	BH Ratio	ER	BKF Elev	TOB Elev
Riffle	C	7.16	10.05	0.71	1.05	14.15	1	8.48	777.63	777.63

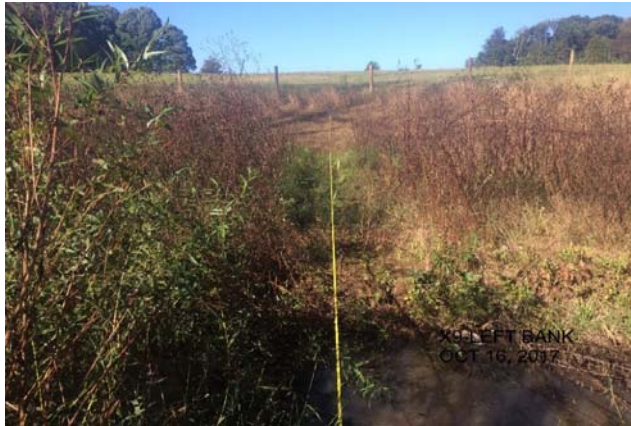
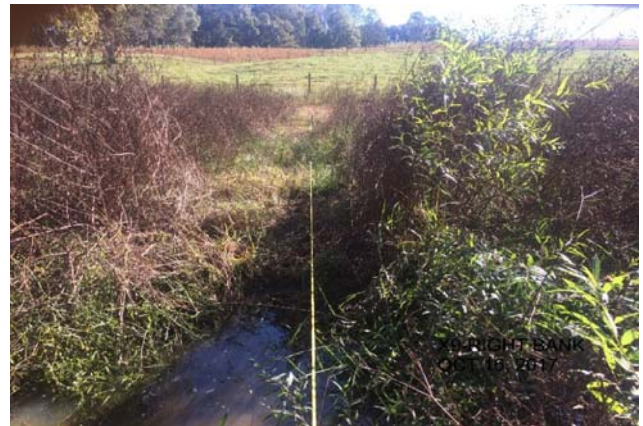
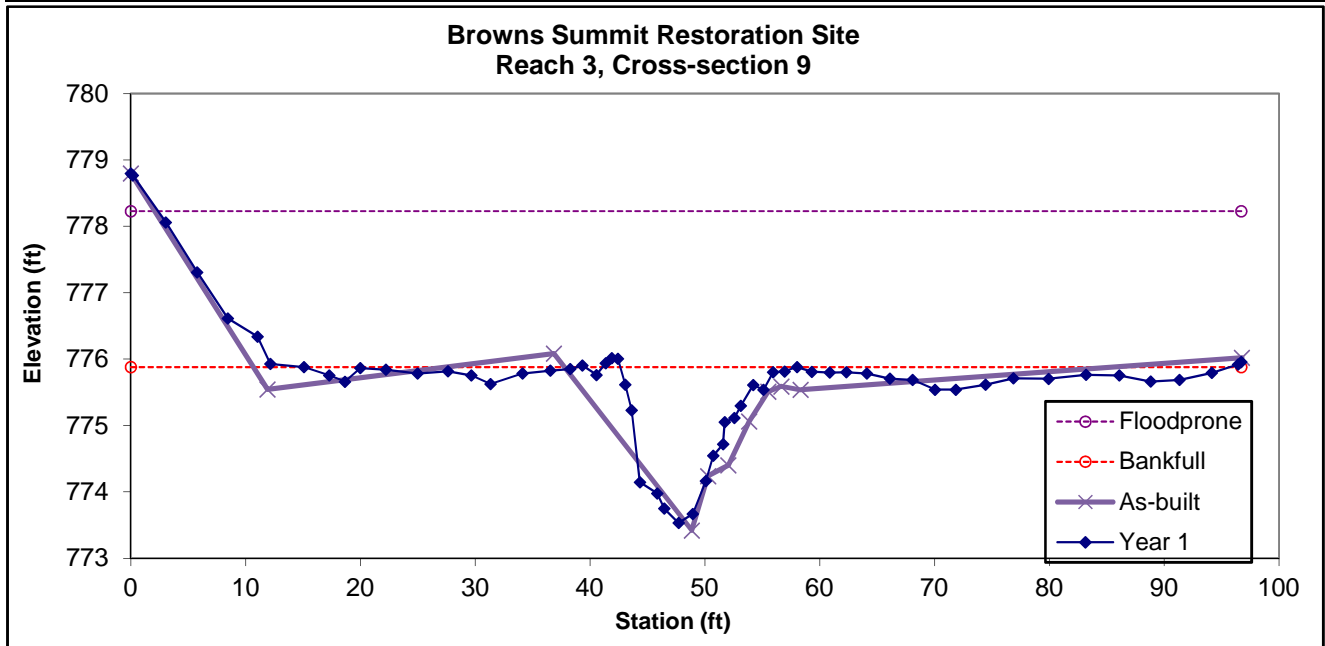
Permanent Cross-section 9

Feature	Stream Type	BKF Area	BKF Width	BKF Depth	Max BKF Depth	W/D	BH Ratio	ER	BKF Elev	TOB Elev
Pool	E	17.2	15.3	1.1	2.4	13.5	--	--	775.88	775.88

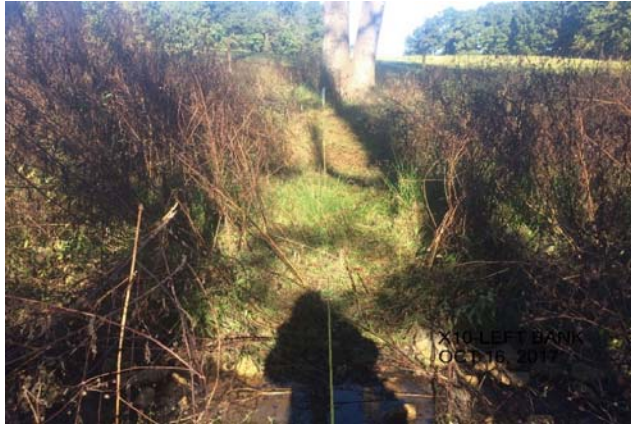
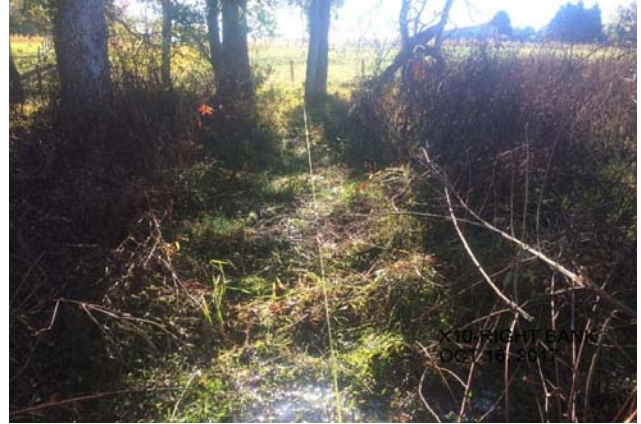
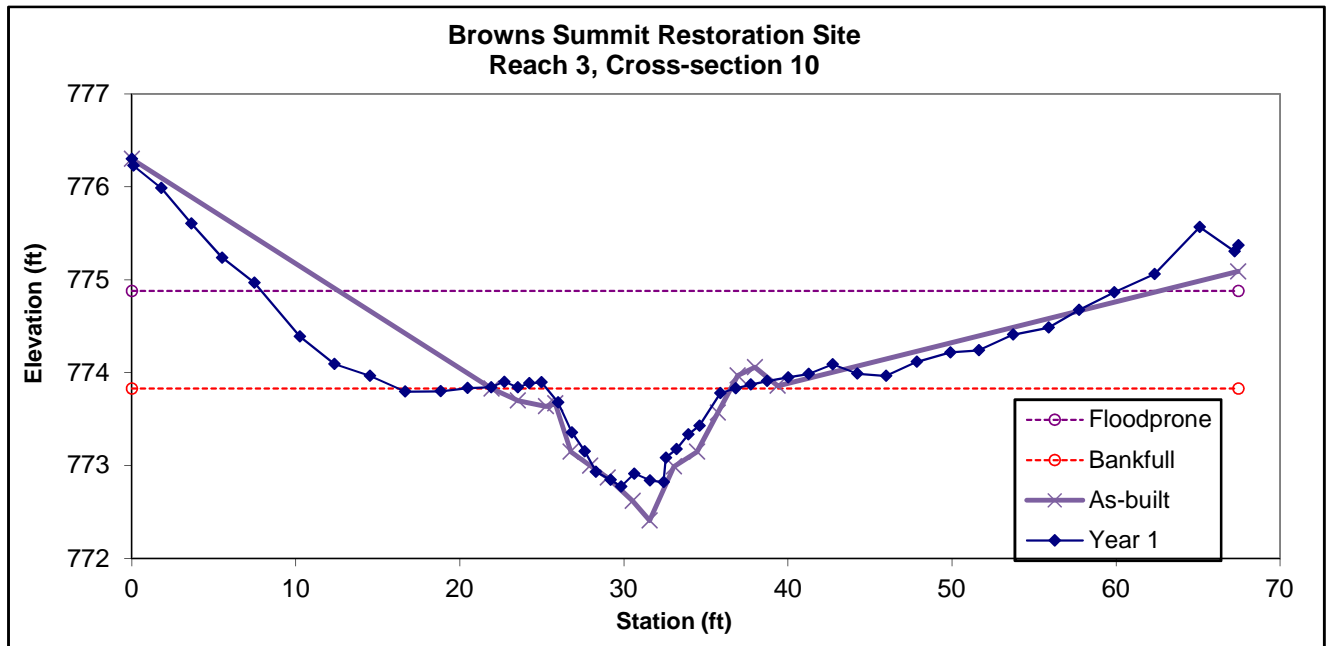
Permanent Cross-section 10

Feature	Stream Type	BKF Area	BKF Width	BKF Depth	Max BKF Depth	W/D	BH Ratio	ER	BKF Elev	TOB Elev
Riffle	C	6.9	11.5	0.6	1.1	19.2	1	4.54	773.83	773.83

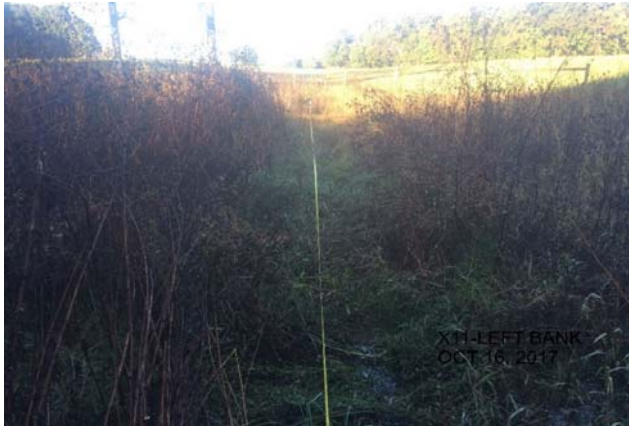
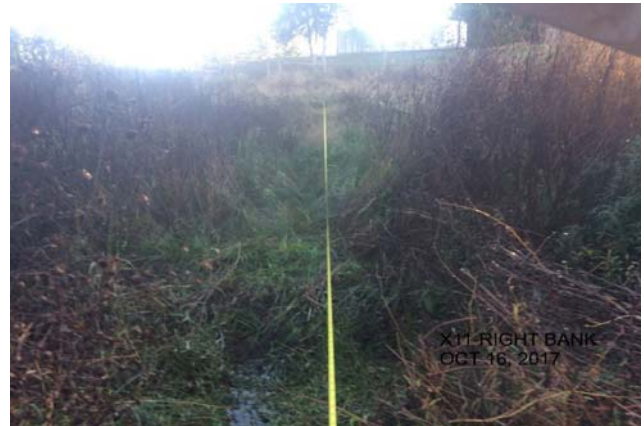
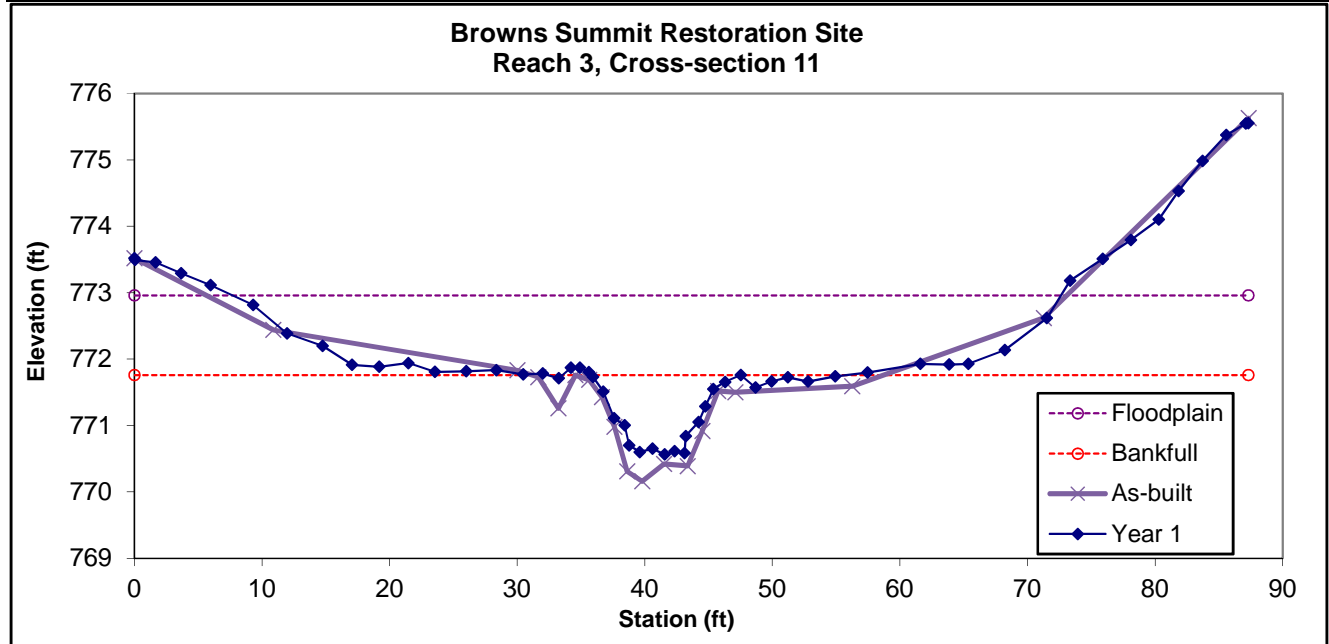
Permanent Cross-section 11

Feature	Stream Type	BKF Area	BKF Width	BKF Depth	Max BKF Depth	W/D	BH Ratio	ER	BKF Elev	TOB Elev
Riffle	C	8.0	11.7	0.7	1.2	17.2	1	5.53	771.76	771.76

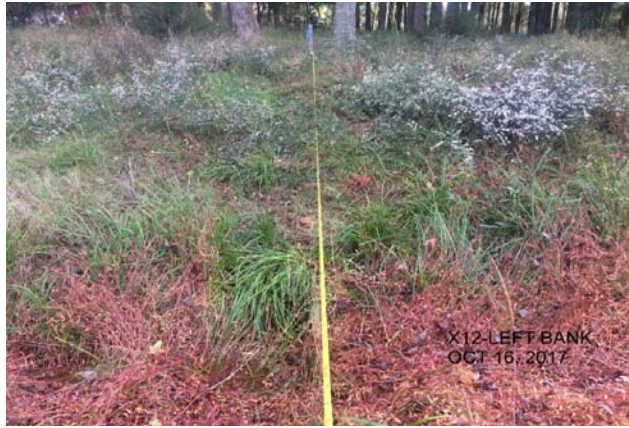
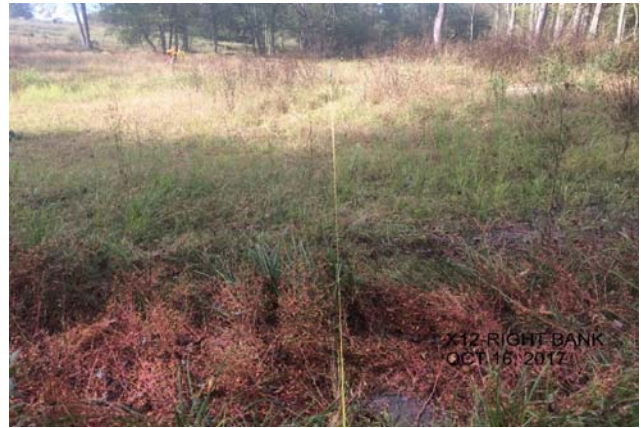
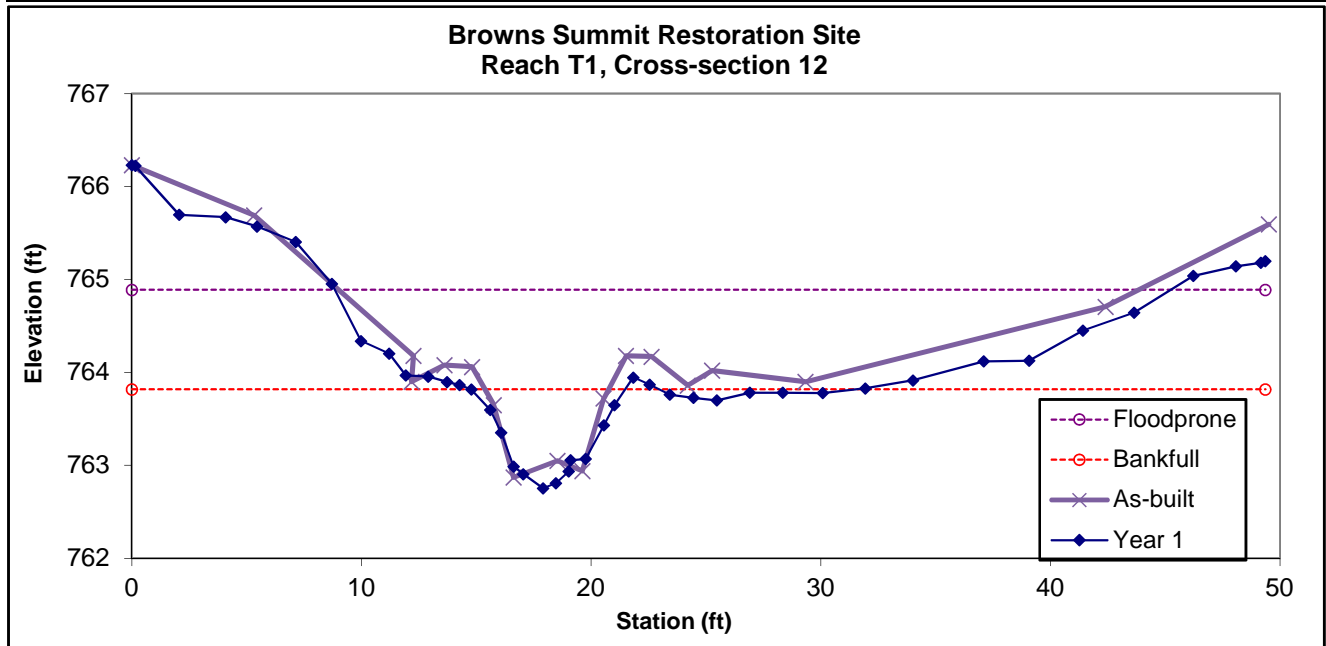
Permanent Cross-section 12

Feature	Stream Type	BKF Area	BKF Width	BKF Depth	Max BKF Depth	W/D	BH Ratio	ER	BKF Elev	TOB Elev
Riffle	E	4.1	6.7	0.6	1.1	11.0	1	5.41	763.8184	763.82

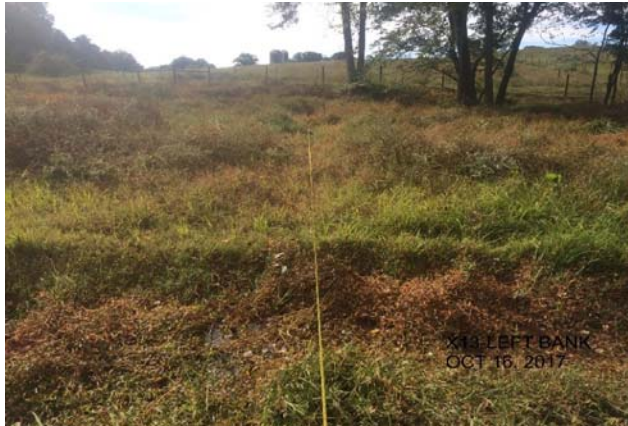
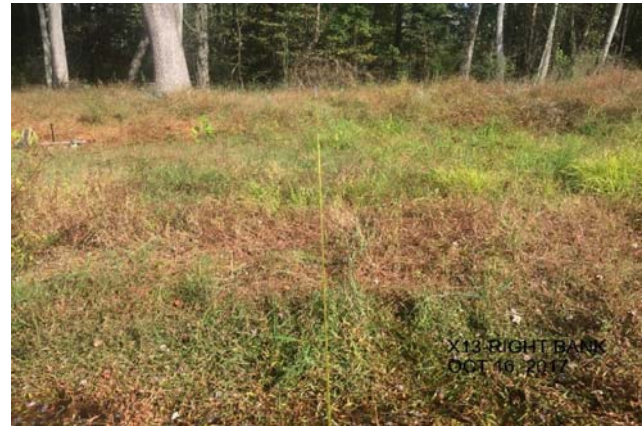
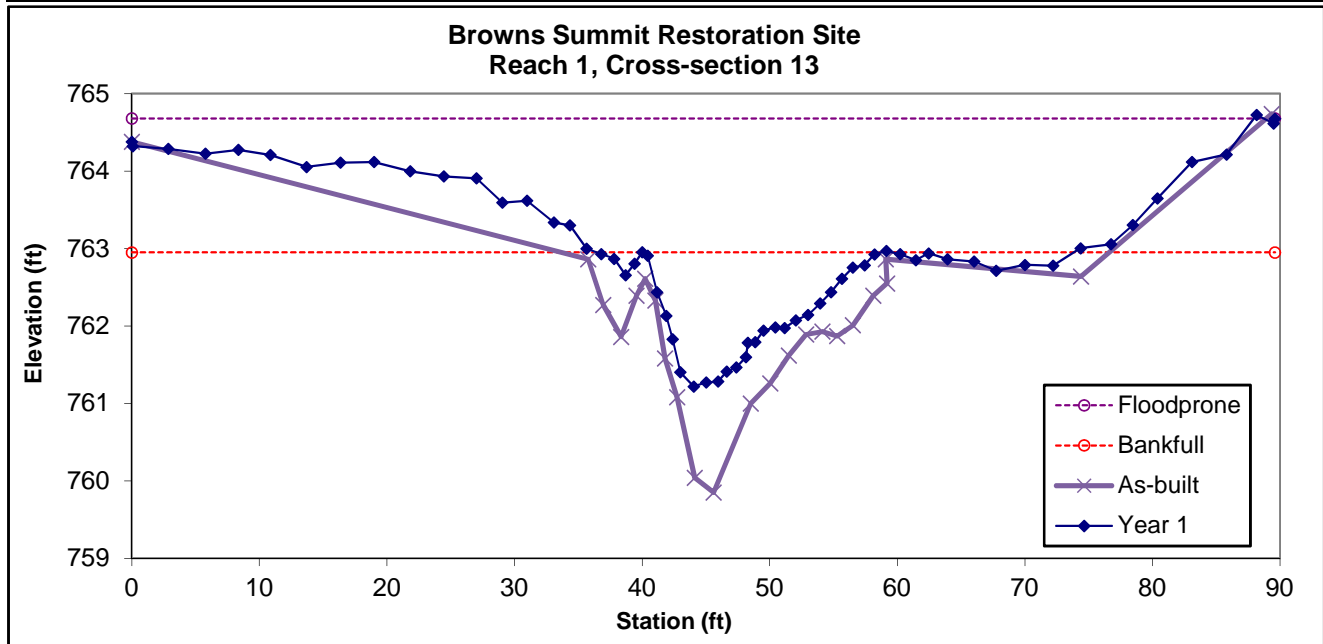
Permanent Cross-section 13

Feature	Stream Type	BKF Area	BKF Width	BKF Depth	Max BKF Depth	W/D	BH Ratio	ER	BKF Elev	TOB Elev
Pool	C	17.1	18.7	0.9	1.7	20.6	--	-	762.95	762.95

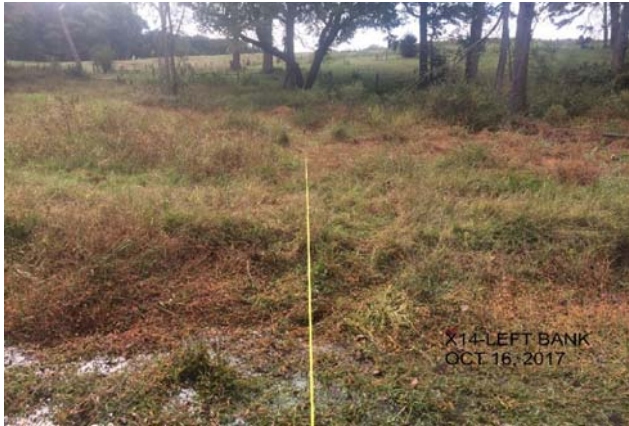
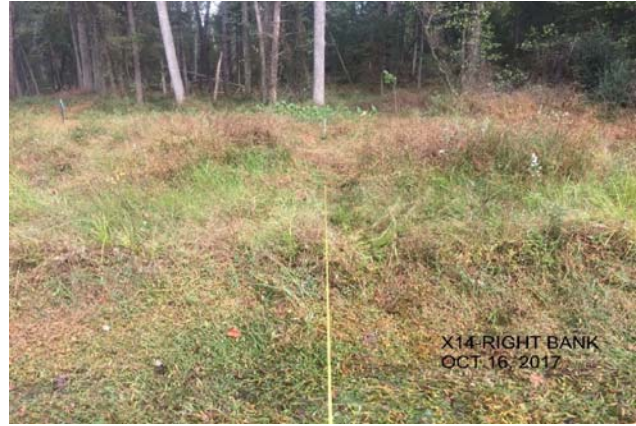
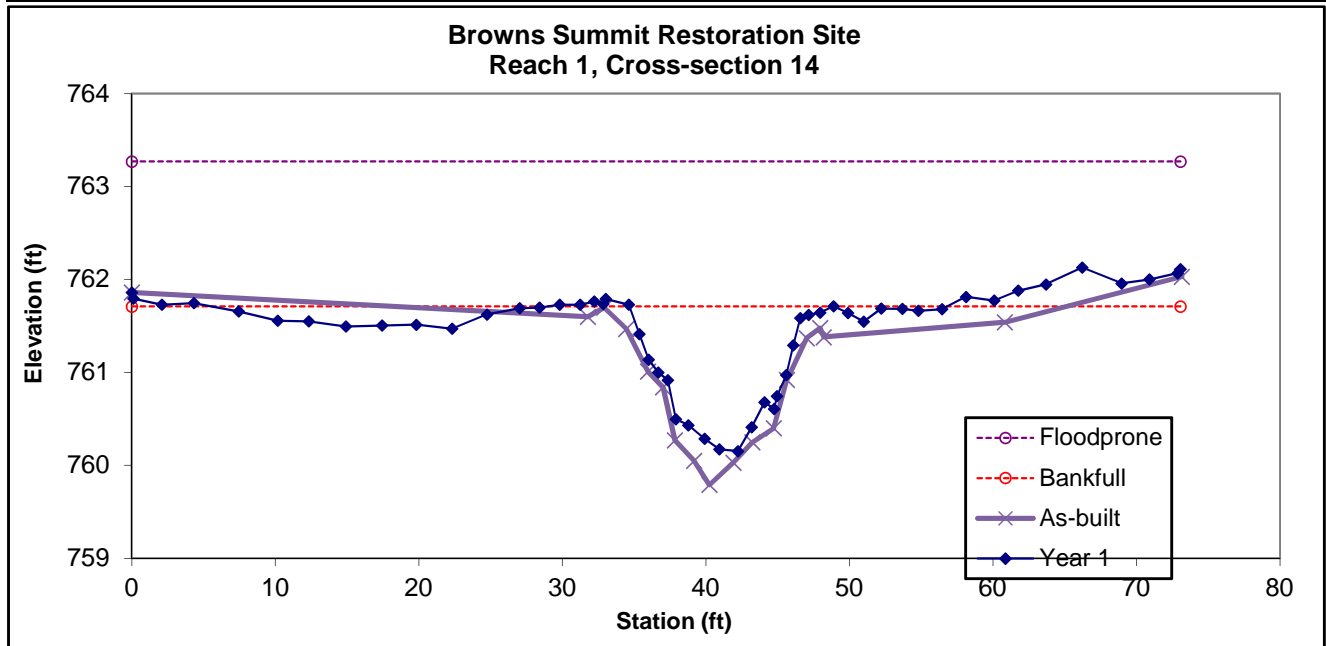
Permanent Cross-section 14

Feature	Stream Type	BKF Area	BKF Width	BKF Depth	Max BKF Depth	W/D	BH Ratio	ER	BKF Elev	TOB Elev
Riffle	C	12.5	14.7	0.9	1.6	17.3	1	4.96	761.71	761.71

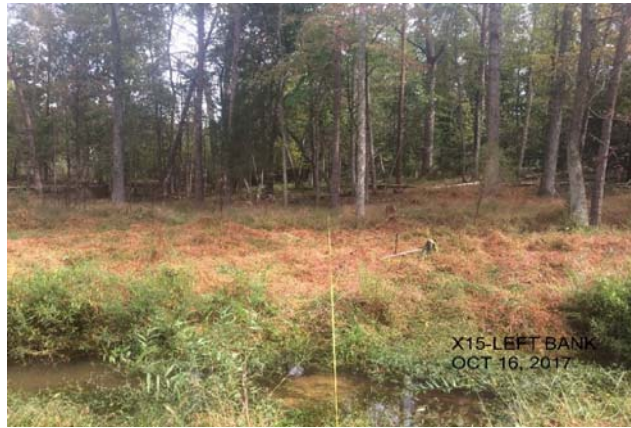
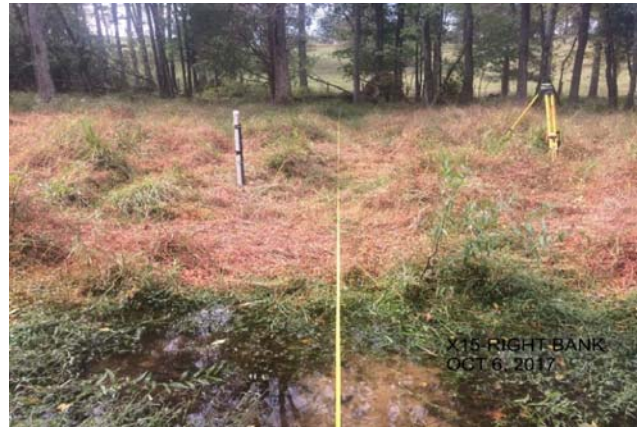
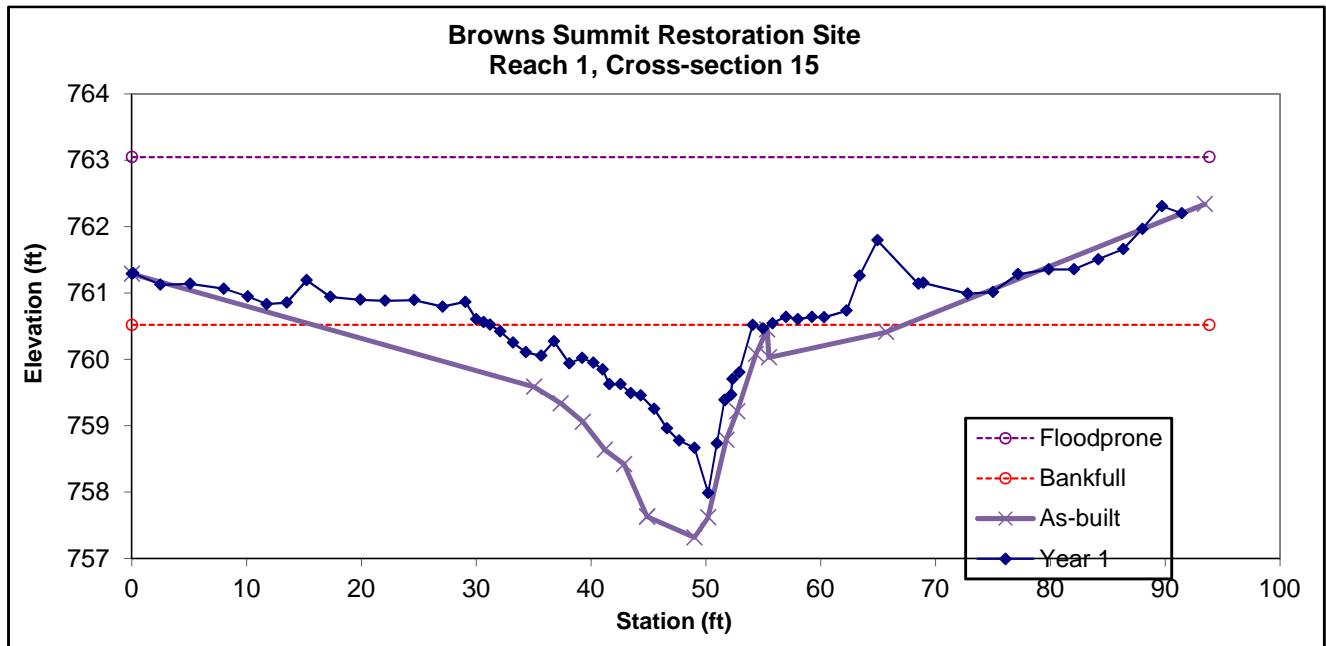
Permanent Cross-section 15

Feature	Stream Type	BKF Area	BKF Width	BKF Depth	Max BKF Depth	W/D	BH Ratio	ER	BKF Elev	TOB Elev
Pool	C	20.8	24.3	0.9	2.5	28.3	--	--	760.52	760.52

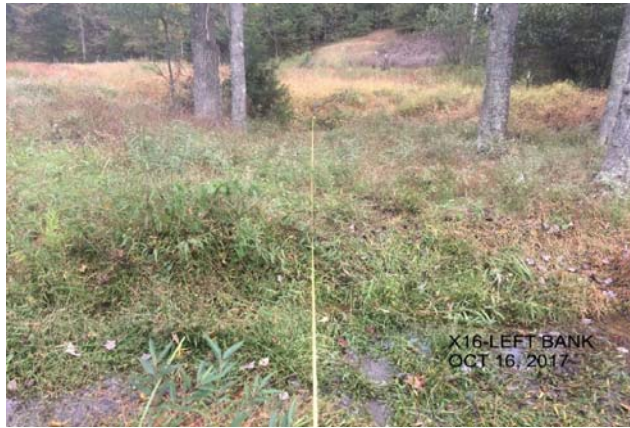
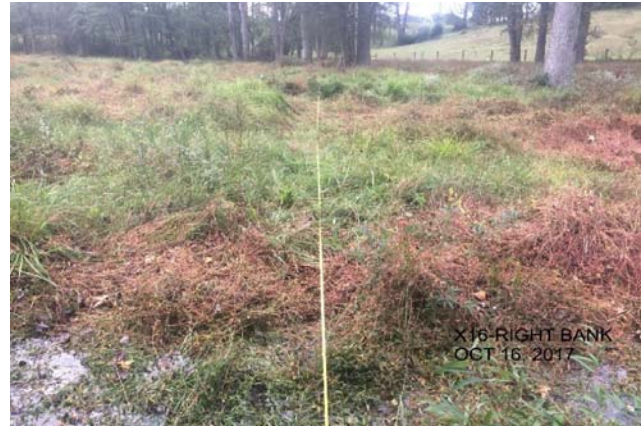
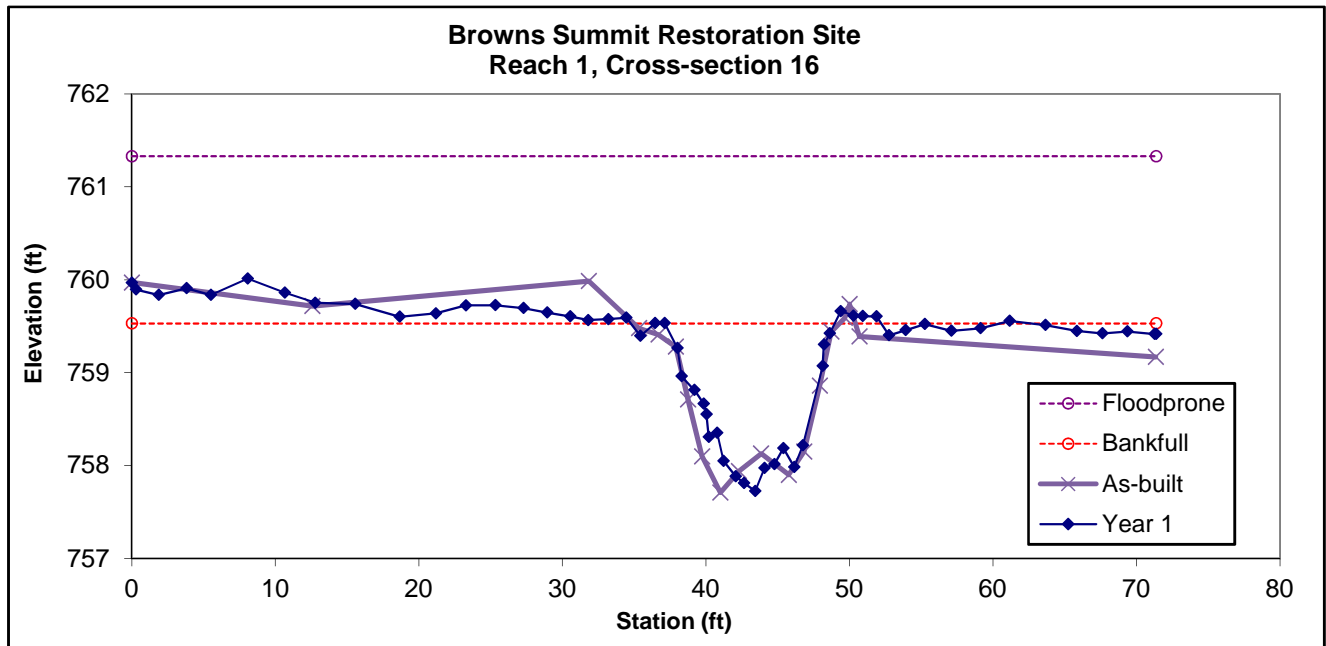
Permanent Cross-section 16

Feature	Stream Type	BKF Area	BKF Width	BKF Depth	Max BKF Depth	W/D	BH Ratio	ER	BKF Elev	TOB Elev
Riffle	E	13.0	11.9	1.09	1.8	10.9	1	6	759.53	759.53

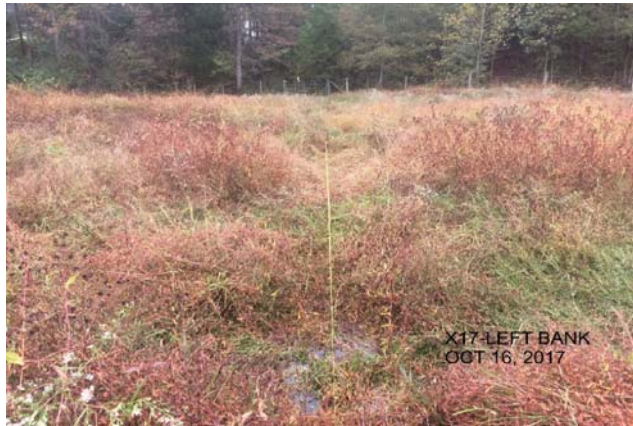
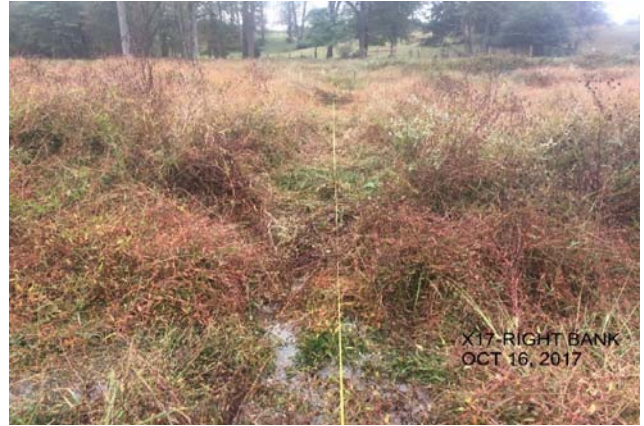
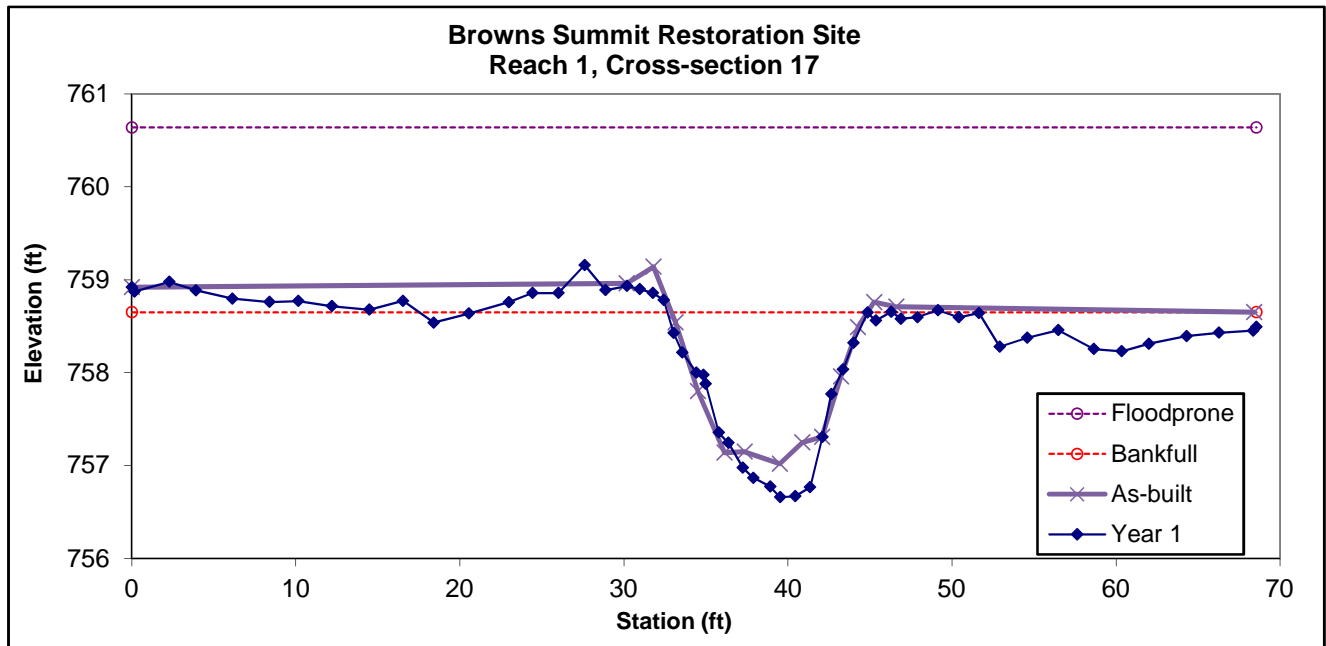
Permanent Cross-section 17

Feature	Stream Type	BKF Area	BKF Width	BKF Depth	Max BKF Depth	W/D	BH Ratio	ER	BKF Elev	TOB Elev
Riffle	E	14.6	12.2	1.2	2.0	10.3	1	5.62	758.65	758.65

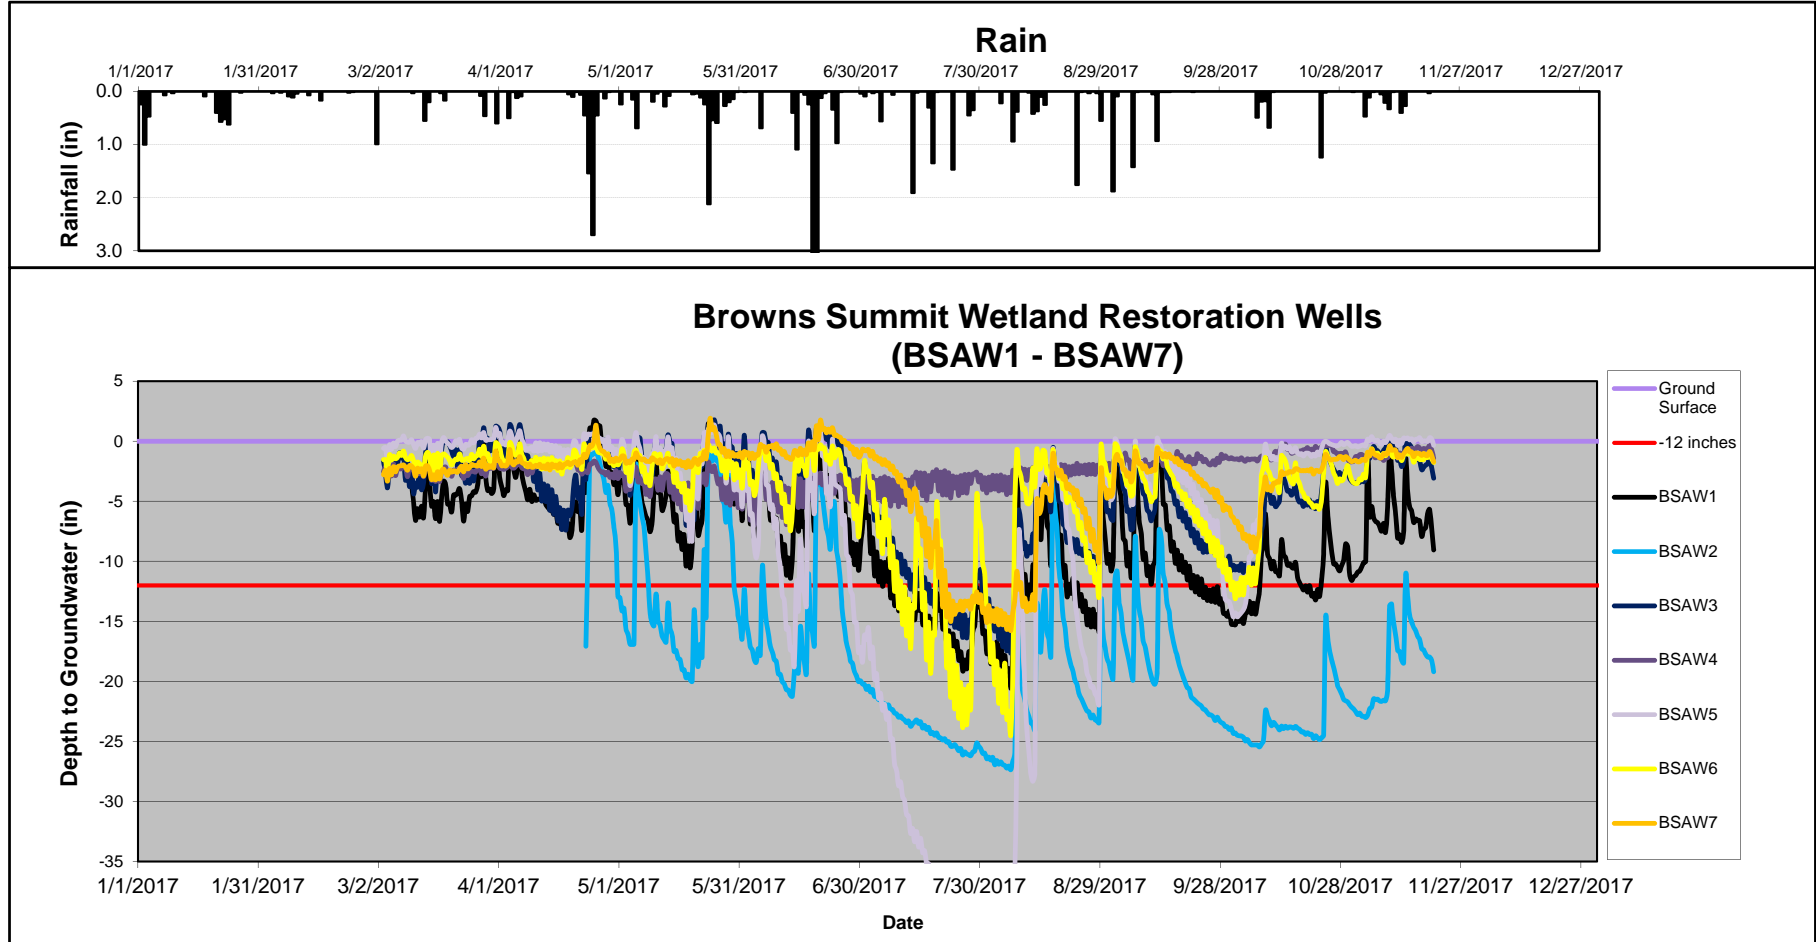
Figure 7 Wetland Restoration Graphs (2017)

Seven (7) groundwater monitoring wells were installed in the wetland mitigation area to document hydrologic conditions of the restored wetland area. Six of the seven wells are showing successful hydrology. BSAW2 is currently unsuccessful; however, the well did not perform initially and had to be re-installed. Thus, approximately a month of the initial part of the growing season is missing. The well is showing a similar wetting cycle to the other wells and will be monitored closely during 2018 for expected improvement. Visually, the wetland areas are performing very well with saturated soils and hydrophytic vegetation.
