## Browns Summit Creek Restoration Project Year 2 Monitoring Report

Guilford County, North Carolina

DMS Project ID No. 96313, DEQ Contract No. 5792

Project Info:            Monitoring Year: 2 of 7  
                                 Year of Data Collection: 2018  
                                 Year of Completed Construction (including planting): 2017  
                                 Submission Date: December 2018

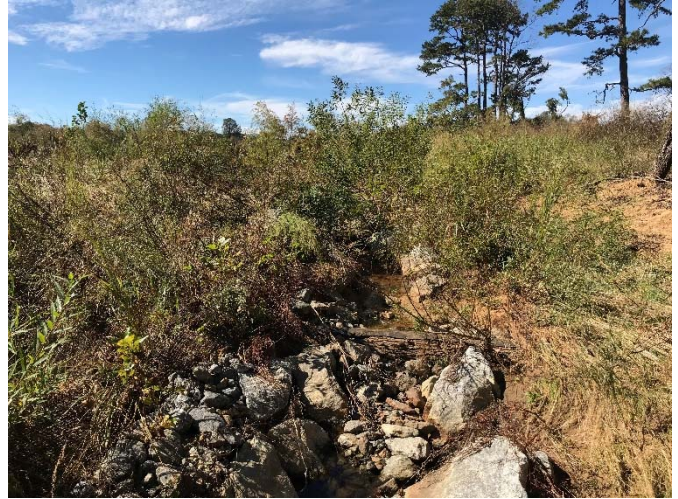
SPA 2 – Reach 6, Station 15+00

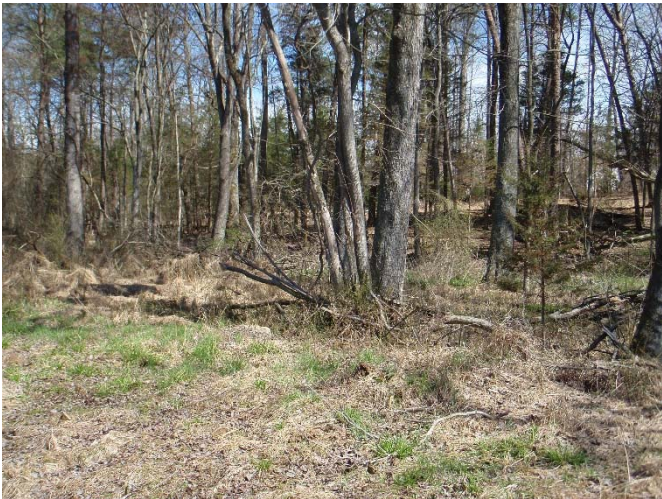
VPA 1 – Reach 1, Left Bank (March 22, 2018)

Additionally, there were noted areas of invasive species vegetation, Chinese Privet (*Ligustrum sinense*), observed during the Year 2 monitoring. These areas are identified in the monitoring year 2 CCPV. We are scheduled to treat these area in the spring of monitoring year 3.

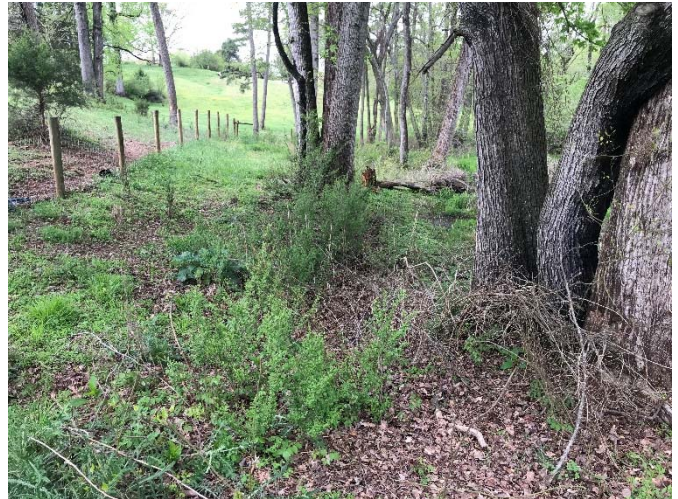
VPA 2 – Reach 1, Right Bank (April 25, 2018)

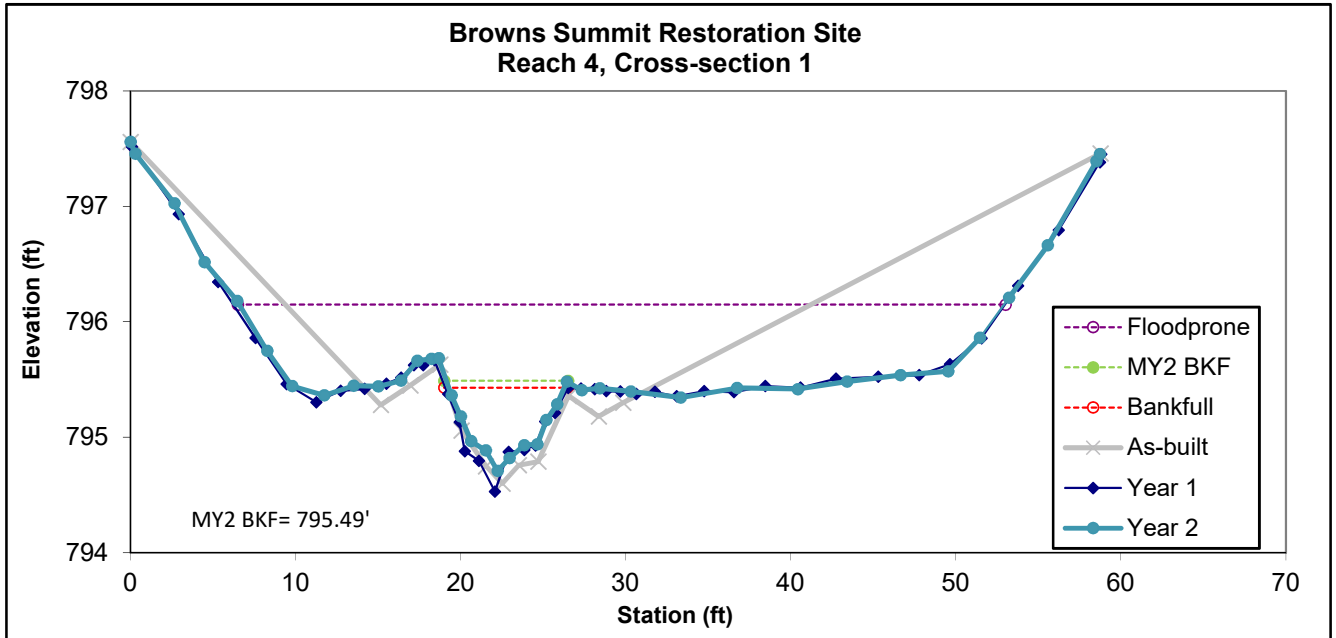
**Permanent Cross-section 1**  
(Year 2 Data - Collected October 2018)

Feature	Stream Type	BKF Area	BKF Width	BKF Depth	Max BKF Depth	W/D	BH Ratio	ER	BKF Elev	TOB Elev
Riffle	C	3	7	0.4	0.7	16.5	1.0	6.6	795.43	795.48

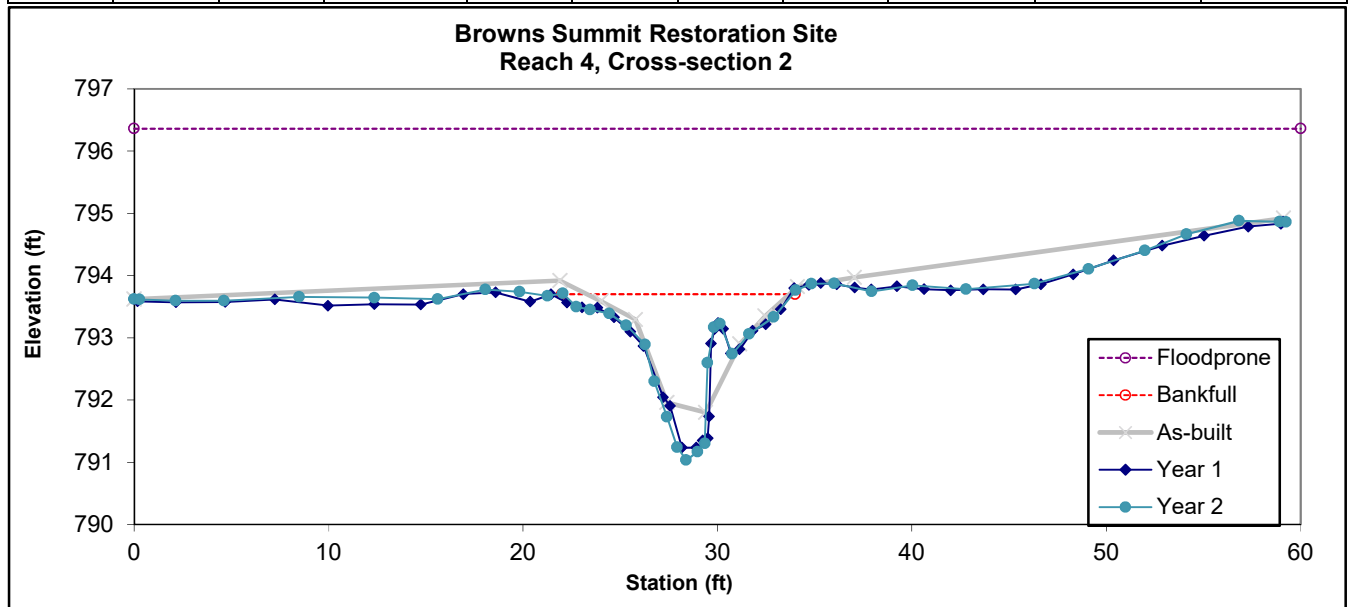
**Permanent Cross-section 2**  
(Year 2 Data - Collected October 2018)

Feature	Stream Type	BKF Area	BKF Width	BKF Depth	Max BKF Depth	W/D	BH Ratio	ER	BKF Elev	TOB Elev
Pool		10.5	12.3	0.9	2.7	14.4	-	-	793.70	793.71

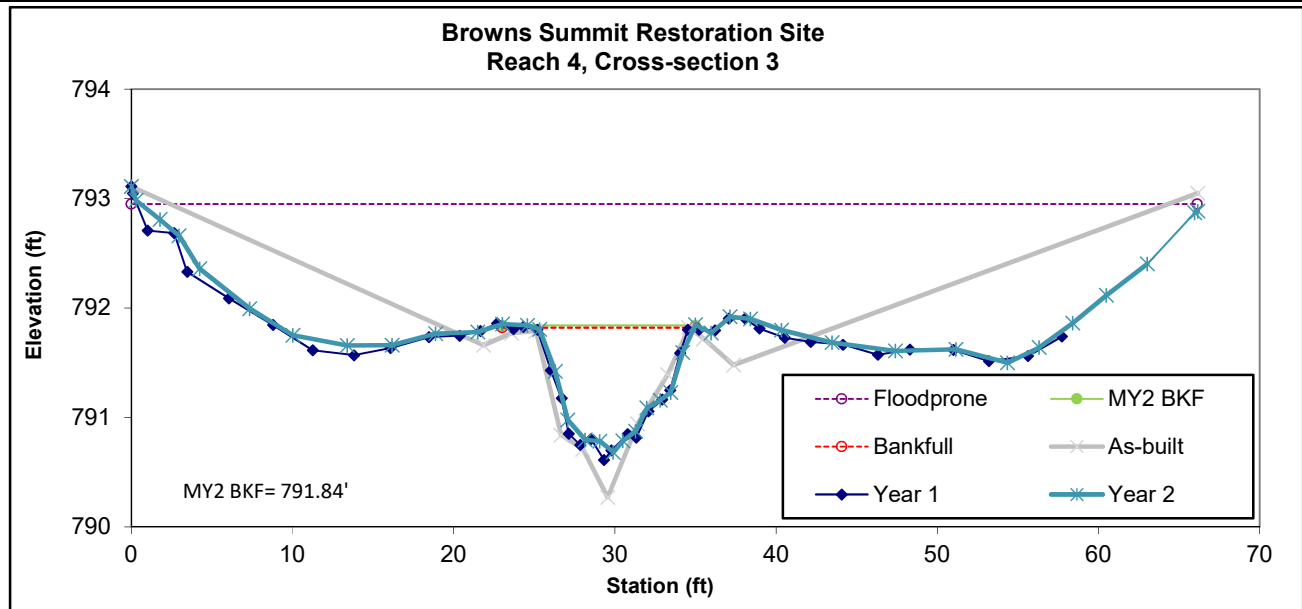
**Permanent Cross-section 3**  
(Year 2 Data - Collected October 2018)

Feature	Stream Type	BKF Area	BKF Width	BKF Depth	Max BKF Depth	W/D	BH Ratio	ER	BKF Elev	TOB Elev
Rifle	C	6.9	10.6	0.7	1.1	16.1	1.0	6.2	791.82	791.80

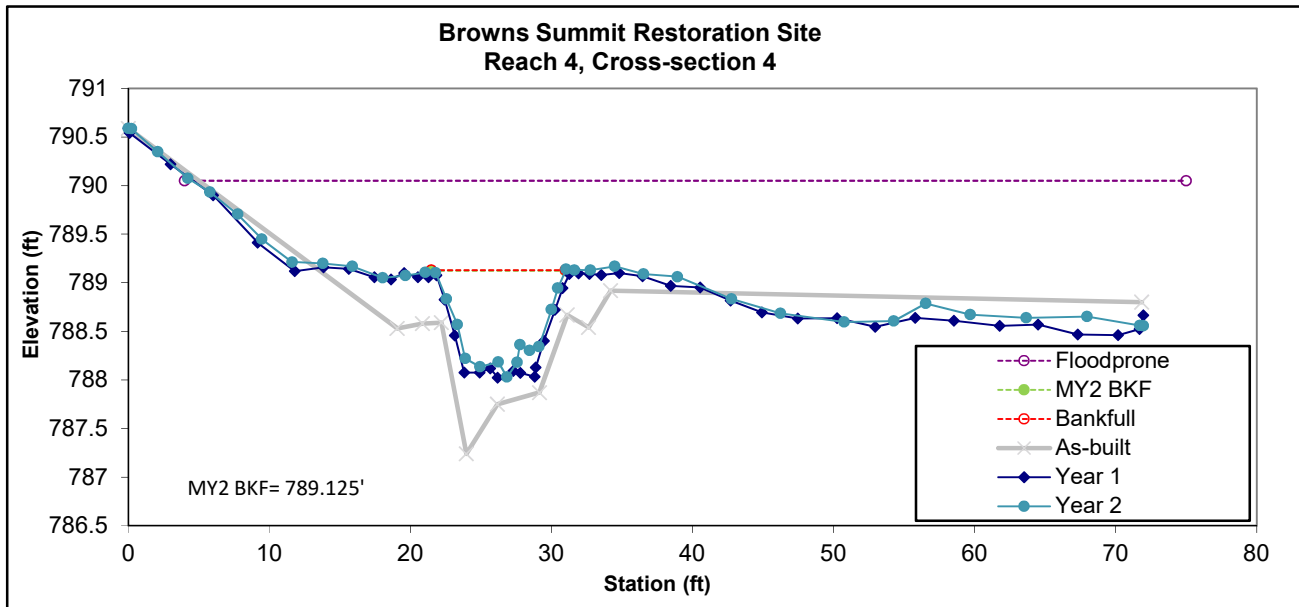
**Permanent Cross-section 4**  
(Year 2 Data - Collected October 2018)

Feature	Stream Type	BKF Area	BKF Width	BKF Depth	Max BKF Depth	W/D	BH Ratio	ER	BKF Elev	TOB Elev
Riffle	C	5.6	8.8	0.6	1	13.6	1.0	7.7	789.13	789.13

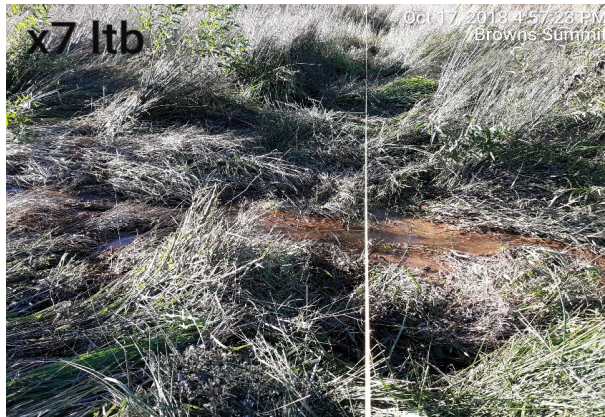
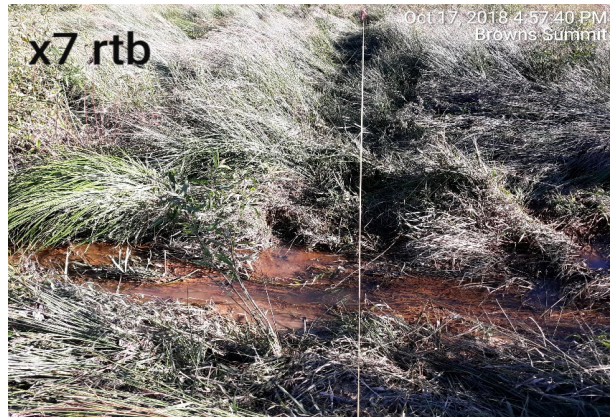
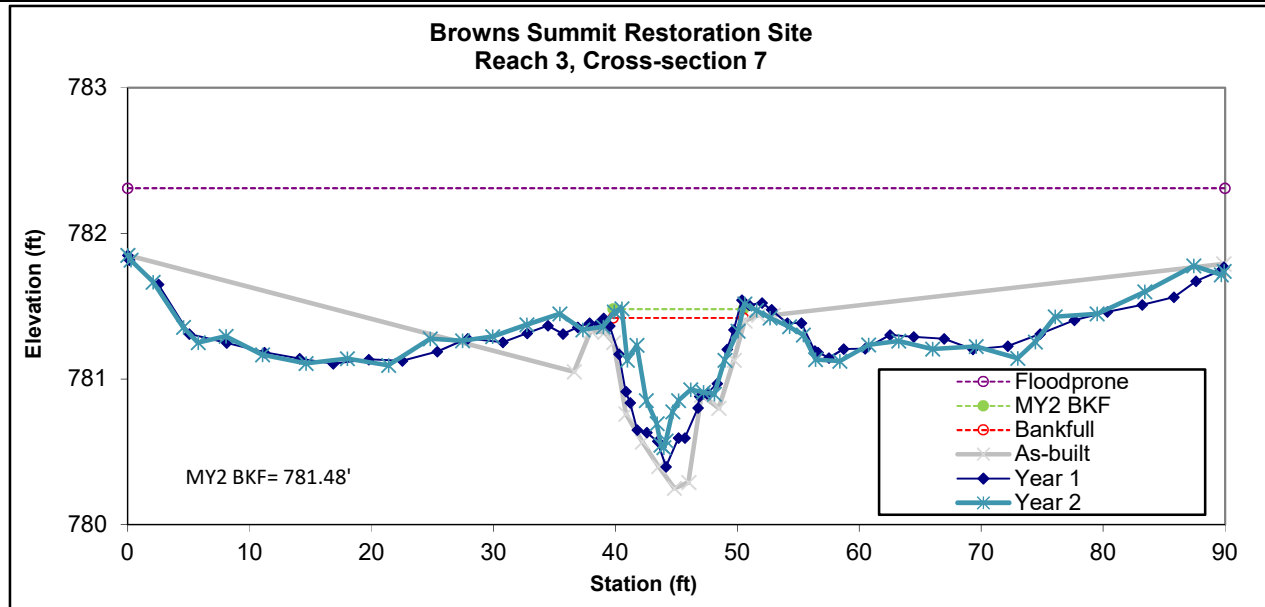
**Permanent Cross-section 7**  
(Year 2 Data - Collected October 2018)

Feature	Stream Type	BKF Area	BKF Width	BKF Depth	Max BKF Depth	W/D	BH Ratio	ER	BKF Elev	TOB Elev
Riffle	C	4.5	9.7	0.5	0.9	21.0	1.0	9.3	781.42	781.48

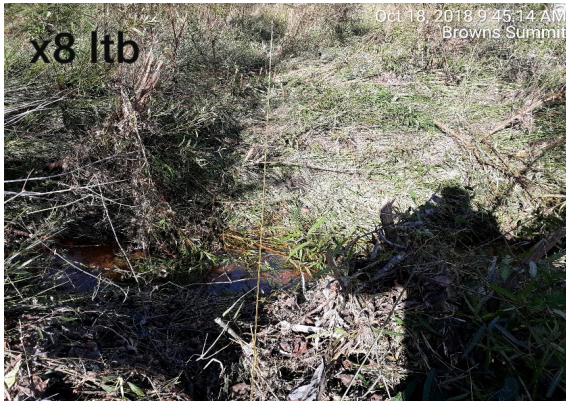
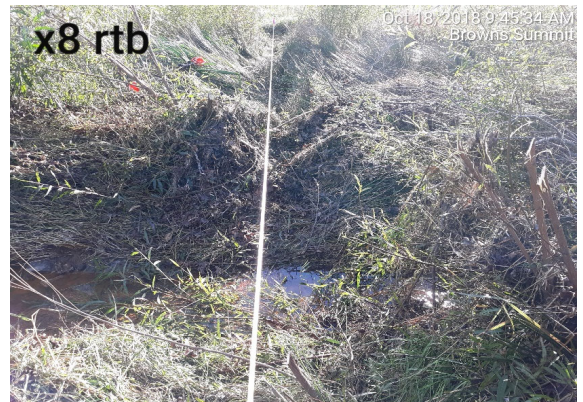
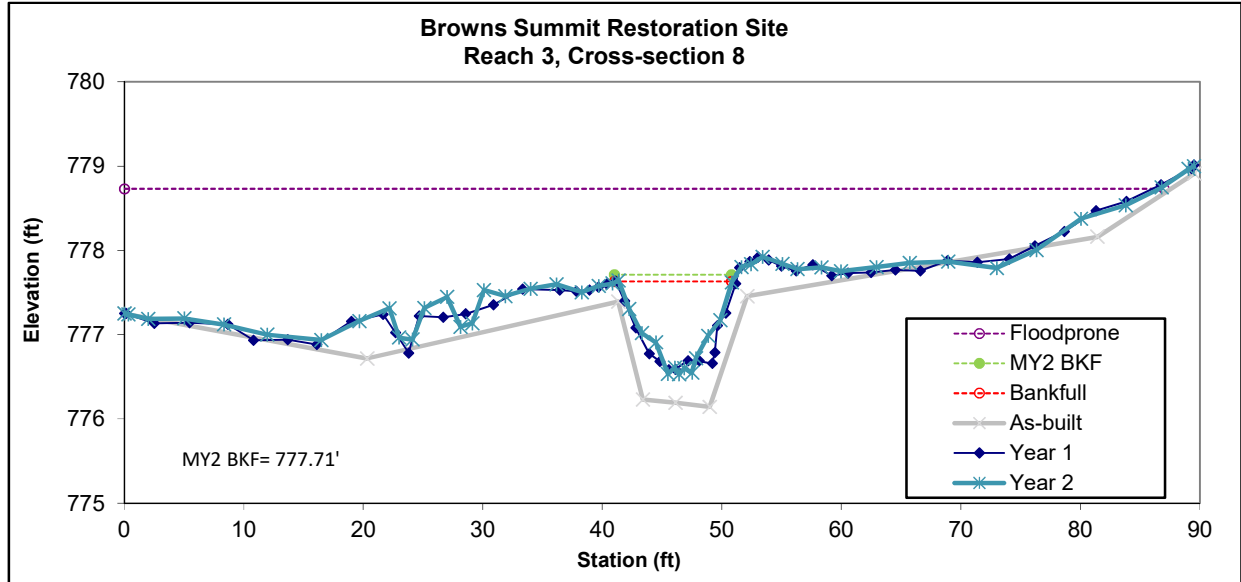
**Permanent Cross-section 8**  
(Year 2 Data - Collected October 2018)

Feature	Stream Type	BKF Area	BKF Width	BKF Depth	Max BKF Depth	W/D	BH Ratio	ER	BKF Elev	TOB Elev
Riffle	C	6.4	9.8	0.7	1.1	15.1	1.0	8.8	777.63	777.64

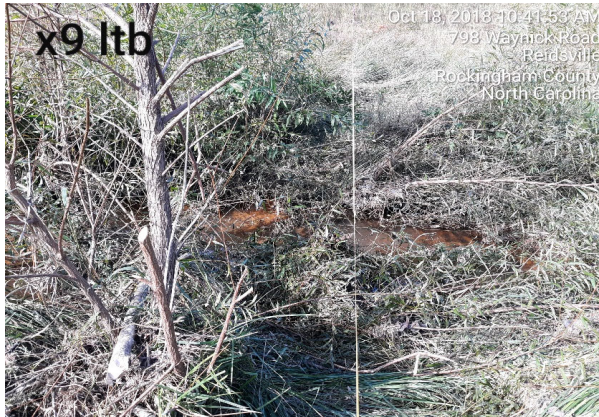
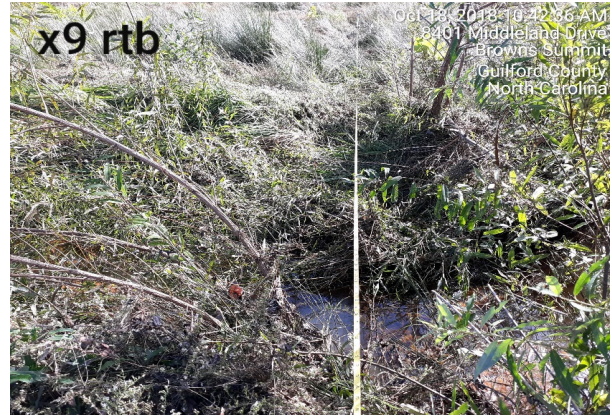
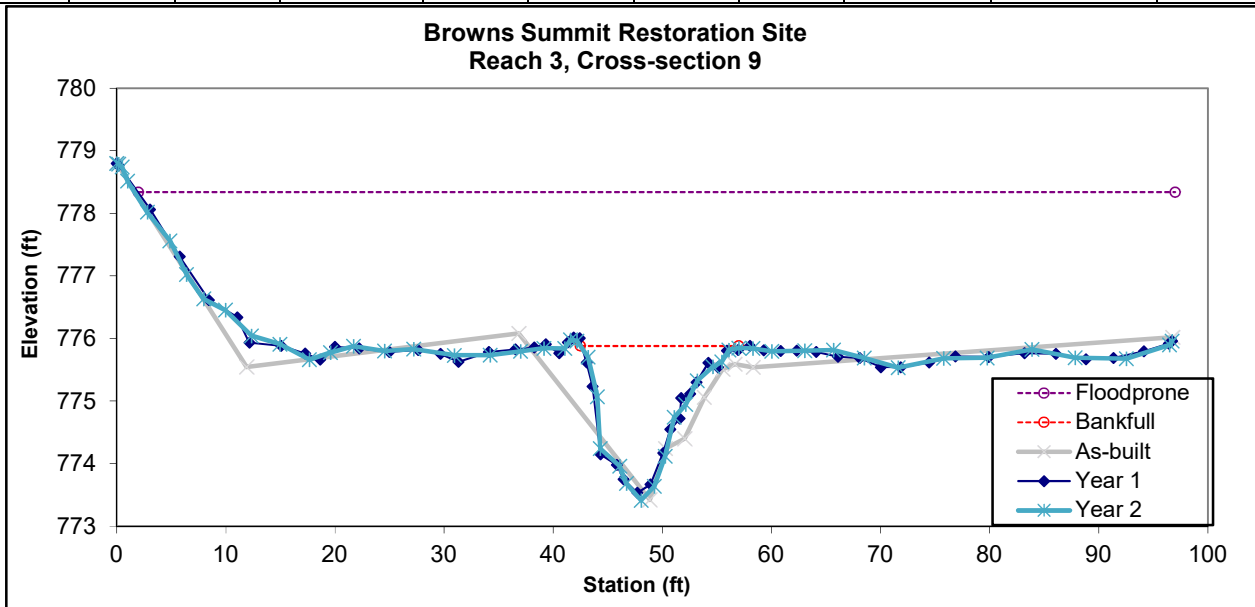
**Permanent Cross-section 9**  
(Year 2 Data - Collected October 2018)

Feature	Stream Type	BKF Area	BKF Width	BKF Depth	Max BKF Depth	W/D	BH Ratio	ER	BKF Elev	TOB Elev
Pool		17.3	14.5	1.2	2.5	12.1	-	-	775.88	775.90

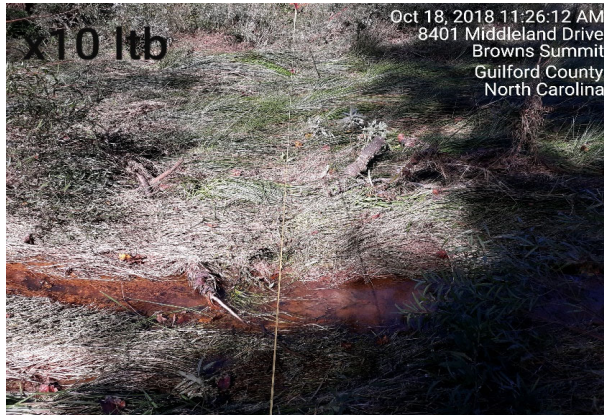
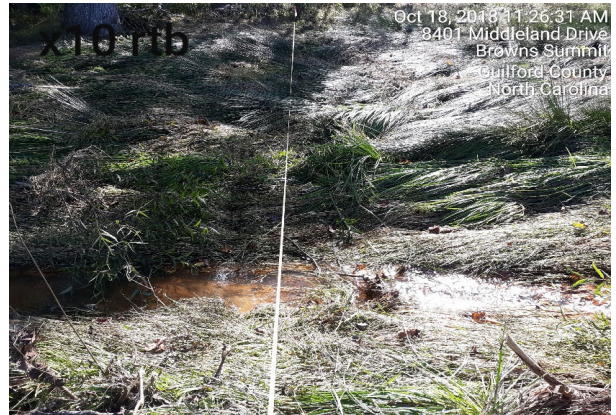
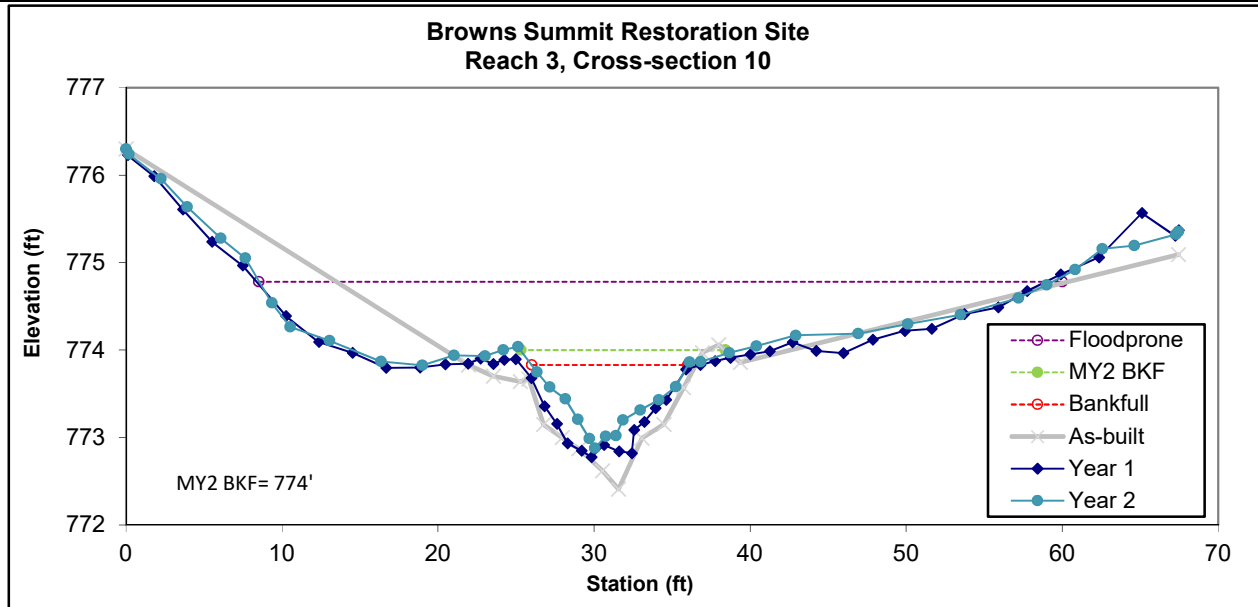
**Permanent Cross-section 10**  
(Year 2 Data - Collected October 2018)

Feature	Stream Type	BKF Area	BKF Width	BKF Depth	Max BKF Depth	W/D	BH Ratio	ER	BKF Elev	TOB Elev
Riffle	C	4.8	10	0.5	1	20.8	1.0	5.1	773.83	774.00

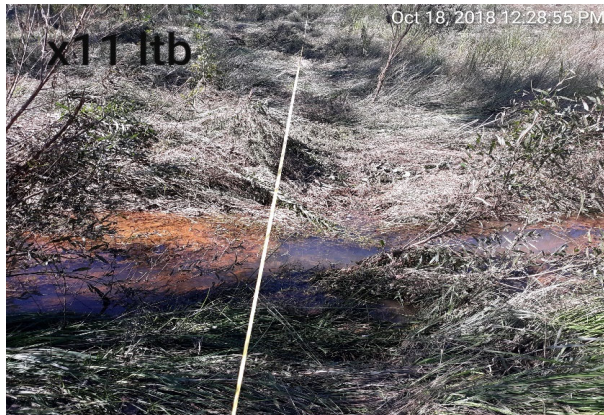
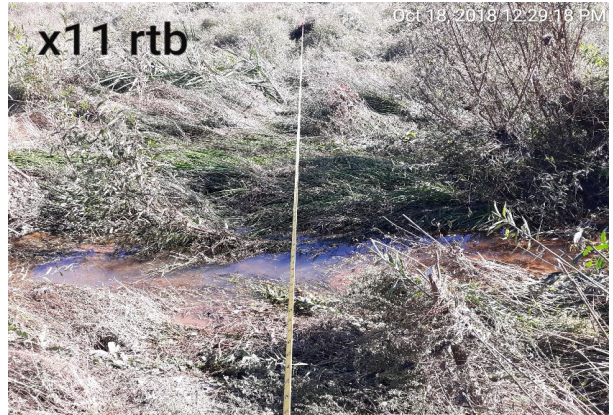
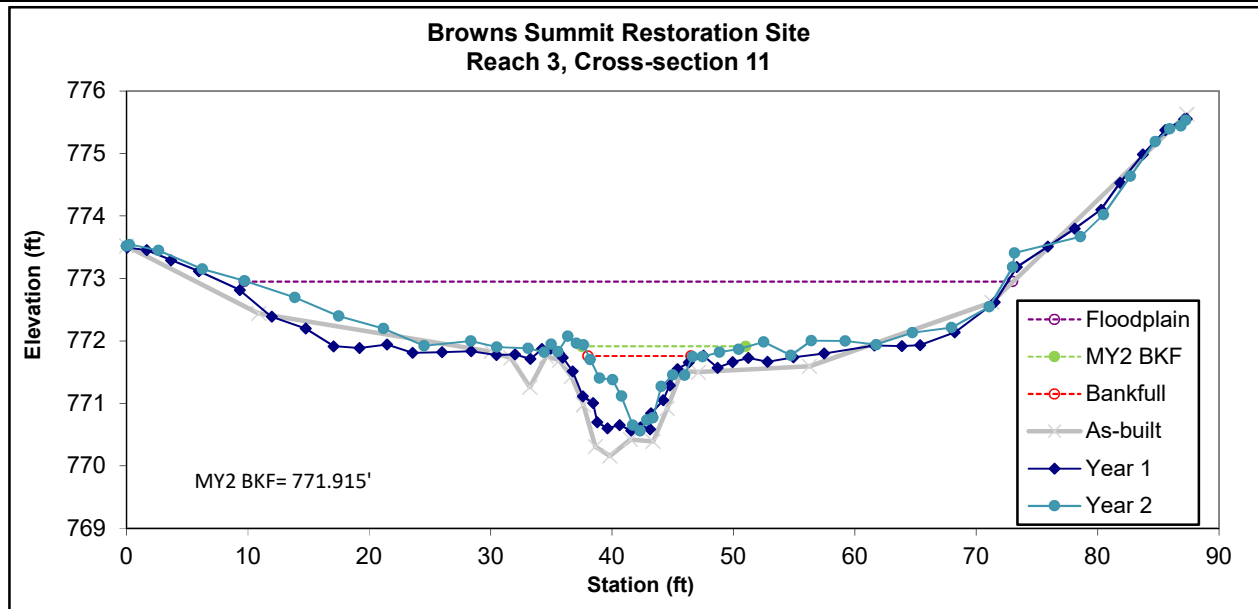
**Permanent Cross-section 11**  
(Year 2 Data - Collected October 2018)

Feature	Stream Type	BKF Area	BKF Width	BKF Depth	Max BKF Depth	W/D	BH Ratio	ER	BKF Elev	TOB Elev
Riffle	C	6	10.5	0.6	1.2	18.5	1.0	6.2	771.76	771.75

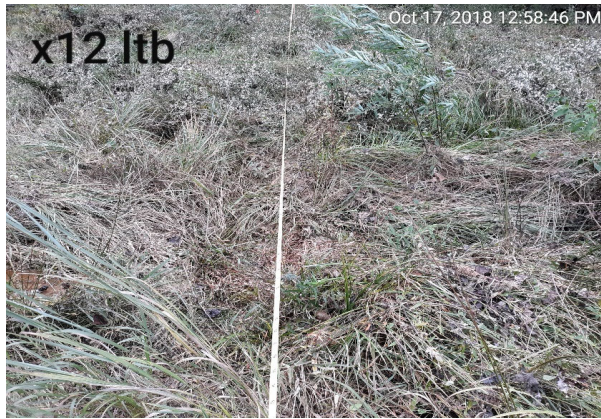
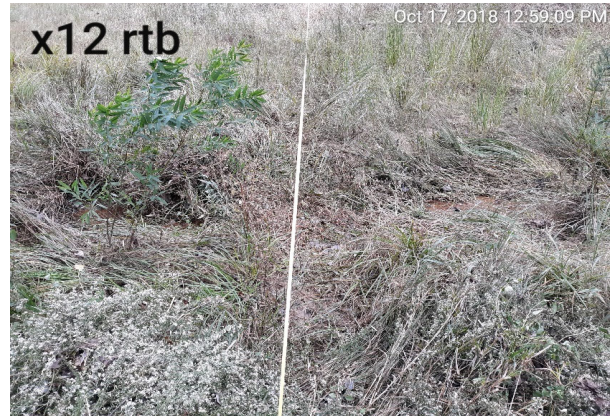
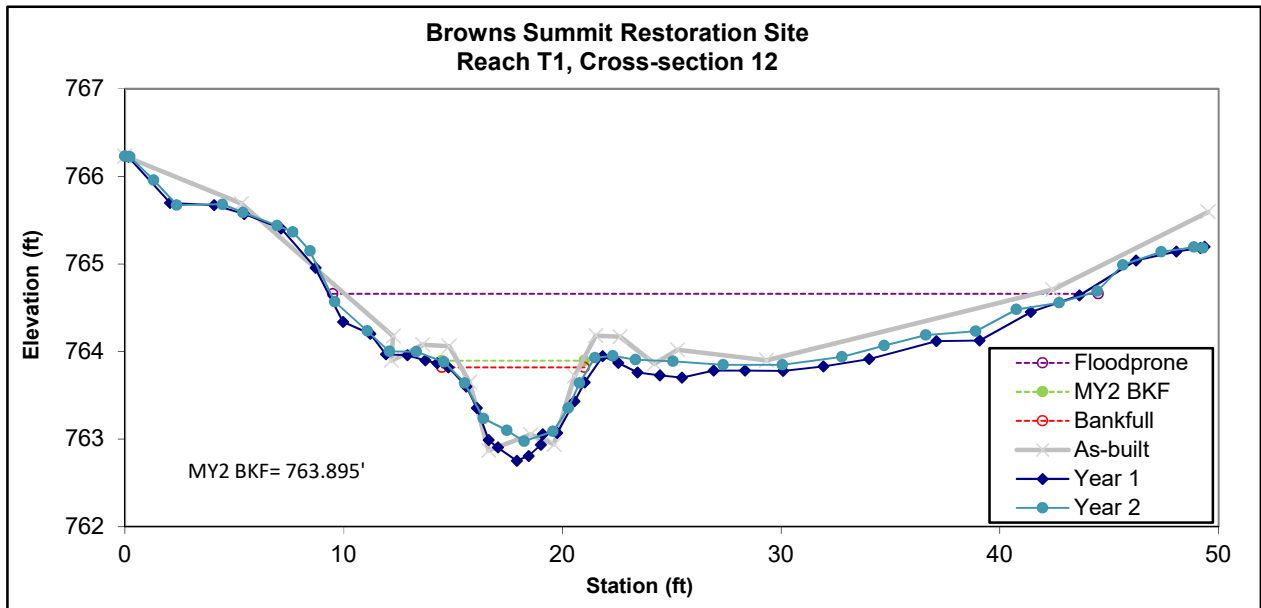
**Permanent Cross-section 12**  
(Year 2 Data - Collected October 2018)

Feature	Stream Type	BKF Area	BKF Width	BKF Depth	Max BKF Depth	W/D	BH Ratio	ER	BKF Elev	TOB Elev
Riffle	C	3.4	6.4	0.5	0.8	12.1	1.0	5.4	763.82	763.90

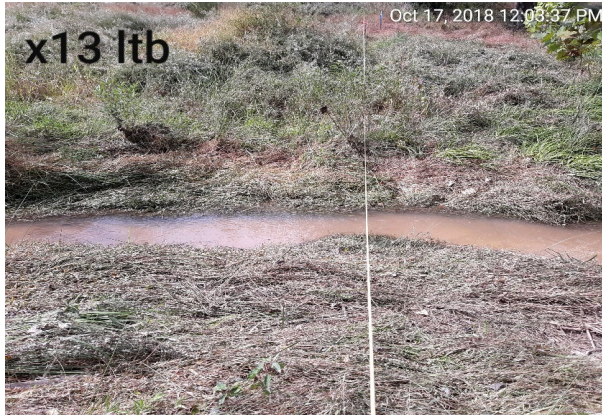
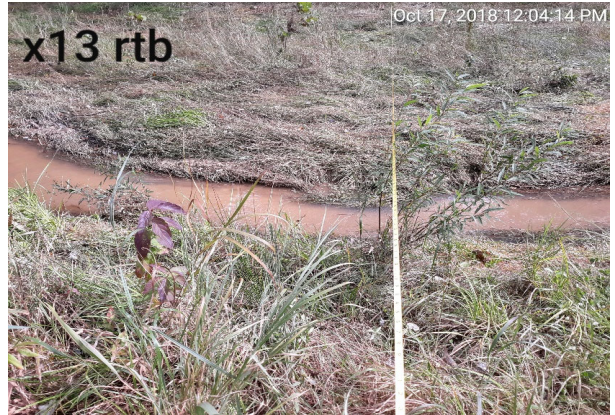
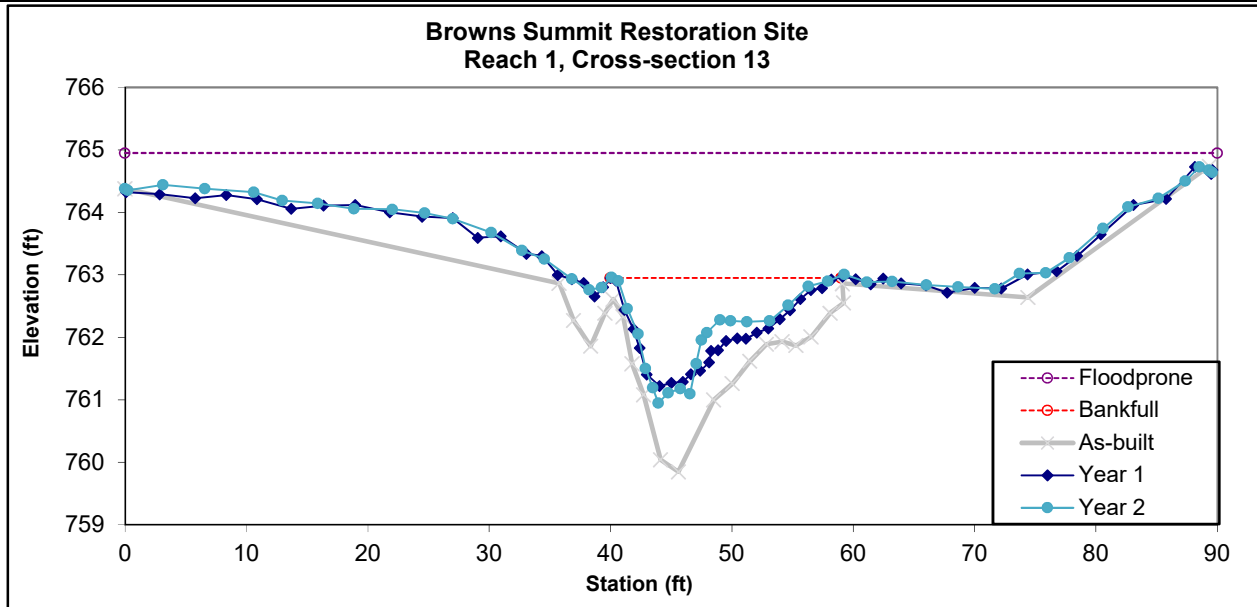
**Permanent Cross-section 13**  
(Year 2 Data - Collected October 2018)

Feature	Stream Type	BKF Area	BKF Width	BKF Depth	Max BKF Depth	W/D	BH Ratio	ER	BKF Elev	TOB Elev
Pool		15.1	18.4	0.8	2	22.4	-	-	762.95	762.95

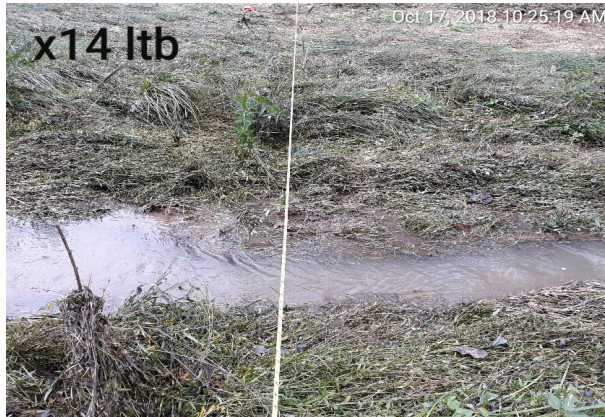
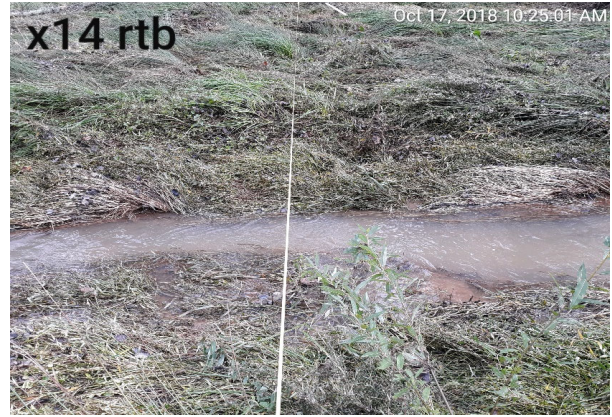
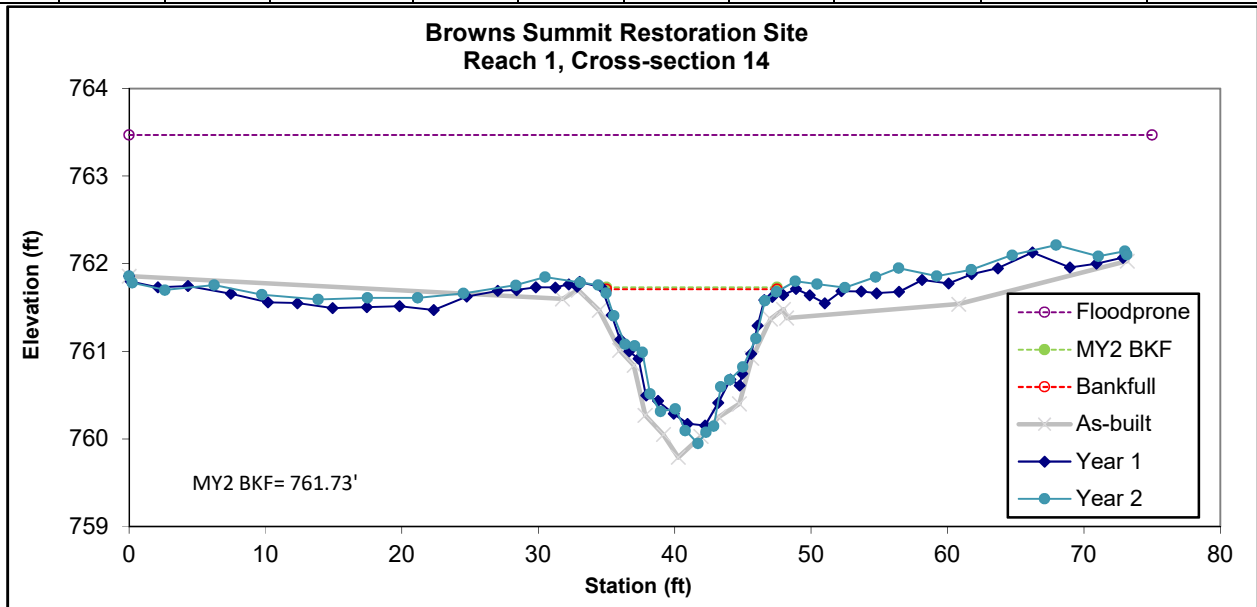
**Permanent Cross-section 14**  
(Year 2 Data - Collected October 2018)

Feature	Stream Type	BKF Area	BKF Width	BKF Depth	Max BKF Depth	W/D	BH Ratio	ER	BKF Elev	TOB Elev
Riffle	C	12.3	13.1	0.9	1.8	14.0	1.0	5.6	761.71	761.70

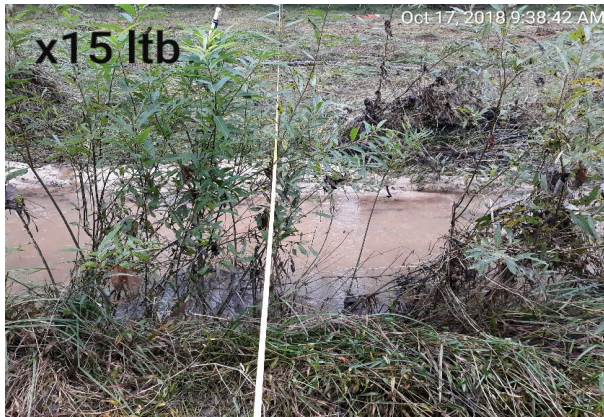
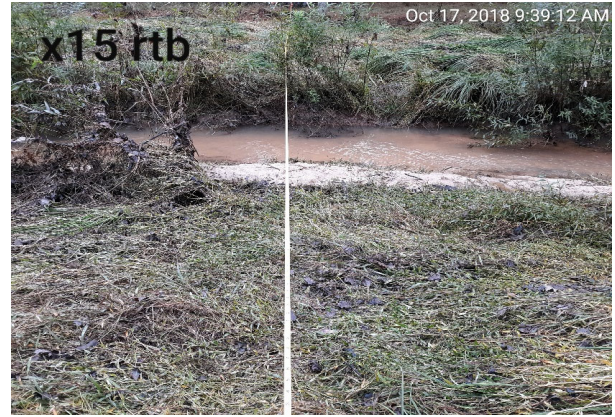
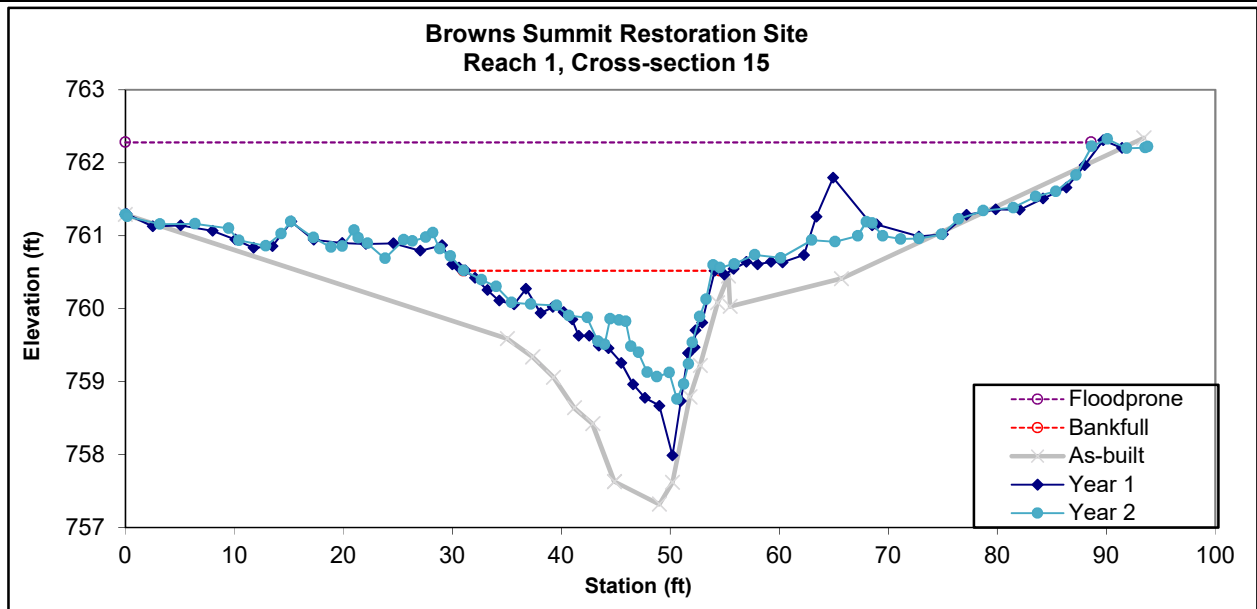
**Permanent Cross-section 15**  
(Year 2 Data - Collected October 2018)

Feature	Stream Type	BKF Area	BKF Width	BKF Depth	Max BKF Depth	W/D	BH Ratio	ER	BKF Elev	TOB Elev
Pool		16.3	22.8	0.7	1.8	31.8	-	-	760.52	760.70

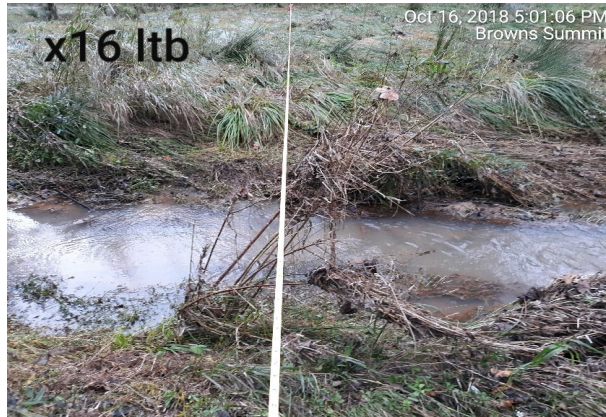
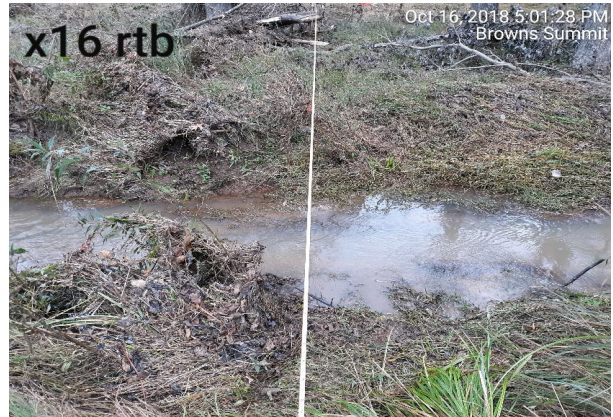
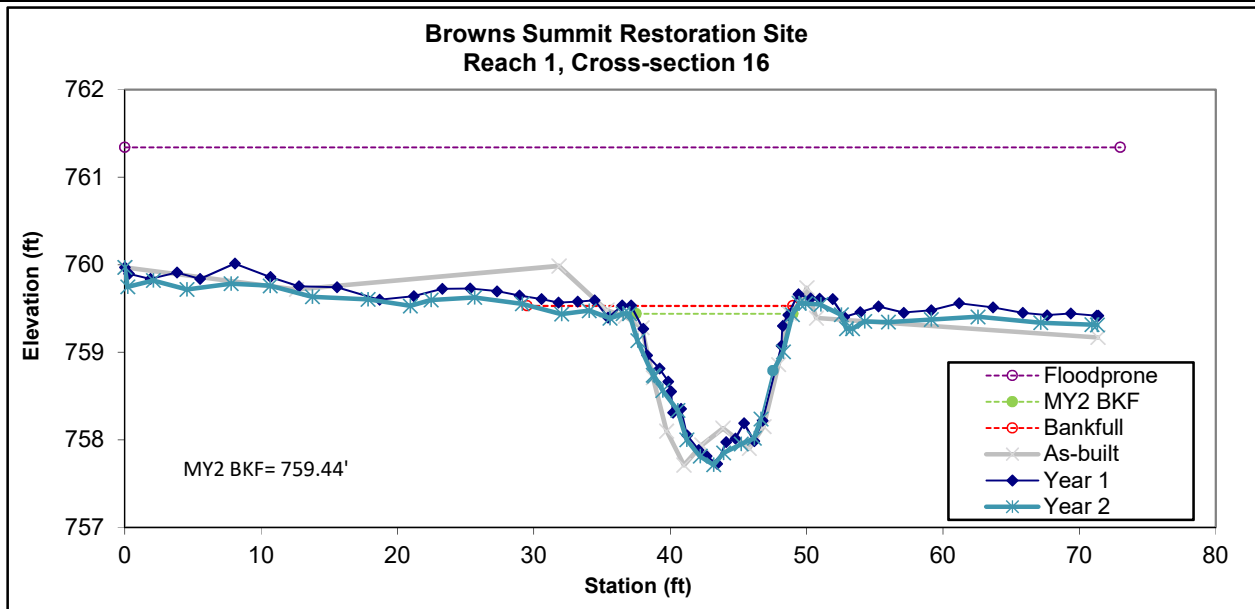
**Permanent Cross-section 16**  
(Year 2 Data - Collected October 2018)

Feature	Stream Type	BKF Area	BKF Width	BKF Depth	Max BKF Depth	W/D	BH Ratio	ER	BKF Elev	TOB Elev
Riffle	C	14.6	19.7	0.7	1.8	26.6	1.0	3.6	759.53	759.44

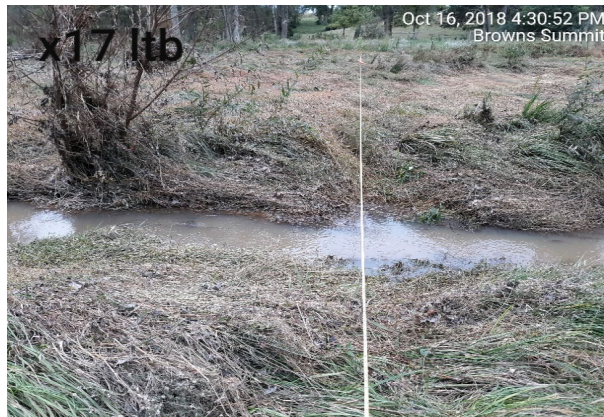
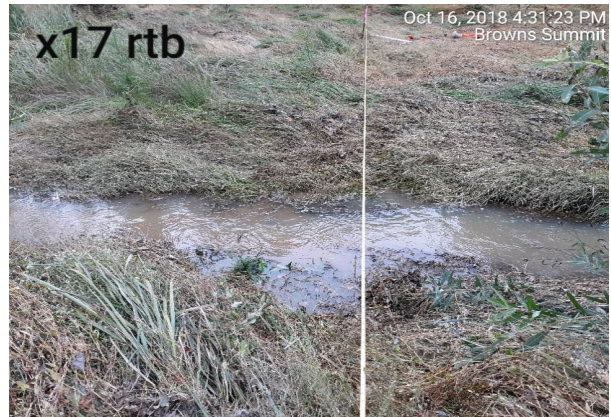
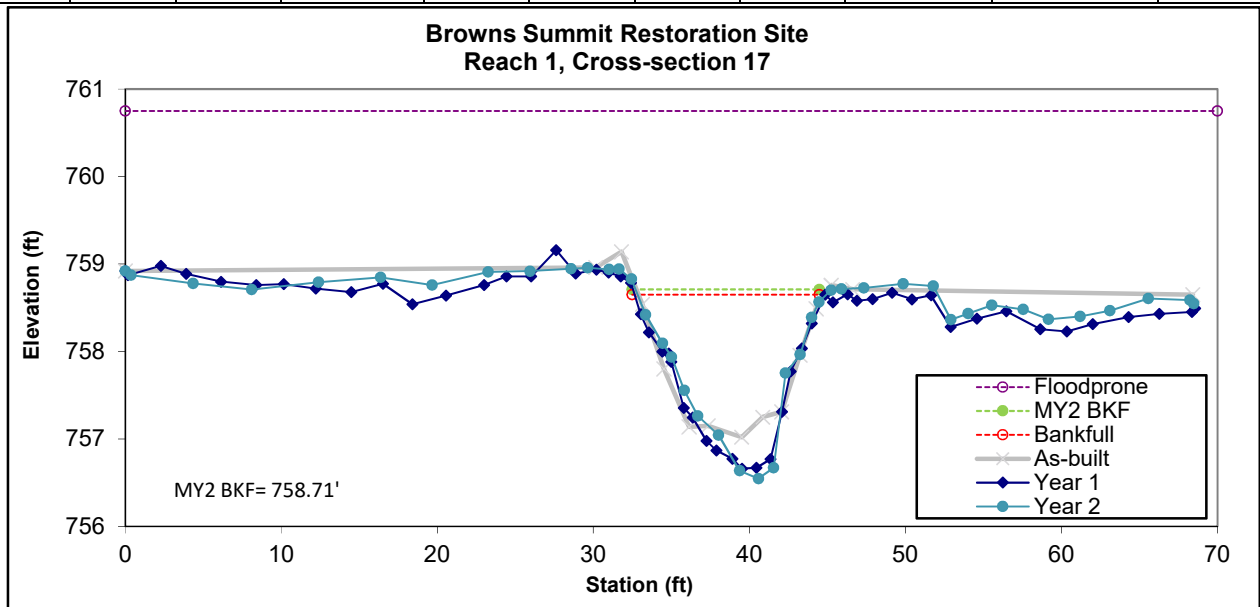
**Permanent Cross-section 17**  
(Year 2 Data - Collected October 2018)

Feature	Stream Type	BKF Area	BKF Width	BKF Depth	Max BKF Depth	W/D	BH Ratio	ER	BKF Elev	TOB Elev
Riffle	E	13.9	12.1	1.1	2.1	10.6	1	5.7	758.65	758.71

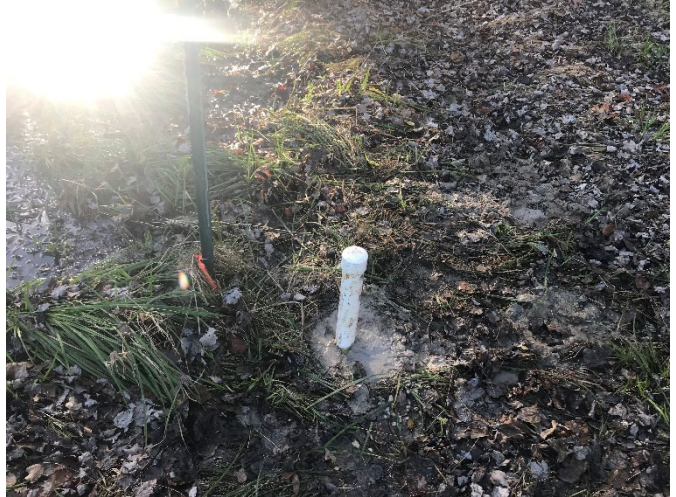
Wetland Well 2 – Reach 2, Station 47+00 March 9, 2017

Seven (7) groundwater monitoring wells were installed in the wetland mitigation area to document hydrologic conditions of the restored wetland area. Six of the seven wells are showing successful hydrology. BSAW2 is currently unsuccessful; however, the well is showing a similar wetting cycle to the other wells and will be monitored closely during 2019. Visually, the wetland areas are performing very well with saturated soils and hydrophytic vegetation.
