Browns Summit Creek Restoration Project Year 3 Monitoring Report

Guilford County, North Carolina

DMS Project ID No. 96313, DEQ Contract No. 5792

Project Info: Monitoring Year: 3 of 7
 Year of Data Collection: 2019
 Year of Completed Construction (including planting): 2017
 Submission Date: December 2019

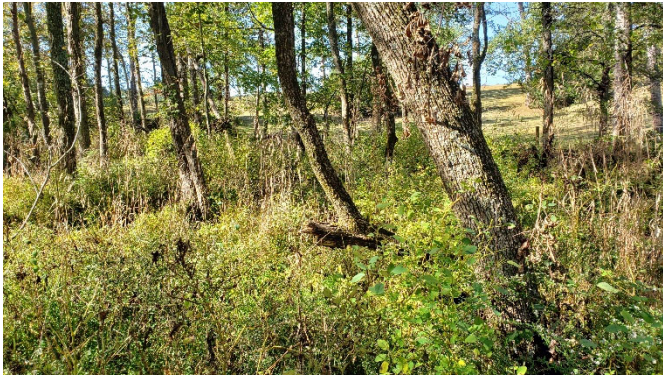
VPA 3-1 – Reach 1, Left Bank (October 17, 2019)

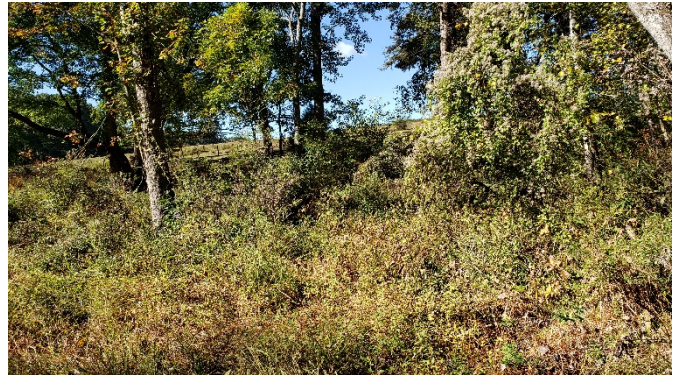
VPA 3-1 – Reach 1, Left Bank (October 17, 2019)

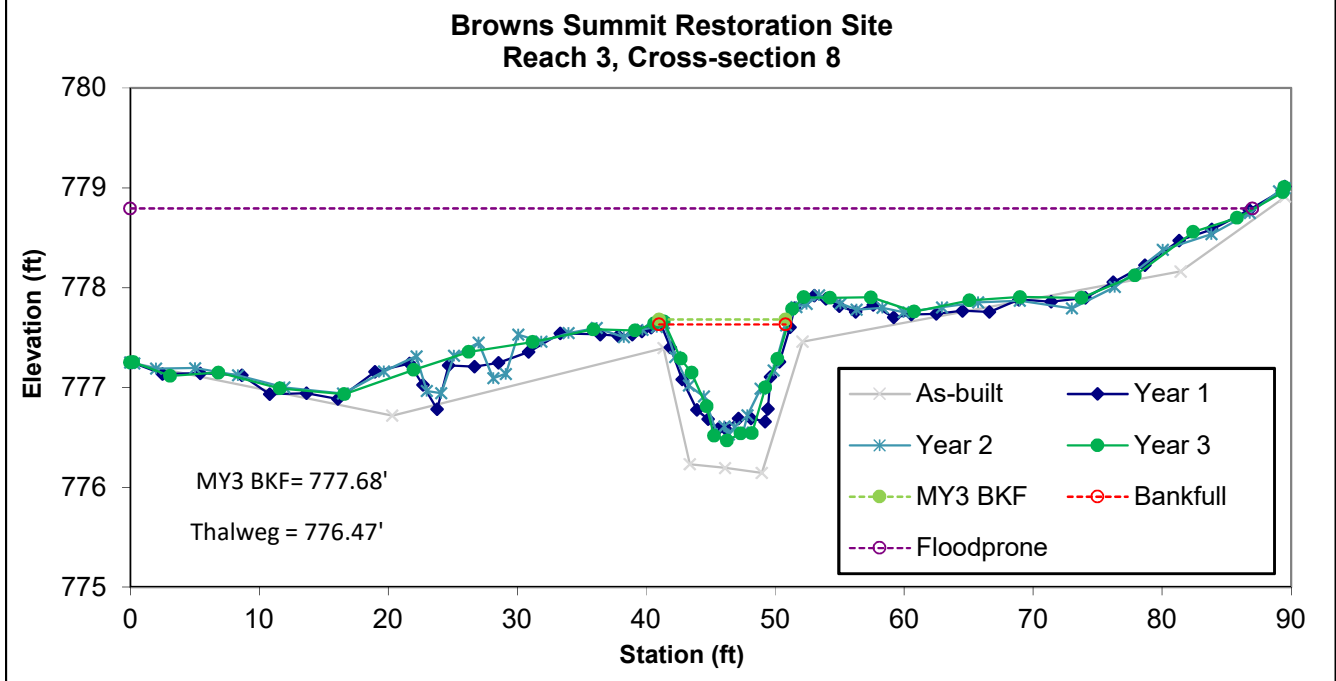
Permanent Cross-section 8
(Year 3 Data - Collected October 2019)

Feature	Stream Type	BKF Area	BKF Width	BKF Depth	Max BKF Depth	W/D	BH Ratio	ER	BKF Elev	TOB Elev
Riffle	C	6.7	9.5	0.7	1.2	13.5	1.0	9.2	777.63	777.66

Note: Per DMS/IRT request, bank height ratio is calculated by setting the current bankfull area to match the asbuilt bankfull area and dividing by the current max depth. Note: MY1 data is being utilized as asbuilt data due to poor quality asbuilt survey.

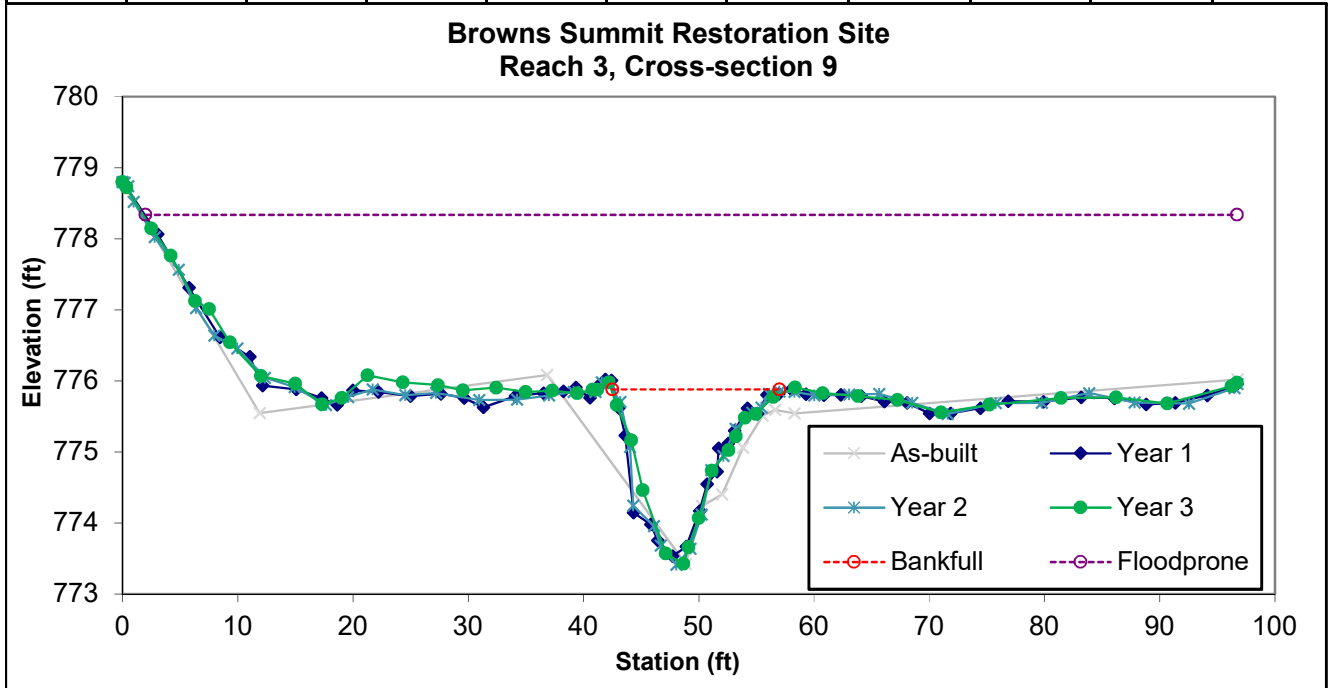
Permanent Cross-section 9
(Year 3 Data - Collected October 2019)

Feature	Stream Type	BKF Area	BKF Width	BKF Depth	Max BKF Depth	W/D	BH Ratio	ER	BKF Elev	TOB Elev
Pool		16.7	15.1	1.1	2.5	13.7			775.88	775.90

Note: MY1 data is being utilized as asbuilt data due to poor quality asbuilt survey.

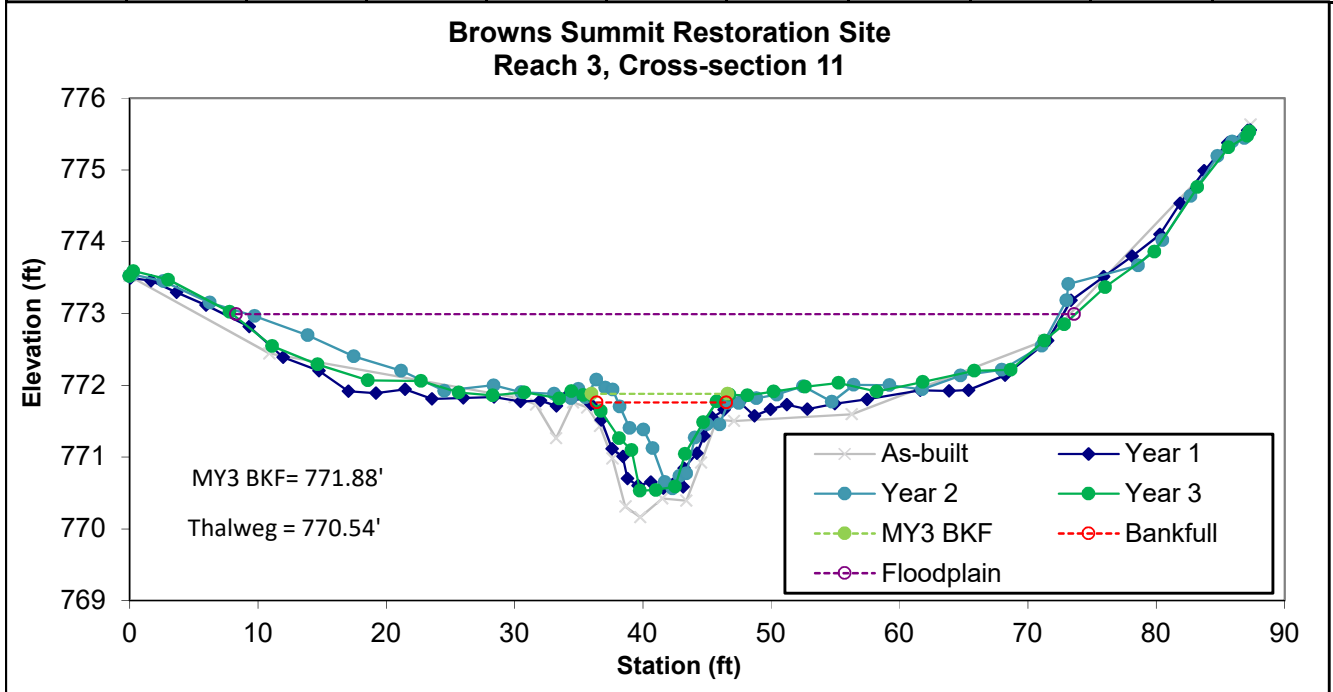
Permanent Cross-section 11
 (Year 3 Data - Collected October 2019)

Feature	Stream Type	BKF Area	BKF Width	BKF Depth	Max BKF Depth	W/D	BH Ratio	ER	BKF Elev	TOB Elev
Riffle	C	6.6	9.7	0.7	1.2	14.5	1.0	6.7	771.76	771.90

Note: Per DMS/IRT request, bank height ratio is calculated by setting the current bankfull area to match the asbuilt bankfull area and dividing by the current max depth. Note: MY1 data is being utilized as asbuilt data due to poor quality asbuilt survey.

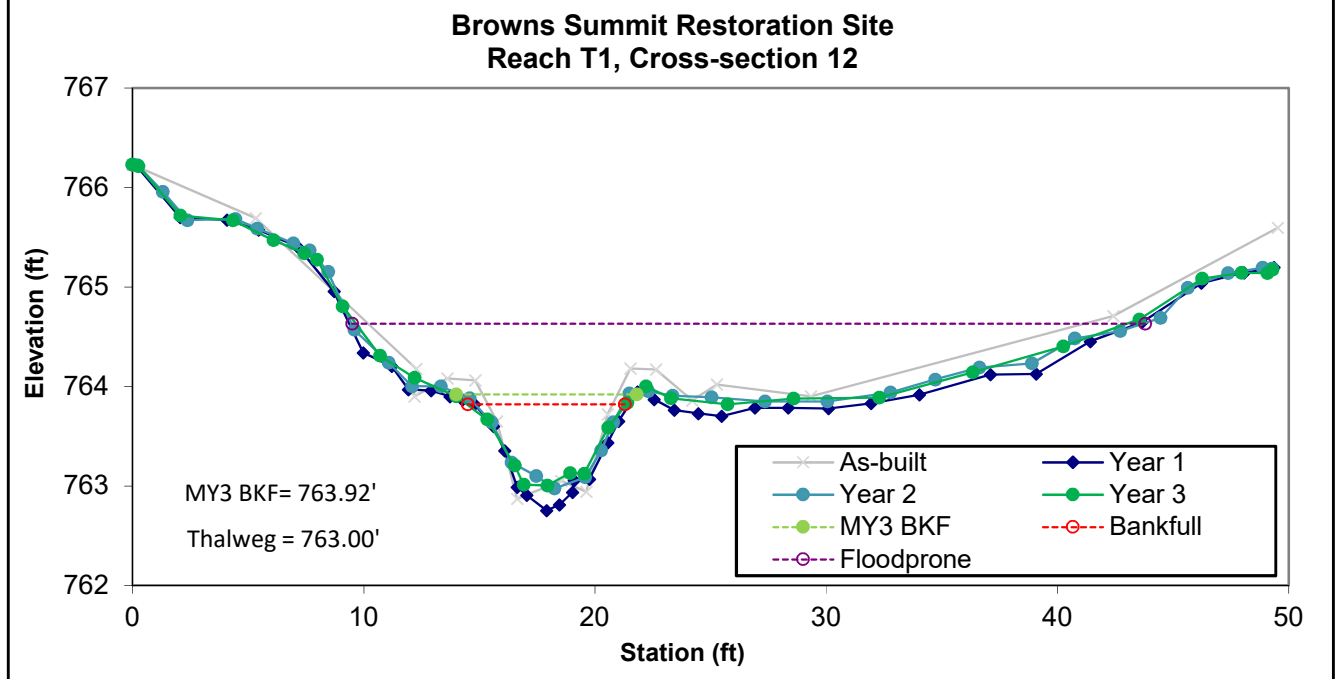
Permanent Cross-section 12
(Year 3 Data - Collected October 2019)

Feature	Stream Type	BKF Area	BKF Width	BKF Depth	Max BKF Depth	W/D	BH Ratio	ER	BKF Elev	TOB Elev
Riffle	C	3.4	6.9	0.5	0.8	14.1	1.1	4.9	763.82	764.00

Note: Per DMS/IRT request, bank height ratio is calculated by setting the current bankfull area to match the asbuilt bankfull area and dividing by the current max depth. Note: MY1 data is being utilized as asbuilt data due to poor quality asbuilt survey.

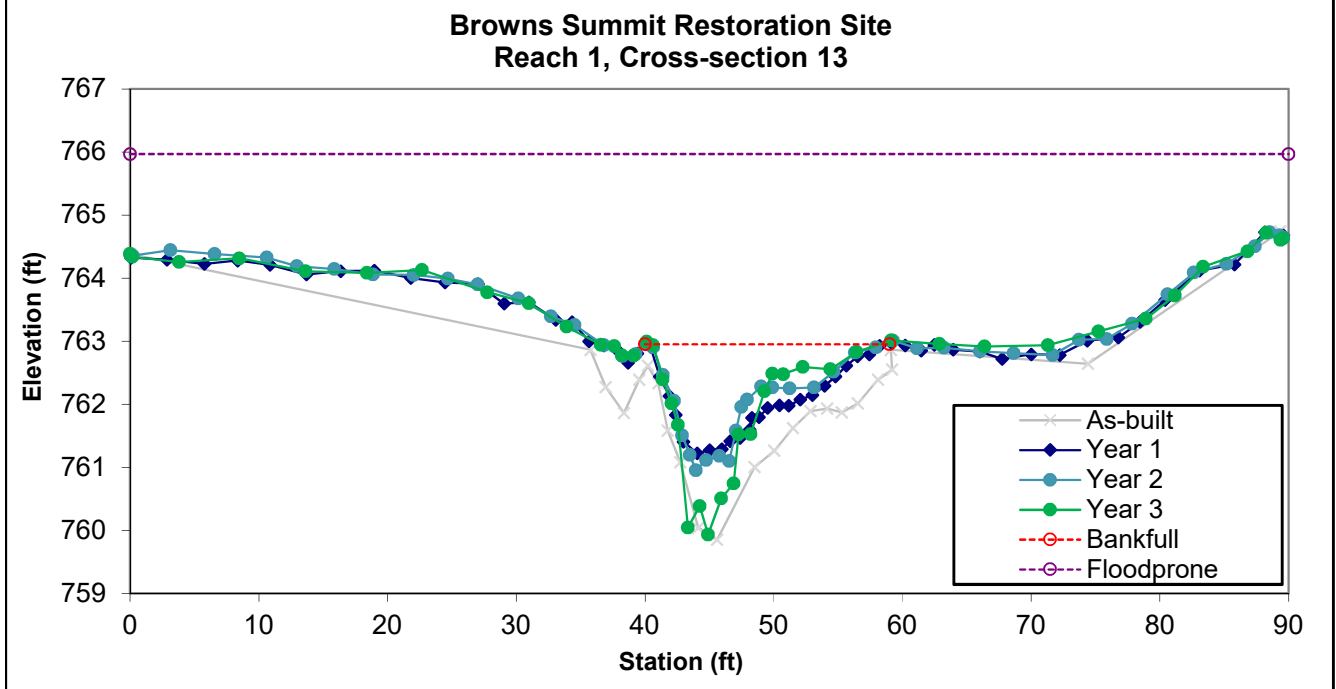
Permanent Cross-section 13
 (Year 3 Data - Collected October 2019)

Feature	Stream Type	BKF Area	BKF Width	BKF Depth	Max BKF Depth	W/D	BH Ratio	ER	BKF Elev	TOB Elev
Pool		18.3	17.6	1.0	3.0	16.9			762.95	762.48

Note: MY1 data is being utilized as asbuilt data due to poor quality asbuilt survey.

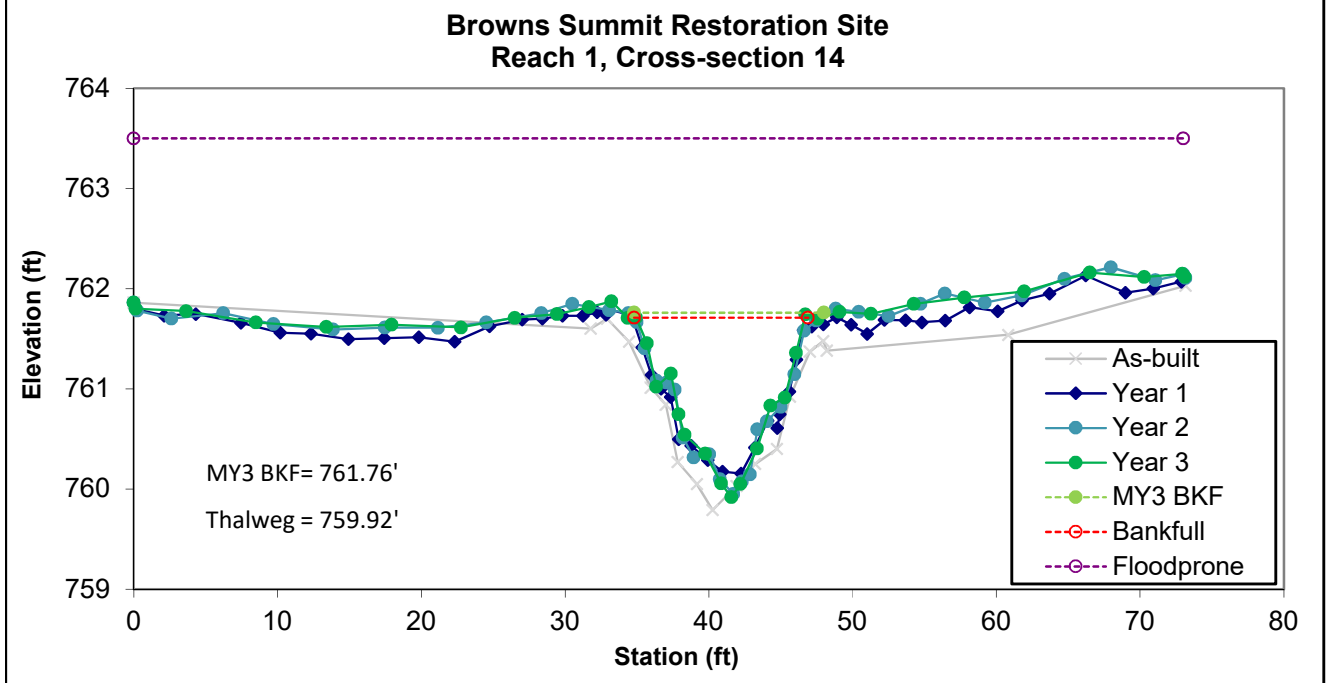
Permanent Cross-section 14
(Year 3 Data - Collected October 2019)

Feature	Stream Type	BKF Area	BKF Width	BKF Depth	Max BKF Depth	W/D	BH Ratio	ER	BKF Elev	TOB Elev
Riffle	C	11.8	12.2	1.0	1.8	12.5	1.0	6.0	761.71	761.70

Note: Per DMS/IRT request, bank height ratio is calculated by setting the current bankfull area to match the asbuilt bankfull area and dividing by the current max depth. Note: MY1 data is being utilized as asbuilt data due to poor quality asbuilt survey.

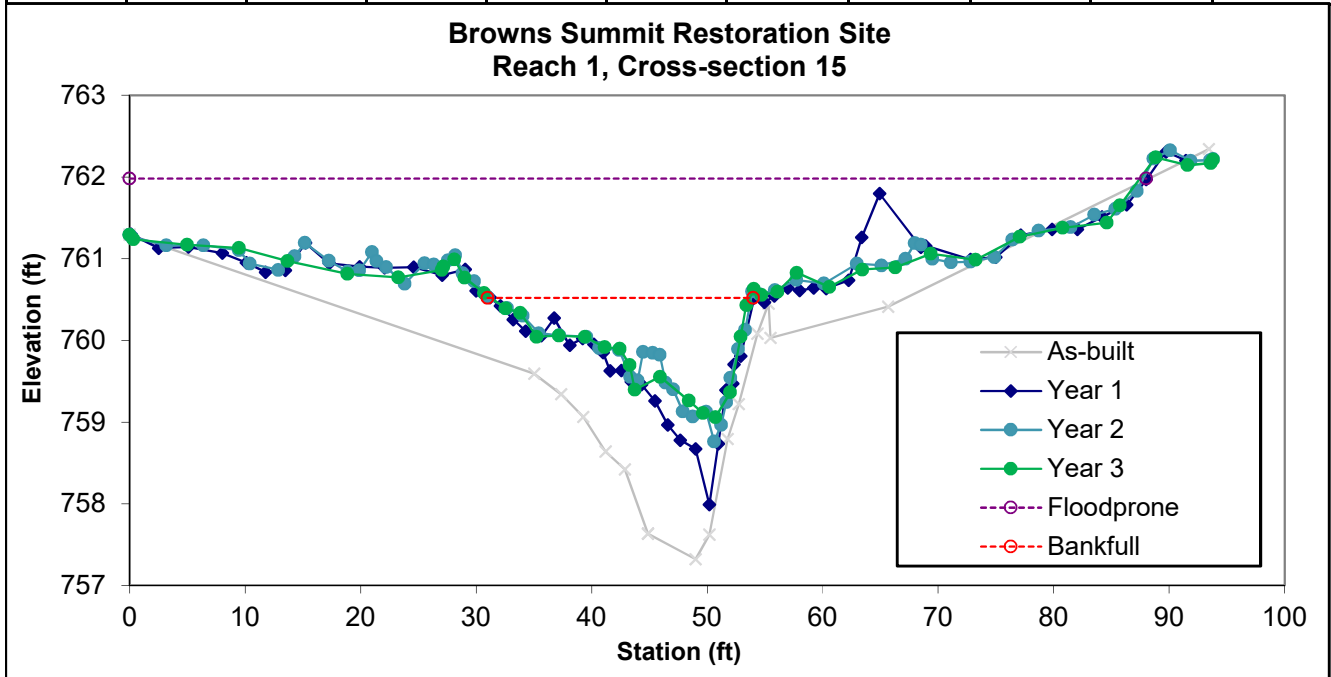
Permanent Cross-section 15
(Year 3 Data - Collected October 2019)

Feature	Stream Type	BKF Area	BKF Width	BKF Depth	Max BKF Depth	W/D	BH Ratio	ER	BKF Elev	TOB Elev
Pool		16.3	22.4	0.7	1.5	30.8			760.52	760.63

Note: MY1 data is being utilized as asbuilt data due to poor quality asbuilt survey.

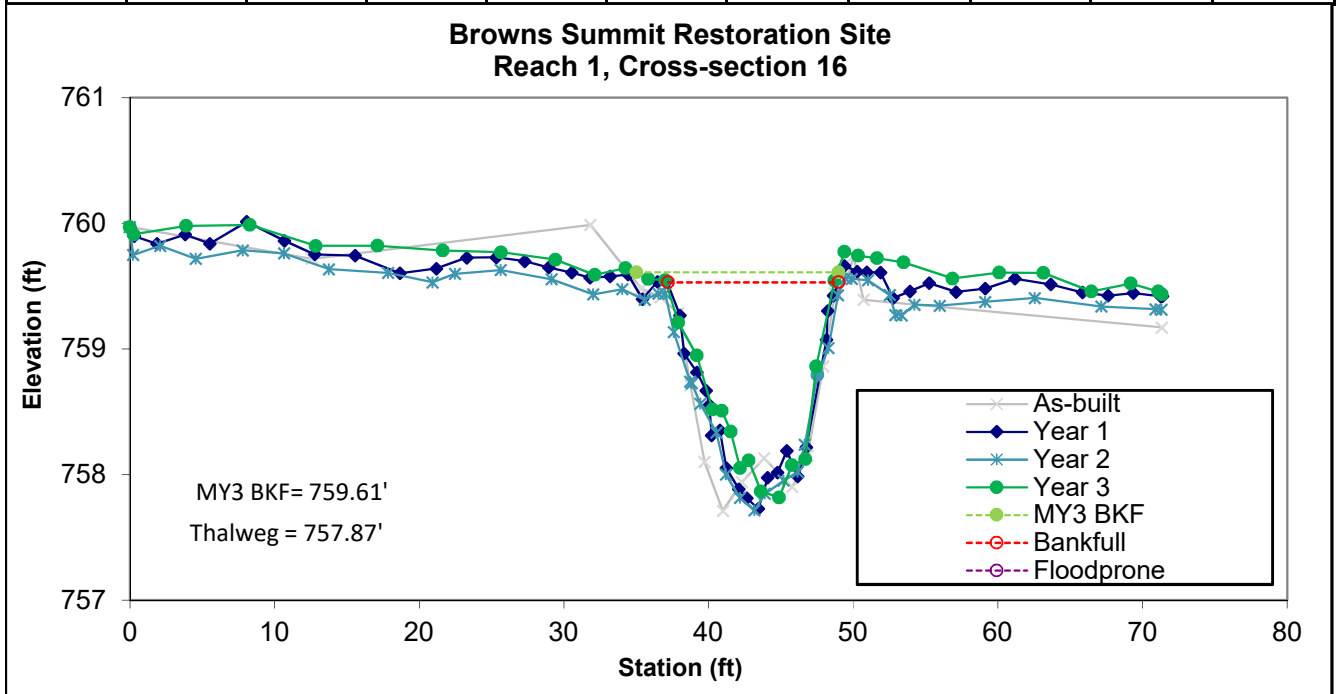
Permanent Cross-section 16
 (Year 3 Data - Collected October 2019)

Feature	Stream Type	BKF Area	BKF Width	BKF Depth	Max BKF Depth	W/D	BH Ratio	ER	BKF Elev	TOB Elev
Riffle	C	12.0	11.6	1.0	1.7	11.3	1.0	6.1	759.53	759.53

Note: Per DMS/IRT request, bank height ratio is calculated by setting the current bankfull area to match the asbuilt bankfull area and dividing by the current max depth. Note: MY1 data is being utilized as asbuilt data due to poor quality asbuilt survey.

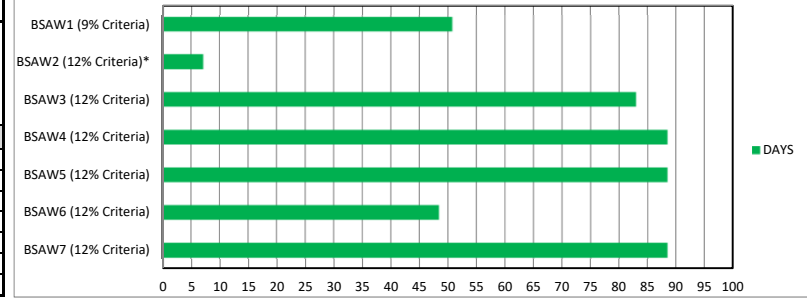
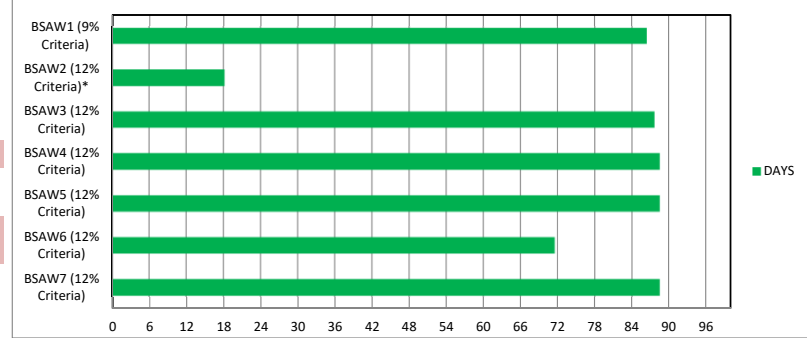
*BSAW 2 malfunctioned (7/3/2019) but has been replaced on (10/30/2019) to capture well data during monitoring year 4.

*Growing season is 236 days long; 9% of 236 days = 21 days

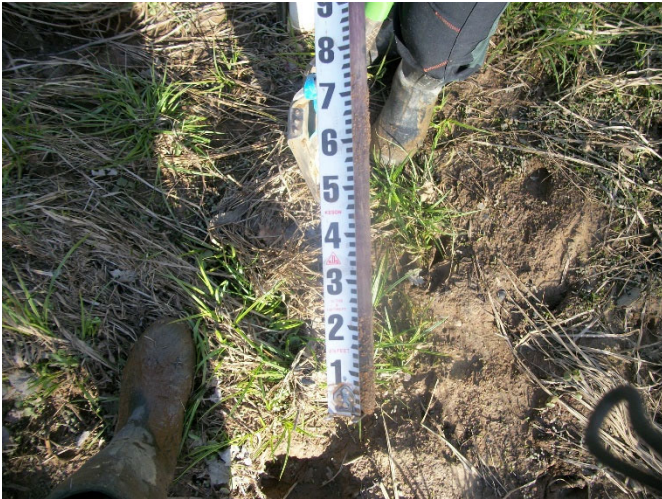
Manual Crest Gauge – Reading 3/28/19

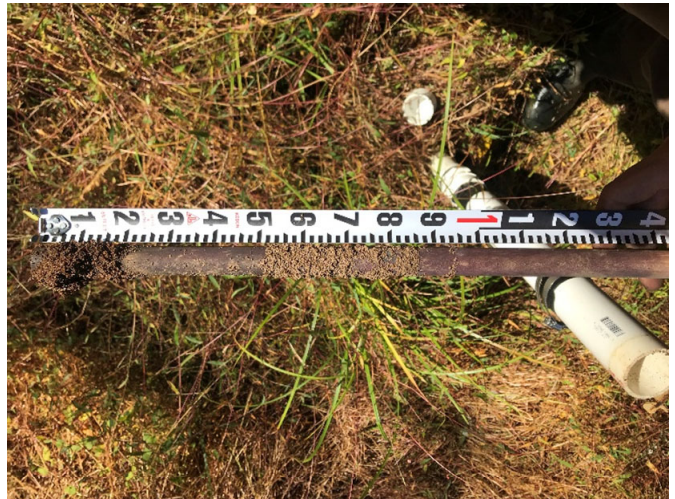
Manual Crest Gauge – Reach 1, Reading 10/17/19
