Browns Summit Creek Restoration Project Year 4 Monitoring Report

Guilford County, North Carolina

DMS Project ID No. 96313, DEQ Contract No. 5792

Project Info: Monitoring Year: 4 of 7
 Year of Data Collection: 2020
 Year of Completed Construction (including planting): 2017
 Submission Date: December 2020

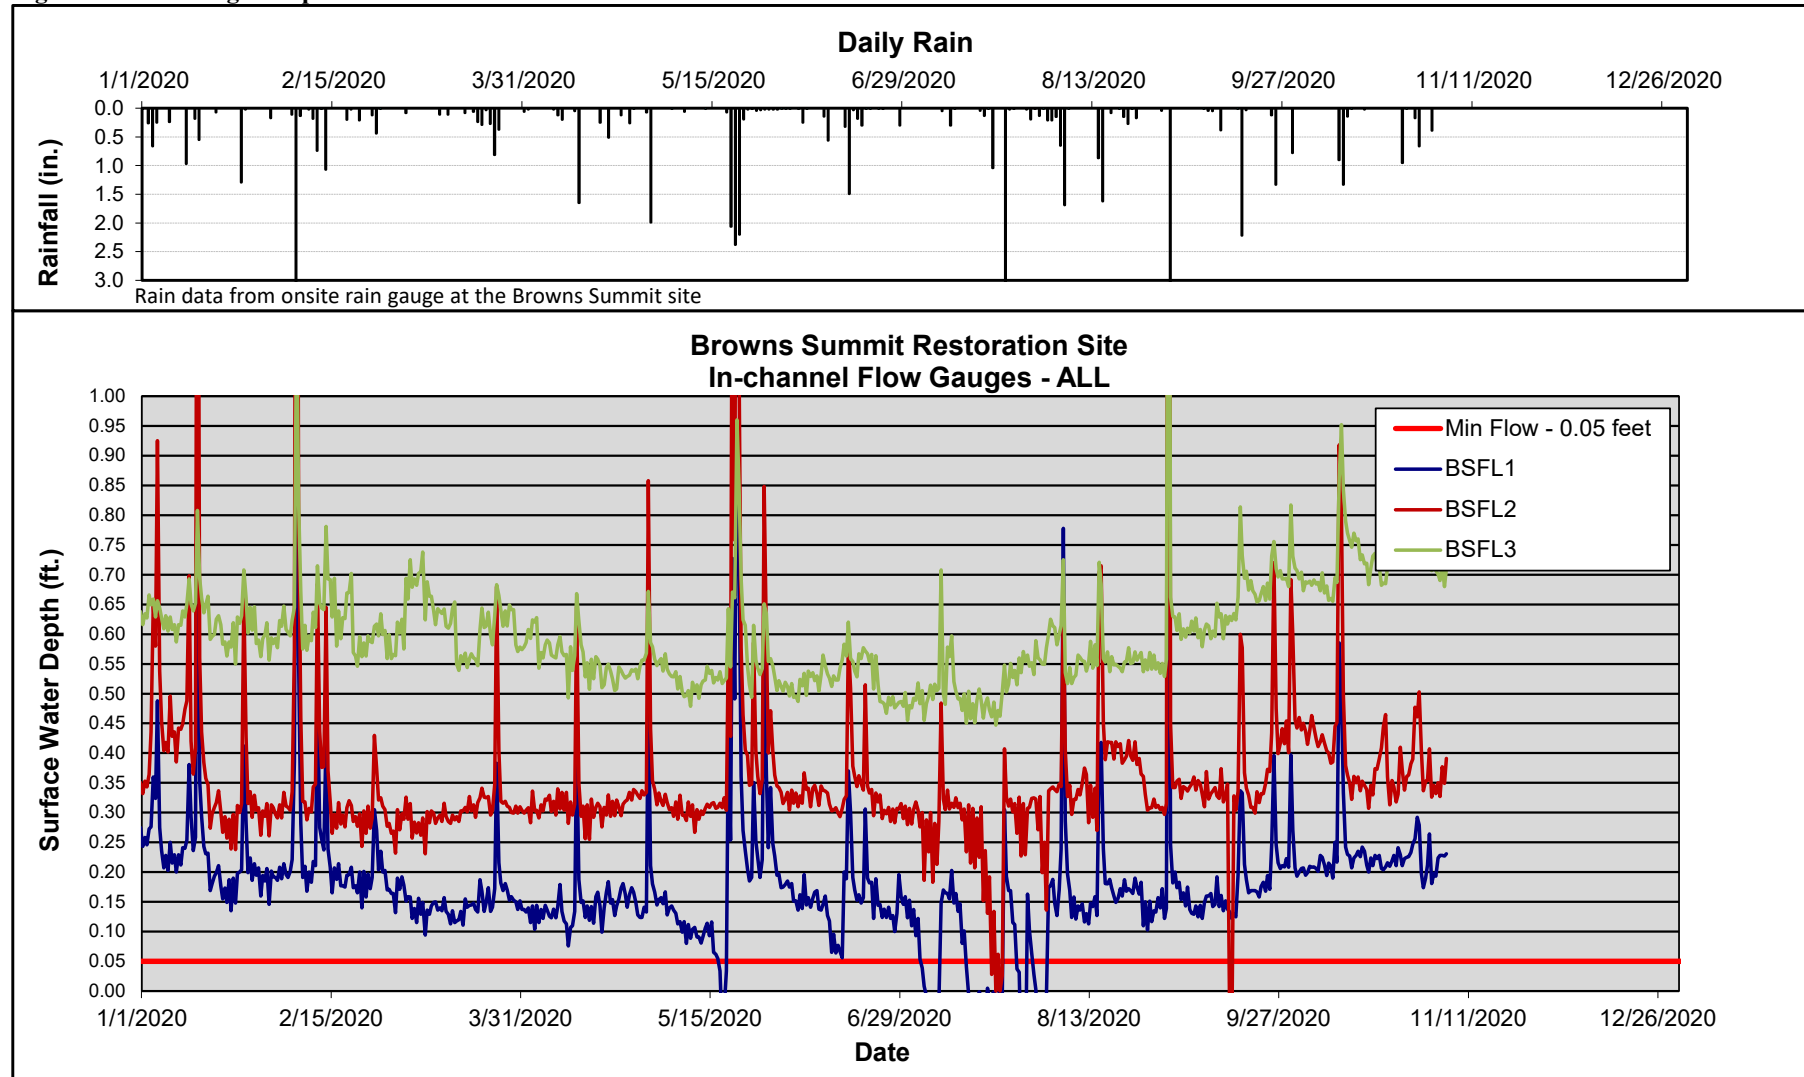
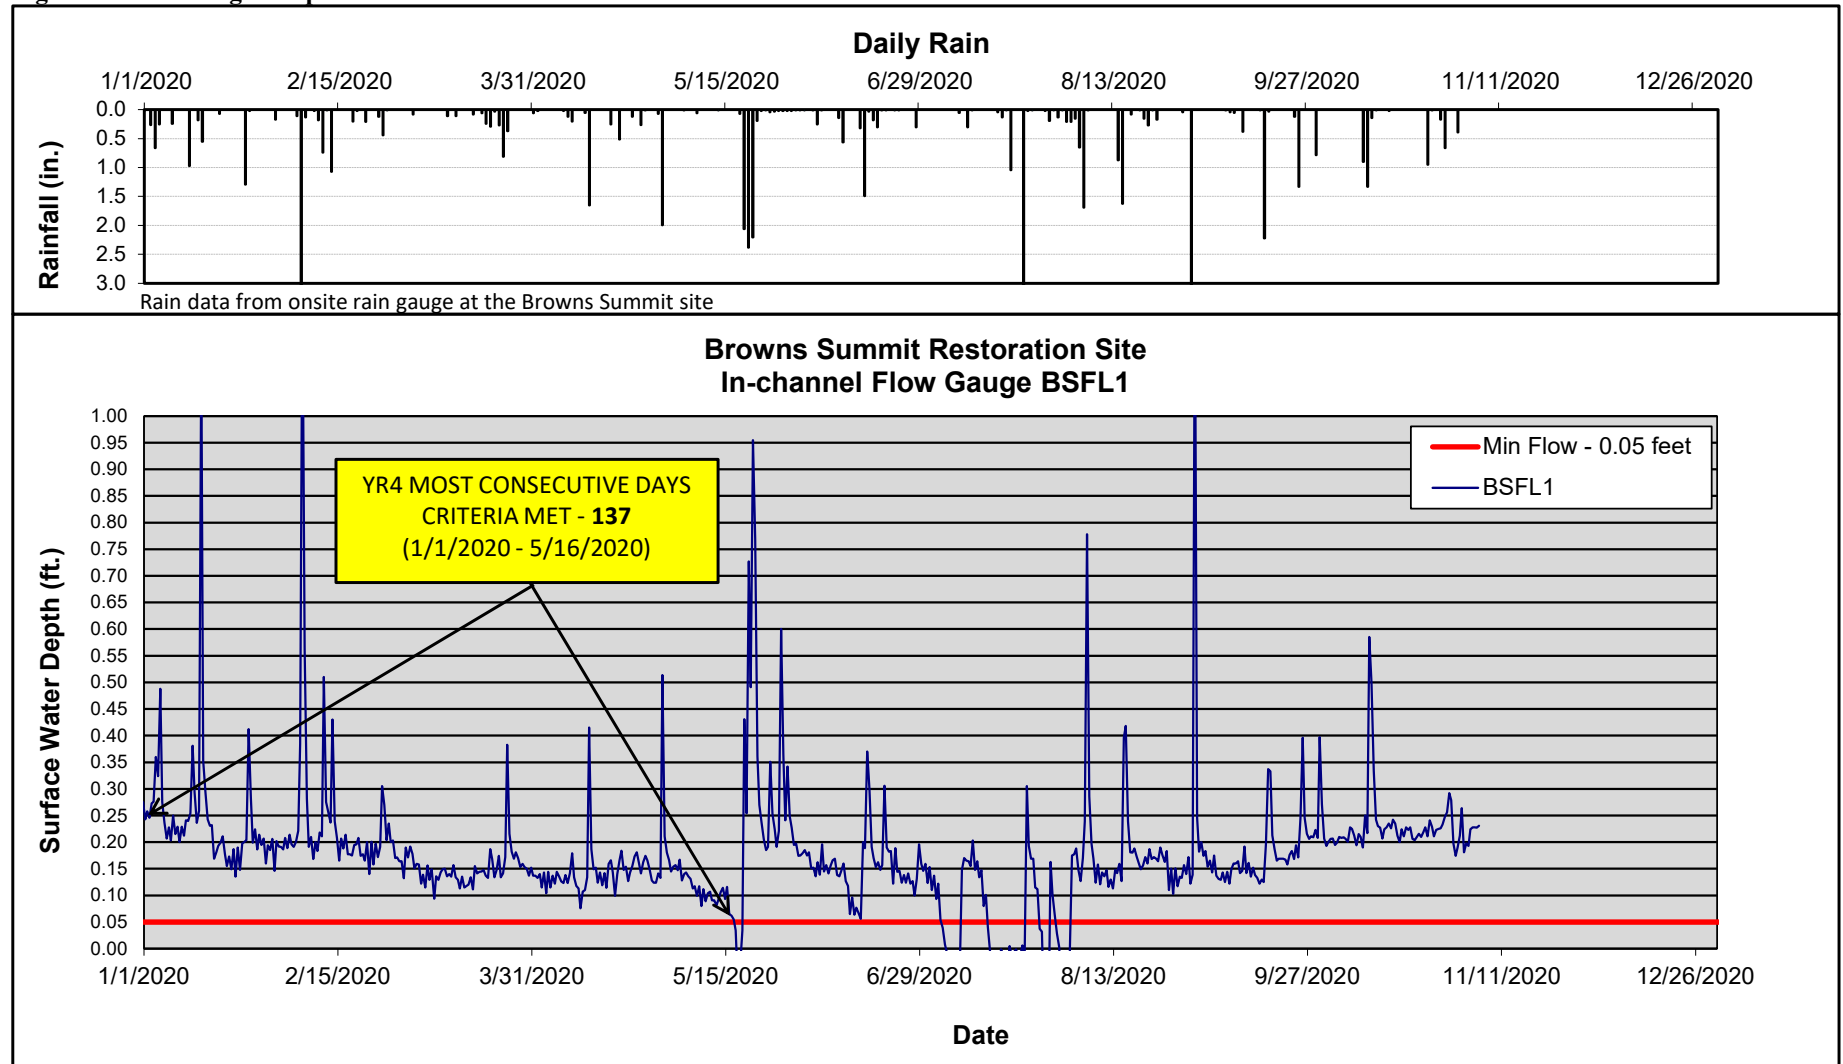
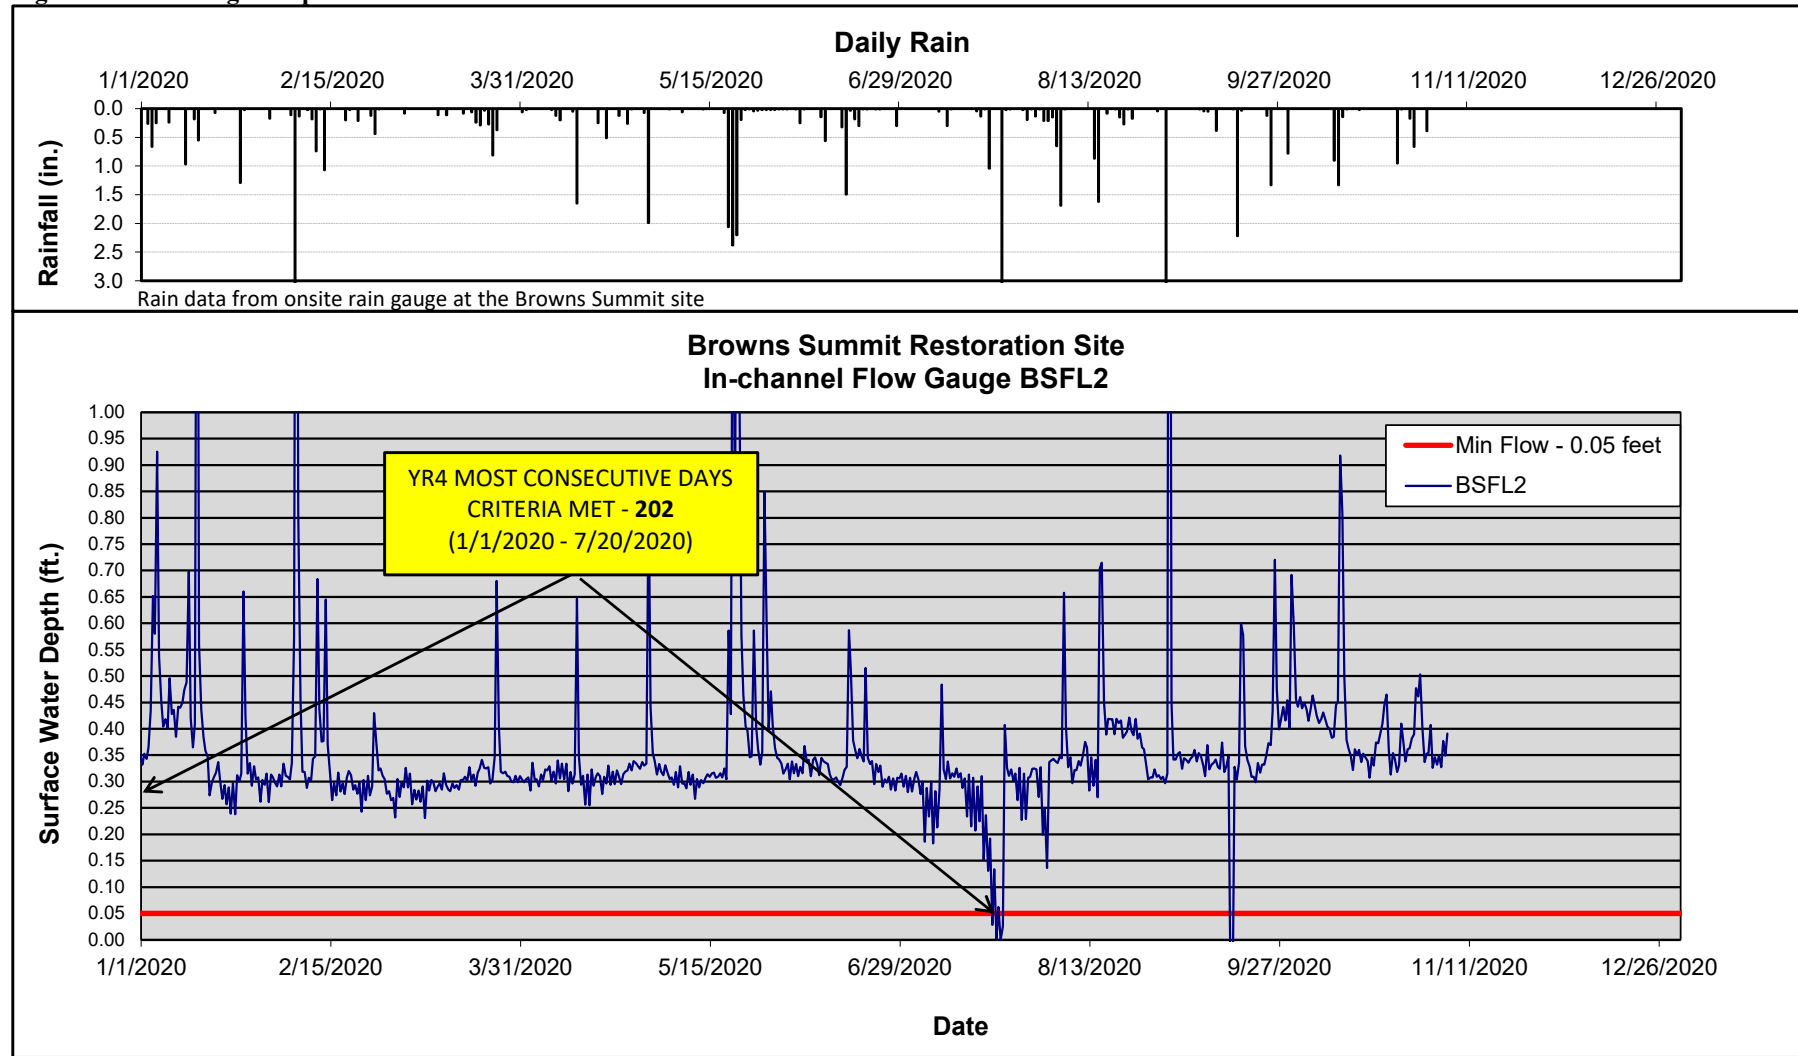
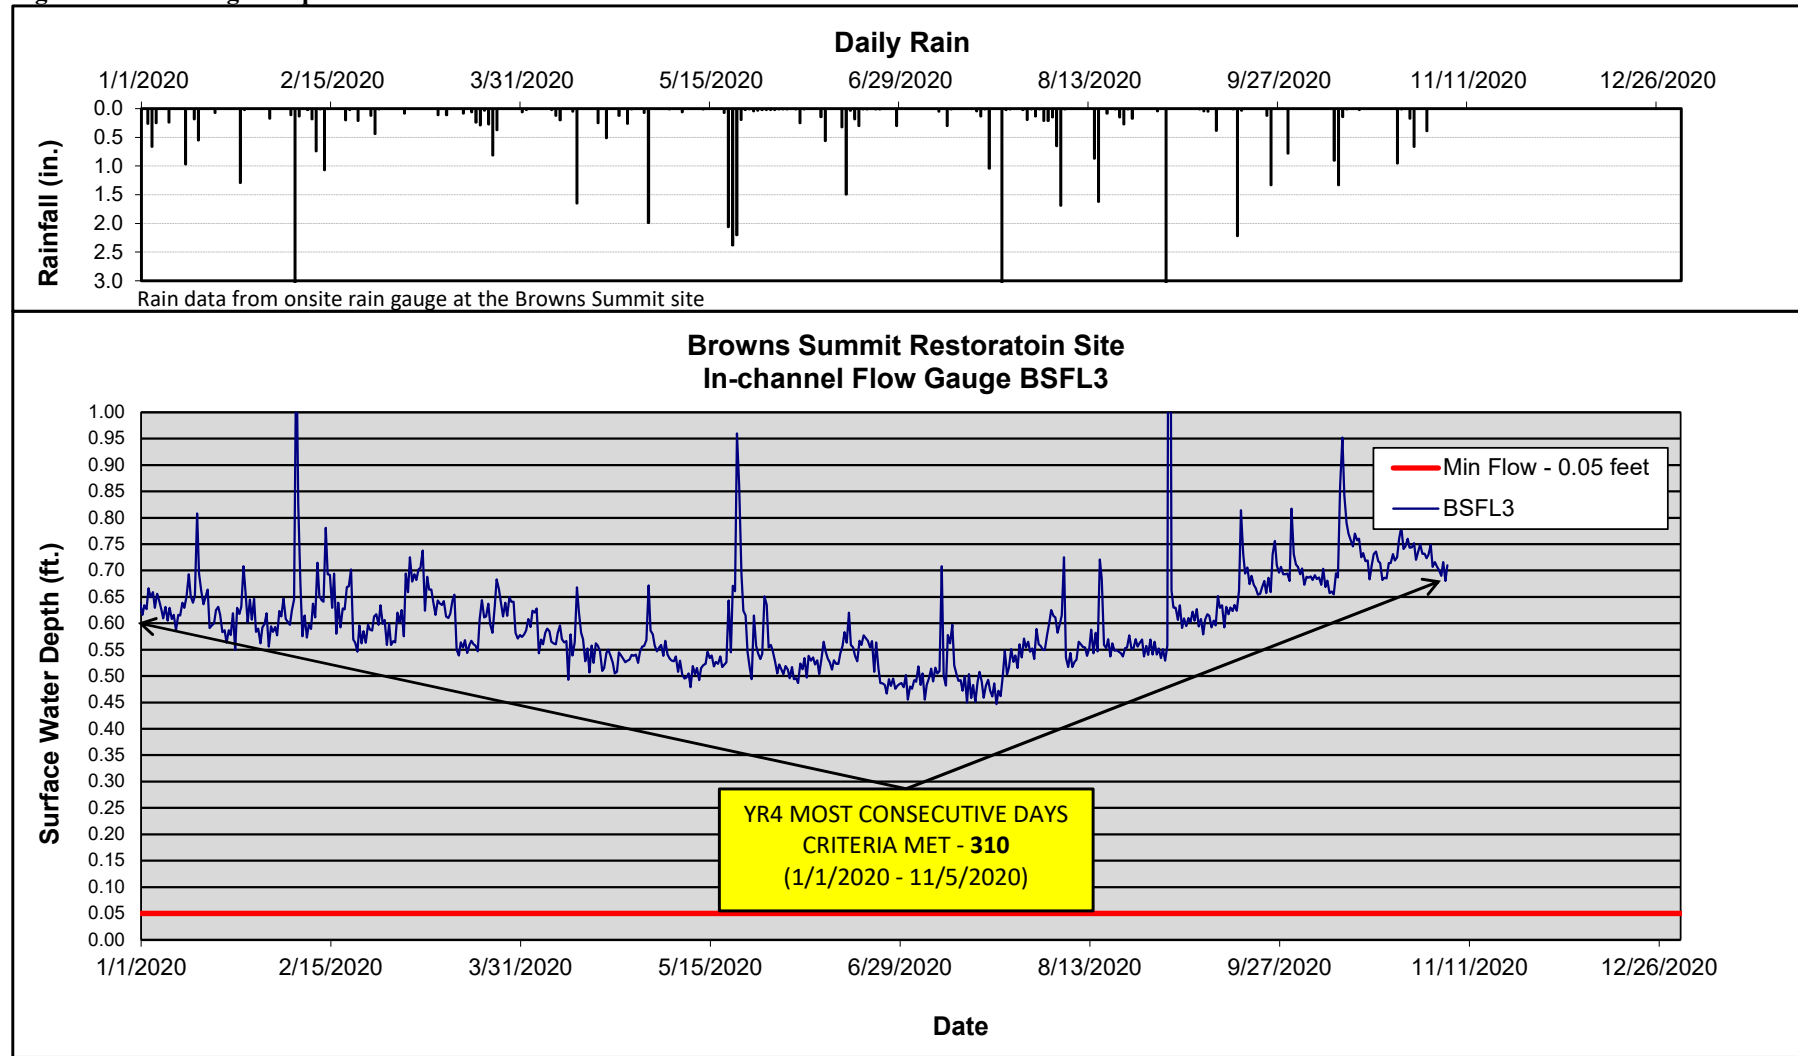
Figure 6. Flow Gauge Graphs

Year 4 flow monitoring demonstrated that all flow gauges (BSFL1, BSFL2 and BSFL3) met the stated success criteria of 30 days or more of consecutive flow through R4, T3 and T1 respectively. The gauges demonstrated similar patterns relative to rainfall events observed in the vicinity of the Site as shown in the flow gauge graphs in Appendix E.
