Browns Summit Creek Restoration Project Year 4 Monitoring Report

Guilford County, North Carolina

DMS Project ID No. 96313, DEQ Contract No. 5792

Project Info: Monitoring Year: 4 of 7
 Year of Data Collection: 2020
 Year of Completed Construction (including planting): 2017
 Submission Date: December 2020

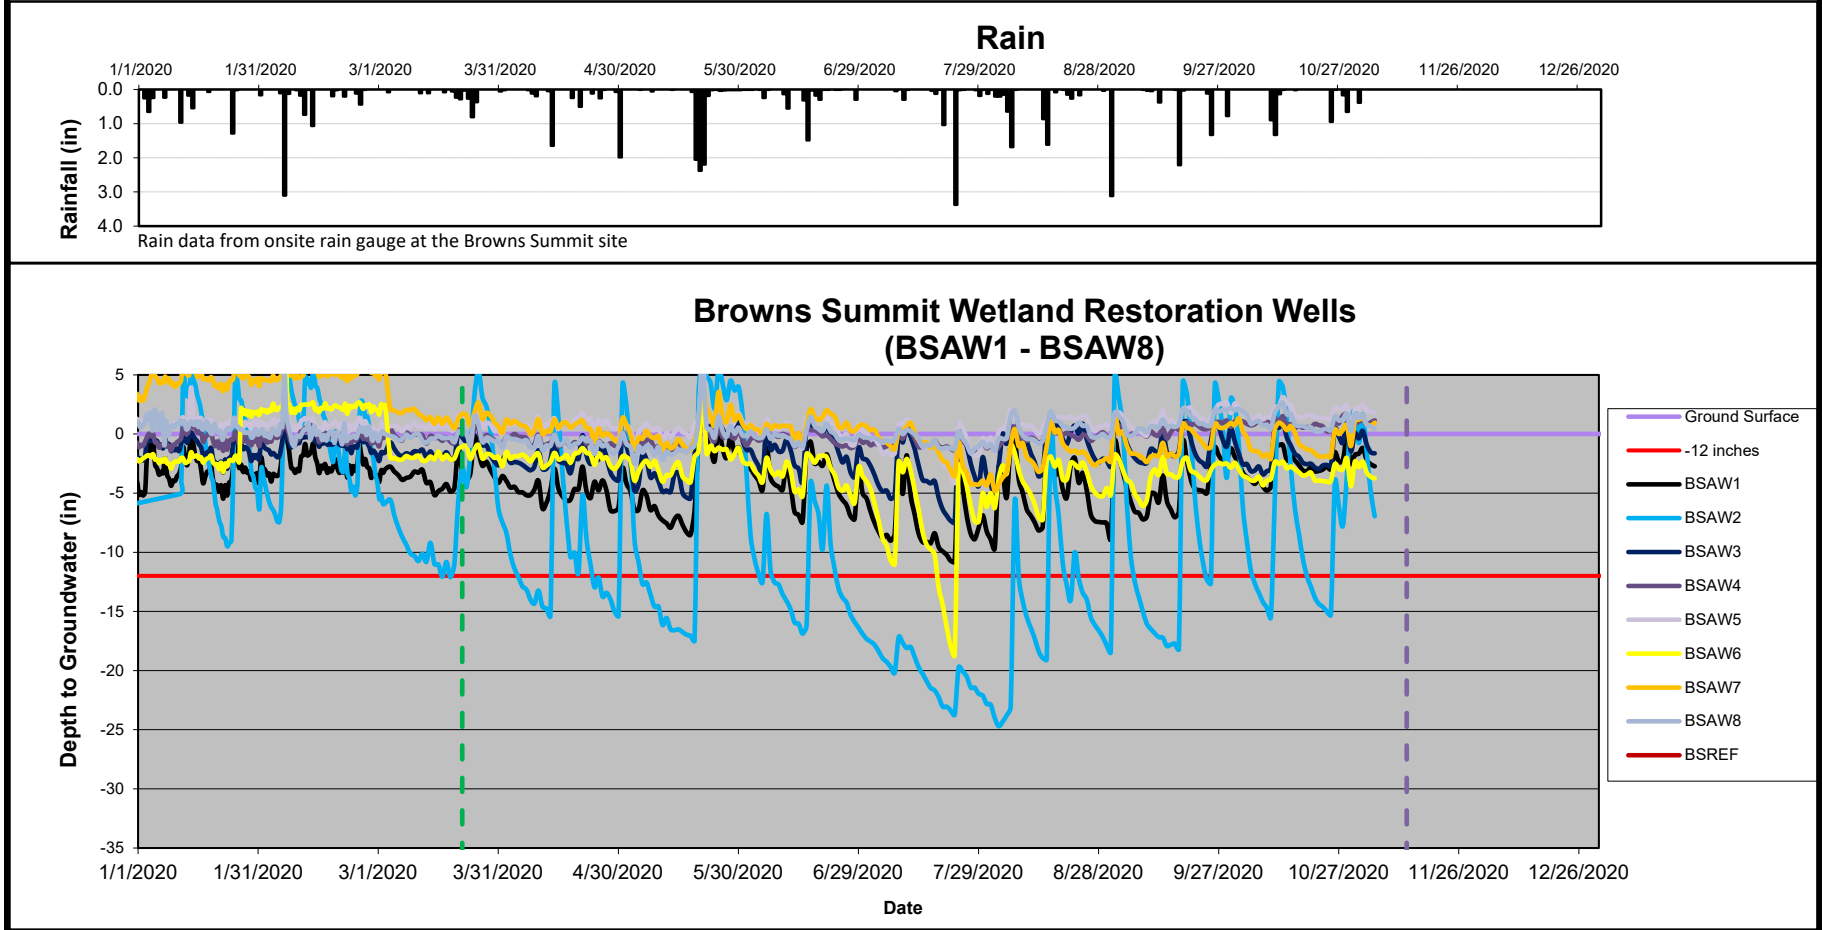
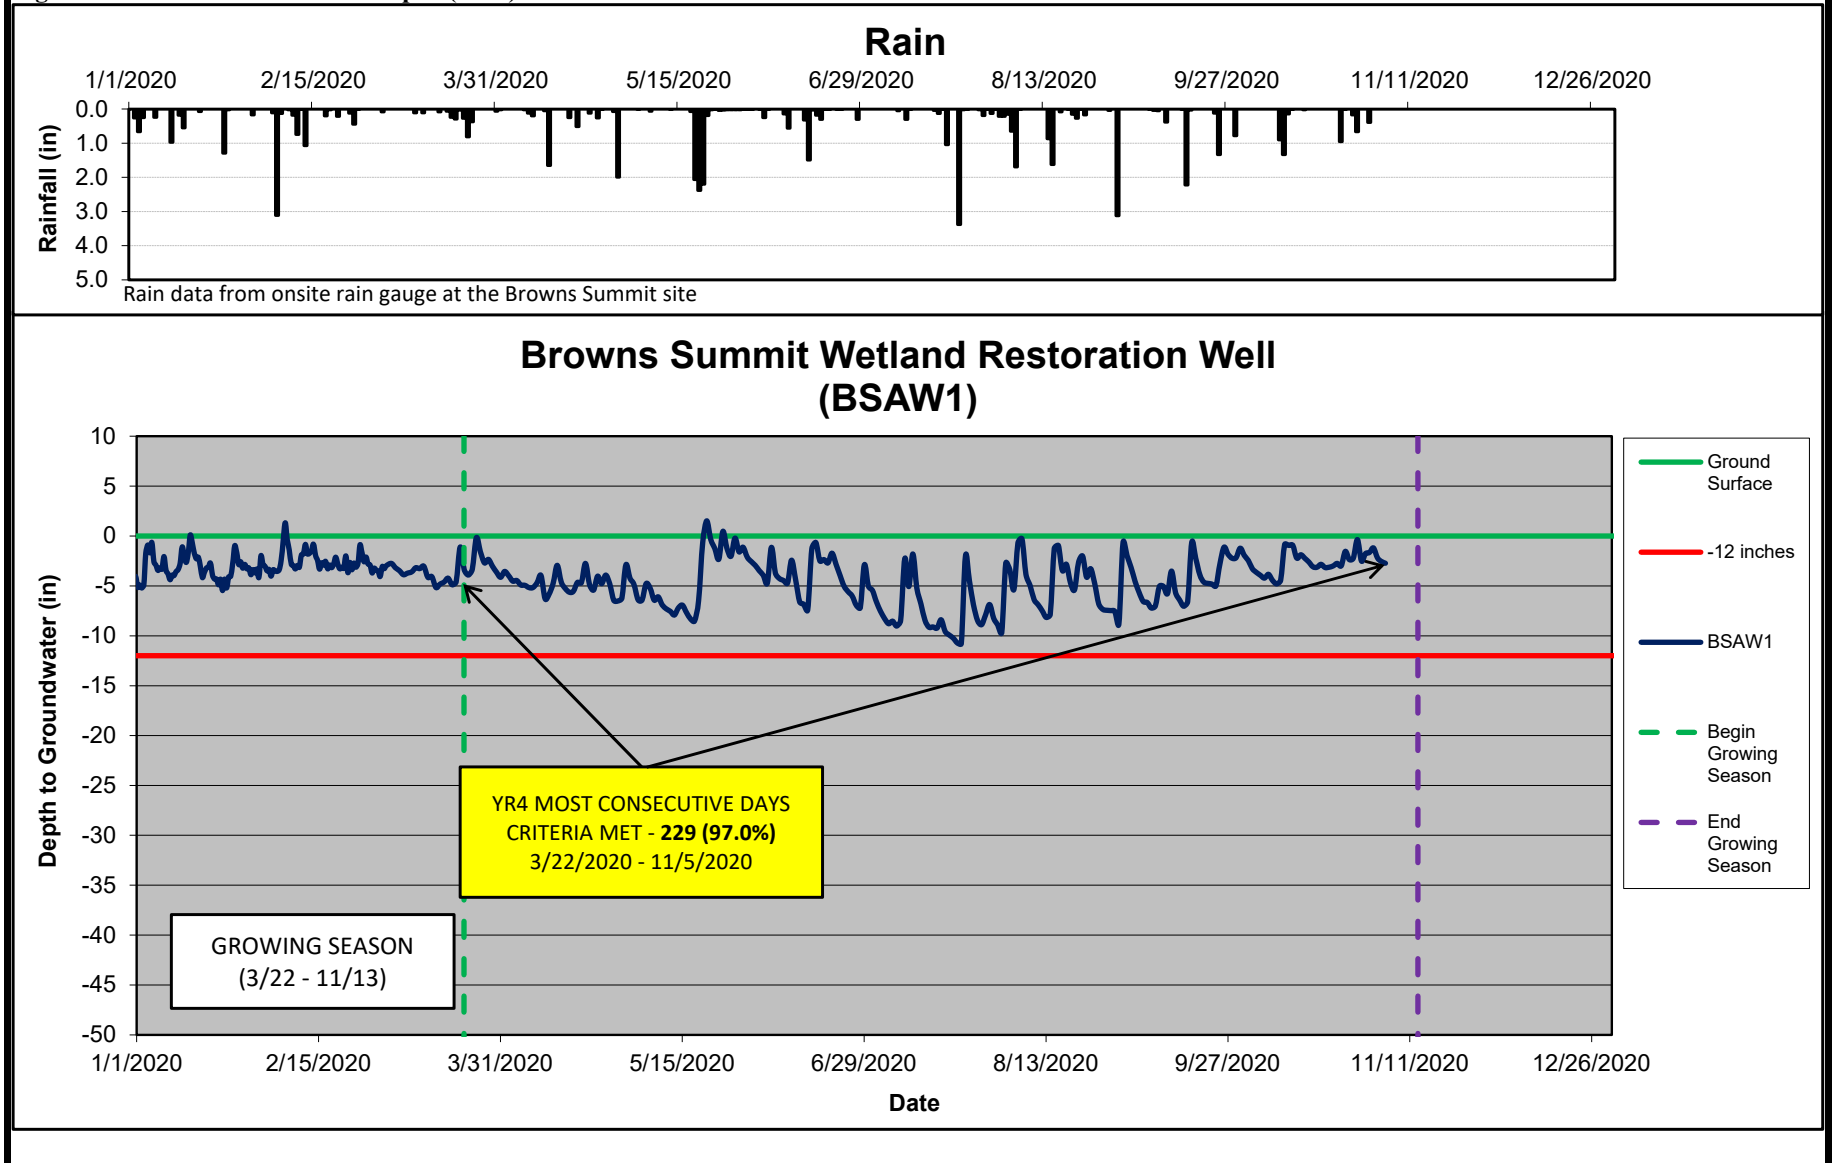
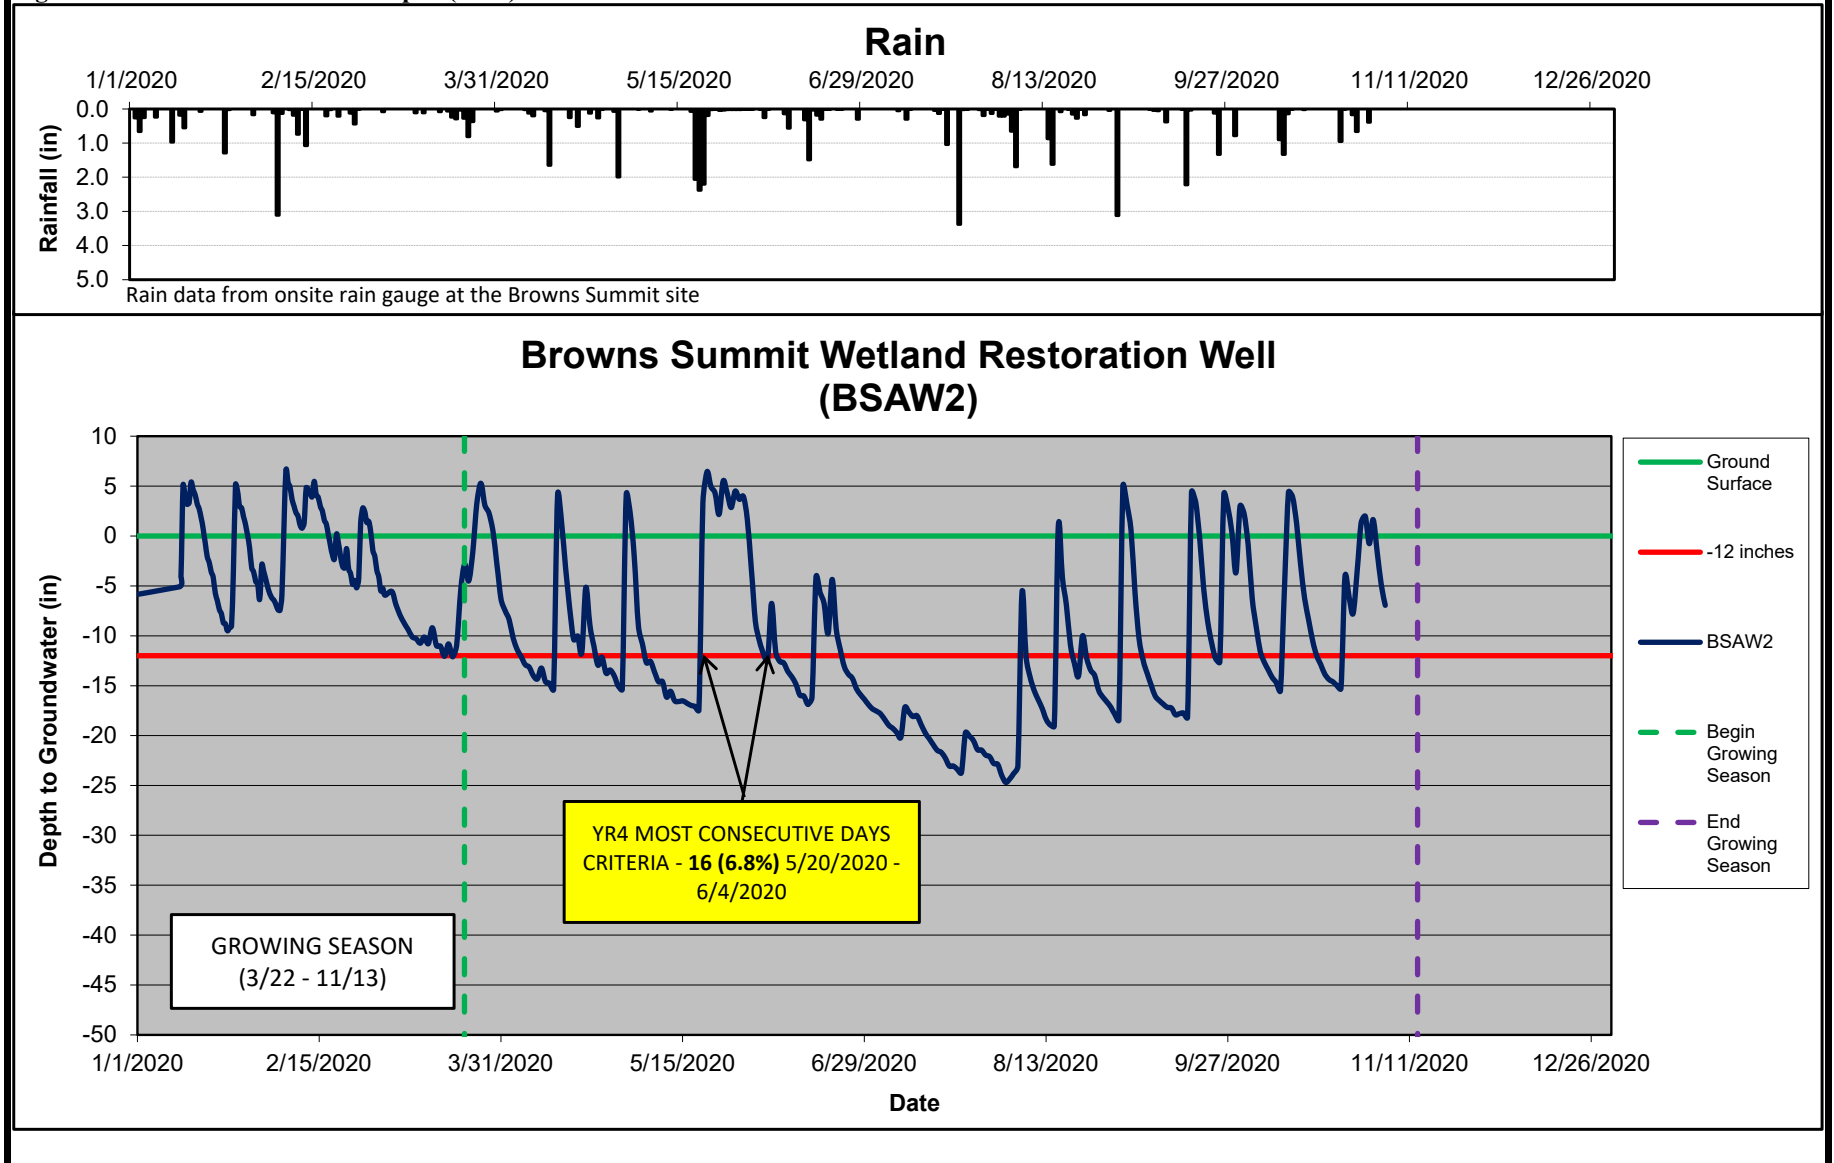
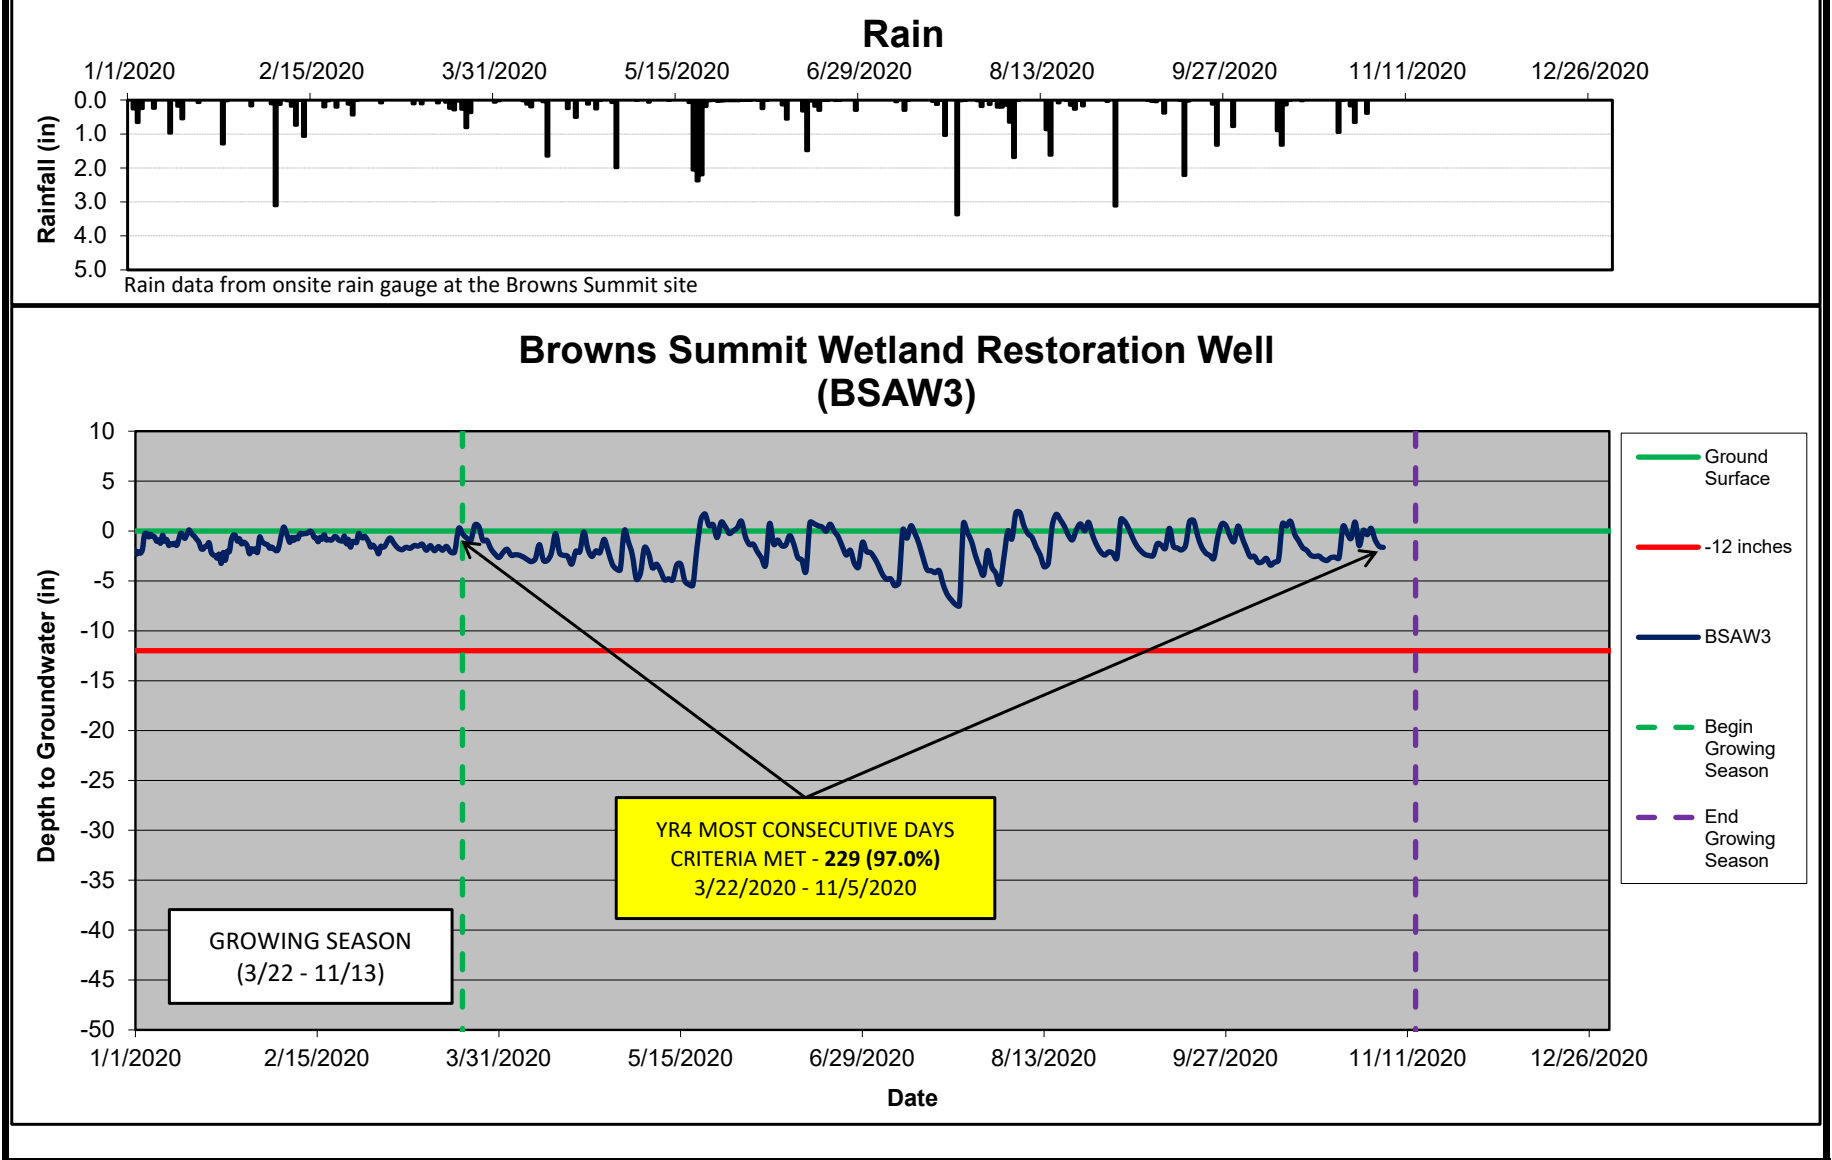
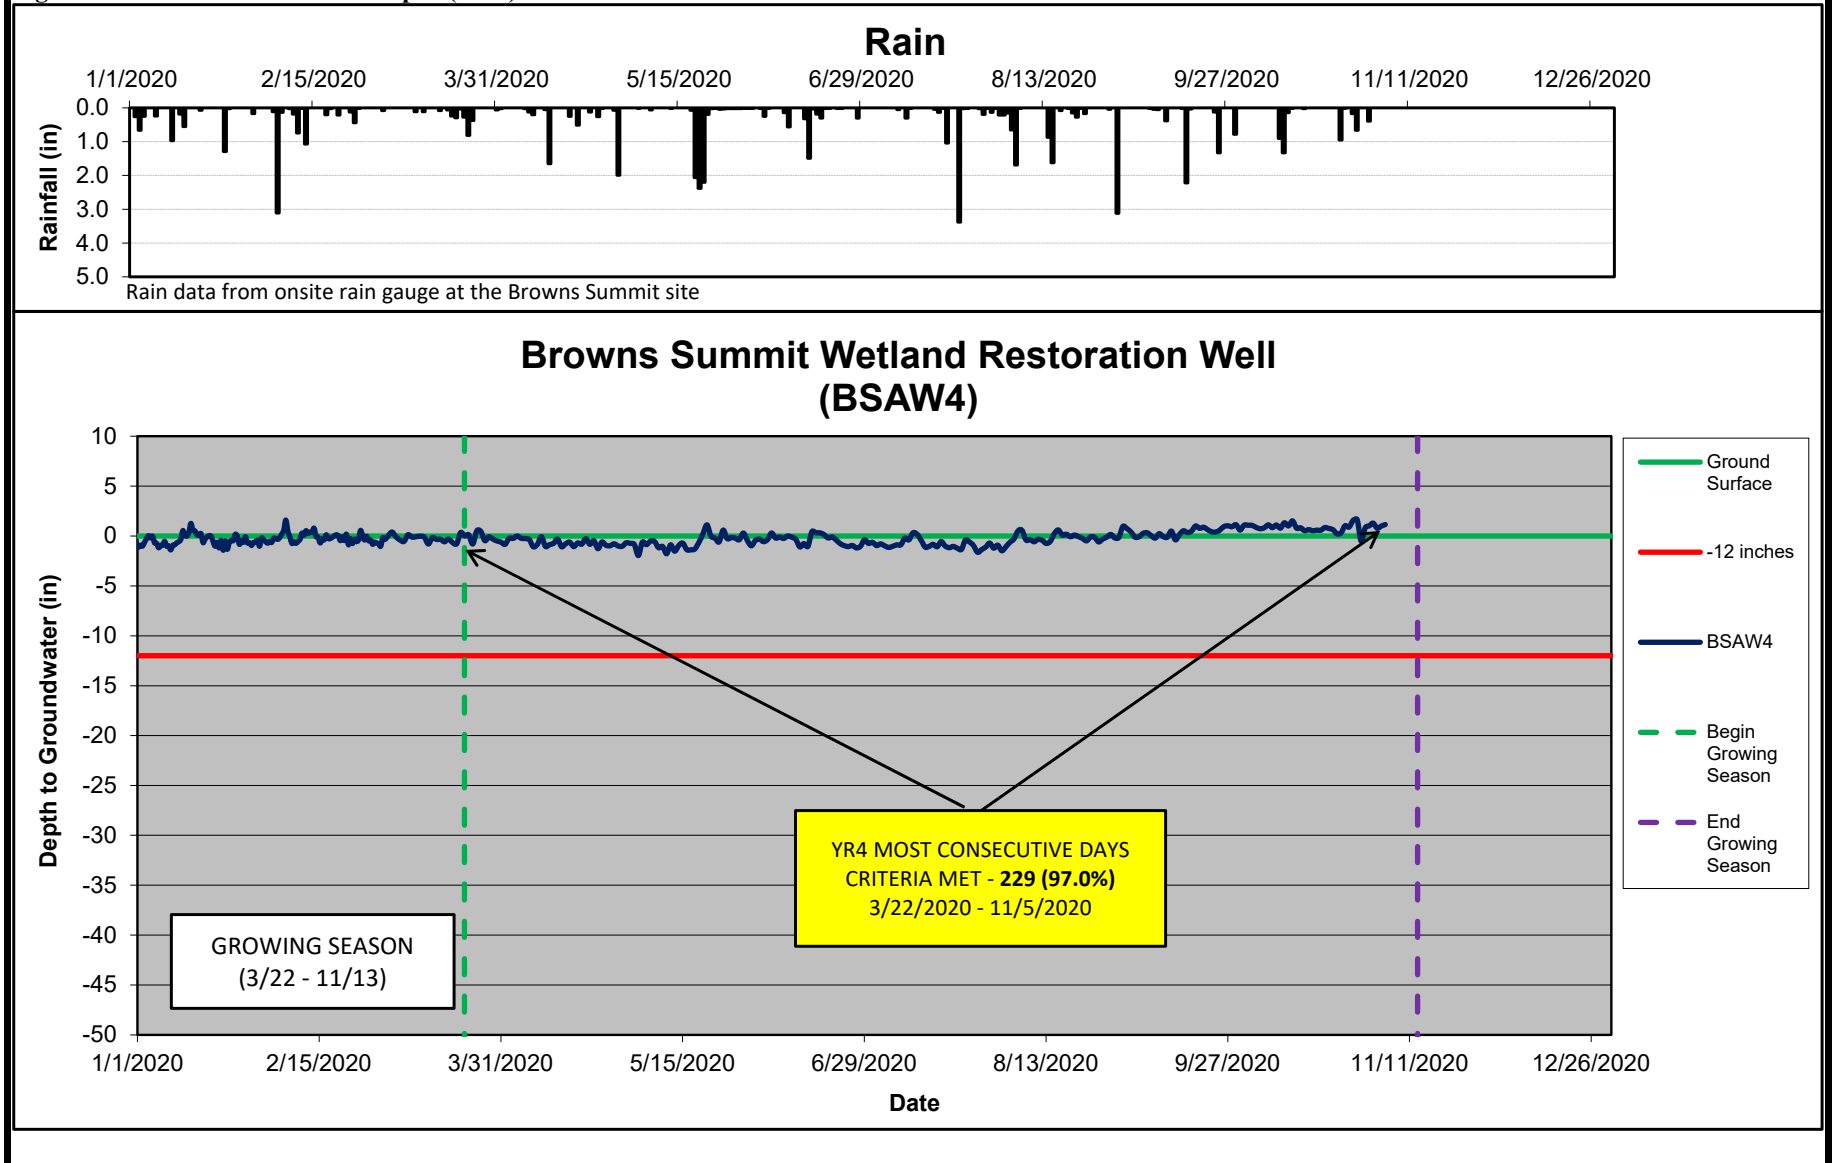
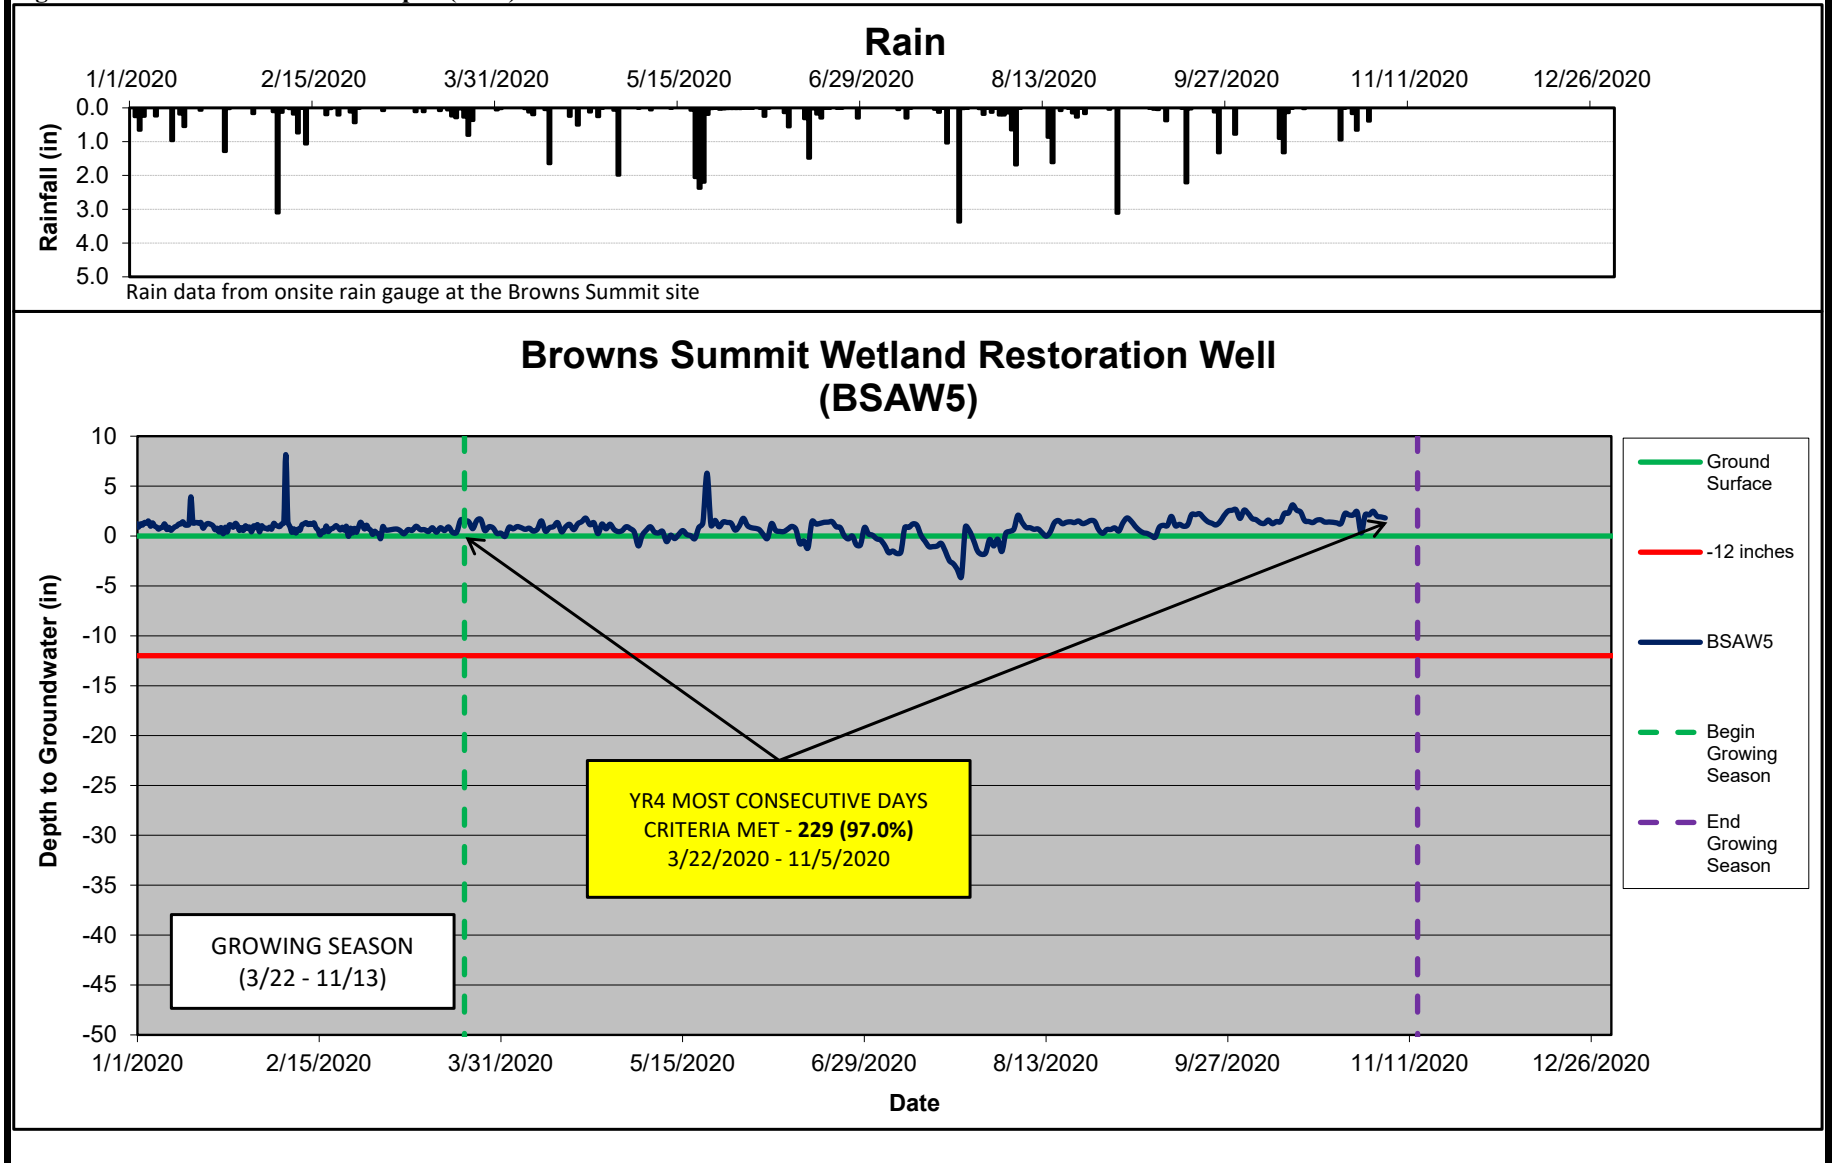
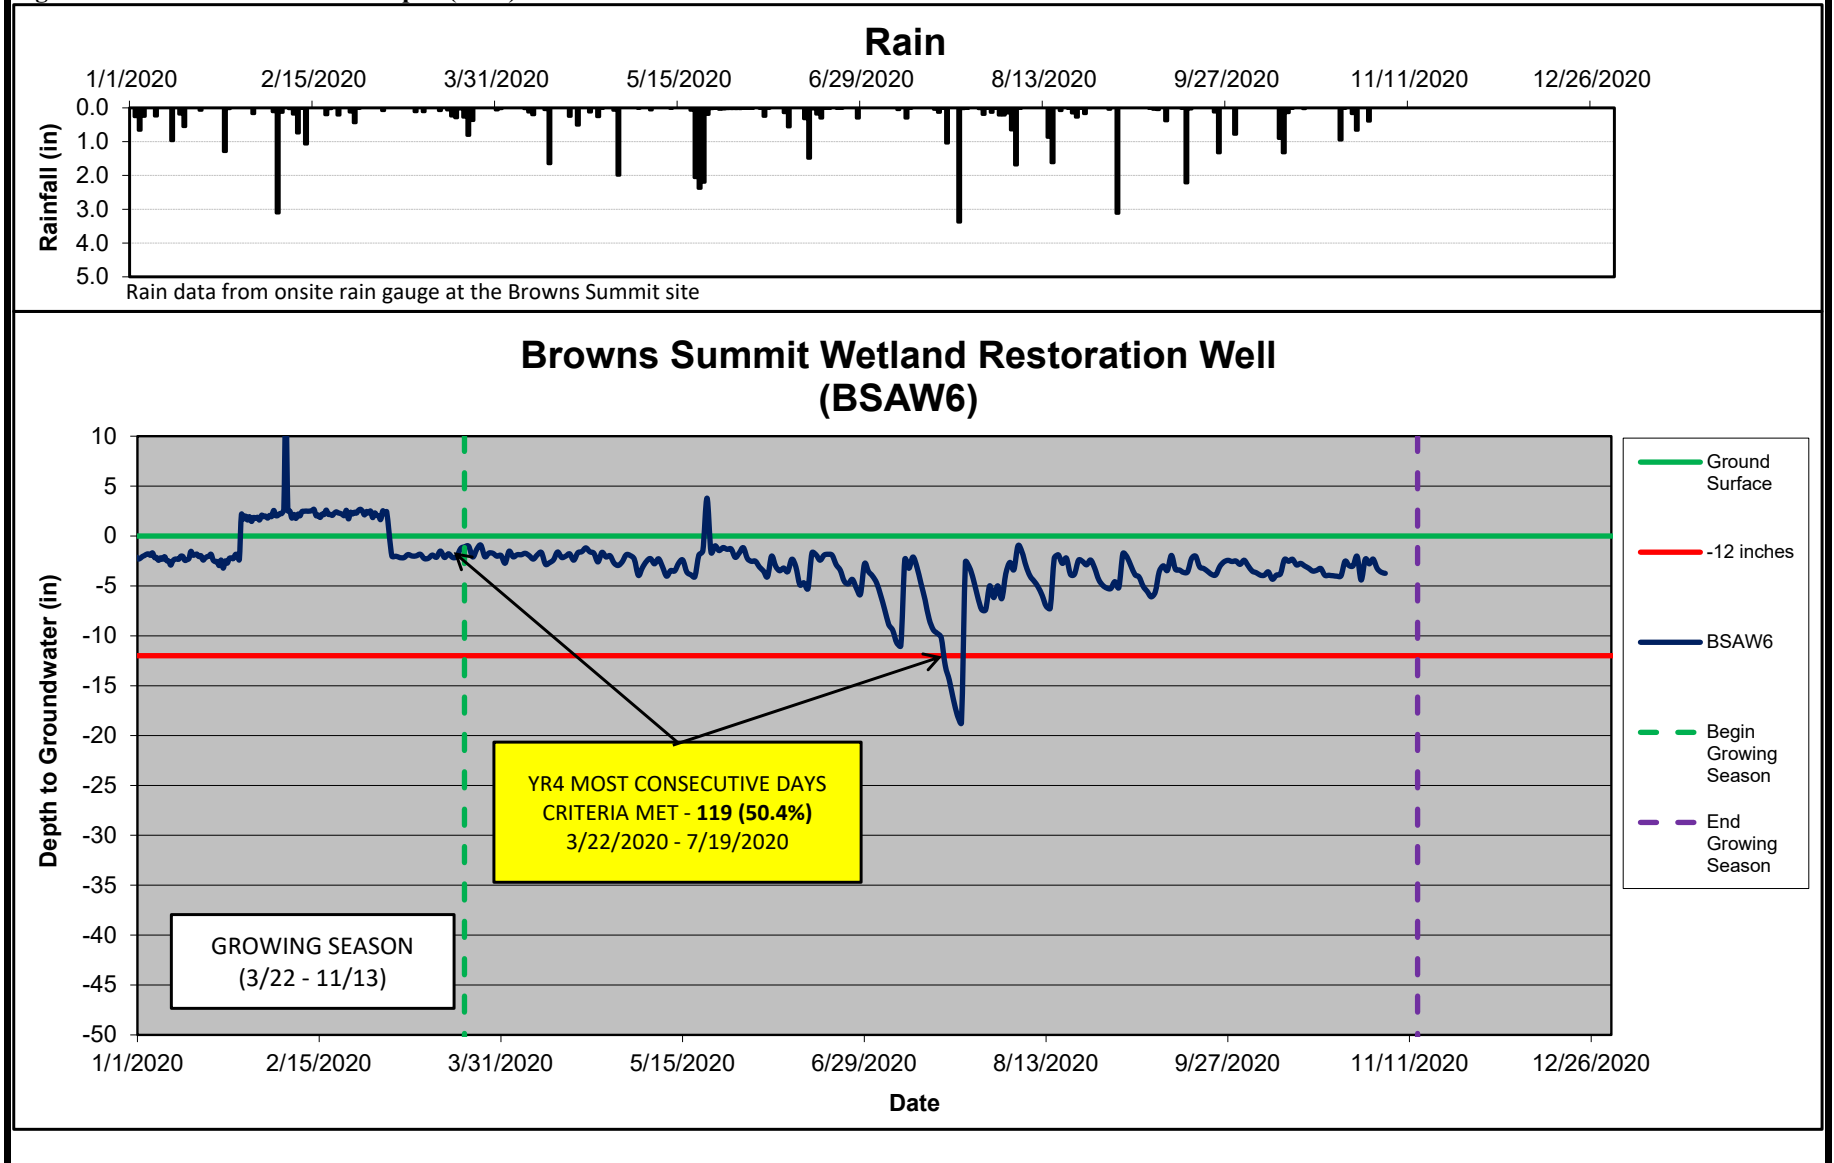
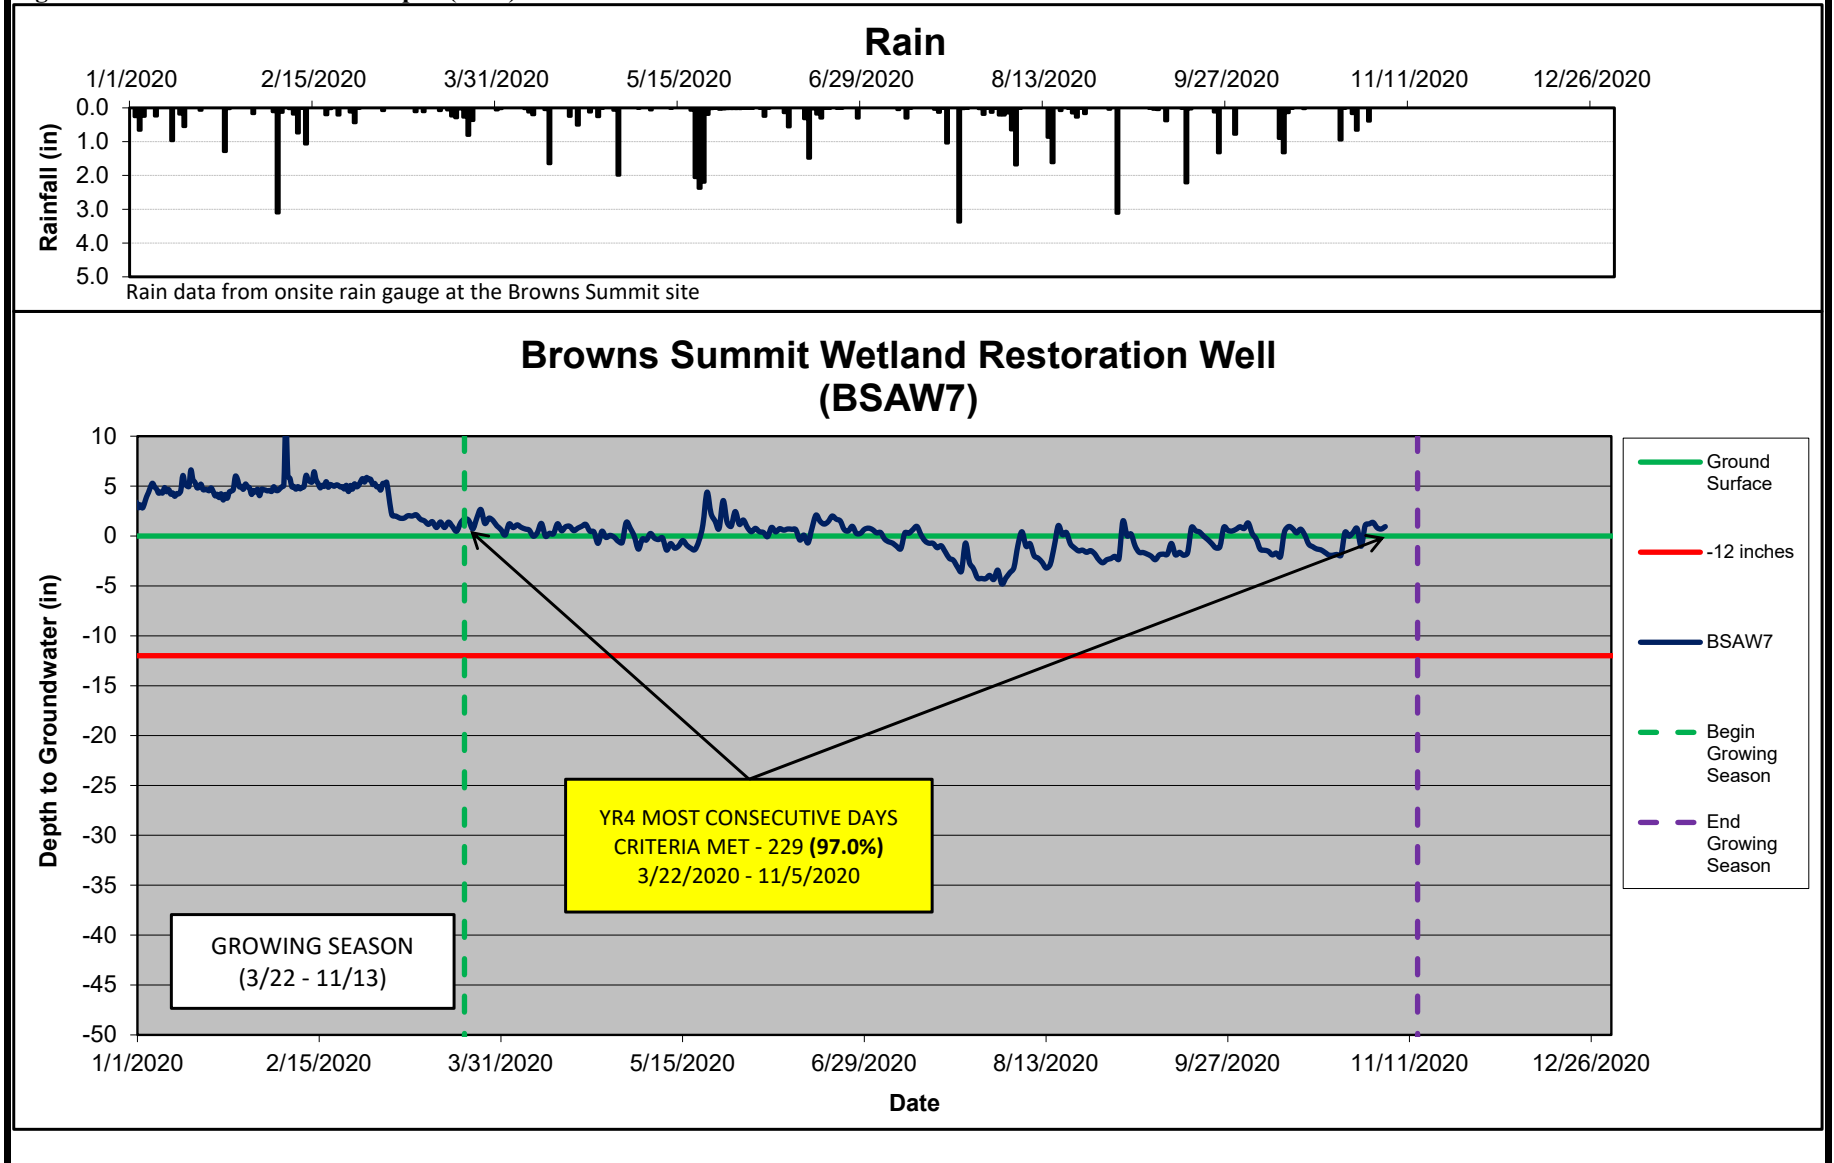
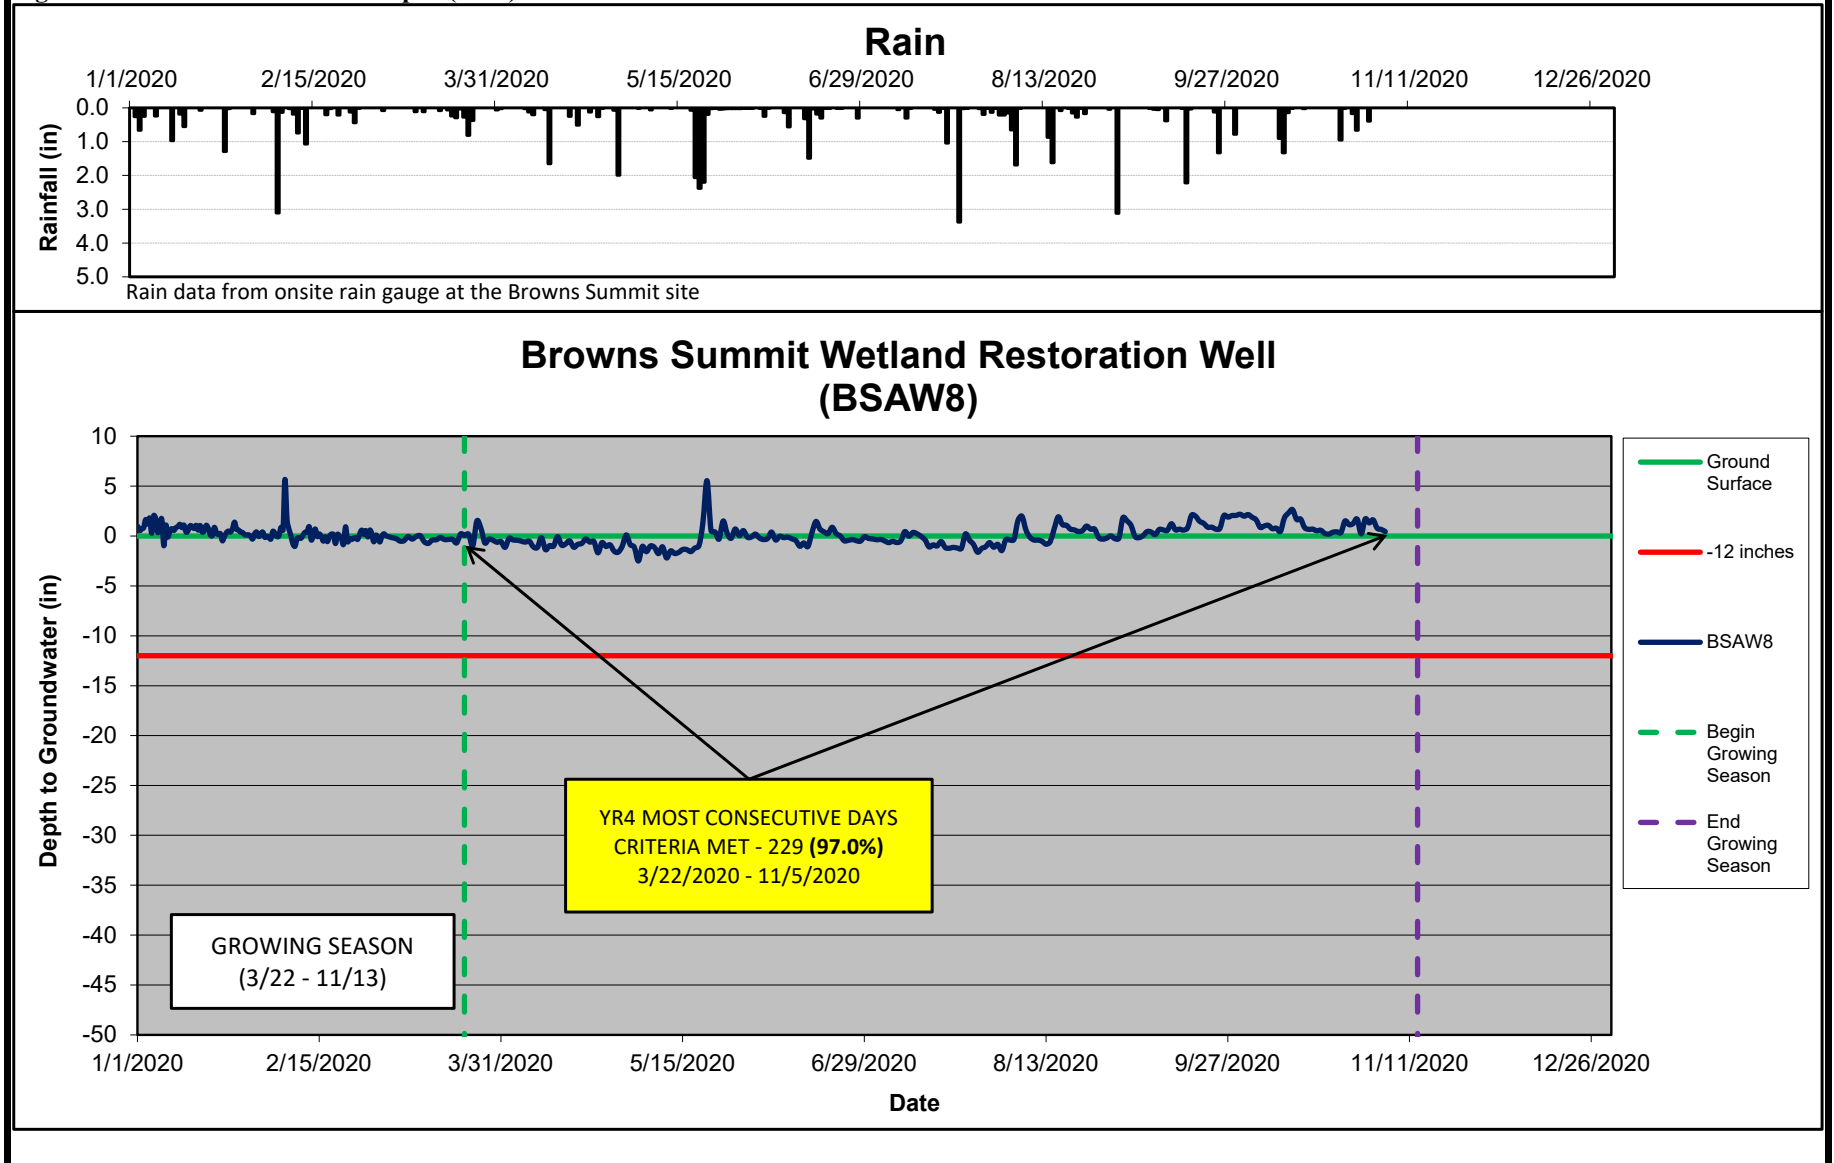
Figure 7. Wetland Restoration Graphs (2020)

According to the Baseline Monitoring Report, the growing season for Guilford County is from March 22 to November 13 and is 229 days long. 12% of the growing season is 28 days and 9% of the growing season is 21 days.

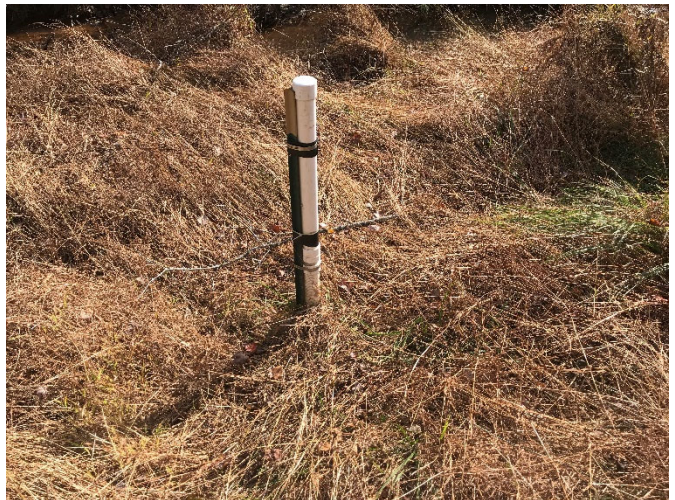
Wrack Line Showing High Flow (11/6/2020)
