Browns Summit Creek Restoration Project Year 6 Monitoring Report

Guilford County, North Carolina

DMS Project ID No. 96313, DEQ Contract No. 5792

Monitoring Year: 6 of 7

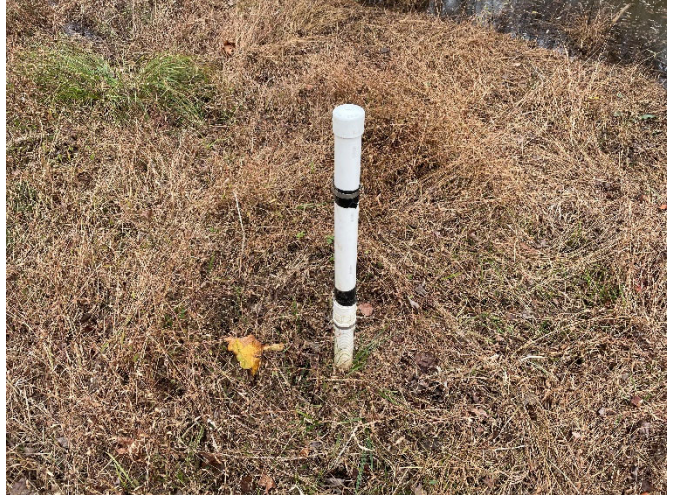
Manual Crest Gauge – Reading 3/22/22 (No Reading)

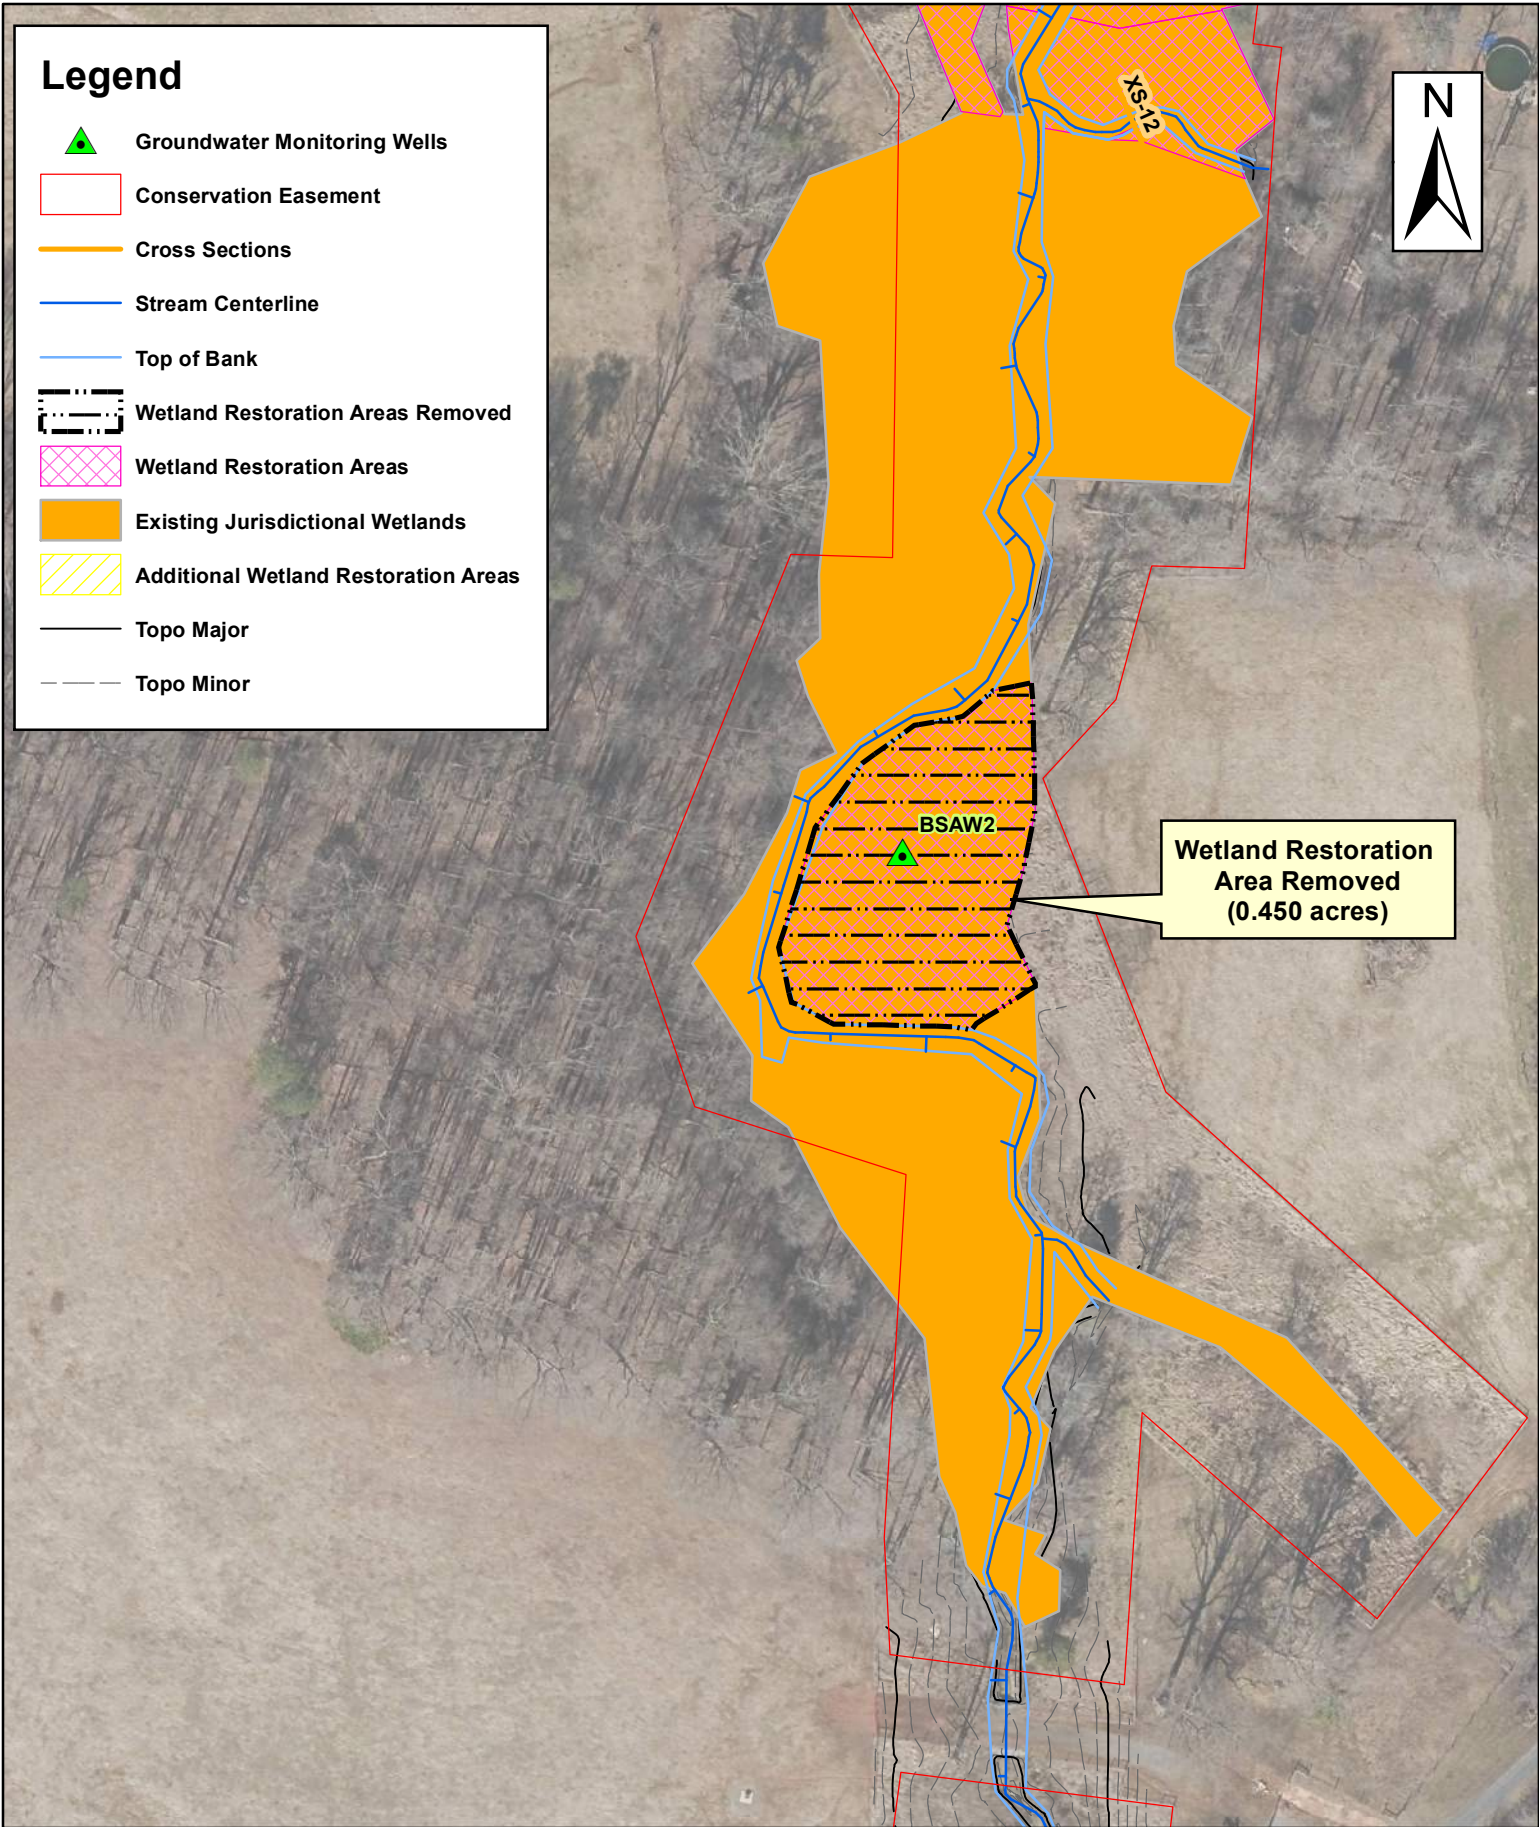
As noted above, an area of filled wetlands around monitoring well BSAW2 has not met ground water hydrology establishment criteria. As such, area around this well that was previously proposed as a restoration wetland (type 4 – filled wetland) has been removed as credit toward Riparian wetland mitigation units (1:1 ratio). Alternatively, areas identified during field investigations on November 10, 2022 were determined to qualify as having at least partially functioning restored wetlands (restoration type R-3; credit 1.5:1). Soils within these wetland restoration areas were hydric and the areas expressed wetland hydrology indicators such as surface water, saturation, iron deposits, water-stained leaves, hydrogen sulfide odor and oxidized rhizospheres along living roots. Additionally, likely-hydrophytic vegetation was also noted including sedges (*Carex lurida*), black willow (*Salix nigra*), green bulrush (*Scirpus atrovirens*), American sycamore (*Platanus occidentalis*), and Smooth alder (*Alnus serrulata*). These areas identified on the November 10, 2022 field visit were deemed to qualify for a wetland restoration ratio of 1.5:1 toward WMUs. Table 1 summarizes the net gain of 0.08 WMUs after Wetland Boundary Readjustment.

Wetland Restoration Area Added (0.414 acres)

Wetland Restoration Area Added (0.372 acres)
