BRUSH CREEK – PROJECT NO. 54

MONITORING YEAR 10

2011 Monitoring Report

Fish and Wildlife Associates, Inc.

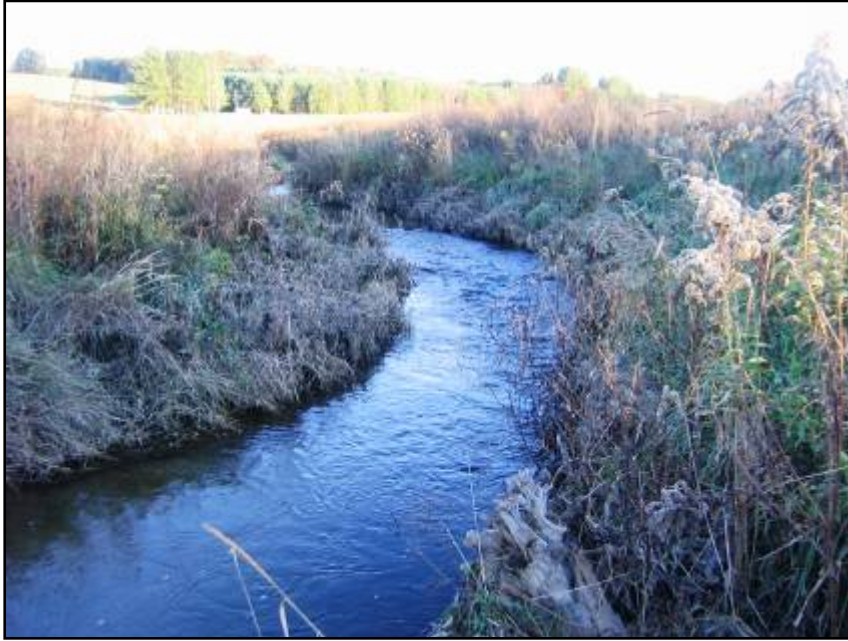
Site: Little Pine Creek
Project No: 54
Photo Station: 7
Date: April 3, 2011
Photographed by: C. Lawson
Description: Taken 115 degrees from north, showing sediment deposits.

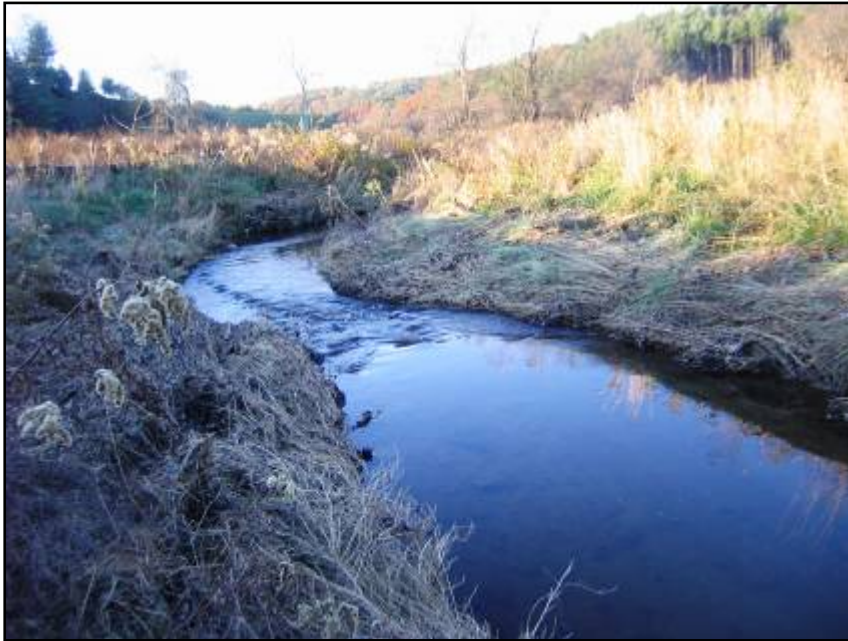
Site: Little Pine Creek
Project No: 54
Photo Station: 7
Date: April 3, 2011
Photographed by: C. Lawson
Description: Taken 352 degrees from north, showing overbank deposits.

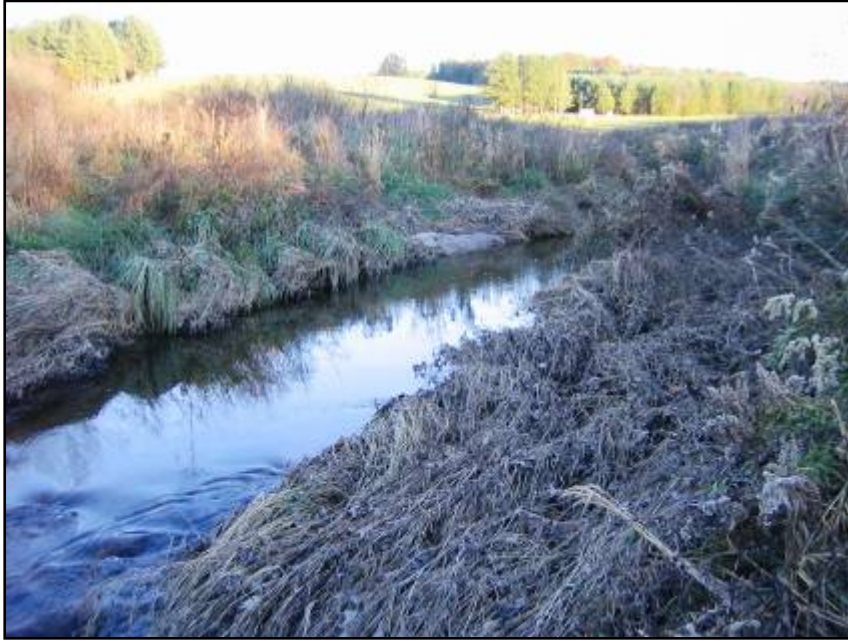
Site: Little Pine Creek
Project No: 54
Photo Station: 8
Date: April 3, 2011
Photographed by: C. Lawson
Description: Taken 100 degrees from north, showing sediment deposition from winter 2010-11 overbank event

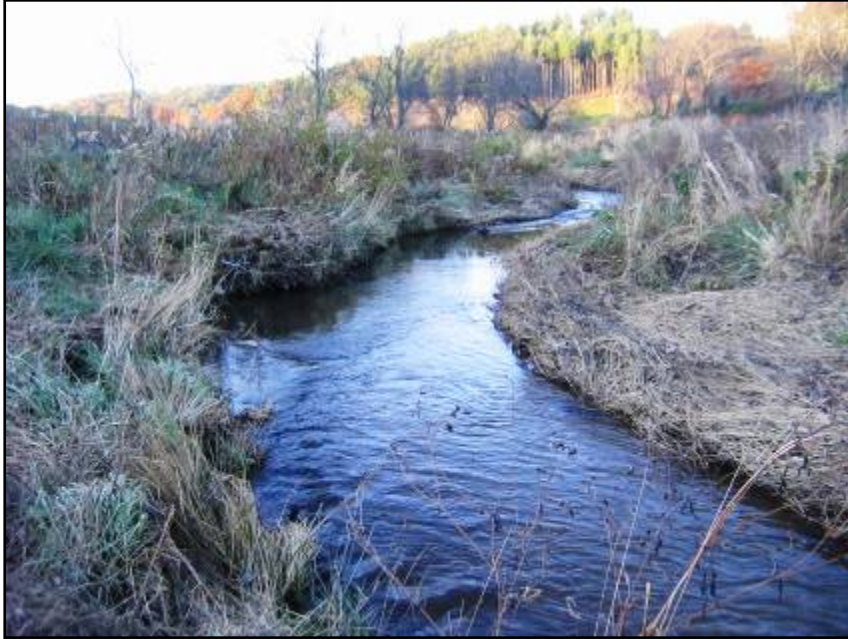
Site: Little Pine Creek
Project No: 54
Photo Station: 8
Date: April 3, 2011
Photographed by: C. Lawson
Description: Taken 350 degrees from north, showing sediment deposition from winter 2010-11 overbank event

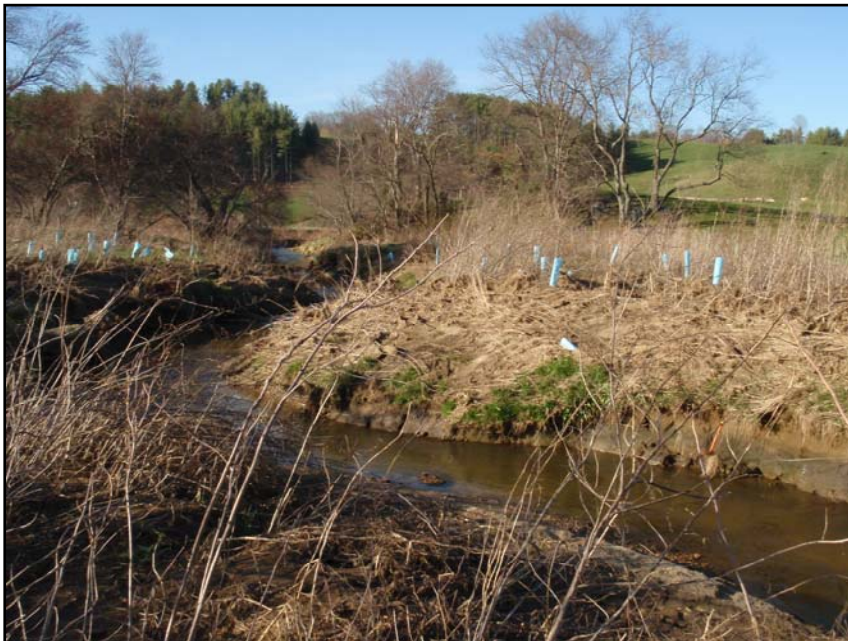
Site: Little Pine Creek
Project No: 54
Photo Station: 9
Date: April 3, 2011
Photographed by: C. Lawson
Description: Taken 20 degrees from north, showing outer bend scour and overbank deposits.

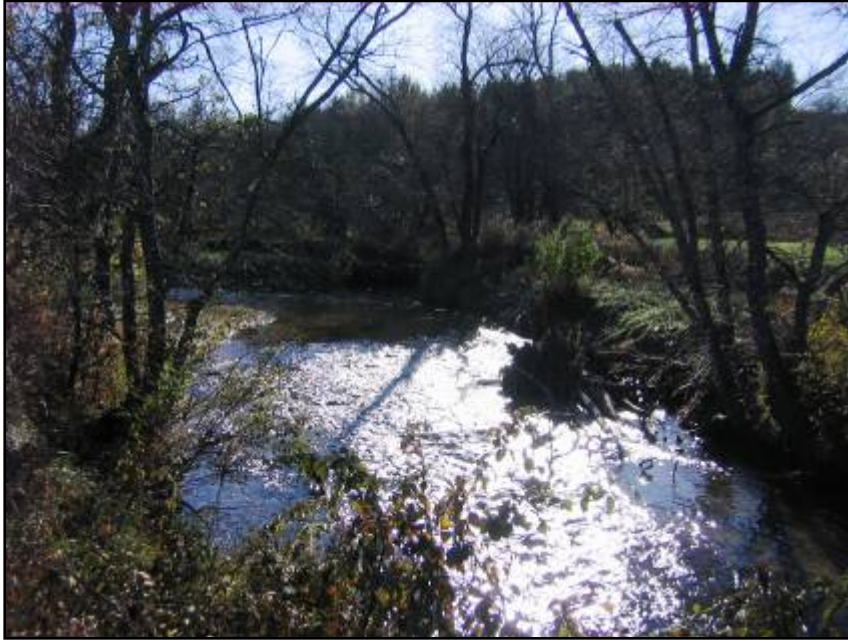
Site: Brush Creek
Project No: 54
Photo Station: 11
Date: April 4, 2011
Photographed by: C. Lawson
Description: Taken 226 degrees from north, showing a group of uprooted trees at project upper limit.

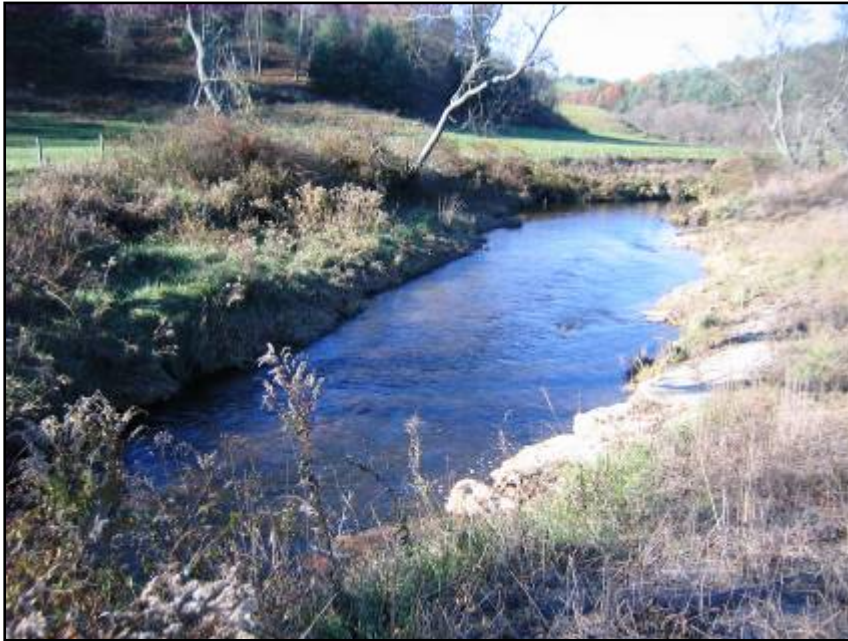
Site: Brush Creek
Project No: 54
Photo Station: 11
Date: April 4, 2011
Photographed by: C. Lawson
Description: Taken 350 degrees from north, showing overbank deposits on the left bank.

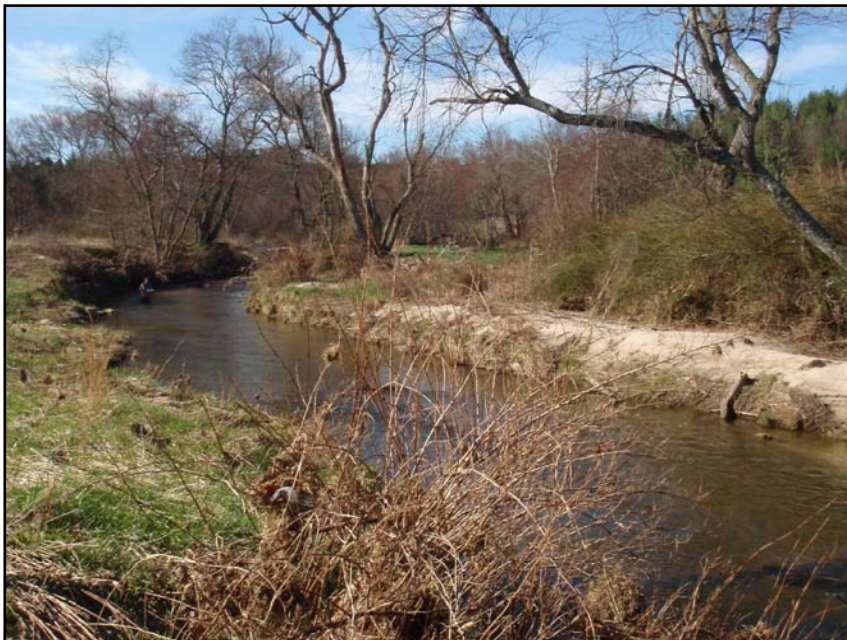
Site: Brush Creek
Project No: 54
Photo Station: 14
Date: April 4, 2011
Photographed by: C. Lawson
Description: Taken 190 degrees from north, facing upstream, bank scour and sediment deposits visible along the banks

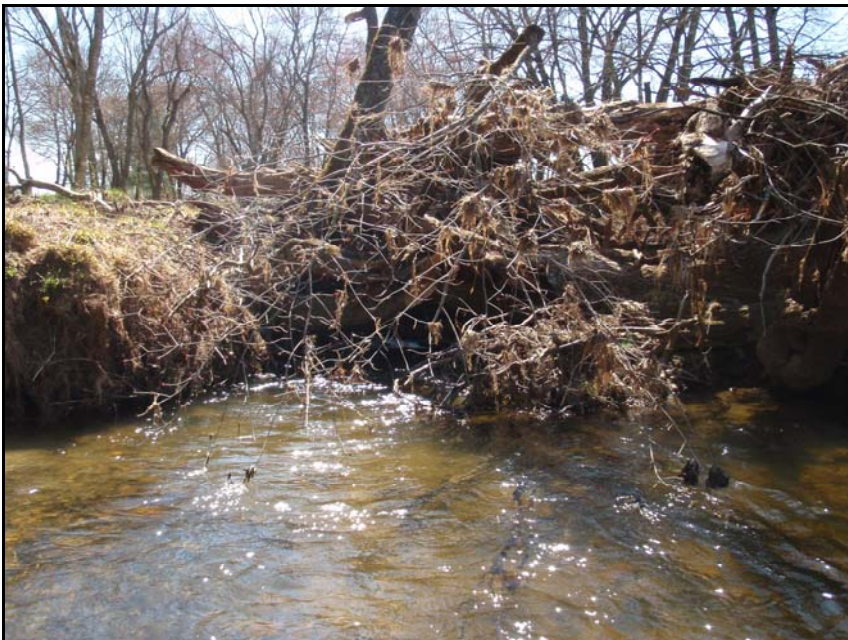
Site: Brush Creek
Project No: 54
Photo Station: 28
Date: April 4, 2011
Photographed by: C. Lawson
Description: Taken 144 degrees from north, showing debris dam created during winter 2009-10 and 2010-11 storm events.
