LITTLE PINE CREEK/BRUSH CREEK 2002 MONITORING REPORT

ALLEGHANY COUNTY, NORTH CAROLINA
HDR Project No. 09177-027-018

January 2003

2002 MONITORING REPORT

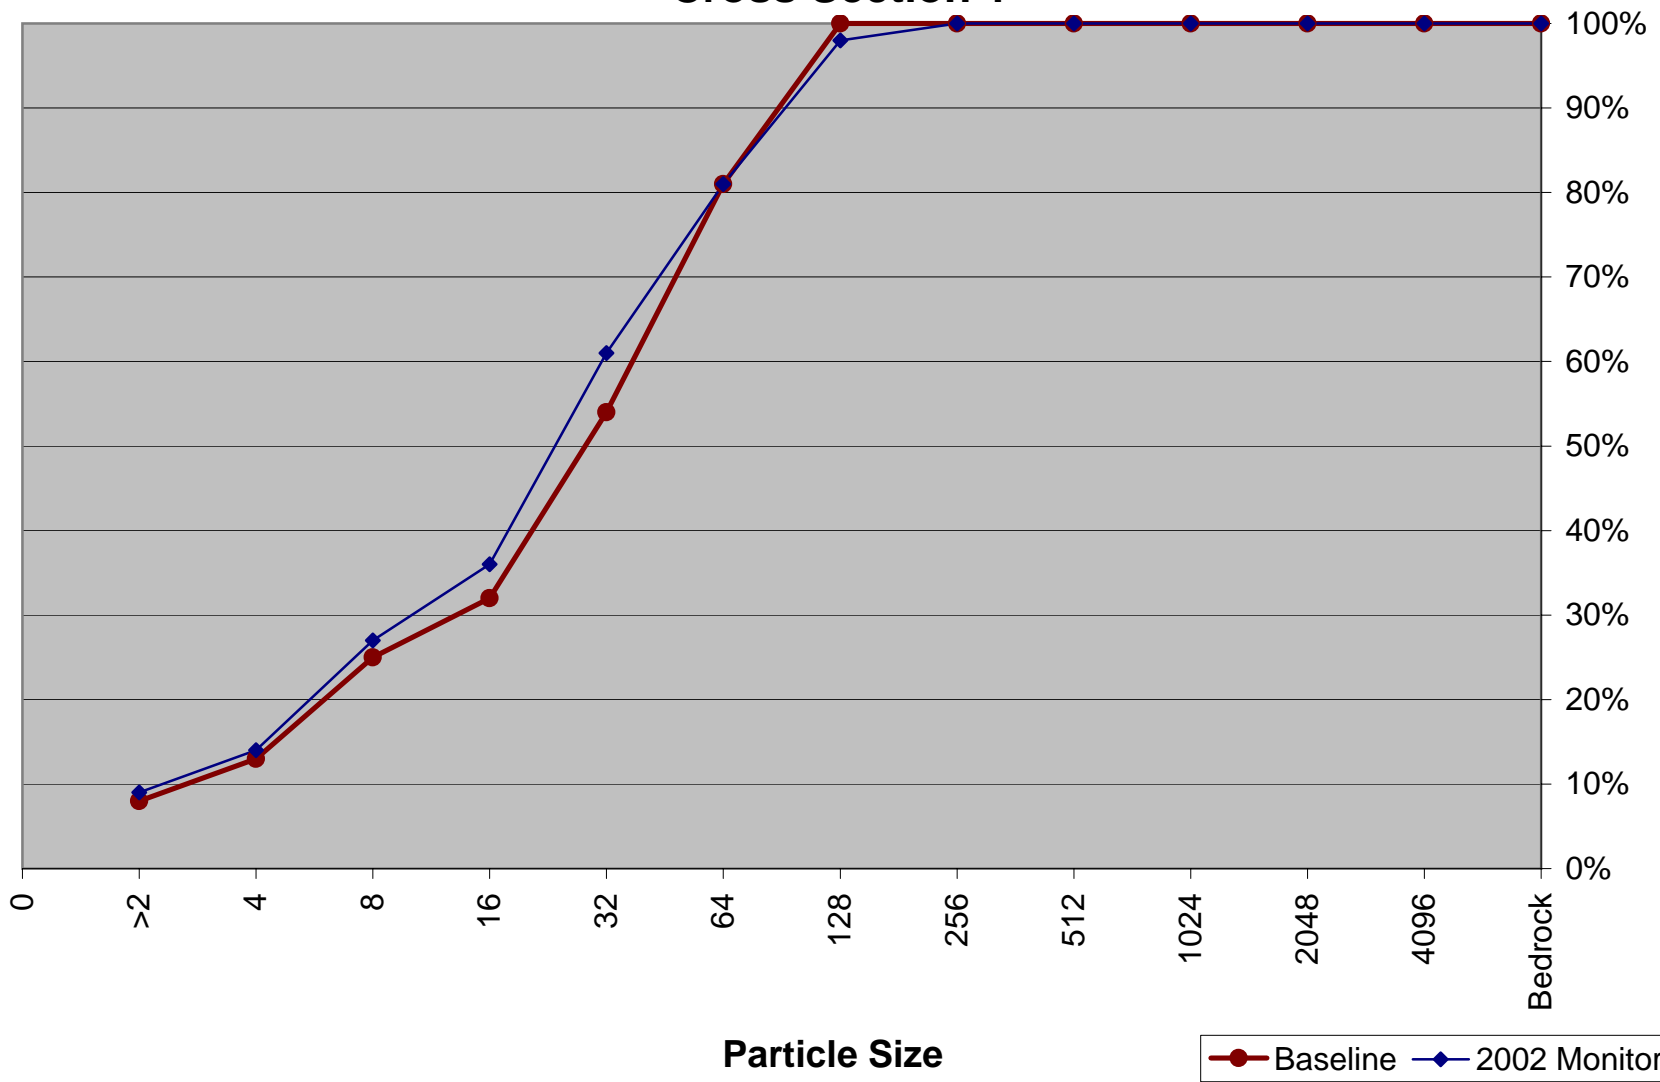
Pebble Count - Little Pine Creek Cross Section 1

Little Pine Creek			
Cross Section 1			
Baseline			
Bed Surface Material Particle Size Class (mm)	Number	% Individual	% Cumulative
<2	8	8.0%	8%
2-4	5	5.0%	13%
4-8	12	12.0%	25%
8-16	7	7.0%	32%
16-32	22	22.0%	54%
32-64	27	27.0%	81%
64-128	19	19.0%	100%
128-256		0.0%	100%
256-512		0.0%	100%
512-1024		0.0%	100%
1024-2048		0.0%	100%
2048-4096		0.0%	100%
Bedrock		0.0%	100%
Total	100	100%	100%
d50 = 29.1 mm, d85 = 77.5 mm

Little Pine Creek			
Cross Section 1			
2002 Monitoring			
Bed Surface Material Particle Size Class (mm)	Number	% Individual	% Cumulative
<2	9	9.0%	9%
2-4	5	5.0%	14%
4-8	13	13.0%	27%
8-16	9	9.0%	36%
16-32	25	25.0%	61%
32-64	20	20.0%	81%
64-128	17	17.0%	98%
128-256	2	2.0%	100%
256-512		0.0%	100%
512-1024		0.0%	100%
1024-2048		0.0%	100%
2048-4096		0.0%	100%
Bedrock		0.0%	100%
Total	100	100%	100%
d50 = 25.0 mm, d85 = 79.0 mm

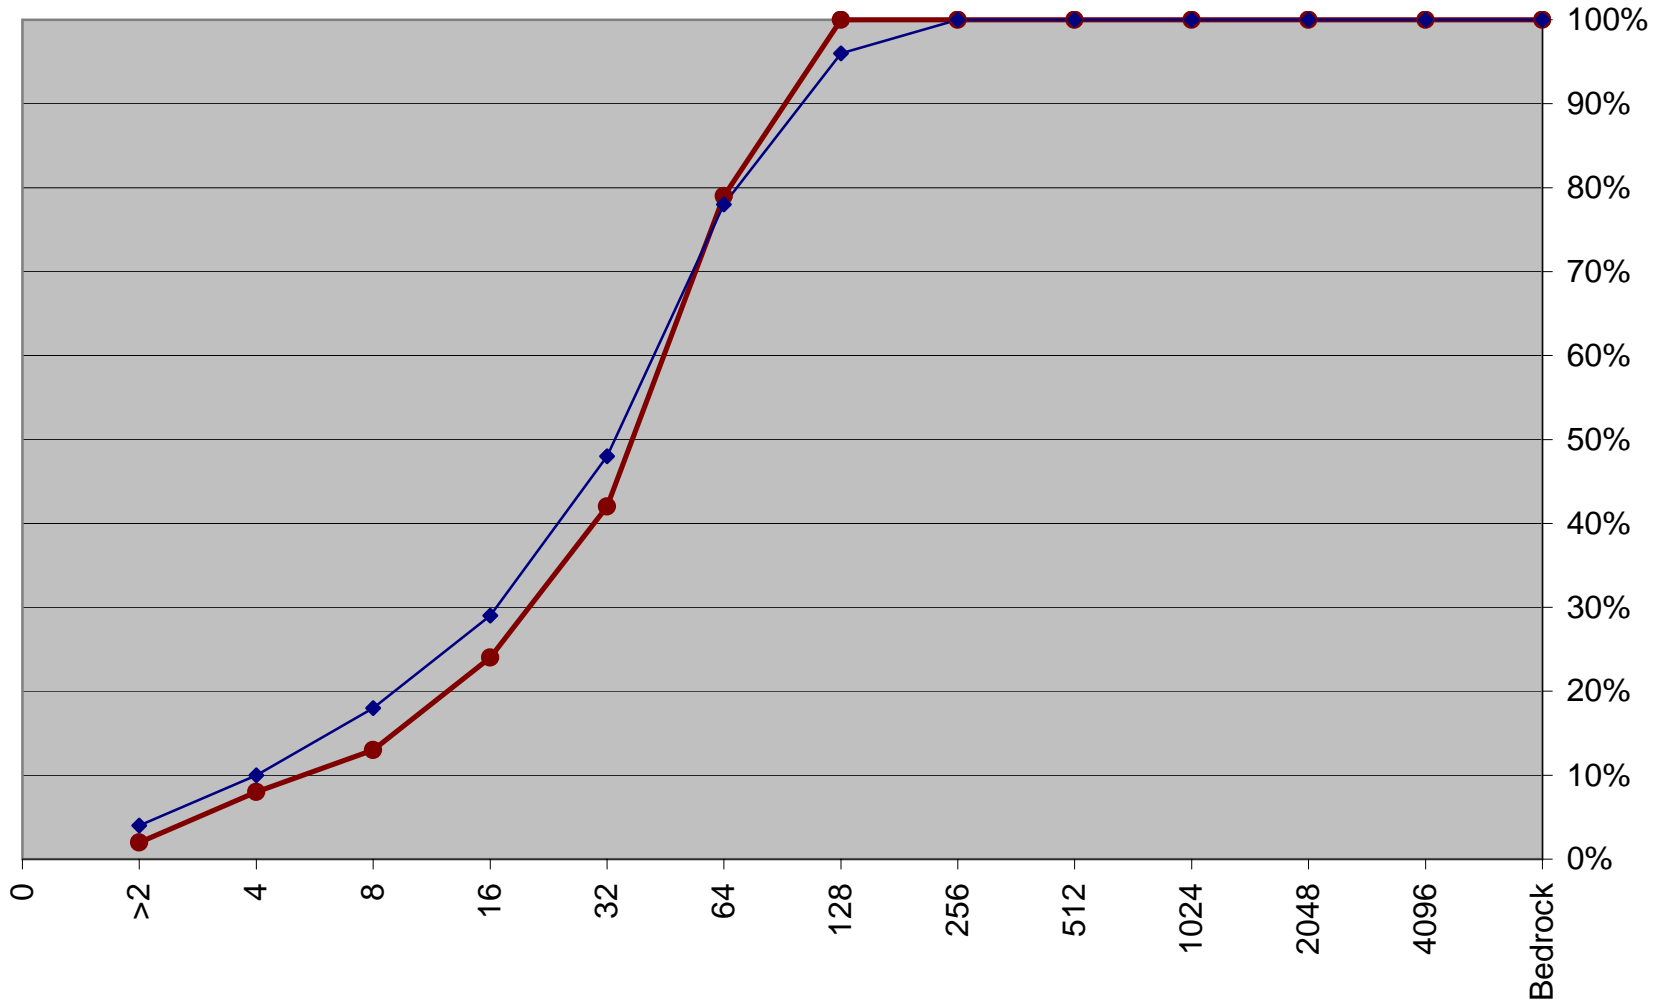
Pebble Count - Little Pine Creek Cross Section 2

Little Pine Creek			
Cross Section 2			
2002 Monitoring			
Bed Surface Material Particle Size Class (mm)	Number	% Individual	% Cumulative
<2	4	4.0%	4%
2-4	6	6.0%	10%
4-8	8	8.0%	18%
8-16	11	11.0%	29%
16-32	19	19.0%	48%
32-64	30	30.0%	78%
64-128	18	18.0%	96%
128-256	4	4.0%	100%
256-512		0.0%	100%
512-1024		0.0%	100%
1024-2048		0.0%	100%
2048-4096		0.0%	100%
Bedrock		0.0%	100%
Total	100	100%	100%
d50 = 34.1 mm, d85 = 88.9 mm

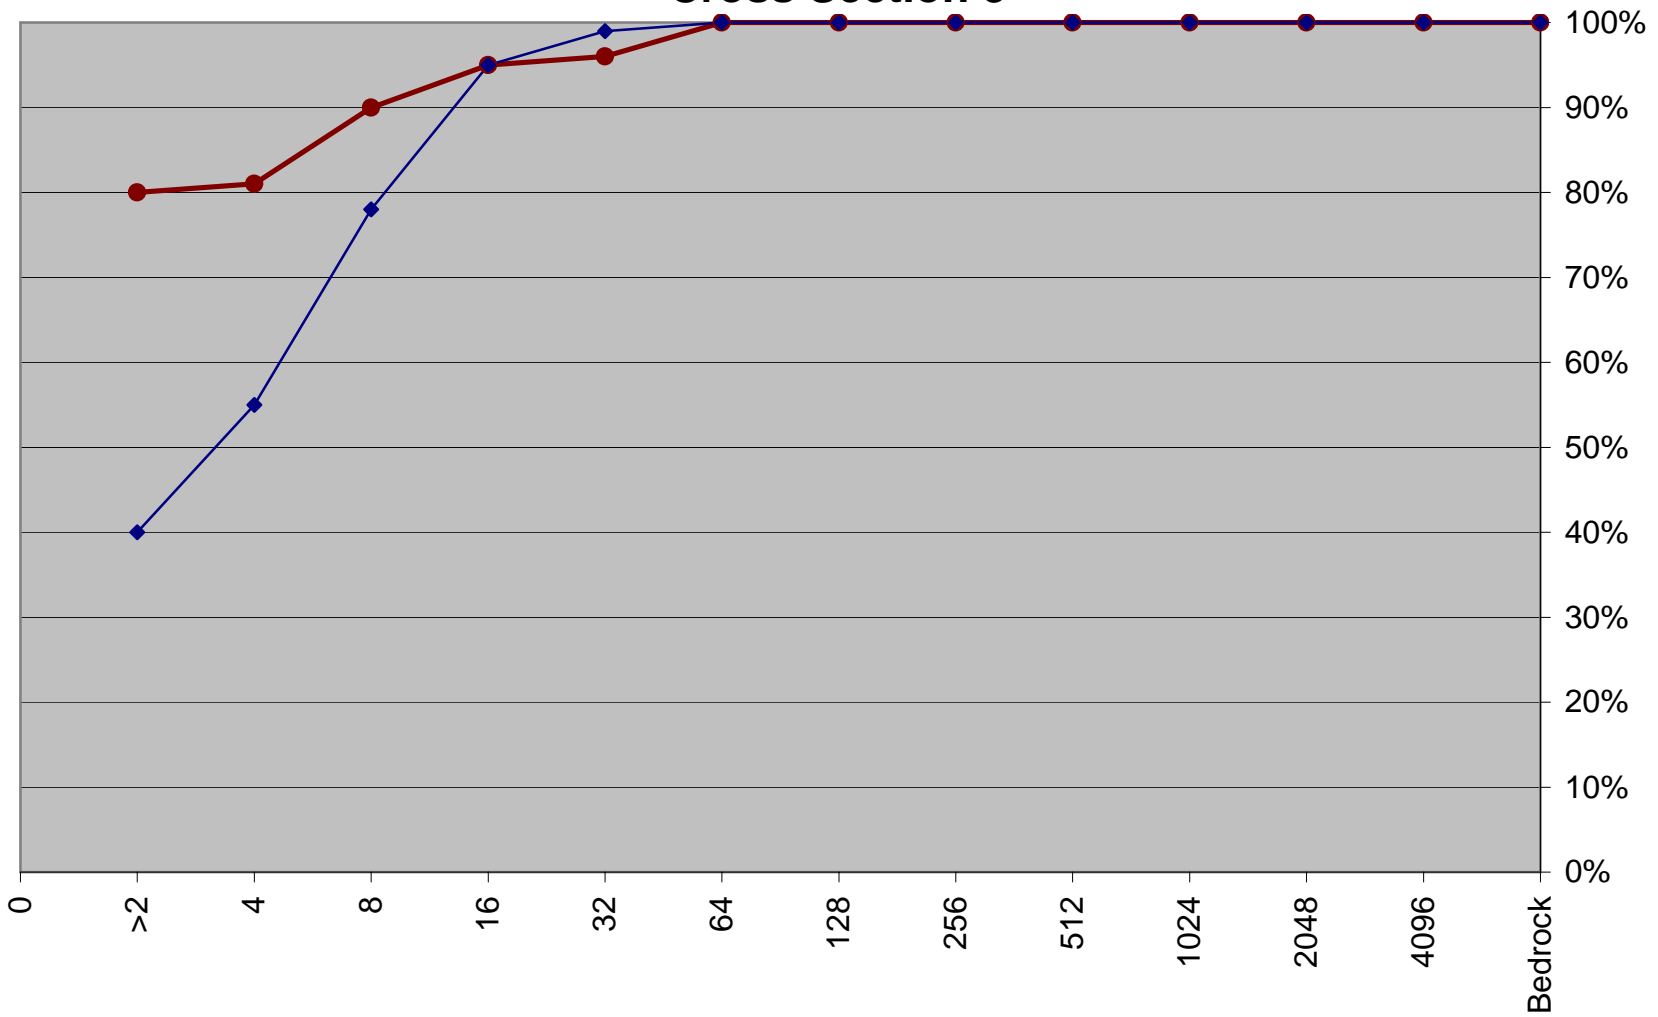
Pebble Count - Little Pine Creek Cross Section 3

Little Pine Creek			
Cross Section 3			
2002 Monitoring			
Bed Surface Material Particle Size Class (mm)	Number	% Individual	% Cumulative
<2	40	40.0%	40%
2-4	15	15.0%	55%
4-8	23	23.0%	78%
8-16	17	17.0%	95%
16-32	4	4.0%	99%
32-64	1	1.0%	100%
64-128		0.0%	100%
128-256		0.0%	100%
256-512		0.0%	100%
512-1024		0.0%	100%
1024-2048		0.0%	100%
2048-4096		0.0%	100%
Bedrock		0.0%	100%
Total	100	100%	100%
d50 = 3.3 mm, d85 = 11.3 mm

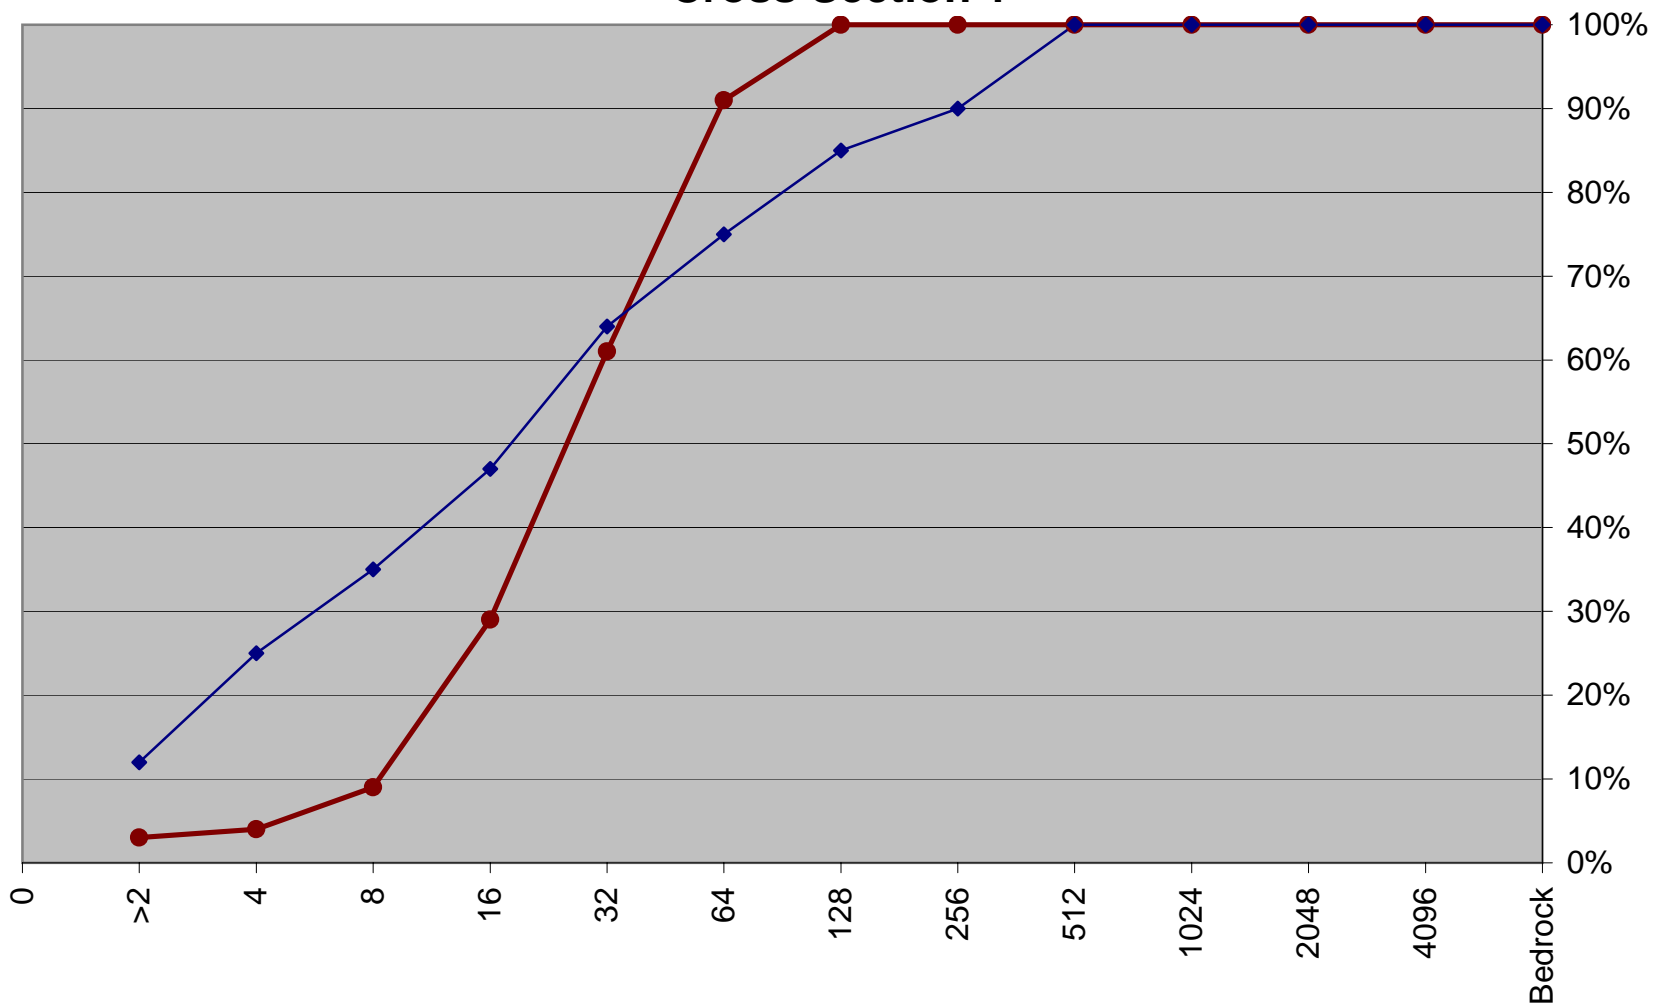
Pebble Count - Brush Creek Cross Section 1

Brush Creek			
Cross Section 1			
2002 Monitoring			
Bed Surface Material Particle Size Class (mm)	Number	% Individual	% Cumulative
<2	12	12.0%	12%
2-4	13	13.0%	25%
4-8	10	10.0%	35%
8-16	12	12.0%	47%
16-32	17	17.0%	64%
32-64	11	11.0%	75%
64-128	10	10.0%	85%
128-256	5	5.0%	90%
256-512	10	10.0%	100%
512-1024		0.0%	100%
1024-2048		0.0%	100%
2048-4096		0.0%	100%
Bedrock		0.0%	100%
Total	100	100%	100%
d50 = 18.8 mm, d85 = 96 mm

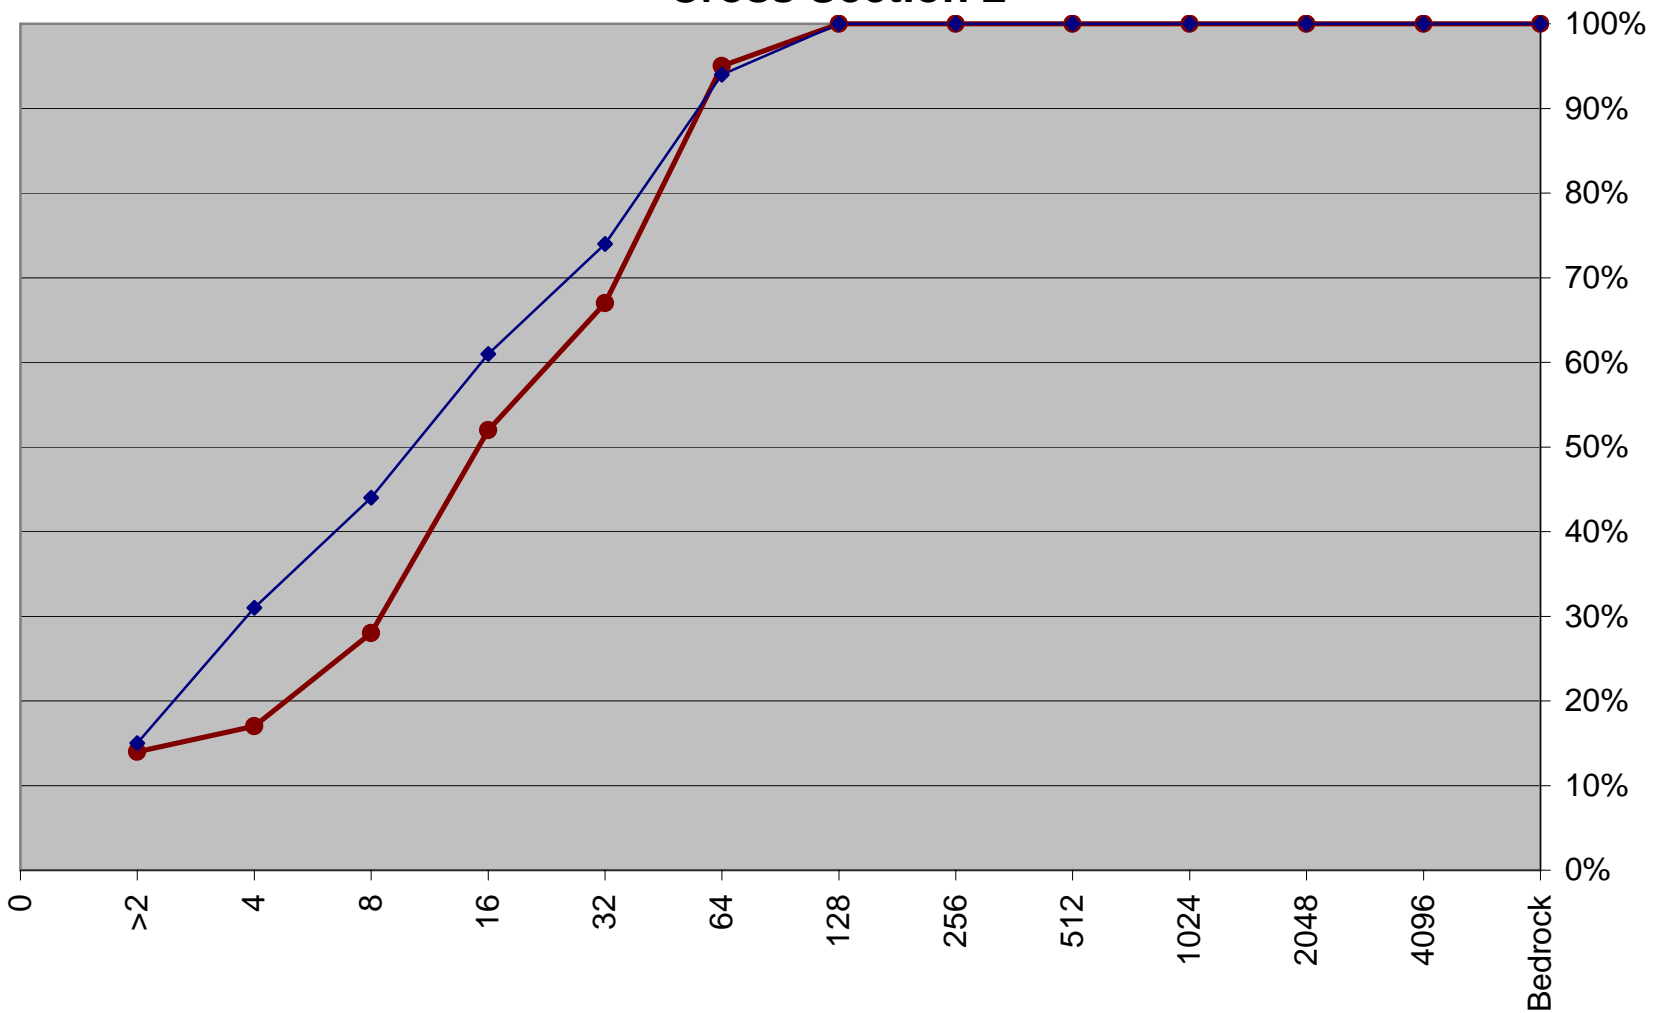
Pebble Count - Brush Creek Cross Section 2

Brush Creek			
Cross Section 2			
2002 Monitoring			
Bed Surface Material Particle Size Class (mm)	Number	% Individual	% Cumulative
<2	15	15.0%	15%
2-4	16	16.0%	31%
4-8	13	13.0%	44%
8-16	17	17.0%	61%
16-32	13	13.0%	74%
32-64	20	20.0%	94%
64-128	6	6.0%	100%
128-256		0.0%	100%
256-512		0.0%	100%
512-1024		0.0%	100%
1024-2048		0.0%	100%
2048-4096		0.0%	100%
Bedrock		0.0%	100%
Total	100	100%	100%
d50 = 10.8 mm, d85 = 49.6 mm

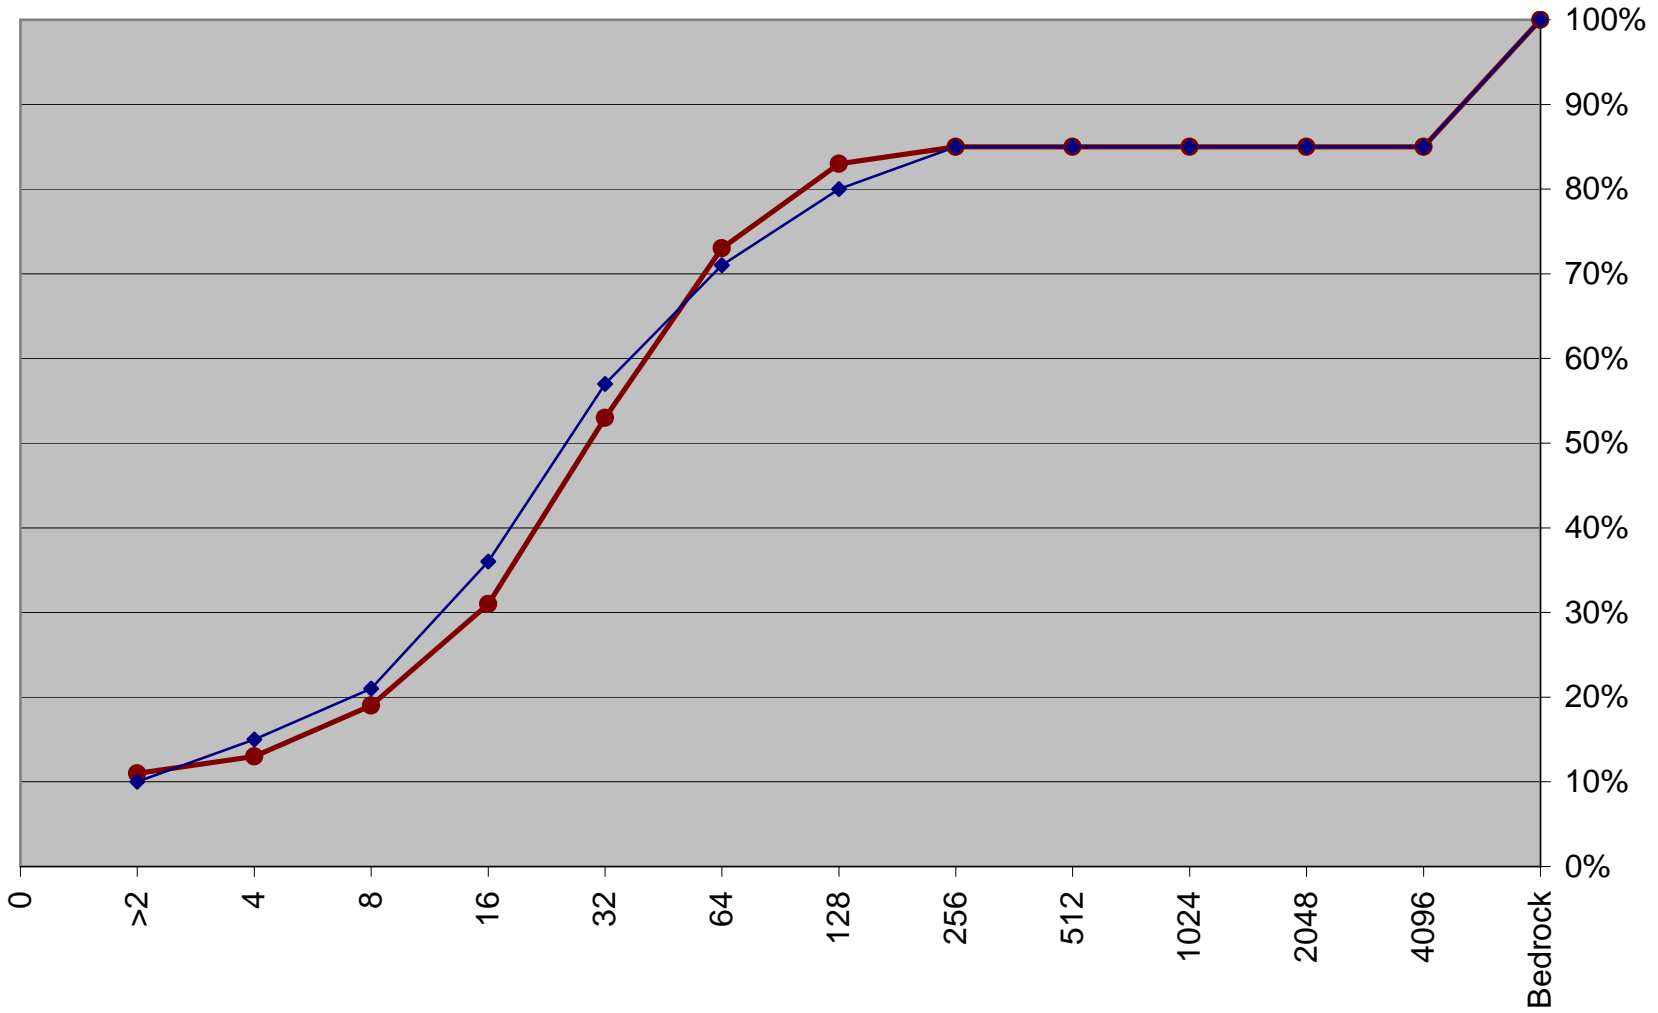
Pebble Count - Brush Creek Cross Section 3

Brush Creek			
Cross Section 3			
2002 Monitoring			
Bed Surface Material Particle Size Class (mm)	Number	% Individual	% Cumulative
<2	10	10.0%	10%
2-4	5	5.0%	15%
4-8	6	6.0%	21%
8-16	15	15.0%	36%
16-32	21	21.0%	57%
32-64	14	14.0%	71%
64-128	9	9.0%	80%
128-256	5	5.0%	85%
256-512		0.0%	85%
512-1024		0.0%	85%
1024-2048		0.0%	85%
2048-4096		0.0%	85%
Bedrock	15	15.0%	100%
Total	100	100%	100%
d50 = 26.7 mm, d85 = 192 mm
