# Little Pine & Brush Creek

## 2003 Annual Monitoring Report

March, 2004

## 2003 Little Pine & Brush Creek Monitoring Abstract

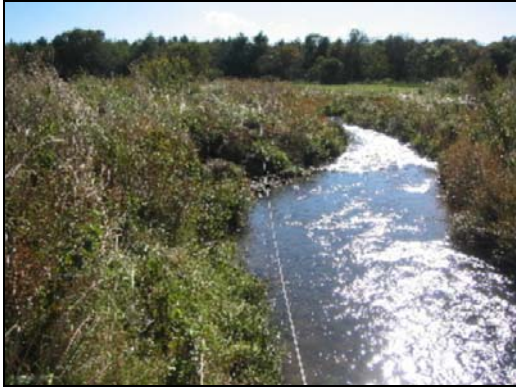
**Little Pine Vegetation Plot Quad 1  
on Little Pine Creek - 2003.**

Vegetation within the riparian buffer of Little Pine Creek varied in degree of success. The planted native herbaceous vegetation was dense and appeared to be mostly outcompeting the fescue from the adjoining field. *Verbenia* spp., *Solidago* spp., and *Bidens* spp. are especially doing well throughout the area. Live stakes are marginally healthy in certain areas. Planted trees and shrubs are doing poorly throughout the entire buffer. In the first plot, only 1 tree stem was counted while 2 were found in the second plot. Although some stakes were found to be thriving, by and large, dead stakes were prevalent throughout. Further, of the shrub and tree stem found alive, most have been browsed.

There was some natural regeneration noted, however due to the season, much leaf drop had occurred and a complete picture of natural regeneration could not be formed. It was noted that a few large planted sycamores and walnuts were thriving and appeared not to have been browsed. Overall, the area appeared to be in an early successional state.

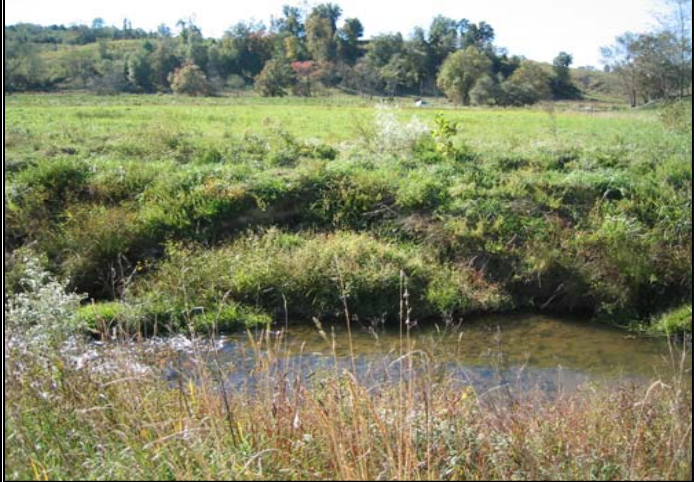
Photo of Cross-Section #1 - Looking Downstream

As-Built	2002	2003
<b>Area</b>	86.7	90.55	101.74
<b>Width</b>	31.5	31.2	31.5
<b>Mean Depth</b>	2.8	2.9	3.2
<b>Max Depth</b>	5.0	5.2	5.0

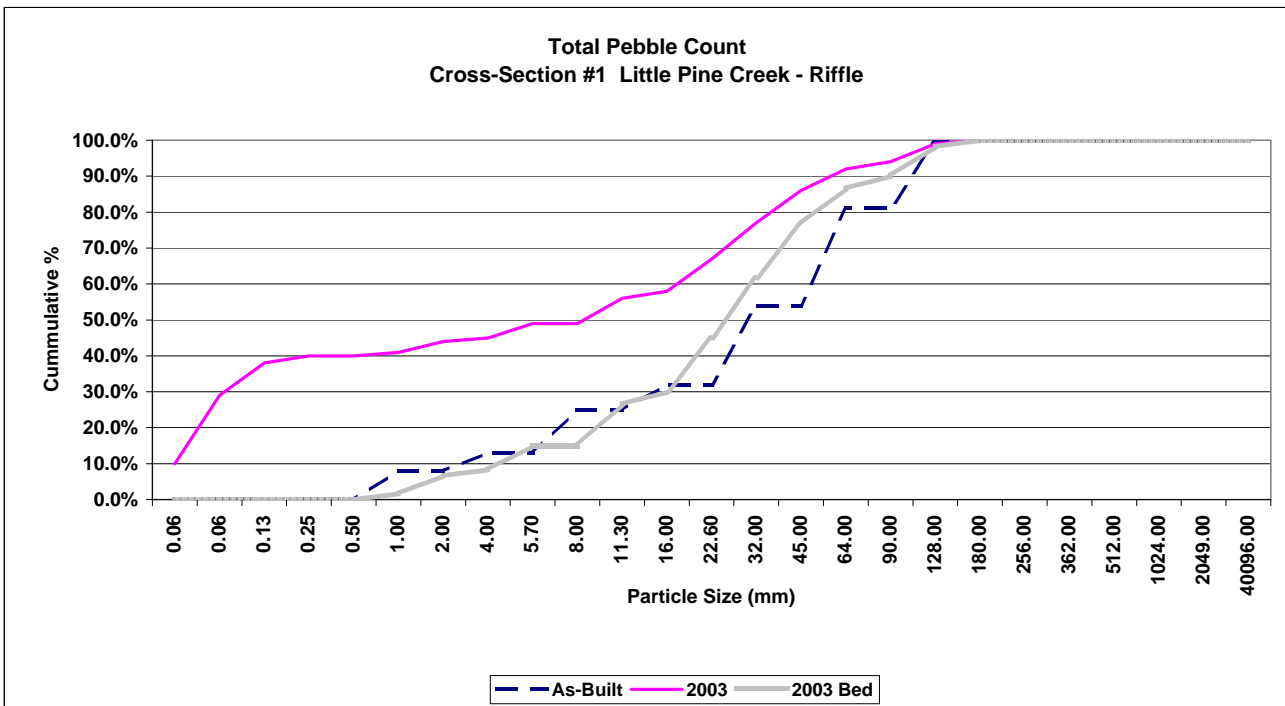
Post construction sedimentation, stream bank scouring and upstream sediment supply is the likely cause of the decrease in particle size. Another possible cause of decrease in particle size is measurement technique. It is not know if previous surveyors used similar sampling technique. Future monitoring should better evaluate channel substrate. It is common for substrate to decrease after construction for several years until fines can be flushed out.

d16	d35	d50	d85	d95
<b>As-Built</b>	7.55	28.83	36.46	116.11	142.16
<b>2003</b>	0.07	0.16	10.22	50.94	118.00

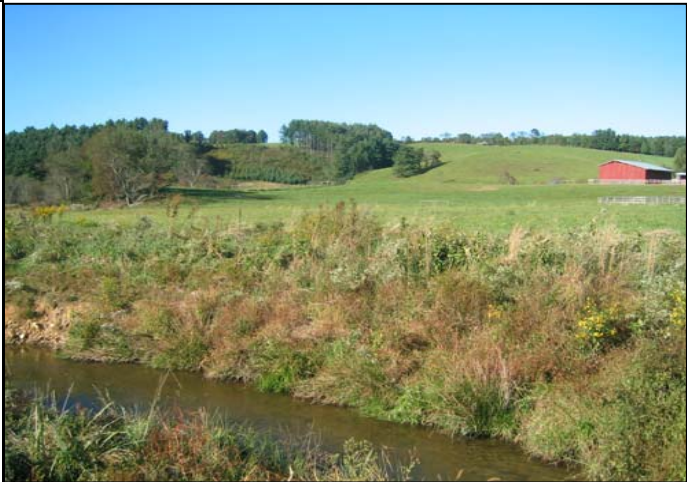
Photo of Cross-Section #2 - Looking Downstream

As-Built	2002	2003
Area	88.7	92.42	87.80
Width	33.7	33.7	32.6
Mean Dept	2.6	2.7	2.7
Max Depth	4.8	4.9	5.5

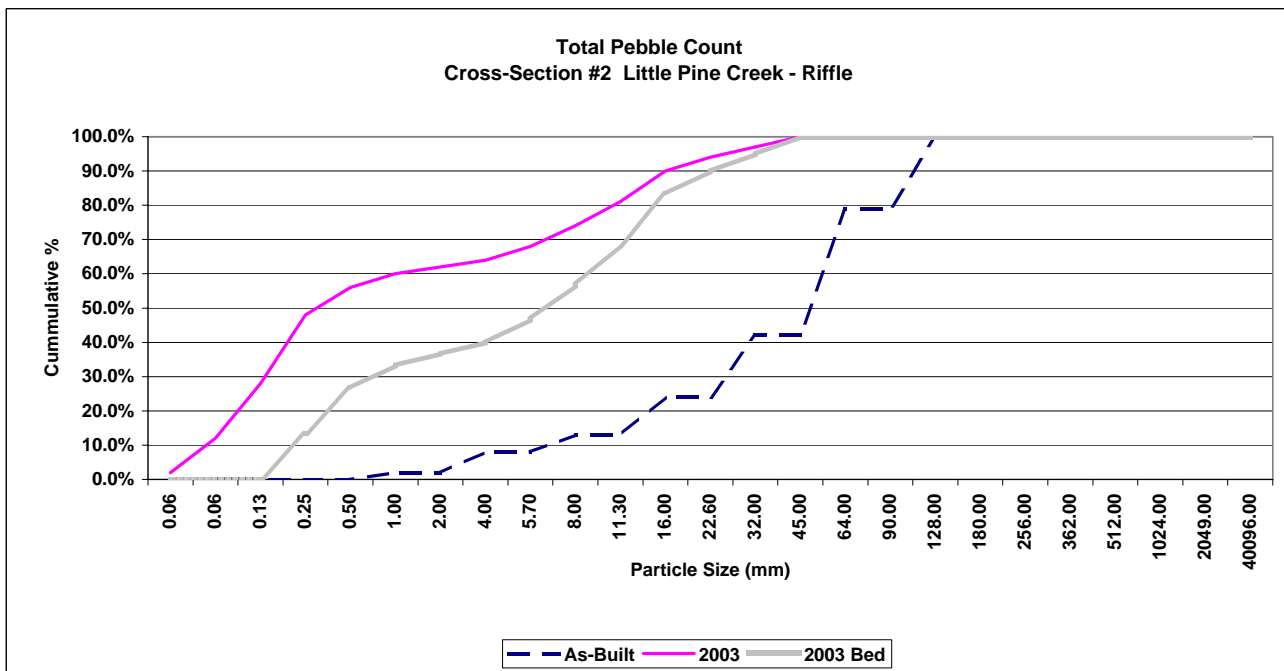
d16	d35	d50	d85	d95
<b>As-Built</b>	15.19	34.14	59.36	119.71	143.29
<b>2003</b>	0.12	0.25	0.47	15.53	31.03

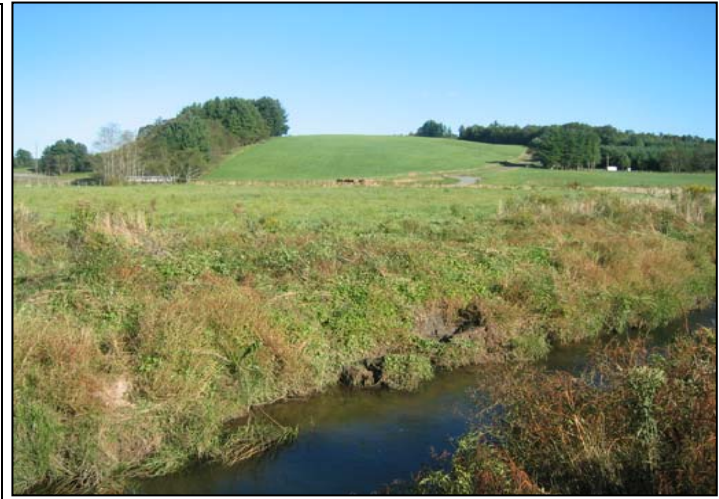
Photo of Cross-Section #3 - Looking Downstream

As-Built	2002	2003
<b>Area</b>	86.6	96.63	100.41
<b>Width</b>	35.4	37.0	40.4
<b>Mean Depth</b>	2.4	2.6	2.5
<b>Max Depth</b>	4.5	5.3	6.4

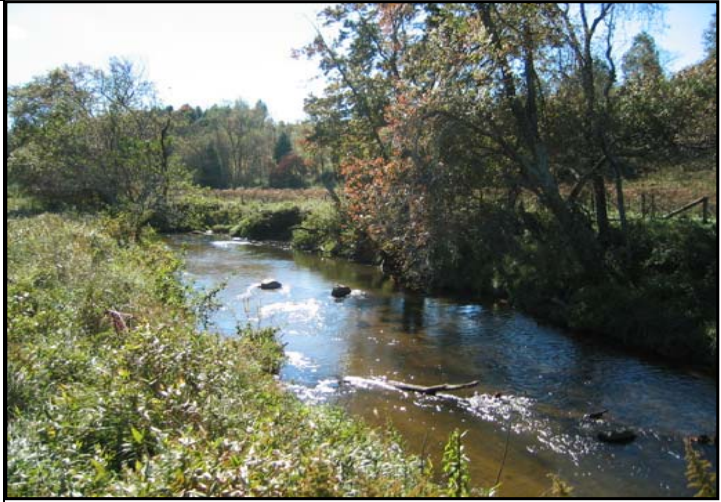
Photo of Cross-Section #4 - Looking Downstream

As-Built	2002	2003
<b>Area</b>	266.9	283.59	305.71
<b>Width</b>	55.3	47.4	53.2
<b>Mean Deptl</b>	4.8	6.0	5.7
<b>Max Depth</b>	8.0	8.1	8.4

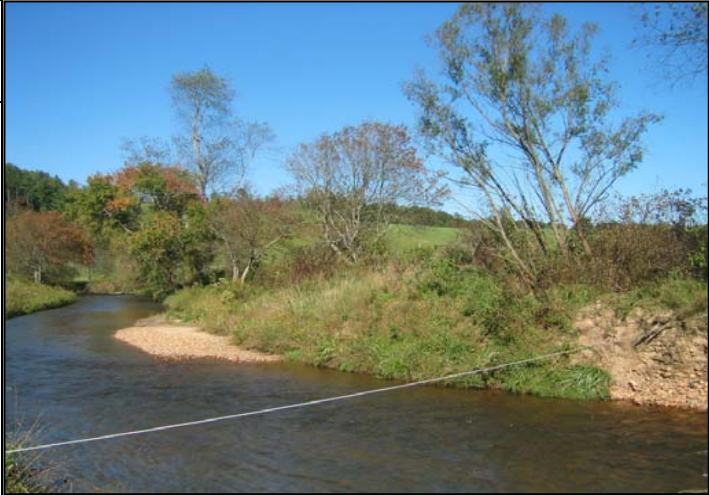
Photo of Cross-Section #5 - Looking Downstream

As-Built	2002	2003
<b>Area</b>	392.0	387.12	384.62
<b>Width</b>	104.3	106.0	105.4
<b>Mean Depth</b>	3.8	3.7	3.6
<b>Max Depth</b>	6.1	6.1	6.6

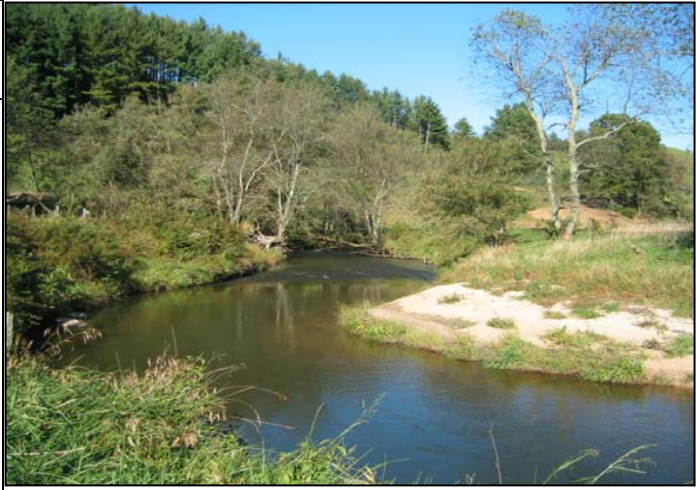
Photo of Cross-Section #6 - Looking Downstream

As-Built	2002	2003
Area	305.0	285.27	297.58
Width	67.3	67.0	68.0
Mean Dept	4.5	4.3	4.4
Max Depth	6.9	6.9	7.2
