BRUSH CREEK – PROJECT NO. 54
MONITORING YEAR 7
2008

NCDENR Ecosystem Enhancement Program
1652 Mail Service Center
Raleigh, NC 27699

January 2009

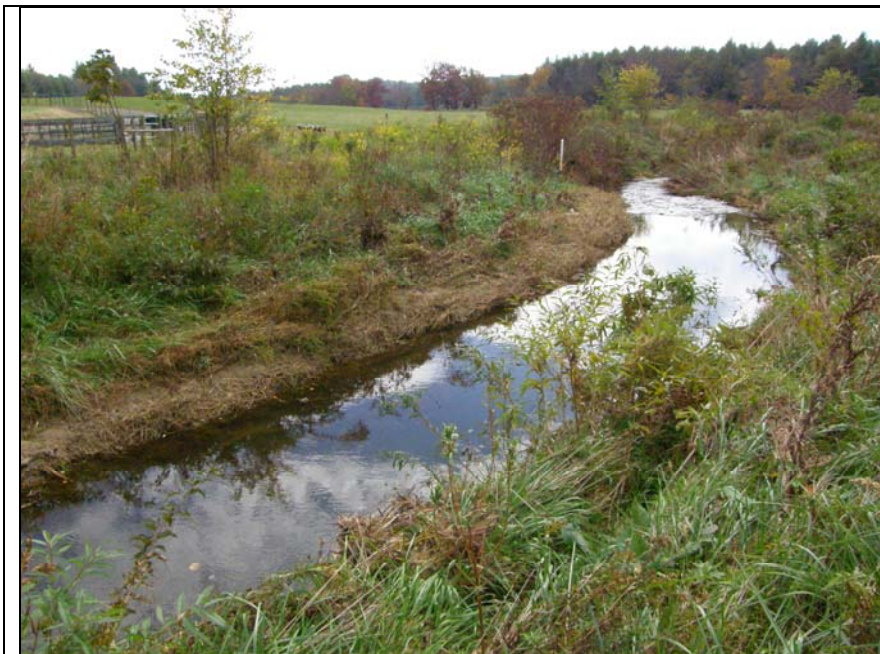
Site: Little Pine Creek
Project No: 54
Photo Station: 2
Date: October 16, 2008
Photographed by: L. Bilbrey
Description: Taken 200 degrees from north. Facing downstream towards riffle cross section 1.

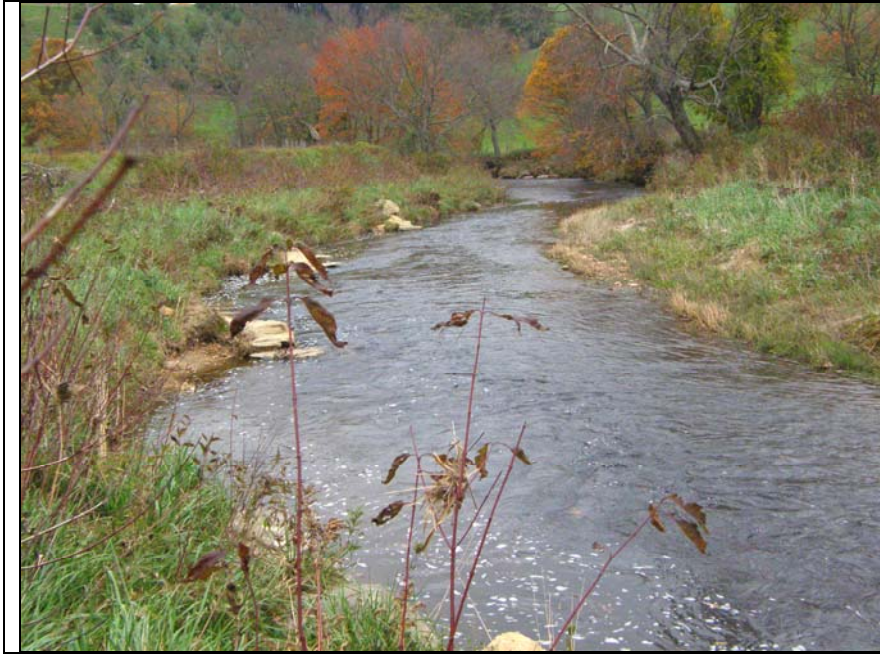
Site: Little Pine Creek
Project No: 54
Photo Station: 15
Date: October 16, 2008
Photographed by: L. Bilbrey
Description: Taken 35 degrees from north

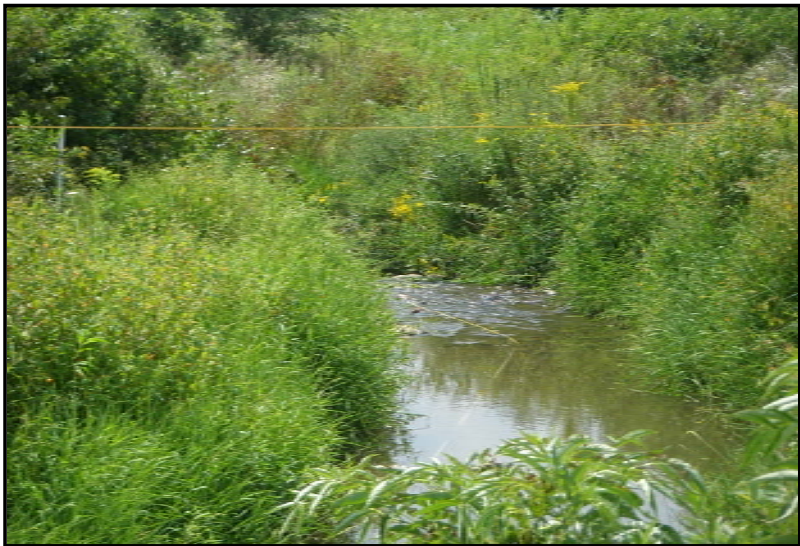
Project Name	Brush Creek Project 54
Cross Section	Little Pine Creek 1 of 3
Feature	Riffle
Date Surveyed	8/19/2008
Crew	Bilbrey, L., Lawson, C.

Facing downstream x-section #1

Bankfull Area			
	AB2	MY6	MY7
Area	45.3	44.4	47.9
Width	24.9	25.4	25.4
Mean Depth	1.8	1.7	1.9
Max Depth	2.8	2.8	3.0
w/d ratio	13.7	14.5	13.5
FPW	105.1	>100	171.0
ER	4.2	3.9	6.7

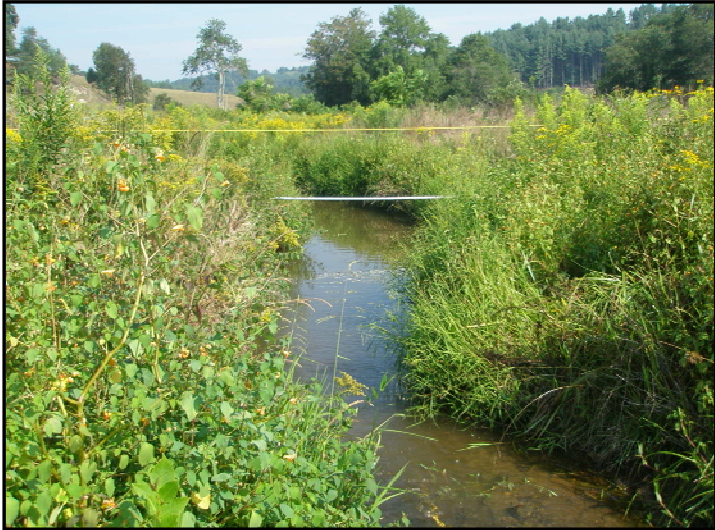
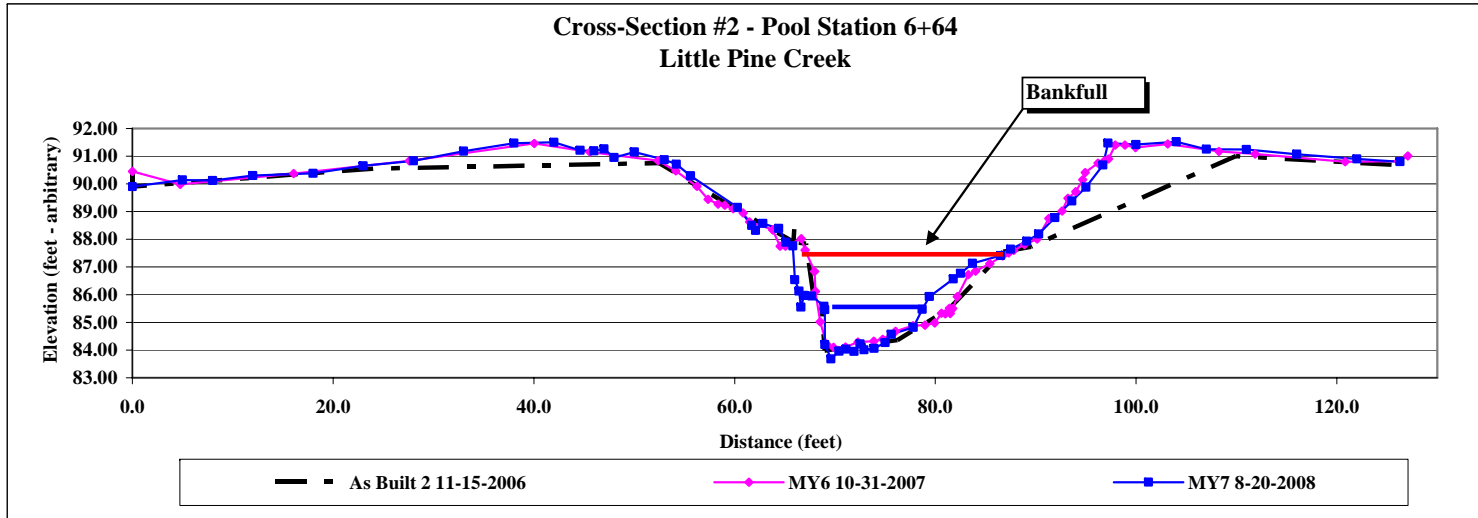
Project Name	Brush Creek Project 54
Cross Section	Little Pine Creek 2 of 3
Feature	Pool
Date Surveyed	8/20/2008
Crew	Bilbrey, L., Lawson, C.

Bankfull Area			
	AB2	MY6	MY7
Area	54.35	51.85	40.21
Width	24.7	26.4	20.6
Mean Depth	2.2	2.0	1.9
Max Depth	3.9	3.8	3.7
w/d ratio	11.2	13.4	n/a
FPW	126.1	>100	n/a
ER	5.1	3.8	n/a

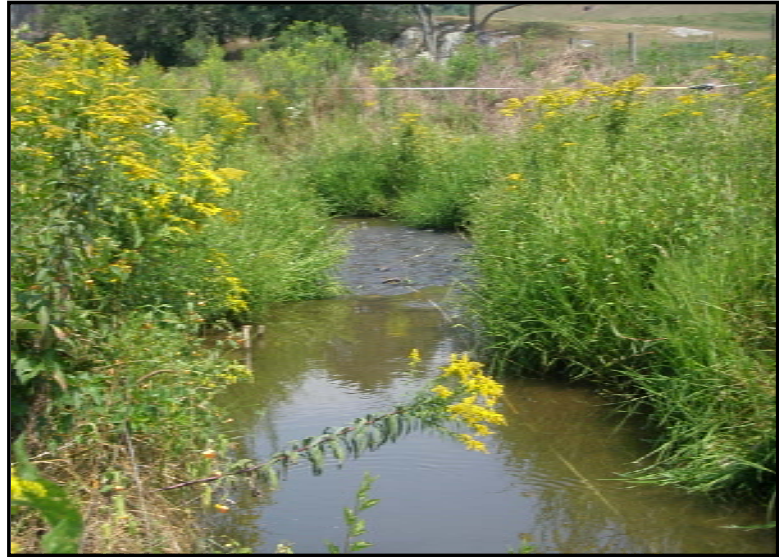
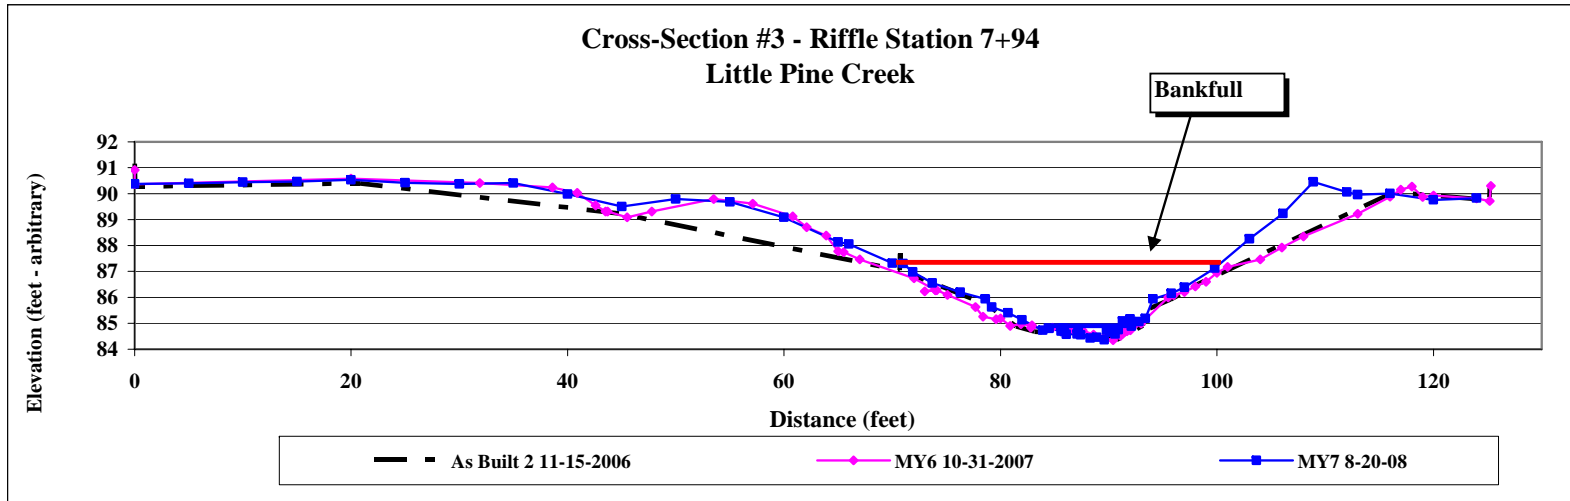
Project Name	Brush Creek Project 54
Cross Section	Little Pine Creek 3 of 3
Feature	Riffle
Date Surveyed	8/20/2008
Crew	Bilbrey, L., Lawson, C.

Bankfull Area			
	AB2	MY6	MY7
Area	45.3	45.97	48.3
Width	24.9	34.0	30.3
Mean Depth	1.8	1.4	1.6
Max Depth	2.8	2.8	3.0
w/d ratio	13.7	25.1	19.1
FPW	105.1	>100	73.9
ER	4.2	2.9	2.4

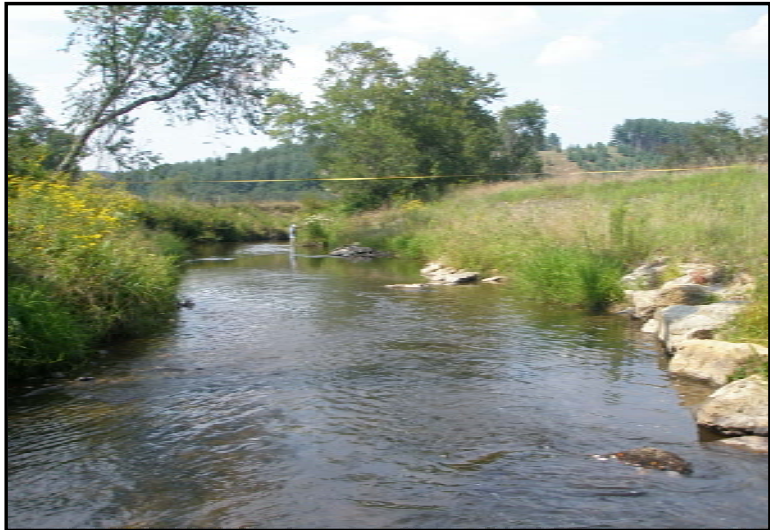
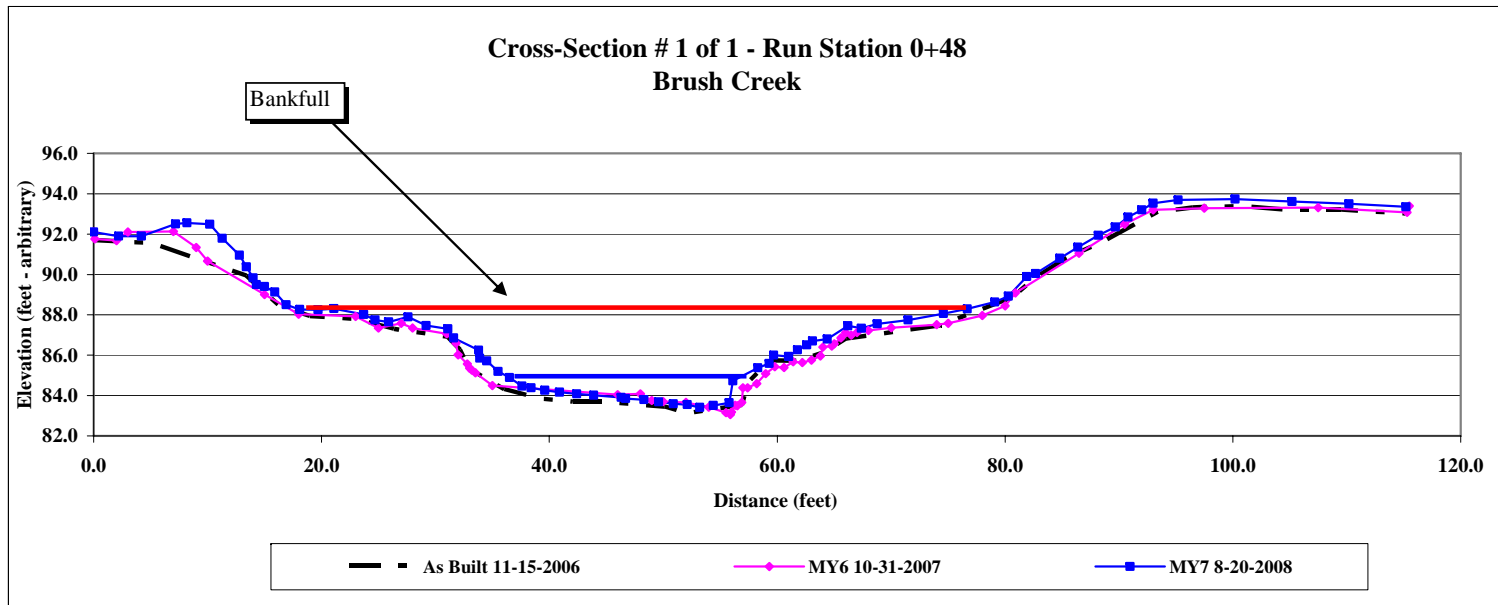
Project Name	Brush Creek Project 54
Cross Section	Brush Creek 1 of 1
Feature	Run
Date Surveyed	8/20/2008
Crew	Bilbrey, L., Lawson, C.

Bankfull Area			
	AB2	MY6	MY7
Area	177.5	45.97	128.8
Width	63.5	34.0	56.6
Mean Depth	2.8	1.4	2.3
Max Depth	5.5	2.8	4.8
w/d ratio	22.8	25.1	24.9
FPW	181.8	>100	225.0
ER	2.9	2.9	4.0

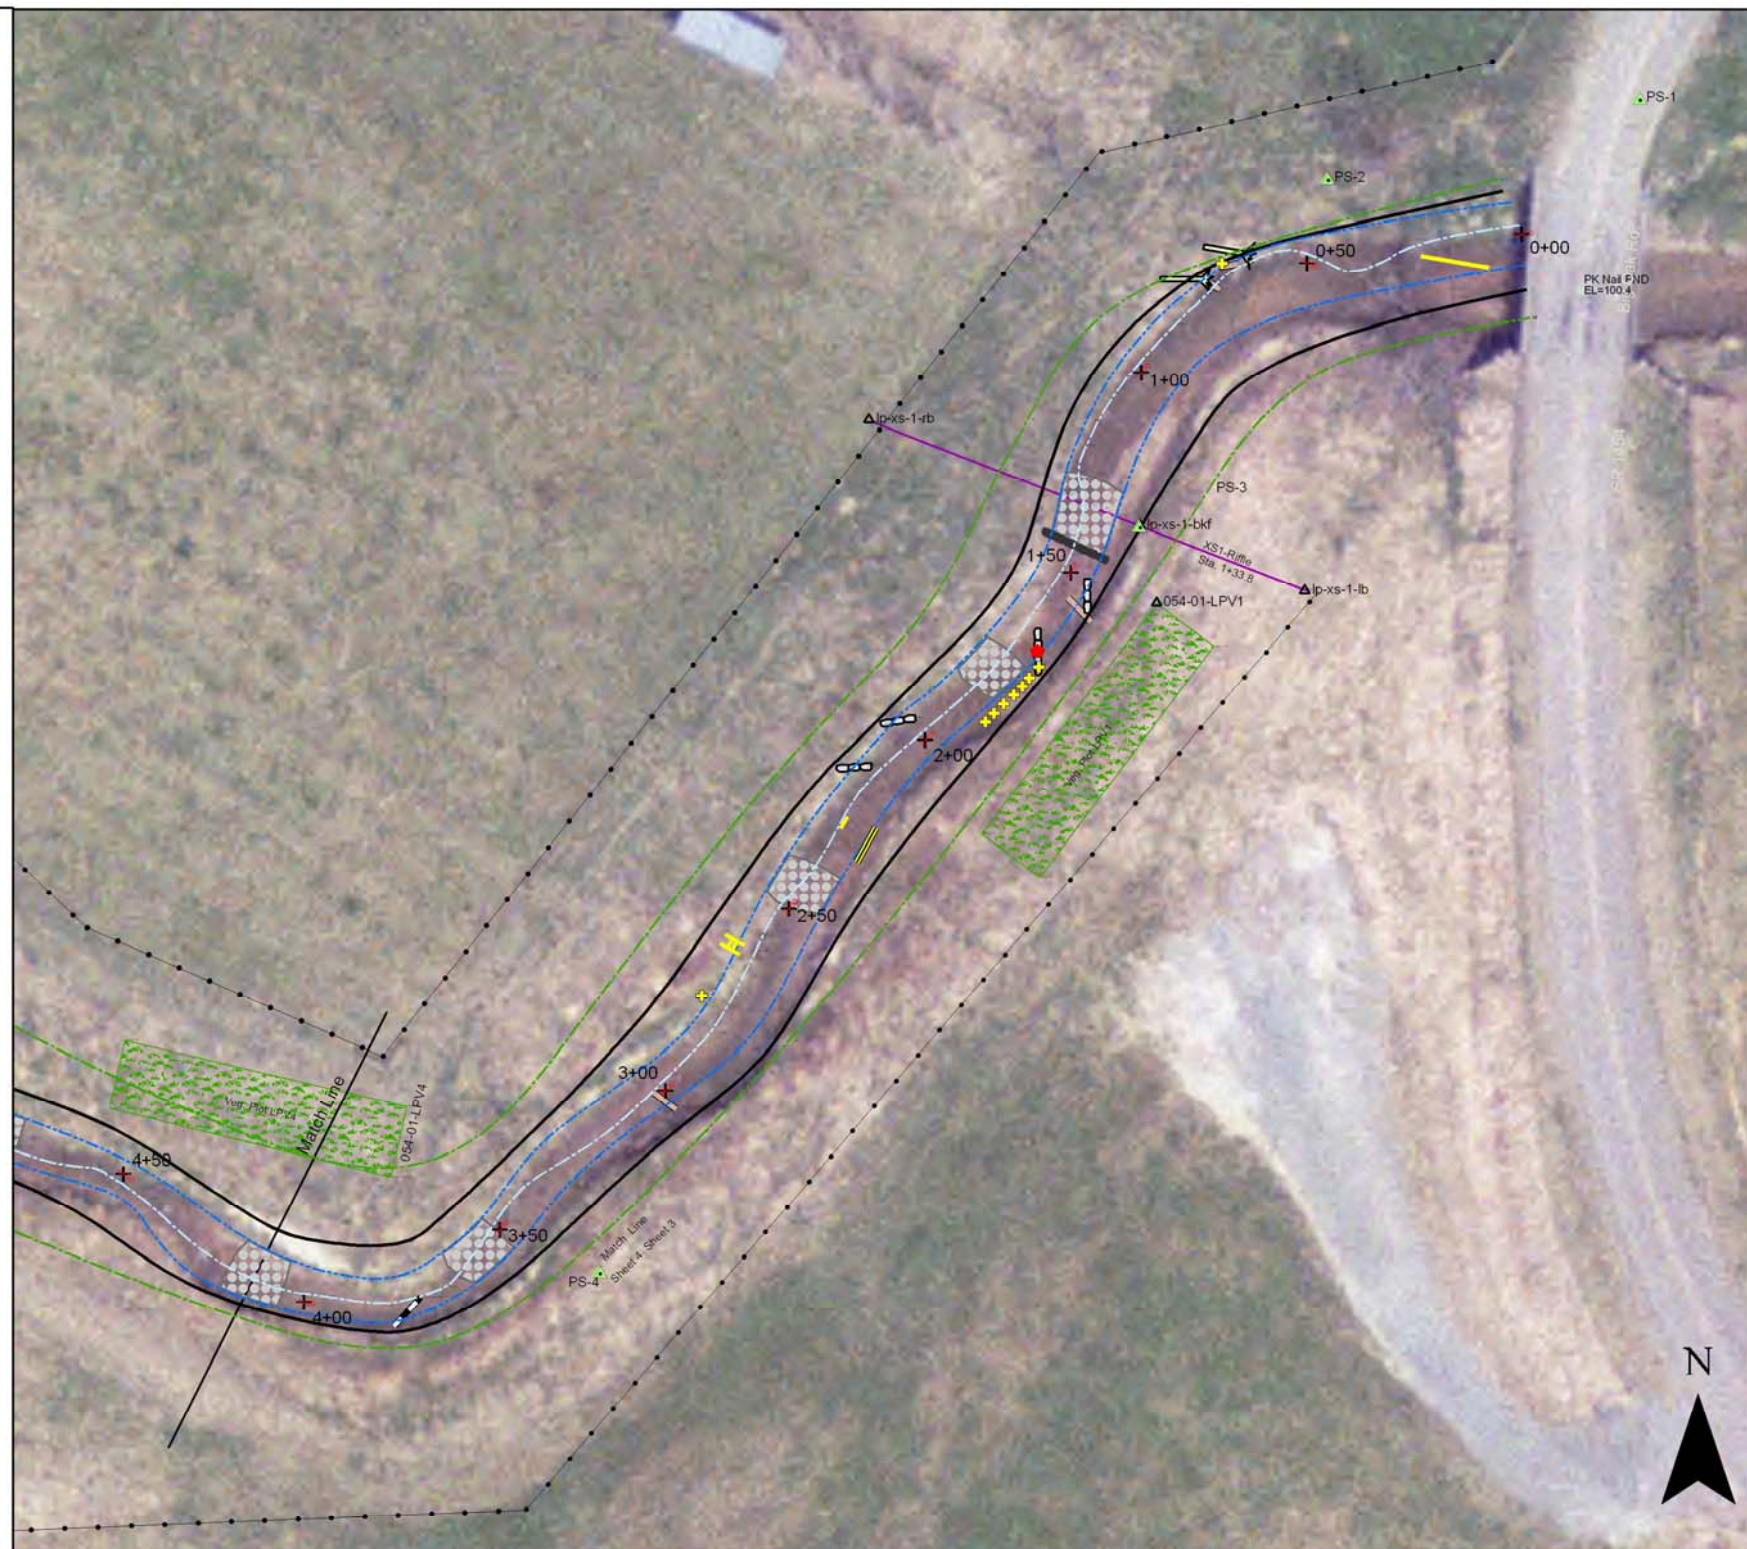
Current Condition
Plan View

- Bare Bank
- To Be Watched
- Failed

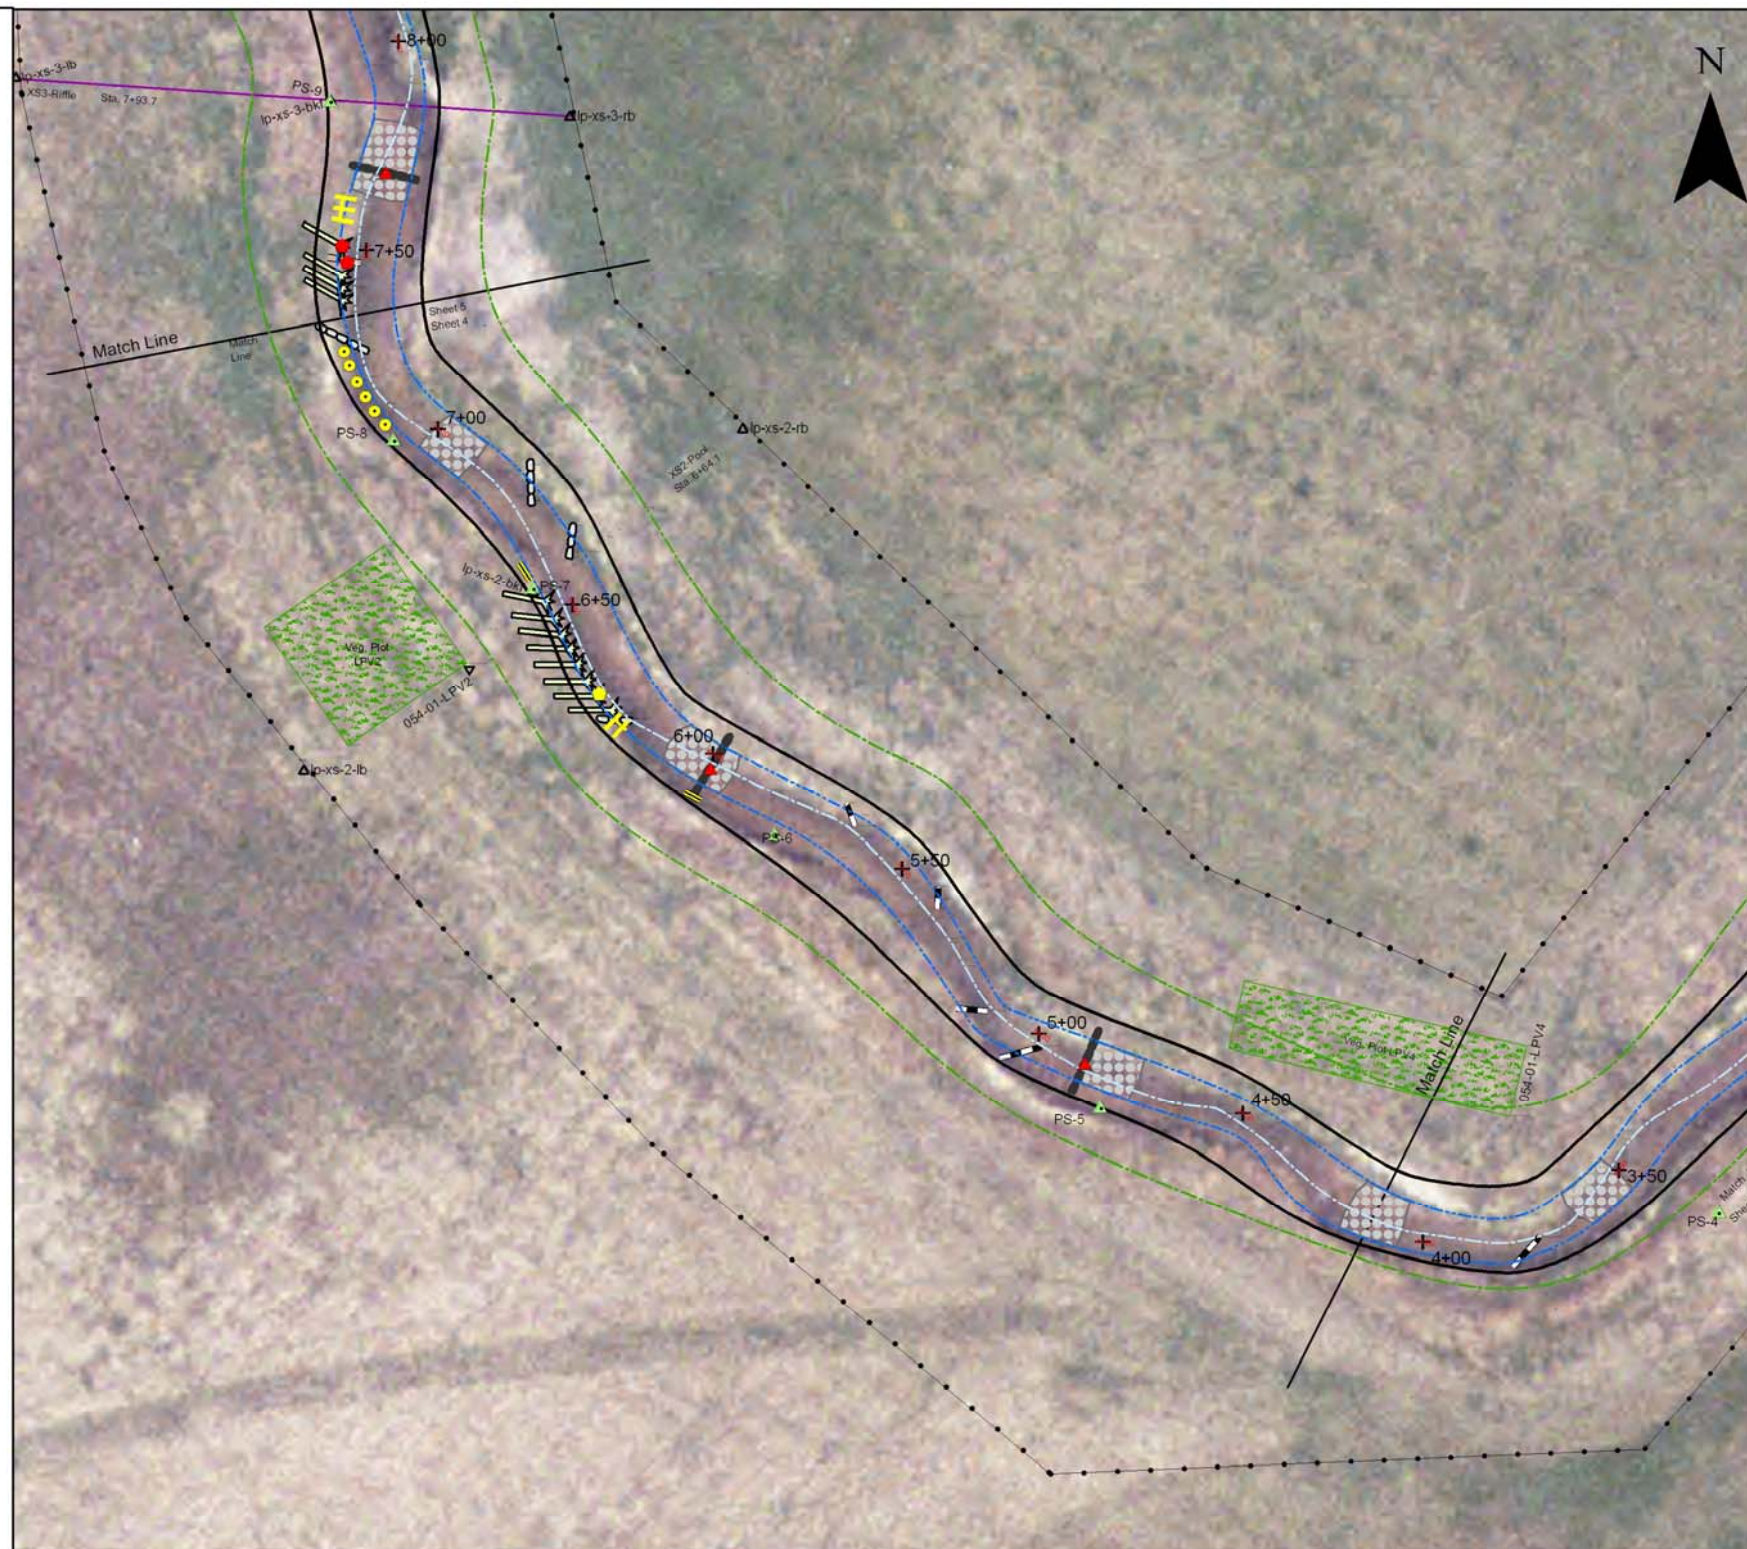
**Current Condition
Plan View**

- Bare Bank**
 To Be Watched (Yellow circle with cross)
 Failed (Red circle with cross)

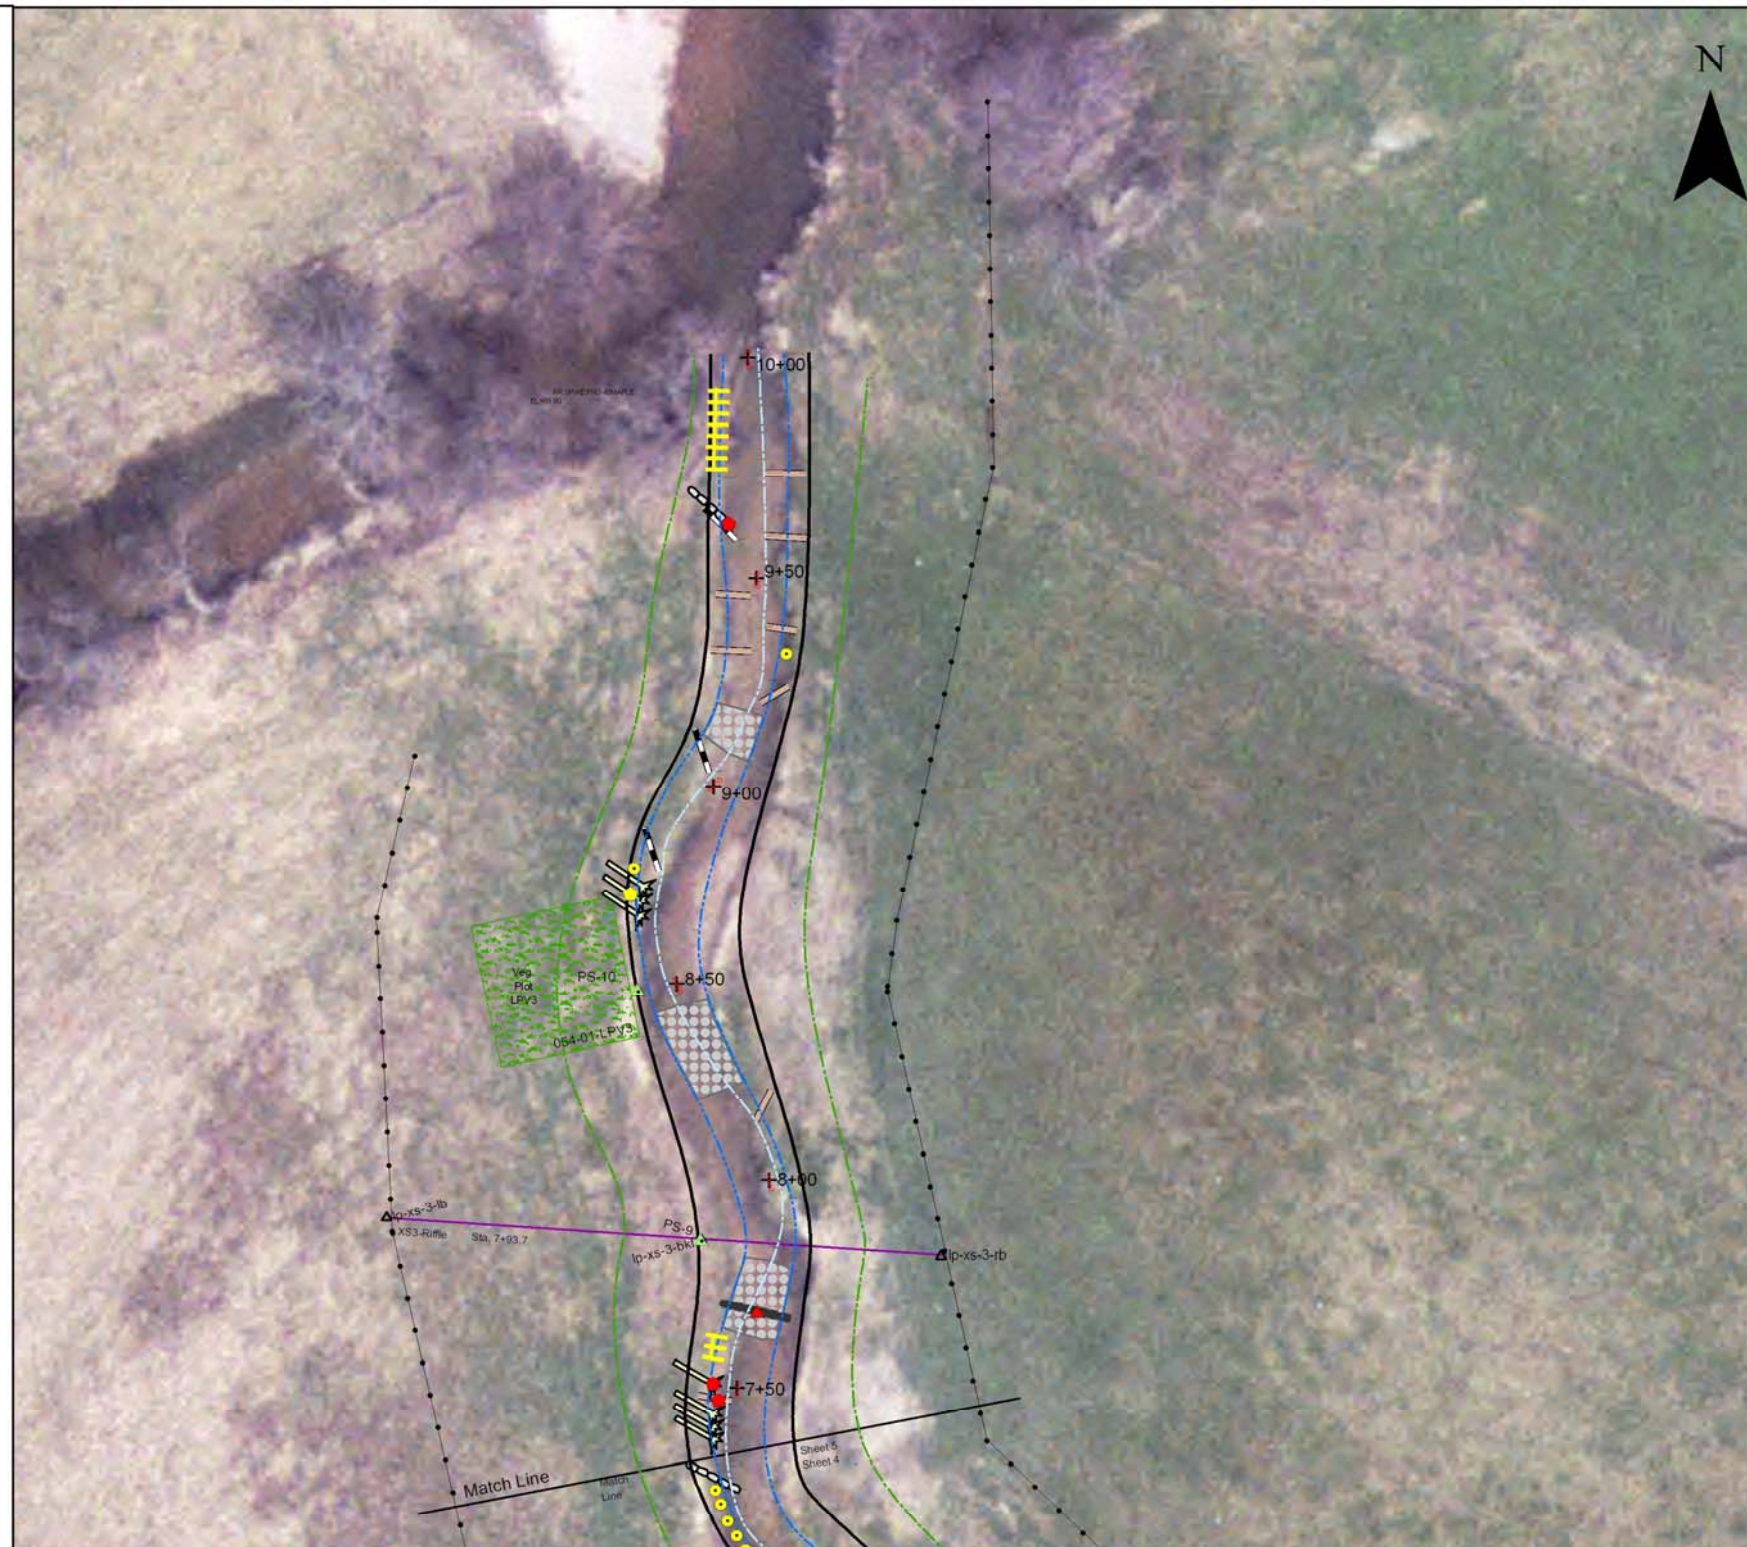
**Current Condition
Plan View**

- Bare Bank**
 To Be Watched (yellow circle with cross)
 Failed (red cross)

- Engineered Structures Other**
 To be watched (yellow circle)
 Failed (red circle)
- Engineered Structures Grade**
 Failed (red triangle)
- Mammal Holes**
 To Be Watched (yellow circle with dot)
 Failed (red circle)
- Slumped Bank**
 To Be Watched (yellow line)
 Failed (red line)
- Bank Scour**
 To Be Watched (yellow H-pattern)
 Failed (red H-pattern)
- Aggradation/Bar Formation**
 To Be Watched (yellow line)
 Failed (red line)

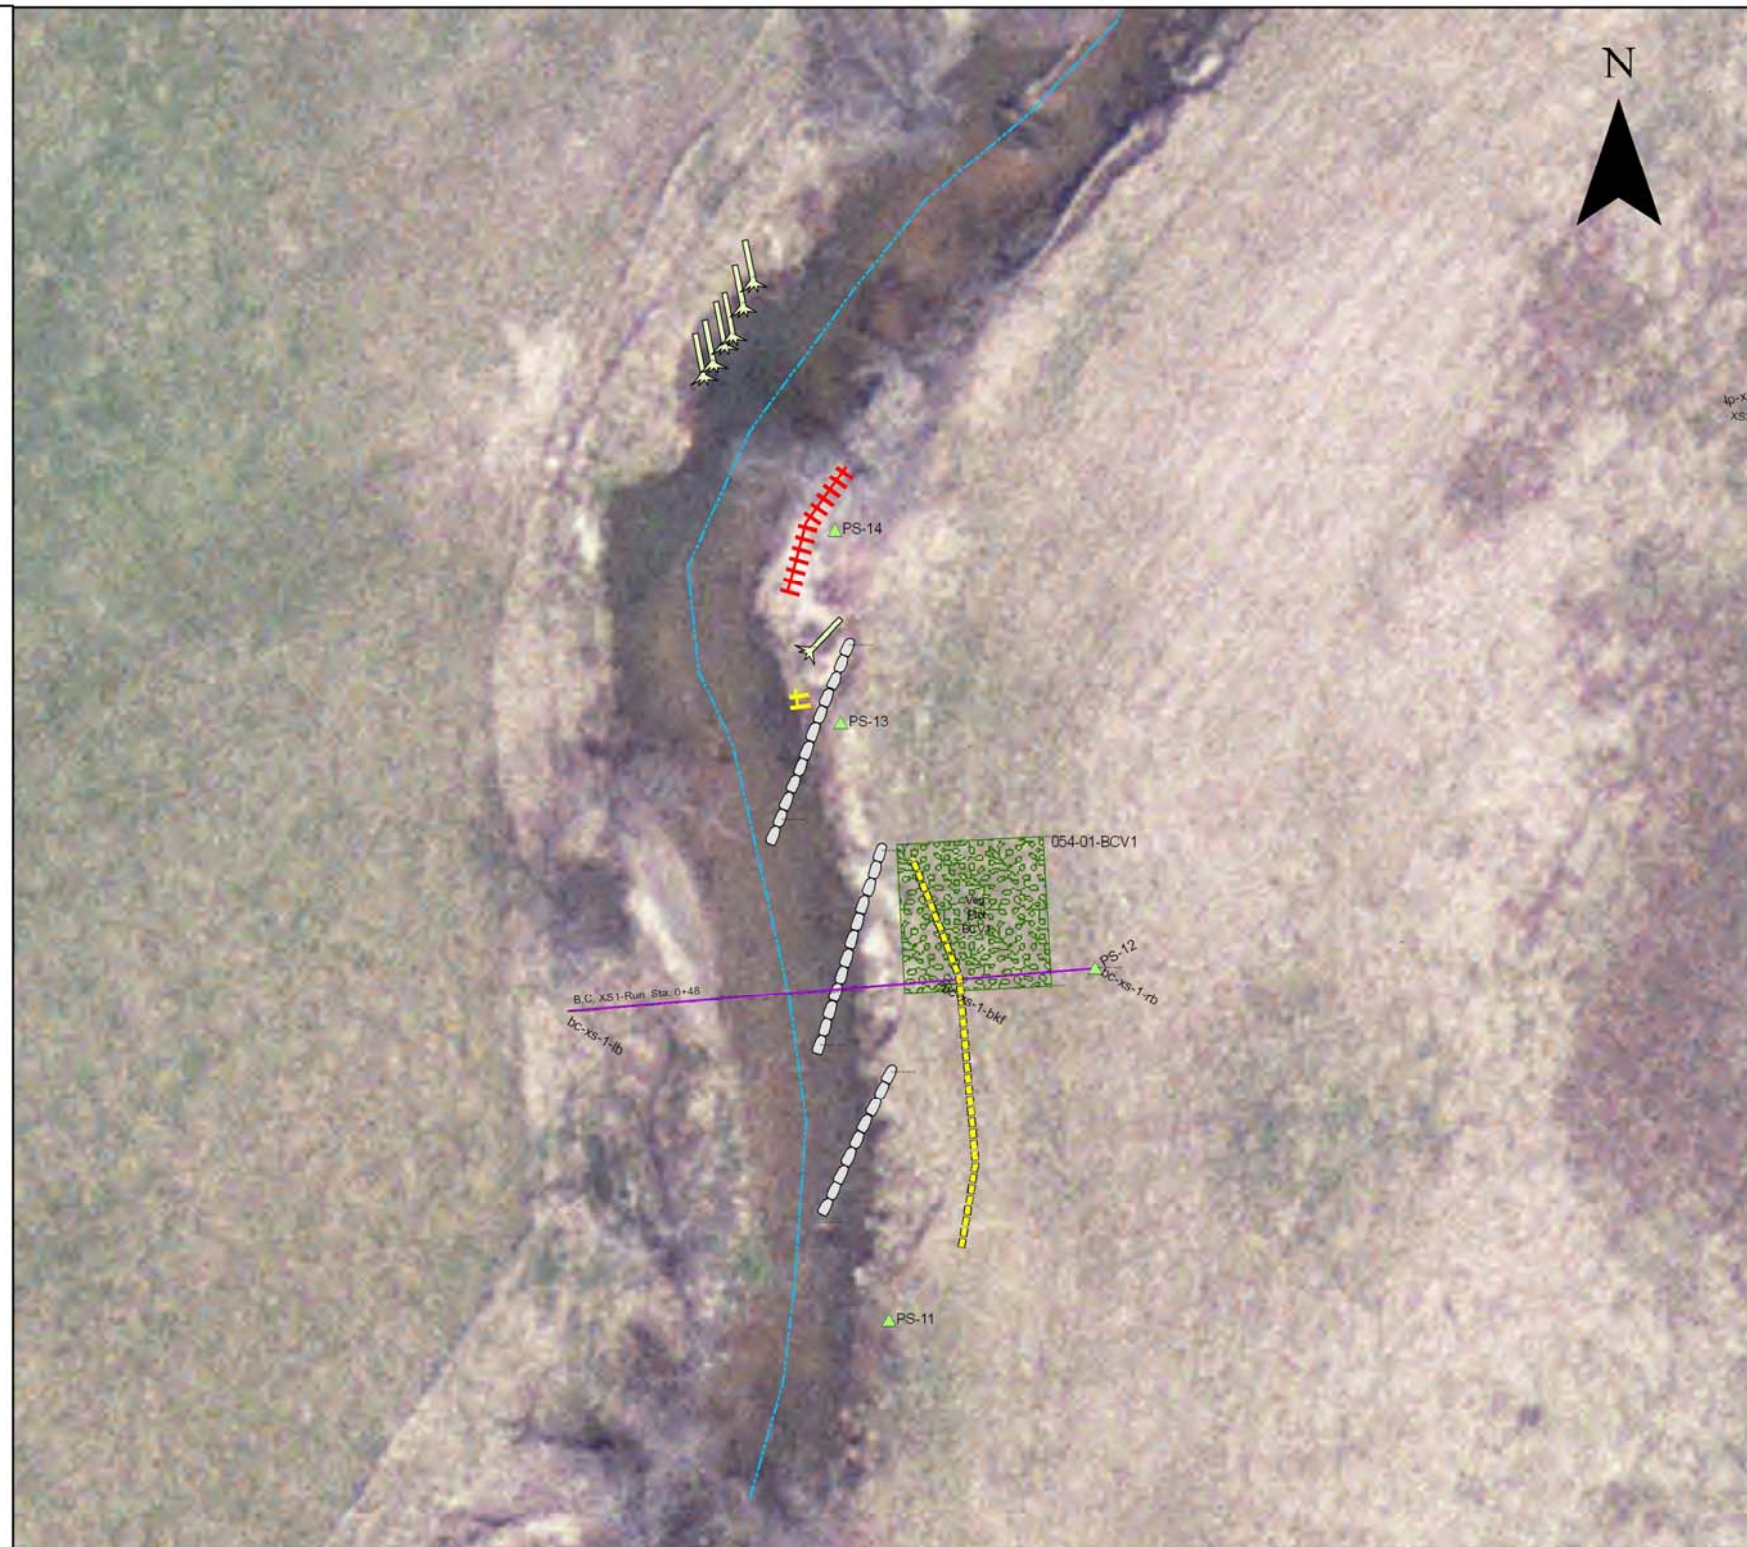
Current Condition
Plan View

----- Failed
