BRUSH CREEK – PROJECT NO. 54

MONITORING YEAR 9

2010 Monitoring Report

Fish and Wildlife Associates, Inc.

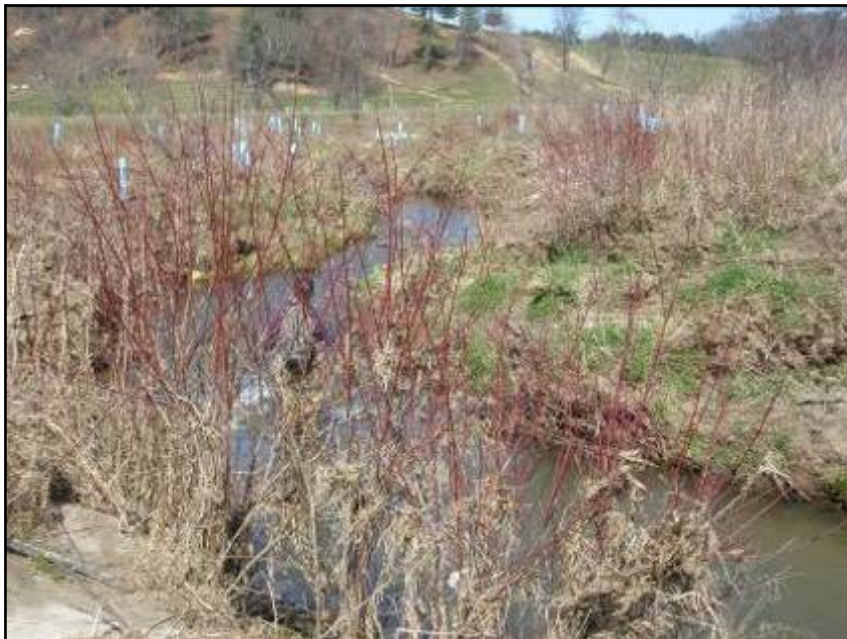
Site: Little Pine Creek
Project No: 54
Photo Station: 5
Date: March 31, 2010
Photographed by: C. Lawson
Description: Taken 300 degrees from north, facing downstream towards breached rock sill.

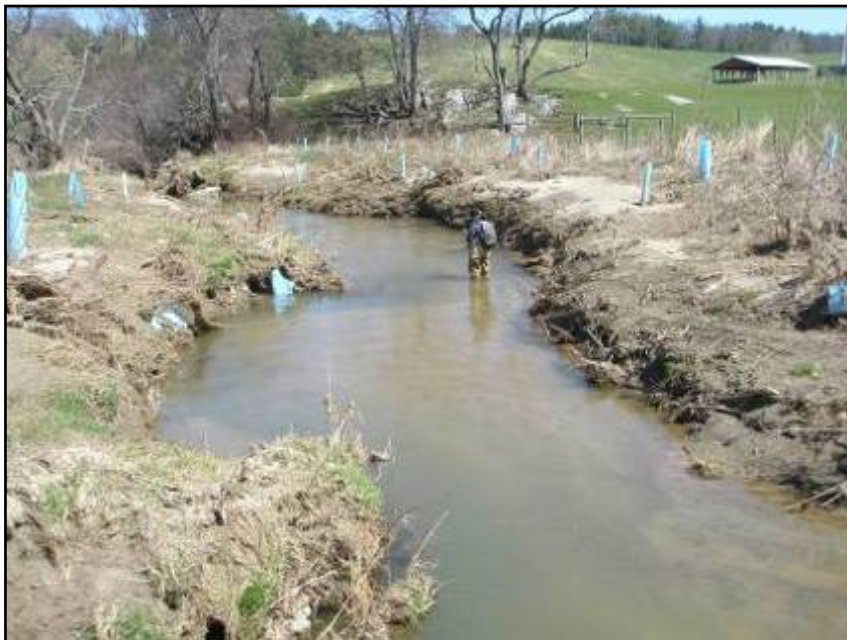
Site: Little Pine Creek
Project No: 54
Photo Station: 10
Date: March 31, 2010
Photographed by: C. Lawson
Description: Taken 20 degrees from north, water flowing under root wads along left descending bank.

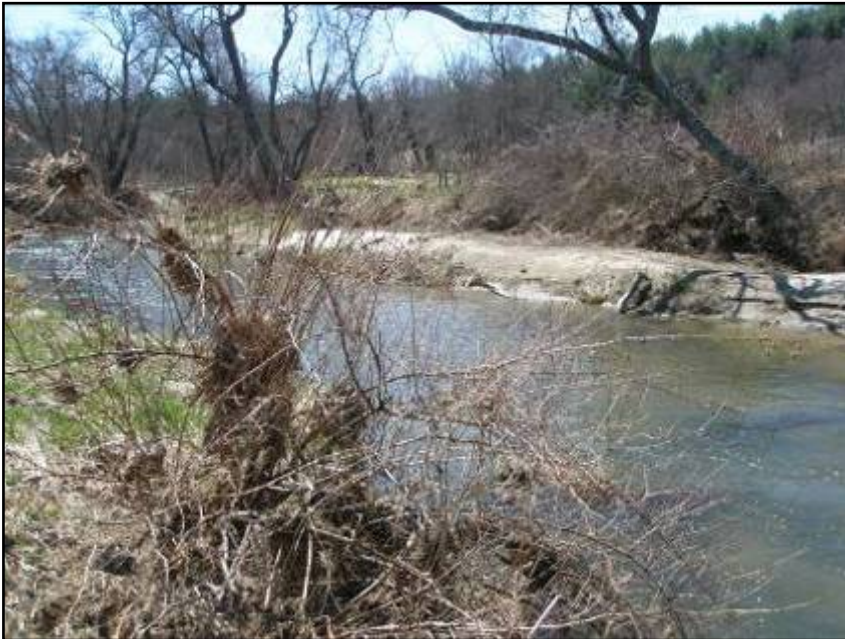
Site: Brush Creek
Project No: 54
Photo Station: 14
Date: March 31, 2010
Photographed by: C. Lawson
Description: Taken 190 degrees from north, facing upstream, bank scour is visible along the right descending bank.

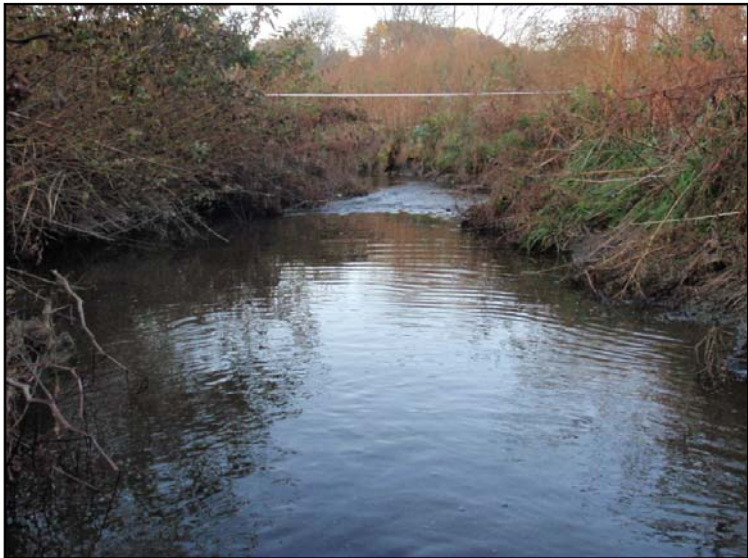
River Basin	New
Watershed	Brush Creek, MY9
Project Name	Brush Creek Project 54
Cross Section	Little Pine Creek 3 of 3
Feature	Riffle
Date Surveyed	10/22/2010
Crew	Lawson, C., Laseter, B.

Facing down stream x-section #3

* Left pin was reset Oct-2010.

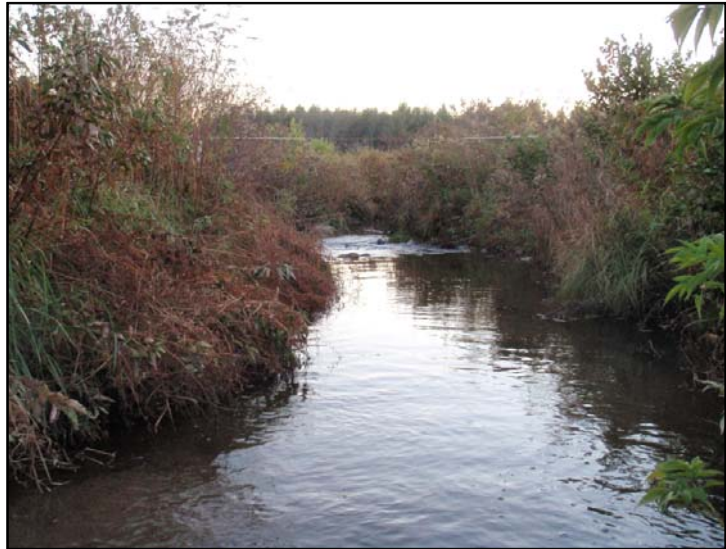
River Basin	New
Watershed	Brush Creek, MY9
Project Name	Brush Creek Project 54
Cross Section	Brush Creek 1 of 1
Feature	Run
Date Surveyed	10/22/2010
Crew	Lawson, C., Laseter, B.

Facing downstream x-section #1
