MONITORING YEAR 1 ANNUAL REPORT FINAL

BUCKWATER MITIGATION SITE

Orange County, NC

DMS Project Number 97084

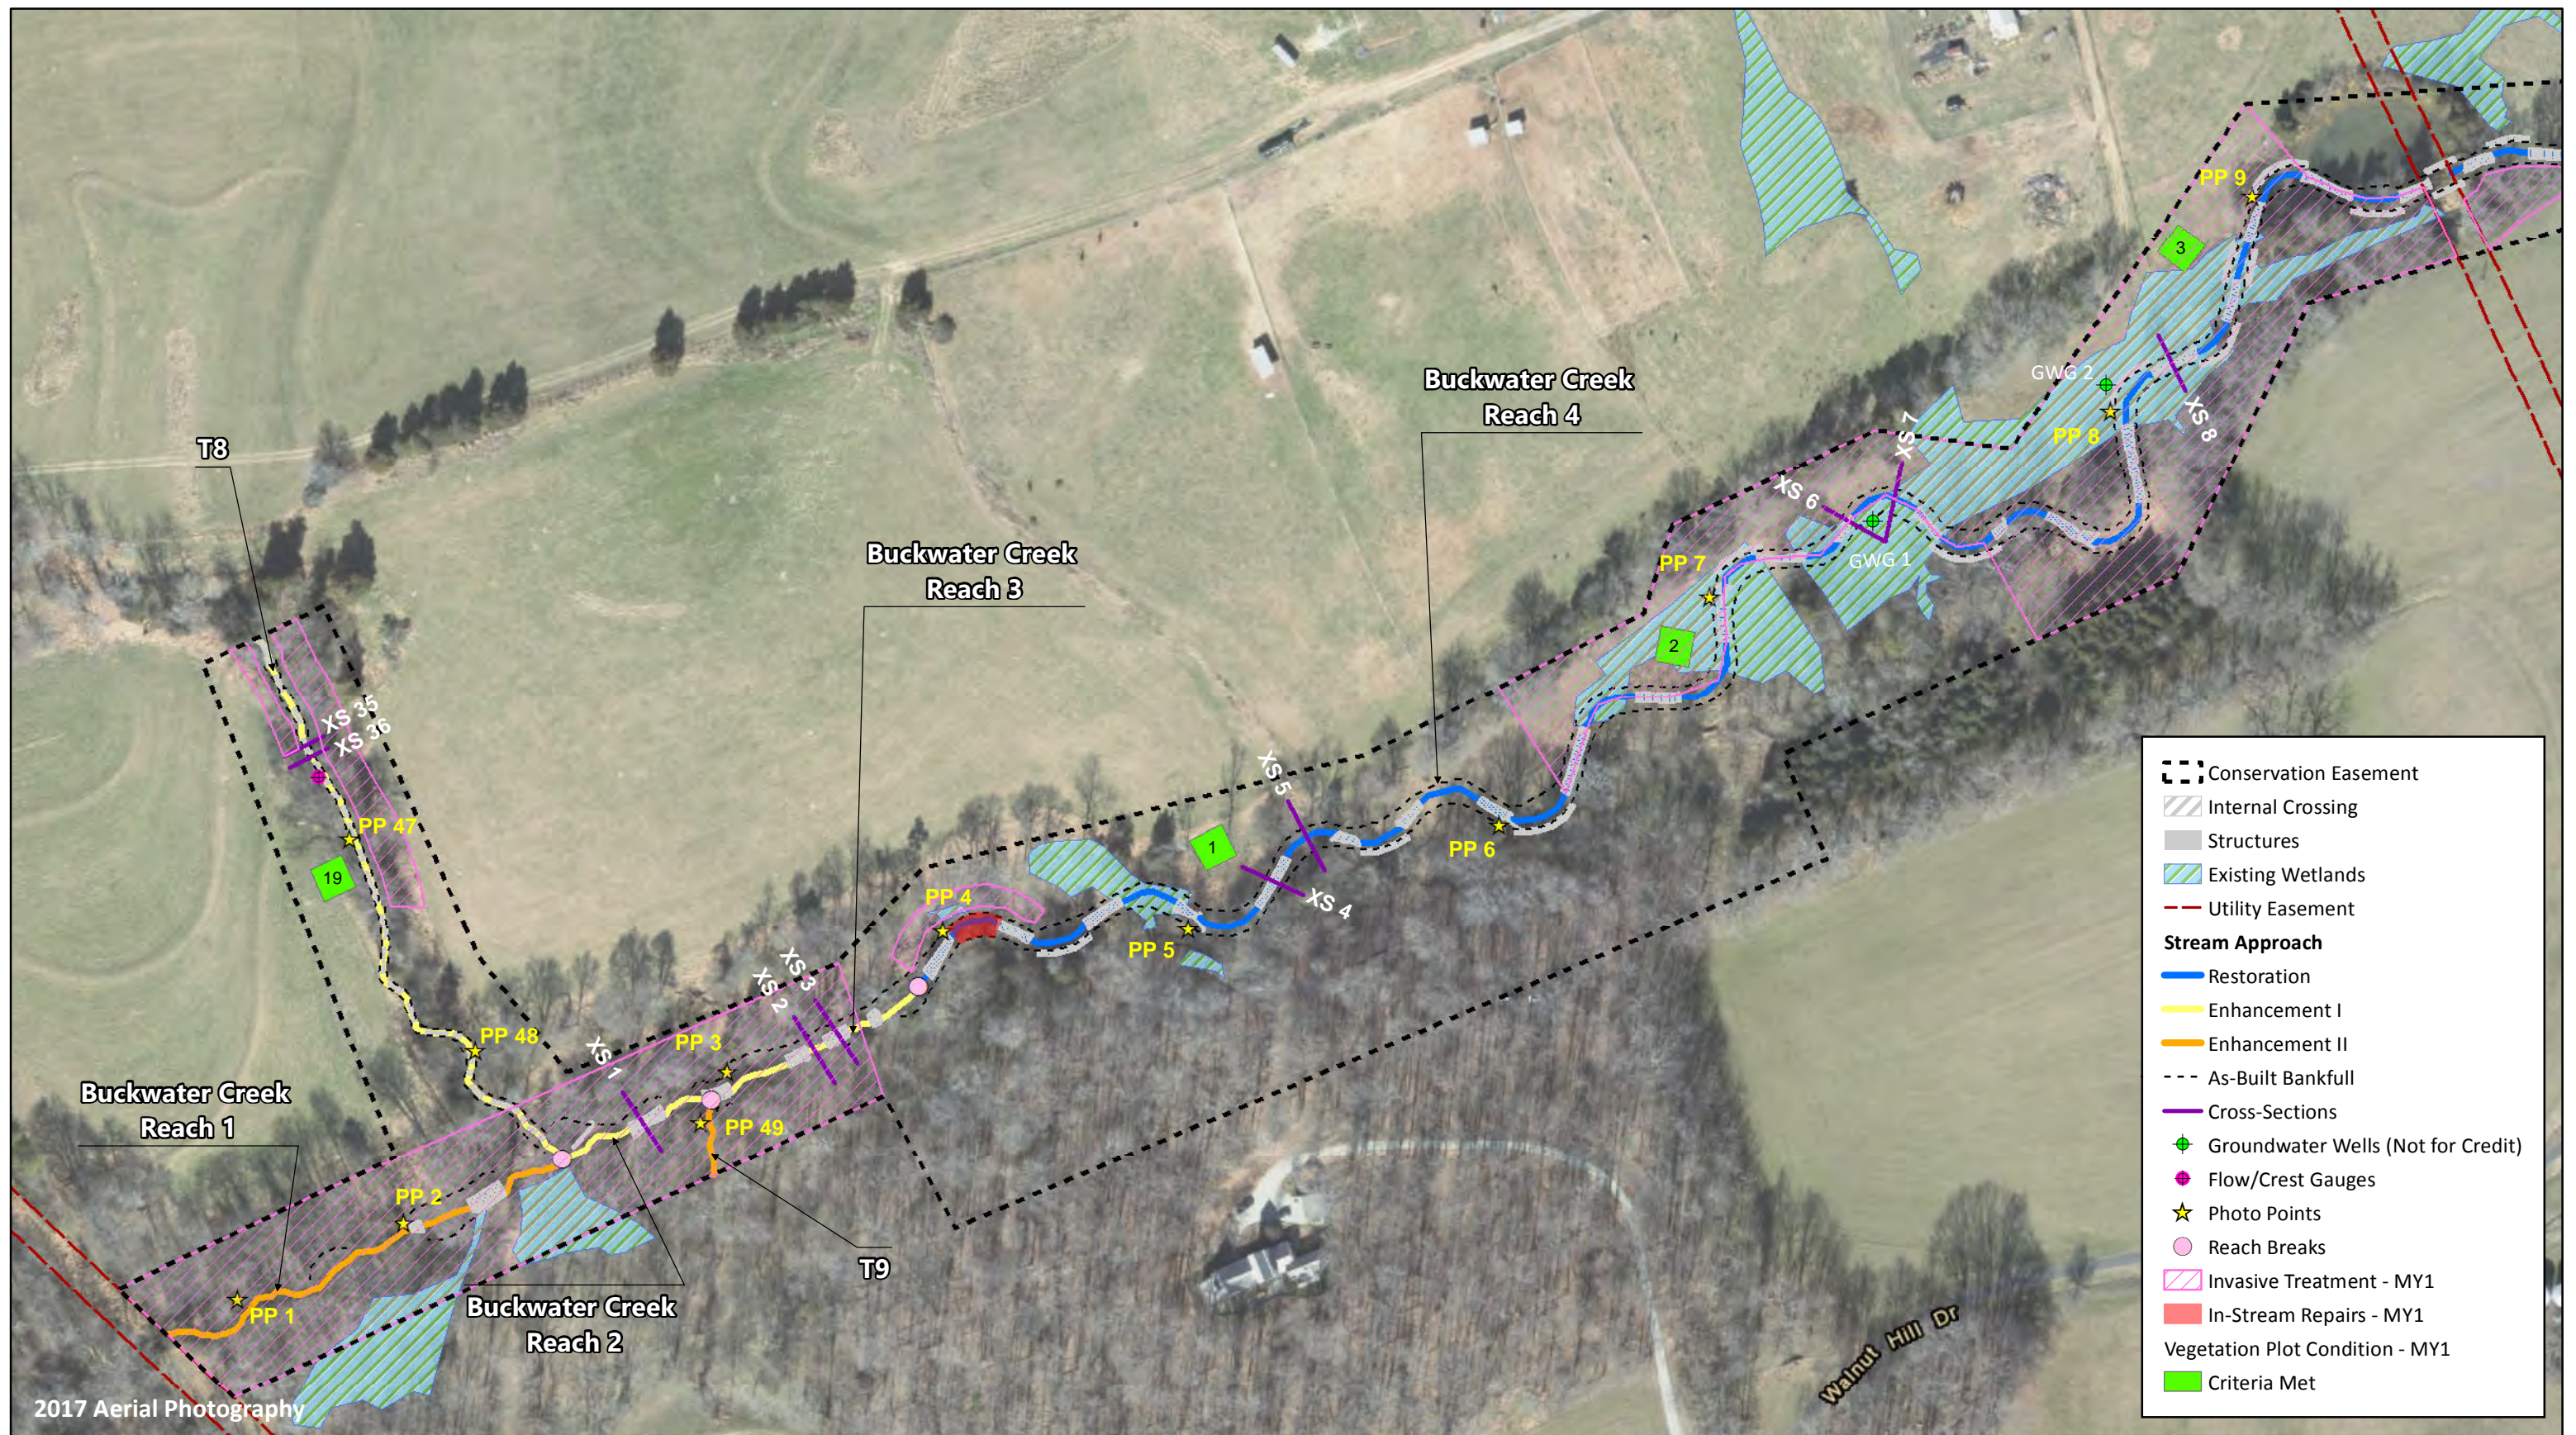
Figure 3b. Integrated Current Condition Plan View
 Buckwater Mitigation Site
 DMS Project No. 97084
 Monitoring Year 1 - 2019

During an IRT site walk on November 21, 2019, bank erosion was identified on Buckwater Creek Reach 7, which is an Enhancement II section. Bank repairs will be conducted during MY2 and are shown on Figure 3b (CCPV Map, Appendix 2).
