**MONITORING YEAR 2  
ANNUAL REPORT  
FINAL**

**BUCKWATER MITIGATION SITE**

Orange County, NC  
NCDEQ Contract No. 006829  
DMS Project Number 97084  
USACE Action ID Number 2016-00873  
NCDWR Project Number 2016-0406

Data Collection Period: January – October 2020  
Draft Submission Date: November 19, 2020  
Final Submission Date: December 18, 2020

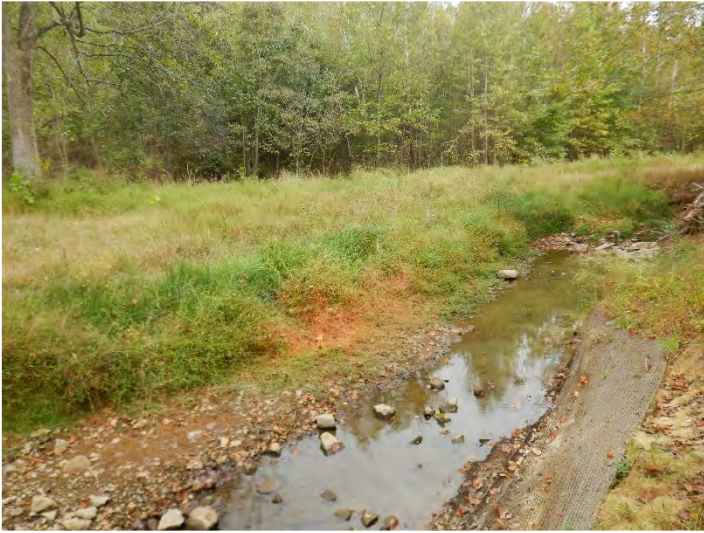
**Stream Areas of Concern Photographs**  
**Buckwater Creek Reach 7**

**Before - Localized Erosion (10/9/2019)**

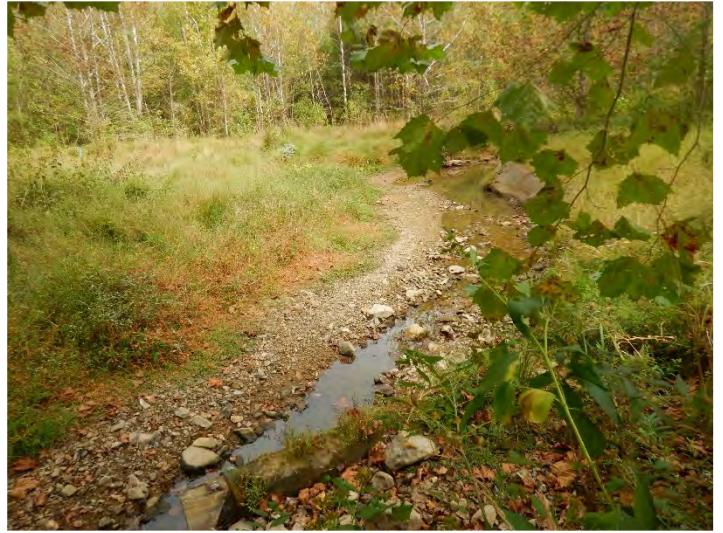
**Before - Localized Erosion (10/9/2019)**
