**MONITORING YEAR 4
ANNUAL REPORT**
Final

BUCKWATER MITIGATION SITE

Orange County, NC
Neuse River Basin
HUC 03020201

DMS Project No. 97084
NCDEQ Contract No. 006829
USACE Action ID No. 2016-00873
DWR Project No. 2016-0406 v2

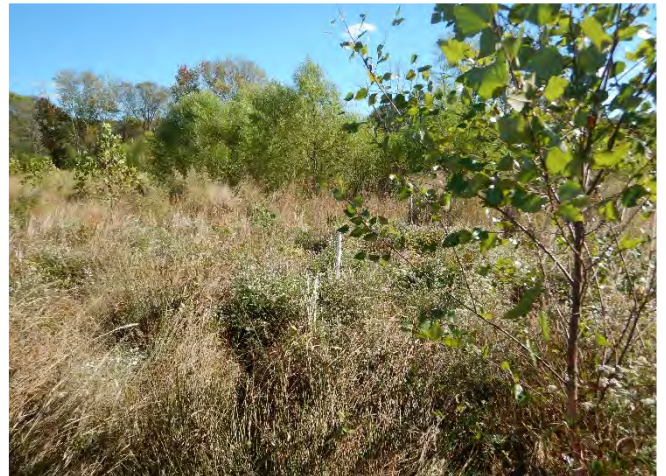
T5 – Additional wetland area (10/6/2022)
